Parks Canada Basic Impact Analysis

Horseshoe Lake Dam Replacement
Trent-Severn Waterway
Horseshoe Lake, 1902 Horseshoe Lake Road, Minden Hills

4. INTERNAL PROJECT FILE # TSW-2016-005 (I)

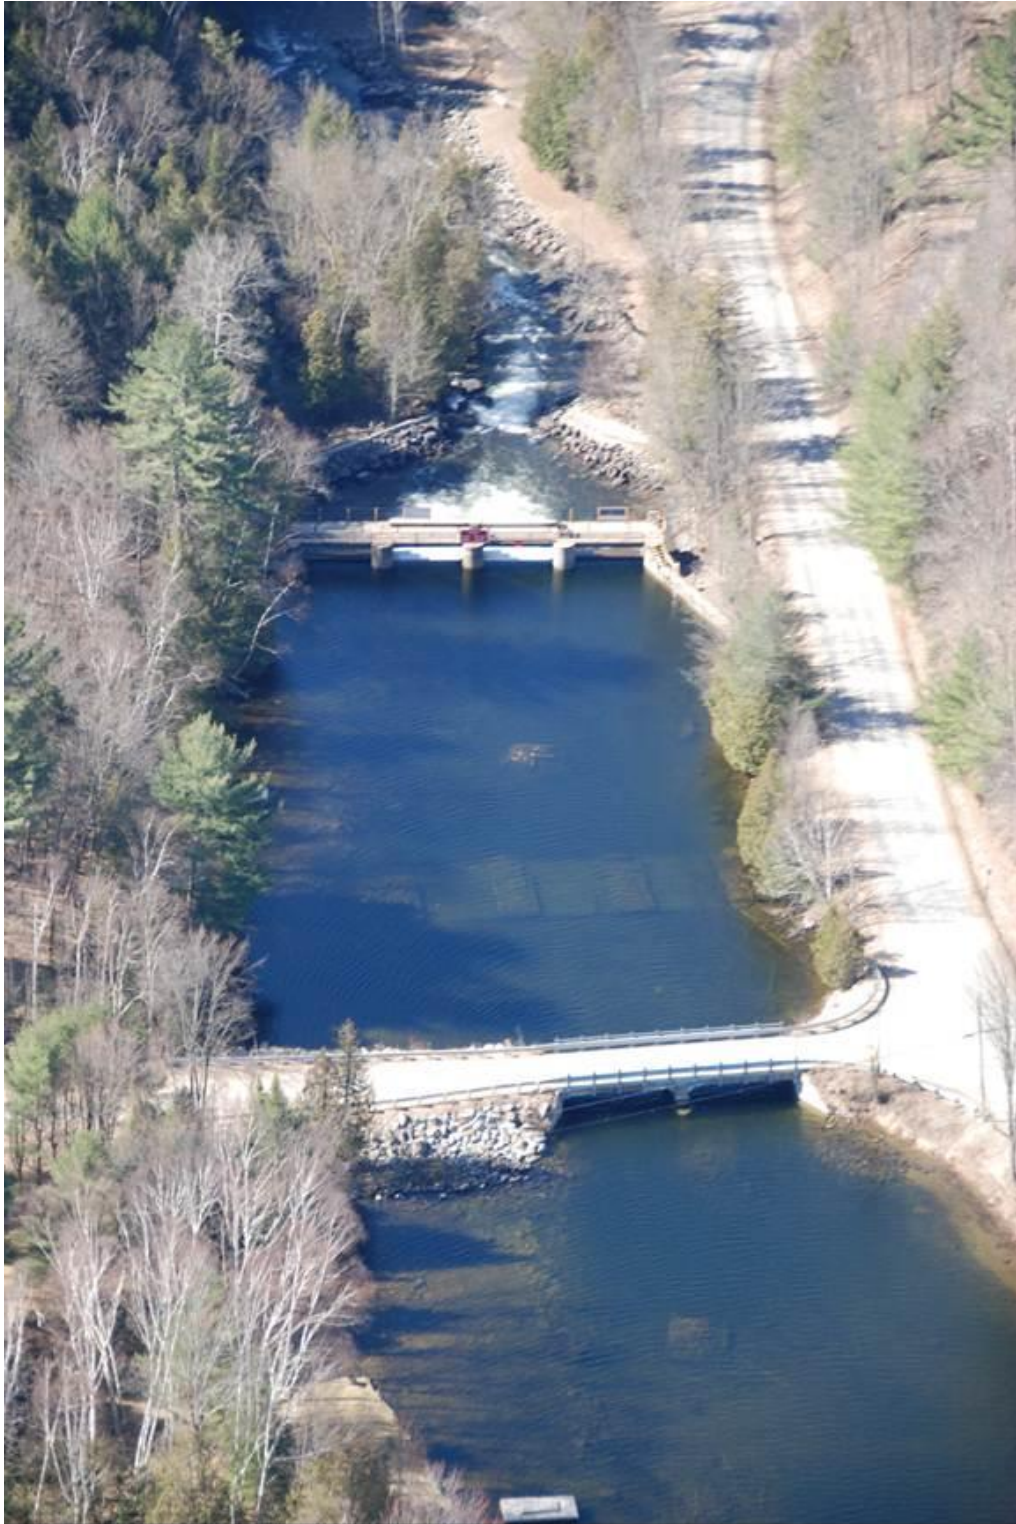
1 Airplane view of the dam looking downstream/south. Remnants of the old timber dam are in the foreground.

Horseshoe Lake Dam was constructed in 1909 (**Attachment 4 – Section Historical Background**). The dam was last recapitalized circa 1948 when major concrete repairs were completed at the toe of the dam's piers and along the wing walls. The deck was also replaced prior to 1948. The submerged remnants of the historical dam – which has value to Parks Canada - are located upstream. (Photo #1, Appendix 2).

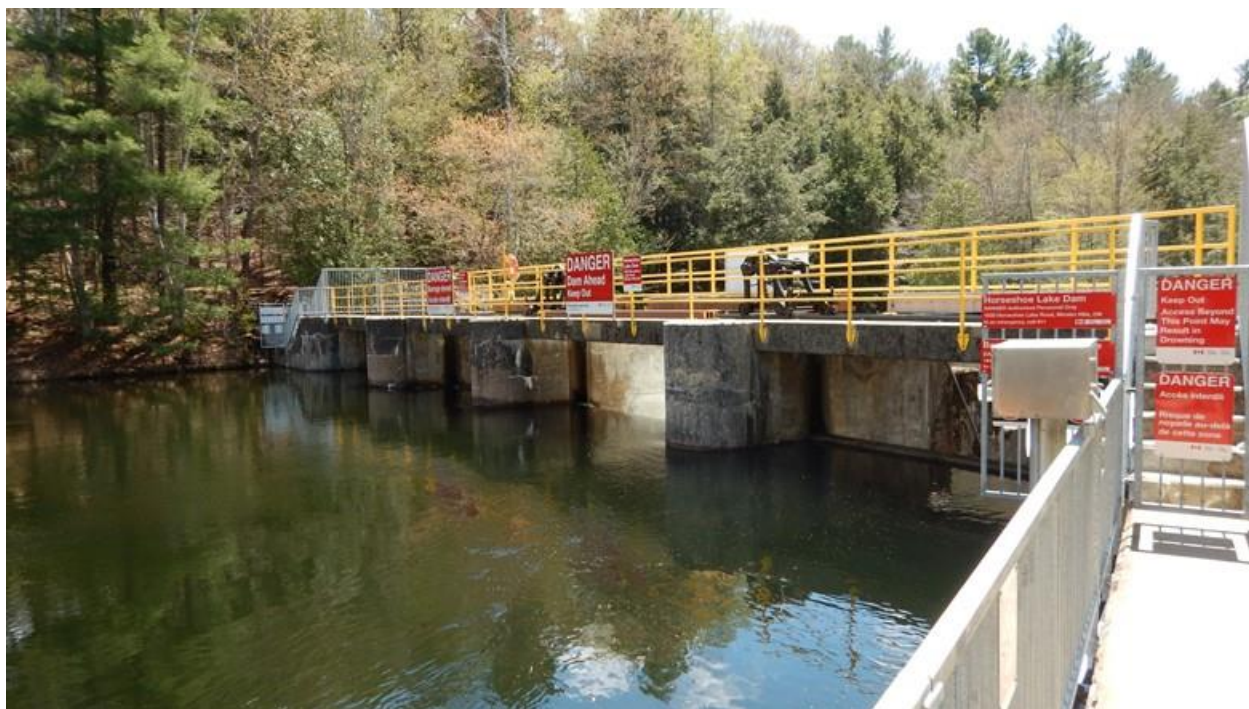
2 Upstream of Horseshoe lake dam, looking southeast.

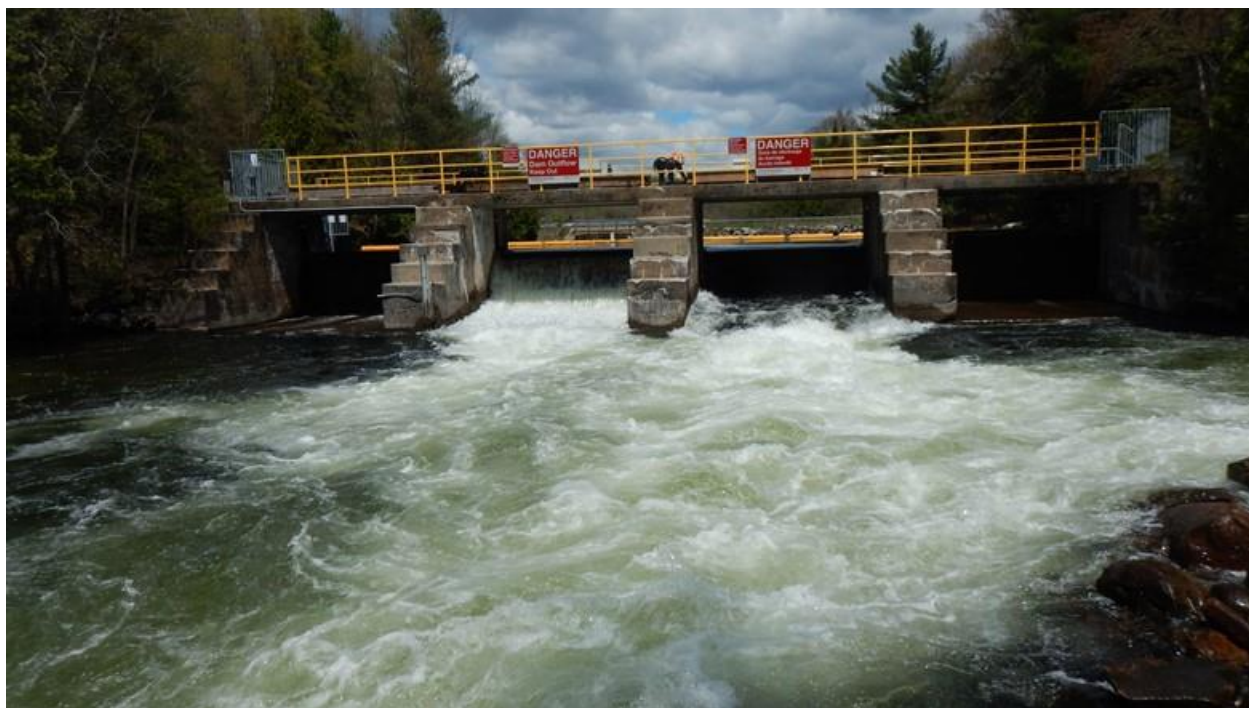
3 Tailrace of Horseshoe lake dam

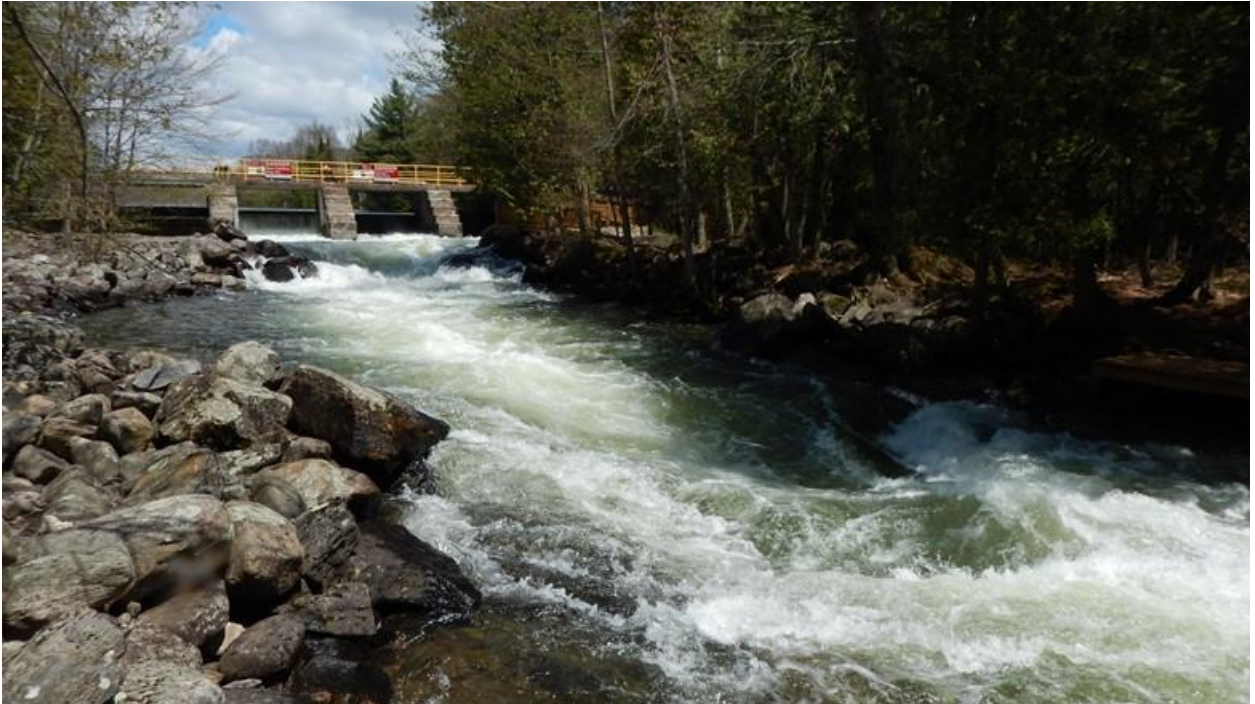
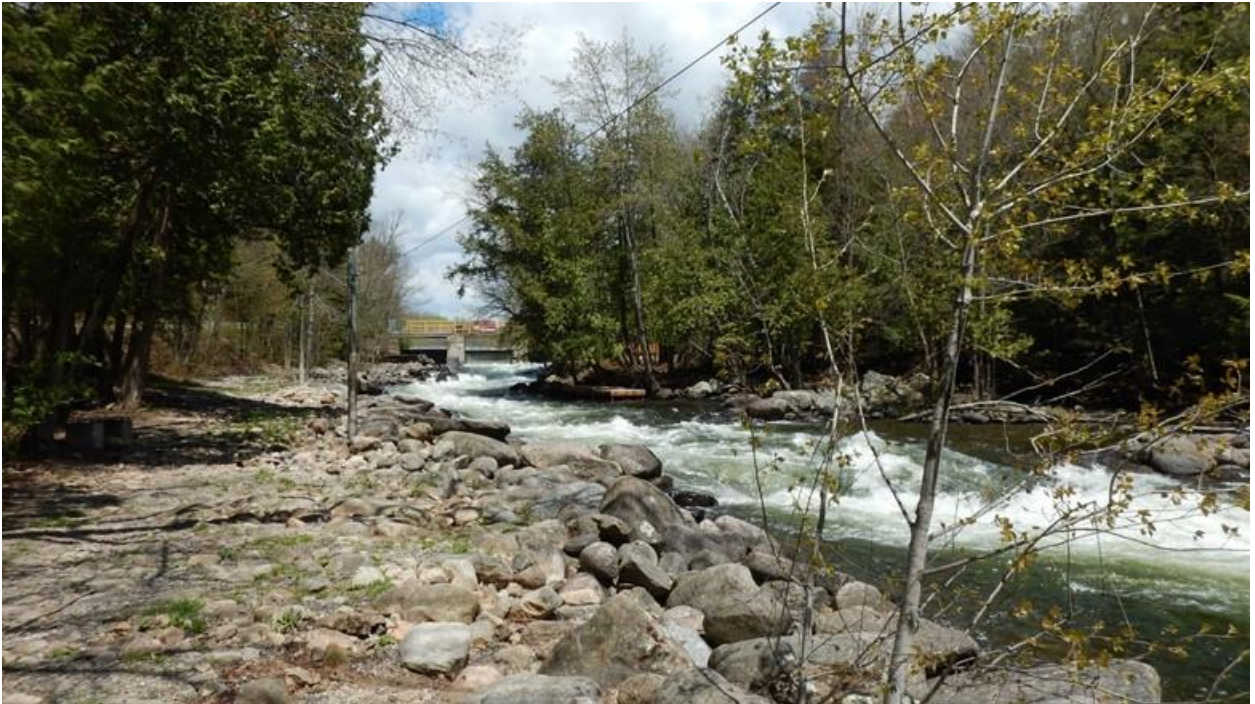
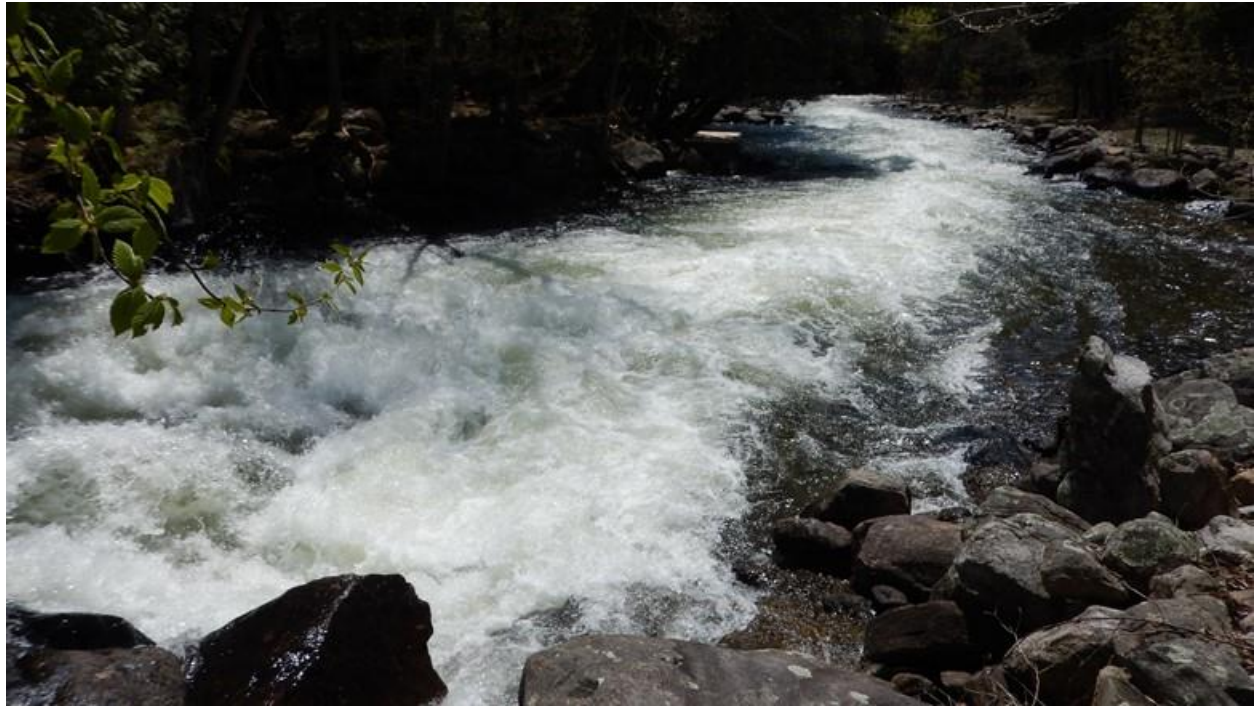
4 a) b), c) River conditions below Horseshoe Dam – May 2016

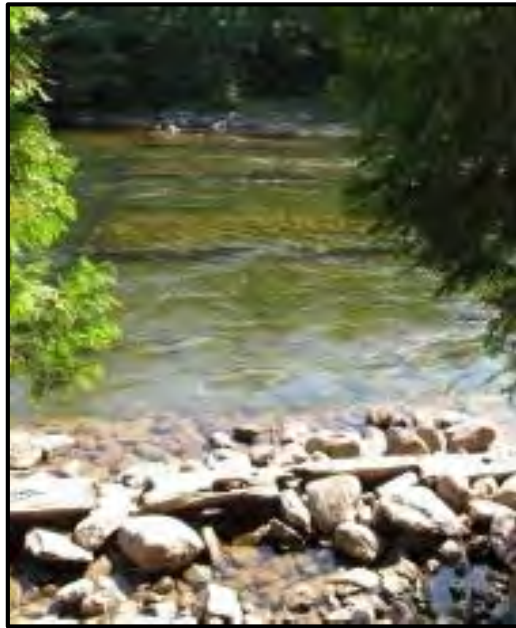
Figure 8. Historical timber dam on Horseshoe Lake (Luning 2009:55).

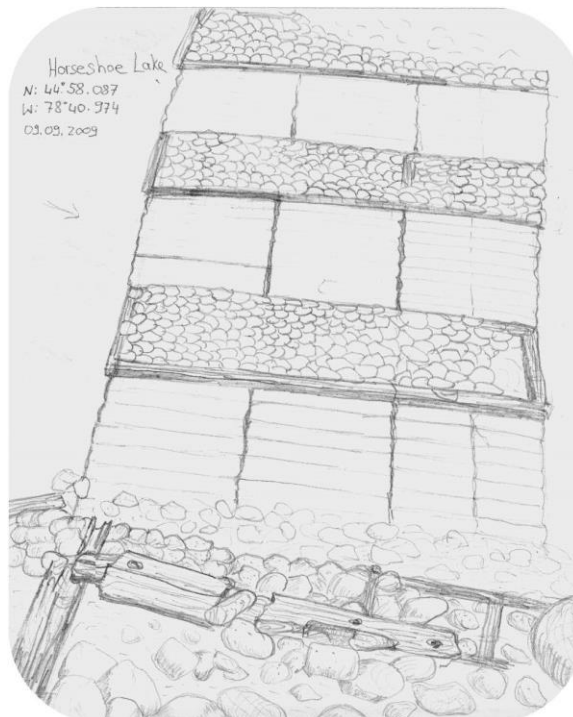
Figure 9. Historical timber dam on Horseshoe Lake (Luning 2009:56).

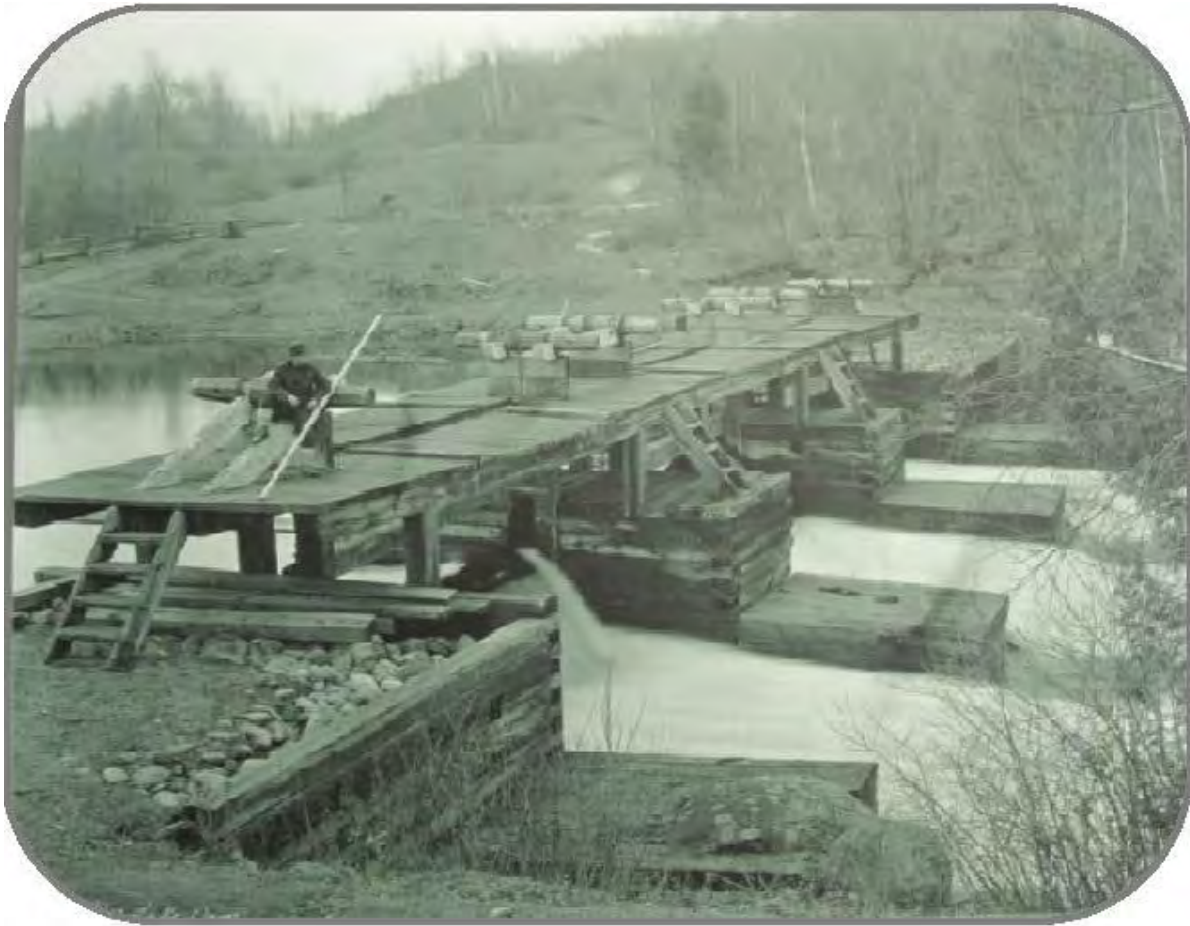
Figure 10. Historical timber dam on Horseshoe Lake (Luning 2009:56).
