PROJECT
FORT ANNE NATIONAL HISTORIC SITE
ANNAPOLIS ROYAL, NOVA SCOTIA

SHEET DESCRIPTION
**FENCE RECONSTRUCTION
PANEL LOCATIONS**

SHEET DESCRIPTION
FENCE RECONSTRUCTION PLAN, NOTES AND DETAILS

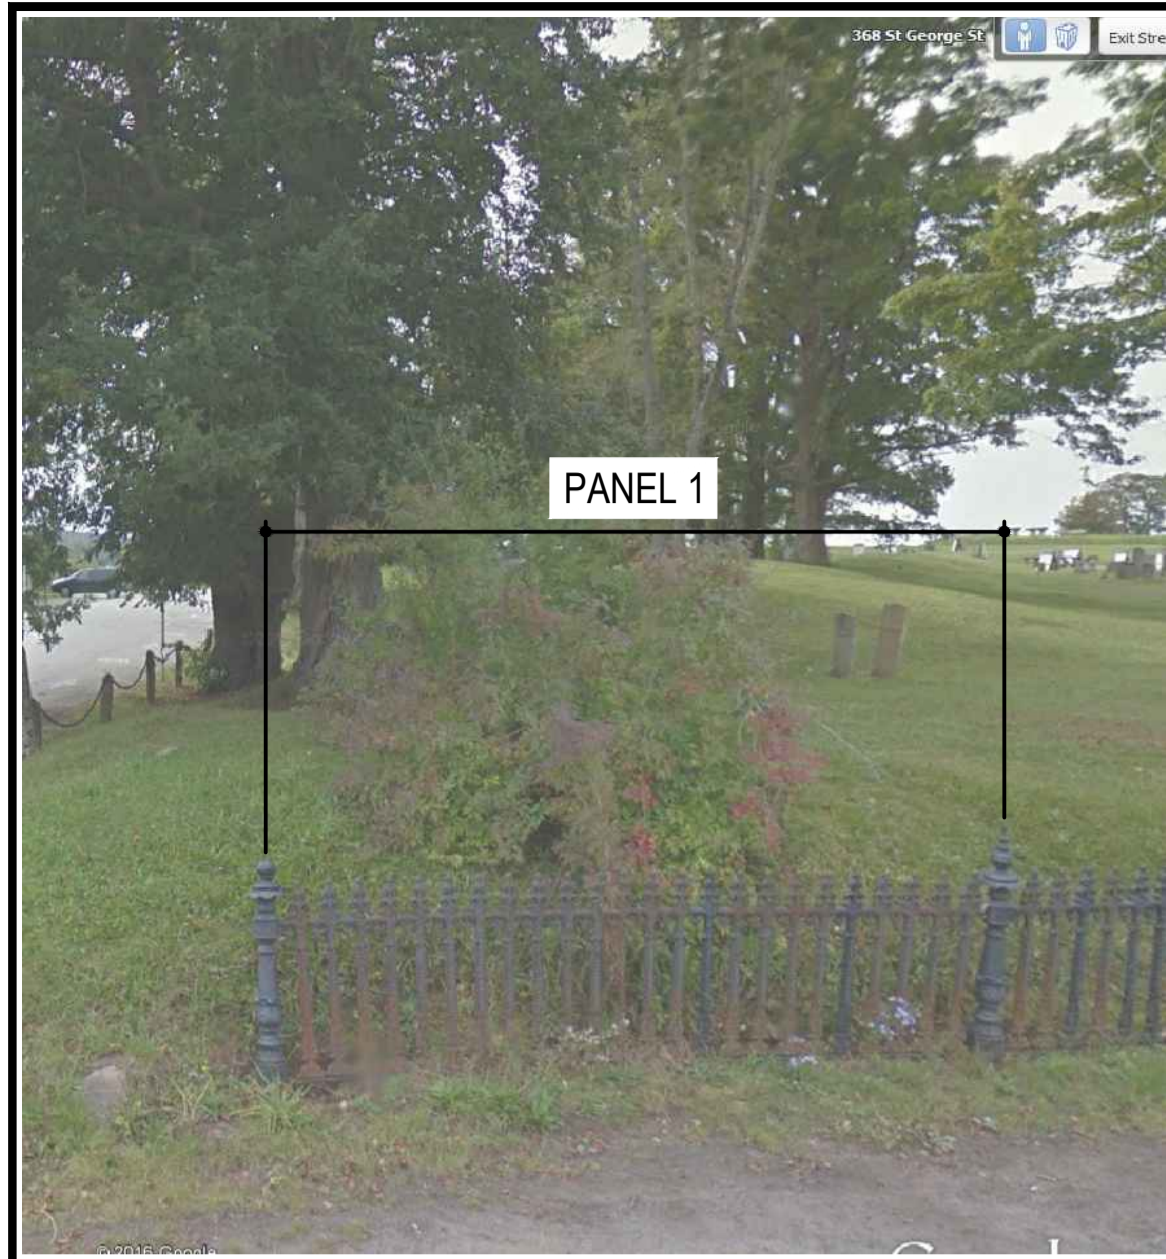
PANEL 1
scale = 1:75

Panel #	BALUSTRADES	HORIZONTAL ROD	CENTRE SUPPORT	GENERAL COMMENT
1	24 good cond.	Good cond.	OK	Panels 1, 2 & 3 were taken apart and re-installed approx. 8 yrs ago by Park staff.
2	24 good cond.	Good cond.	OK	
3	24 good cond.	Good cond.	OK	
4	24 good cond.	Poor cond.	OK	Panel in good condition however horizontal rod needs to be scraped, sealed and painted (in situ.)
5	24 good cond.	Poor cond.	Into a tree needs to be removed and re set.	Same comment as above.
6	24 good cond.	Poor cond.	Loose. Needs reconnected.	Same comment as above.
7	3 broken and 1 cracked.	v. poor condition	Into a tree needs to be removed and re set.	Remove panel and dismember, treat and re assemble using new rod. & replaced balustrades.
8	1 broken, 1 cracked and 1 partially cracked.	v. poor condition	Loose.	Remove panel and dismember, treat and re assemble using new rod. & replaced balustrades. Panel is bent.
9	1 broken, 3 cracked	v. poor condition	loose	Remove panel and dismember, treat and re assemble using new rod. & replaced balustrades.

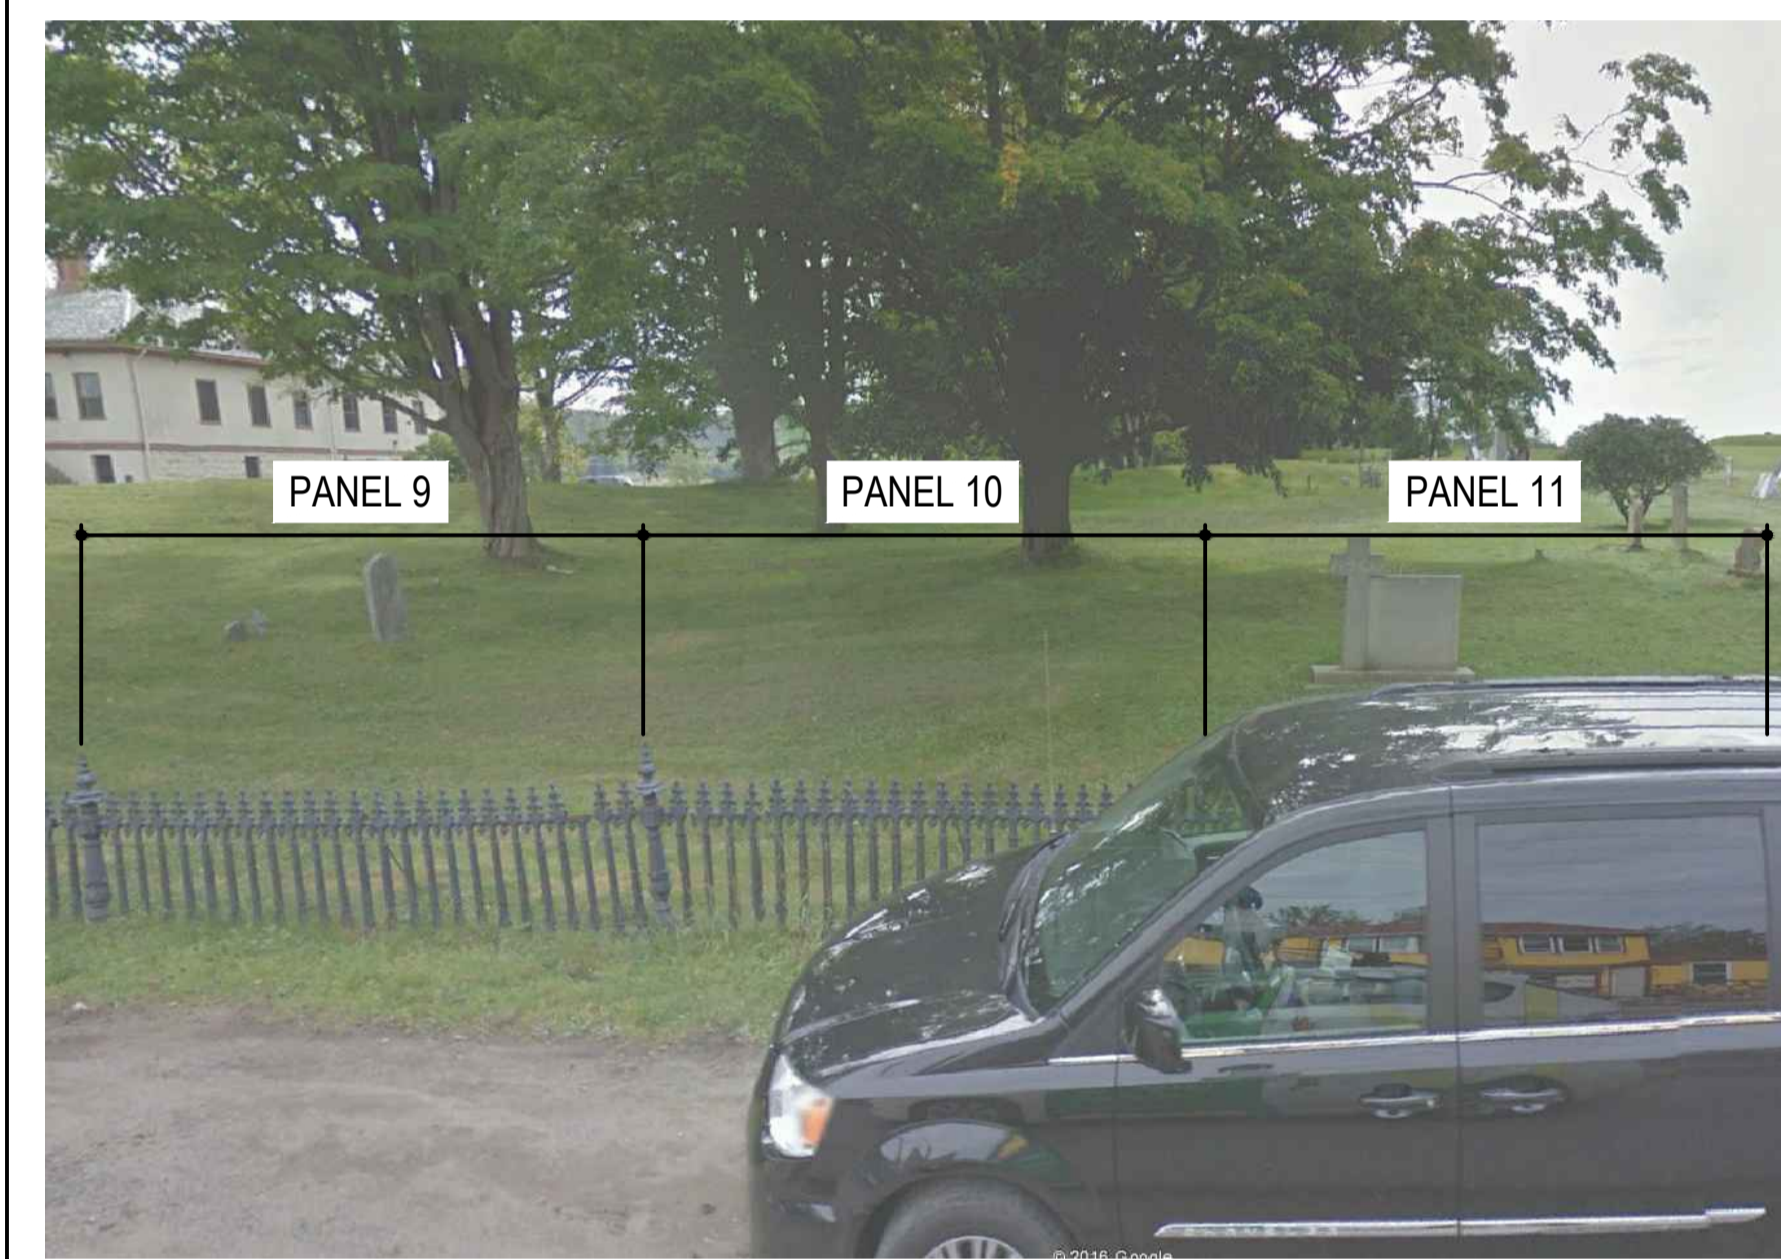
PANEL 9, 10 & 11
scale = 1:75

10	24 good condition	Reasonable. see comments	loose	Panel in good condition however horizontal rod needs to be scraped, sealed and painted (in situ.)
11	3 broken, 1 cracked.	v. poor condition	Need to replace.	Remove panel and dismember, treat and re assemble using new rod. & replaced balustrades.
12	2 broken, 1 cracked	Poor condition	OK	Remove panel— dismember, treat and re assemble using new rod and replace balustrades.
13	4 broken, 1 cracked	Poor condition	OK	Remove panel— dismember, treat and re assemble using new rod and replace balustrades.
NOTE				Post between panels 13 and 14 has shifted.
14	24 good condition	Reasonable: see comments	OK Large tree stump behind.	Panel and rod could be scraped, treated and sealed etc. (in situ.)
NOTE				Post between Panels 14 and 15 completely broken.
15	24 good condition	Reasonable; see comments	Small tree stump. Remove centre support and relocate.	Panel and rod could be scraped, treated and sealed etc. (in situ.) Will have to reconnect S. side to new post.

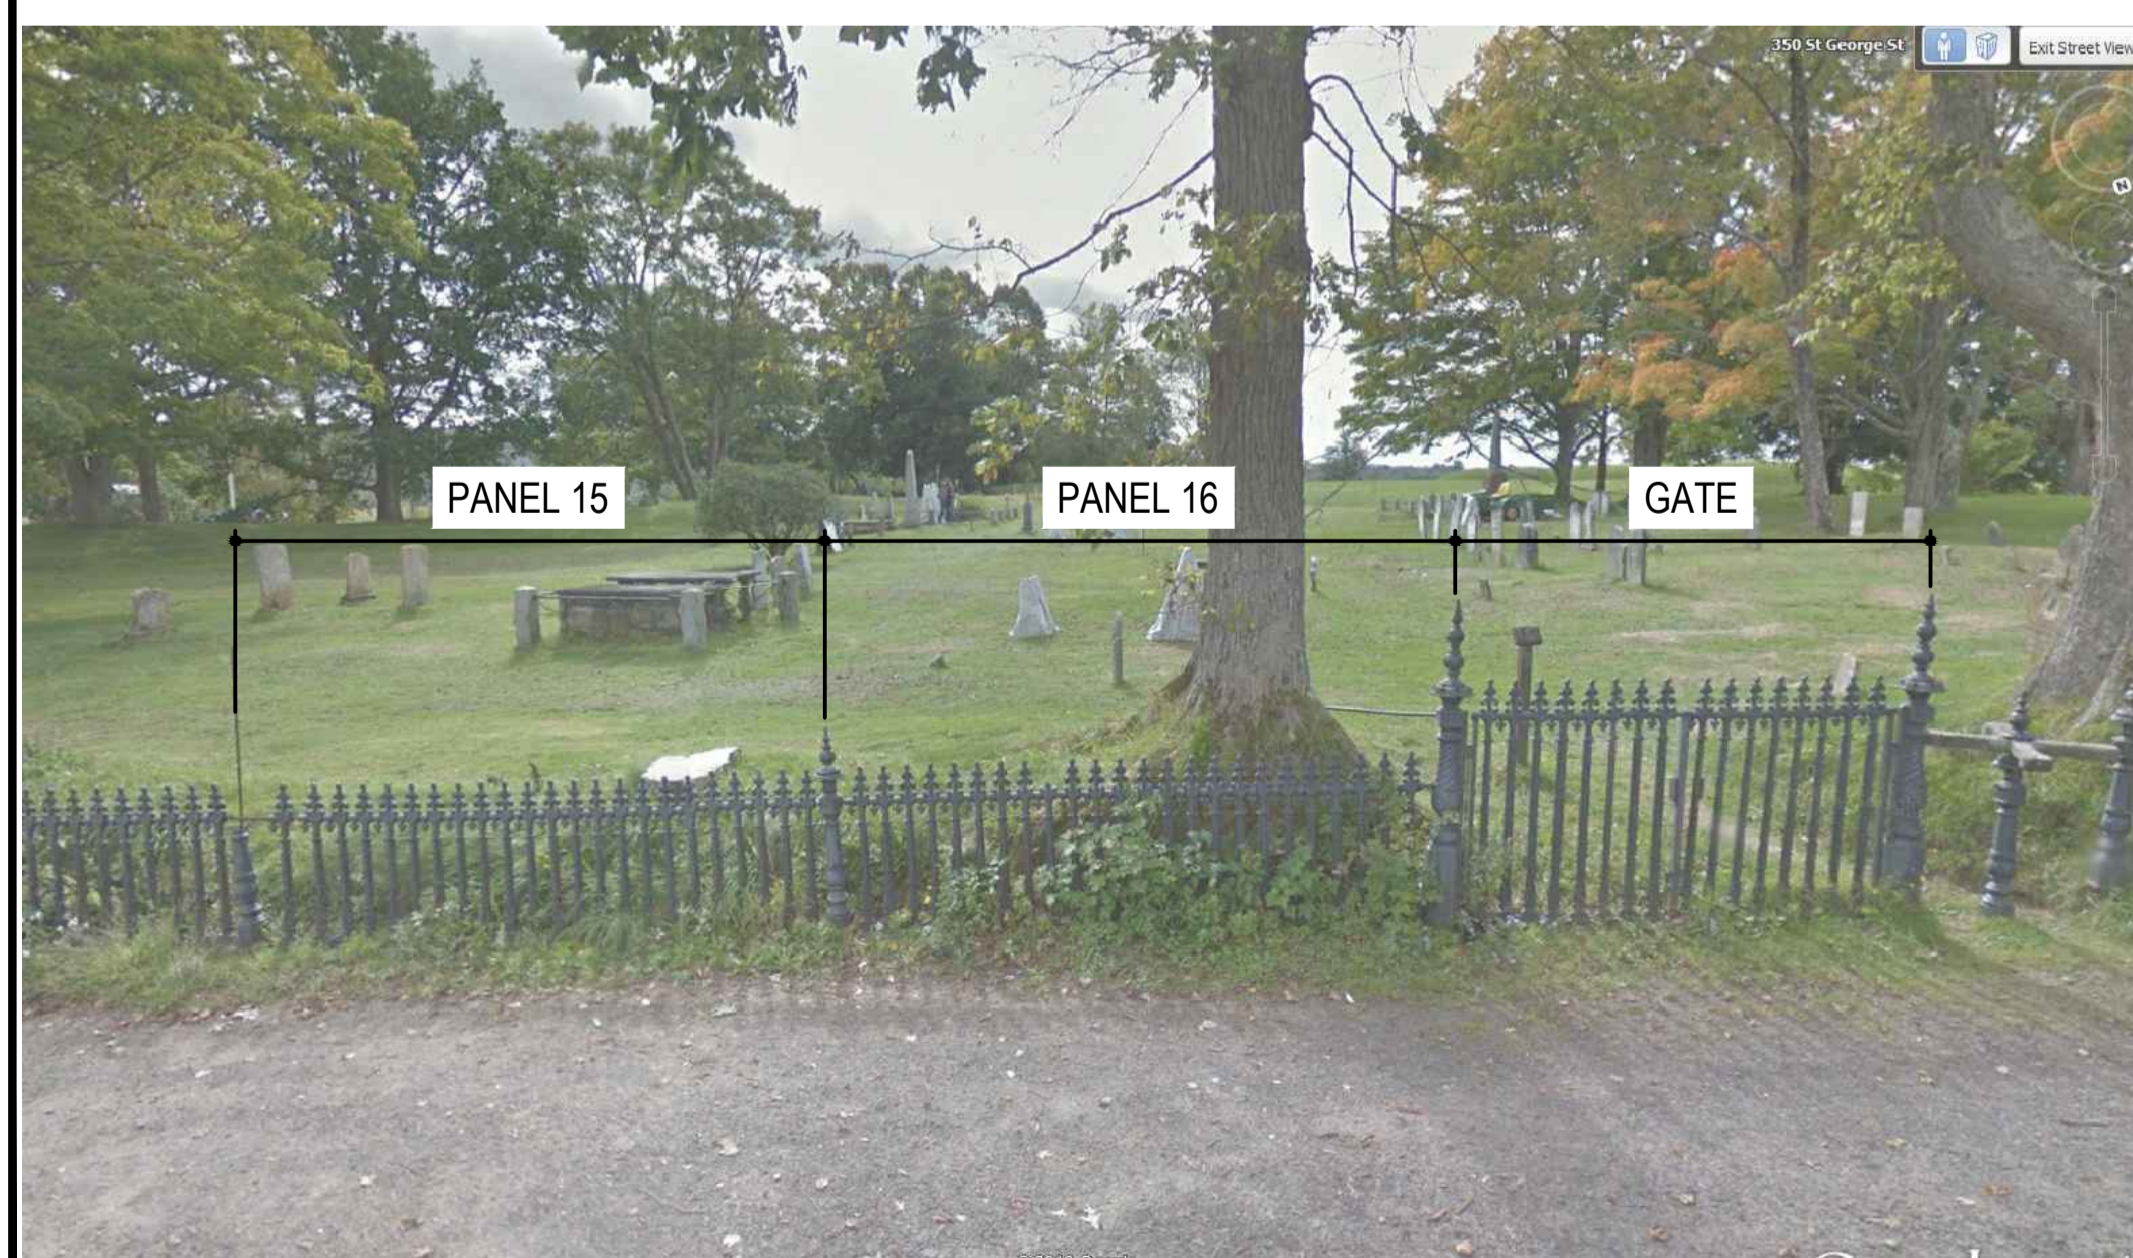
PANEL 15, 16 & GATE
scale = 1:75

NOTE				Post between Panels 15 and 16 has 2 small cracks. Care needed when re setting.
16	1 broken	Reasonable	NO centre support.	Panel v. close to large tree. Remove panel— dismember, treat and re assemble using new rod and replace balustrade.
GATE	8 balustrades per side. All in good cond.	Both rods in good condition.	Remove support rod from S. gate post and tree. Reset in other location.	2 gate posts in excellent condition. 2 gate panels could be treated in situ.
TURN Style	7 broken	v. poor cond.	Goes into tree.	In good condition. Clean and treat wooden X bars. This panel is very close to a large tree. Panel is bent. Remove panel— dismember, treat and re assemble using new rod and replace balustrades.
18	2 broken, 1 cracked.	v. poor cond.	loose	Remove panel— dismember, treat and re assemble using new rod and replace balustrades.
19	6 broken, 3 cracked	v. poor condition.	loose	Remove panel— dismember, treat and re assemble using new rod and replace balustrades.
