Parks Canada Agency

763 - Waterton Boundary Fence Detailed Design Report

AECOM

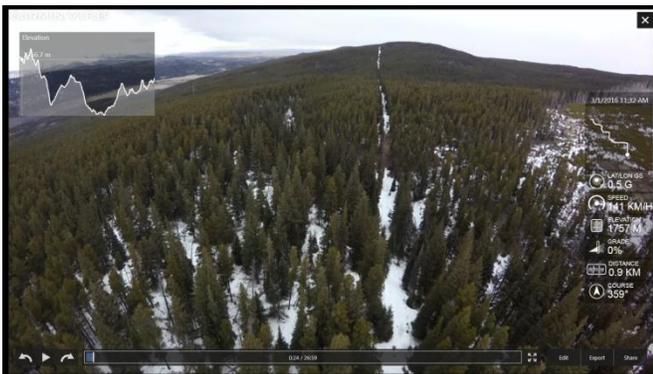
KM 0-8.3: Generally well defined cut line through coniferous forest. Trees of varying height to be cleared. Lower brush was generally masked by the lingering snow.

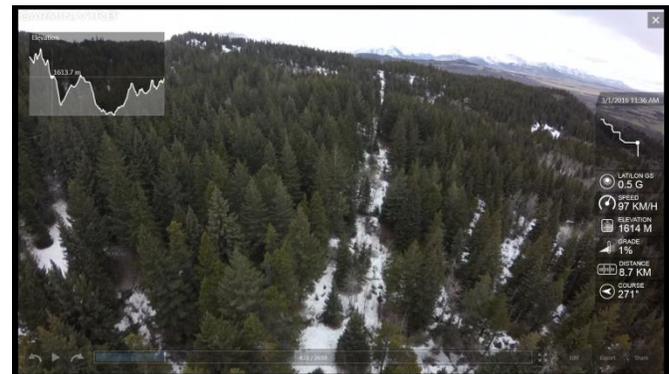
KM 8.3-11.1: Moderately defined cut line through mixed coniferous & deciduous forest. Considered one of the most difficult areas to maintain.

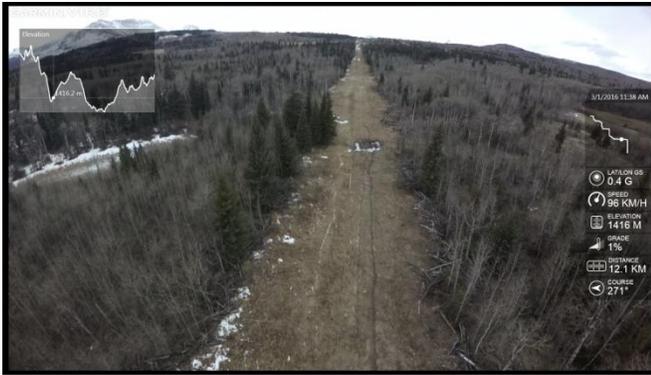
KM 11.1-14.9: Very well defined through mixed forest. KM 11.1-14.3 is out of scope, maintained by the Blood Timber Reserve.

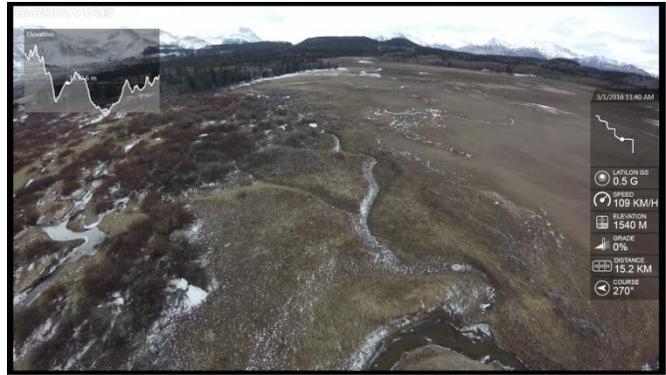
KM 14.9-16.2: Seasonally underwater, the existing steel post fence has generally collapsed and cannot be maintained.

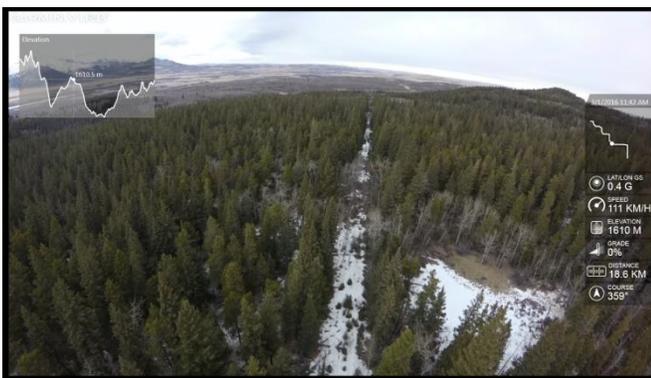
KM 16.2-19.0: Moderately defined cutline through predominantly coniferous forest, with numerous smaller trees and brush evident.

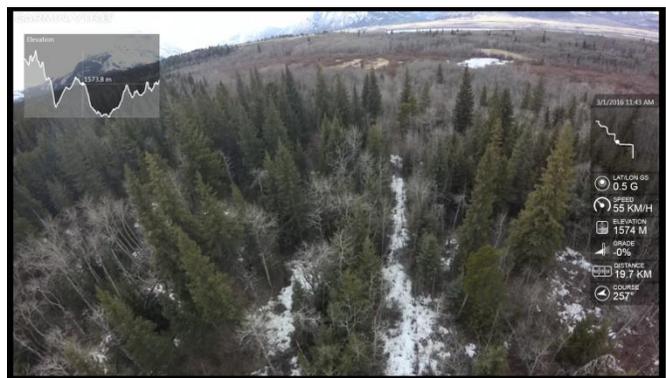
KM 19.0-25.7: Typically a poorly defined cutline through deciduous forest.

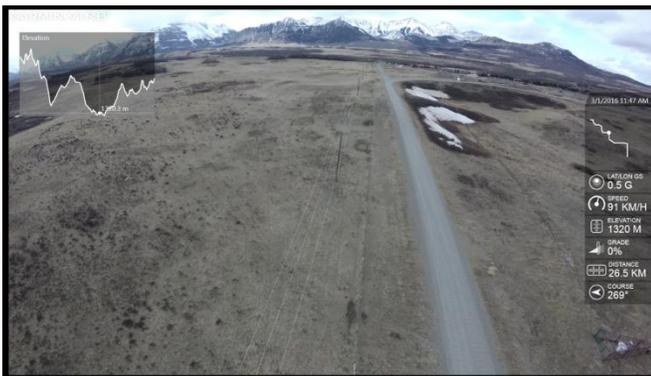
KM 25.7-31.4: Grasslands with thick deciduous patches. Portions have adjacent roads and power lines.

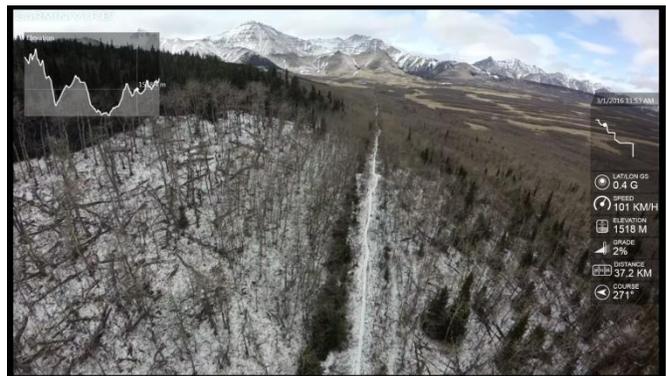
KM 31.4-39.4: Moderately defined through deciduous forest. Remnants of a former road run generally parallel, used now unofficially as a hiking trail.

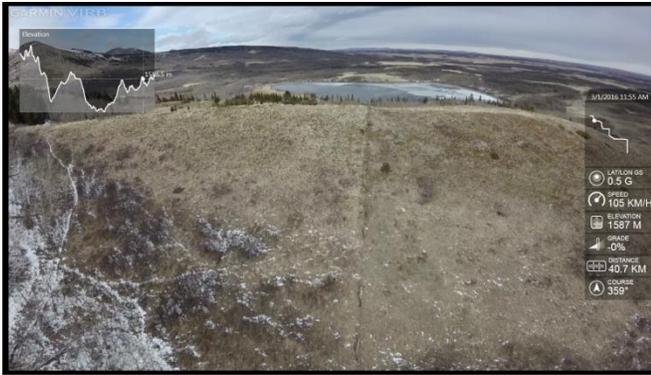
KM 39.4-41.4: Opens up into more open terrain with patches of deciduous forest. The fence breaks as it passes through Kesler Lake.

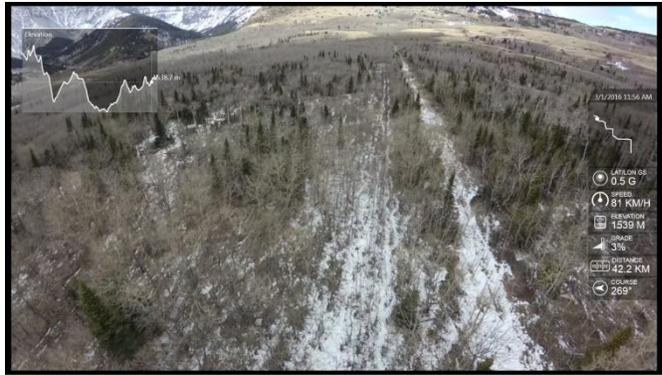
KM 41.4-42.7: Becomes poorly defined and overgrown through deciduous forest. A partially overgrown cutline runs parallel to adjacent private land.

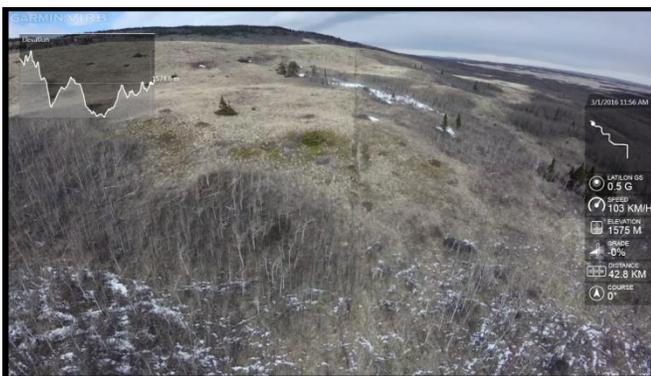
KM 42.7-43.4: Minimal clearing required through grassy hills.

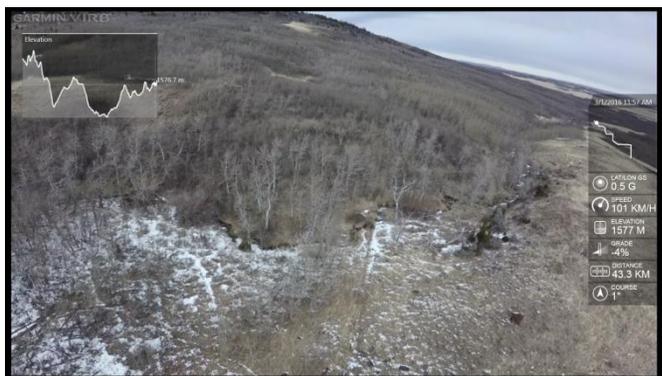
KM 43.4-44.9: Very poorly defined through overgrown deciduous forest. Access and terrain is difficult.

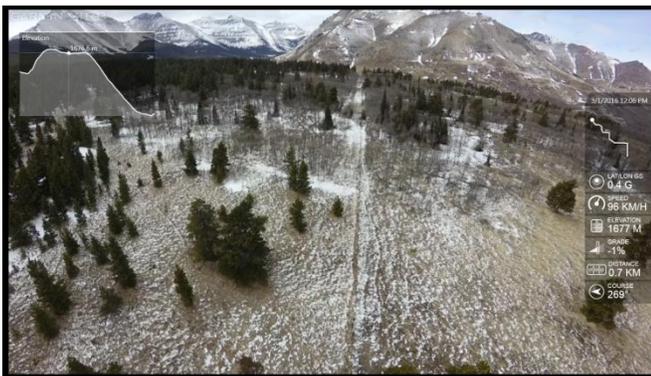
KM 44.9-46.1: Well delineated as it passes through mixed forest, ending at Yarrow Canyon. Some long steep slopes.

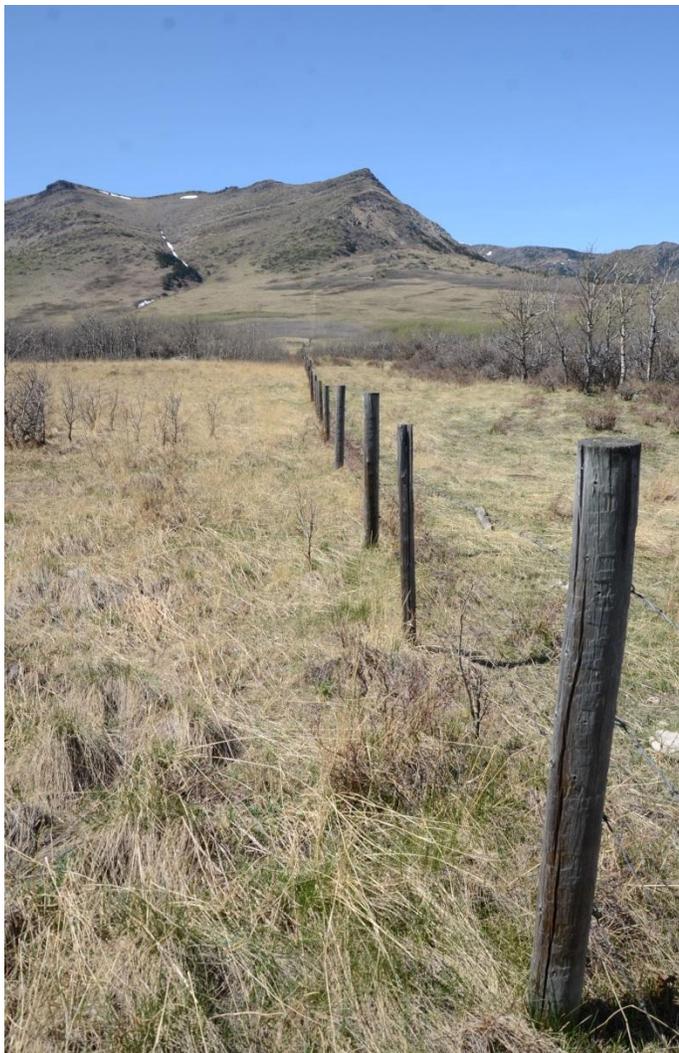
Negligible Brushing – Generally open grasslands, with sporadic trees or brush.

To better establish the on-ground conditions, the full length of the fence was walked during April 2016 over the span of a few days. Due to a low snow pack and warmer than average temperatures, conditions were unusually dry and trees/foliage were 3 to 4 weeks ahead of their normal spring cycle. While walking, the relative amount of brushing required was assessed, and this breakdown is presented on the Environmental Alignment Sheets. Brushing was qualitatively categorized as negligible, light, moderate, or heavy. Images representing these typical conditions are presented as follows.

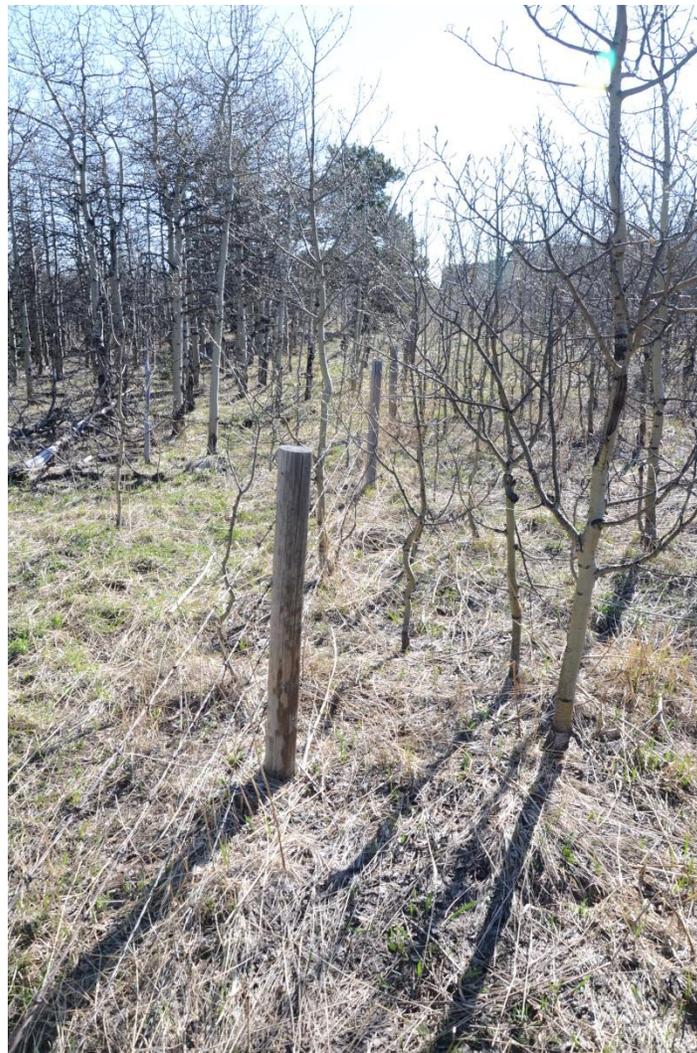
Light Brushing – Well spaced trees and brush, generally easy to walk through.

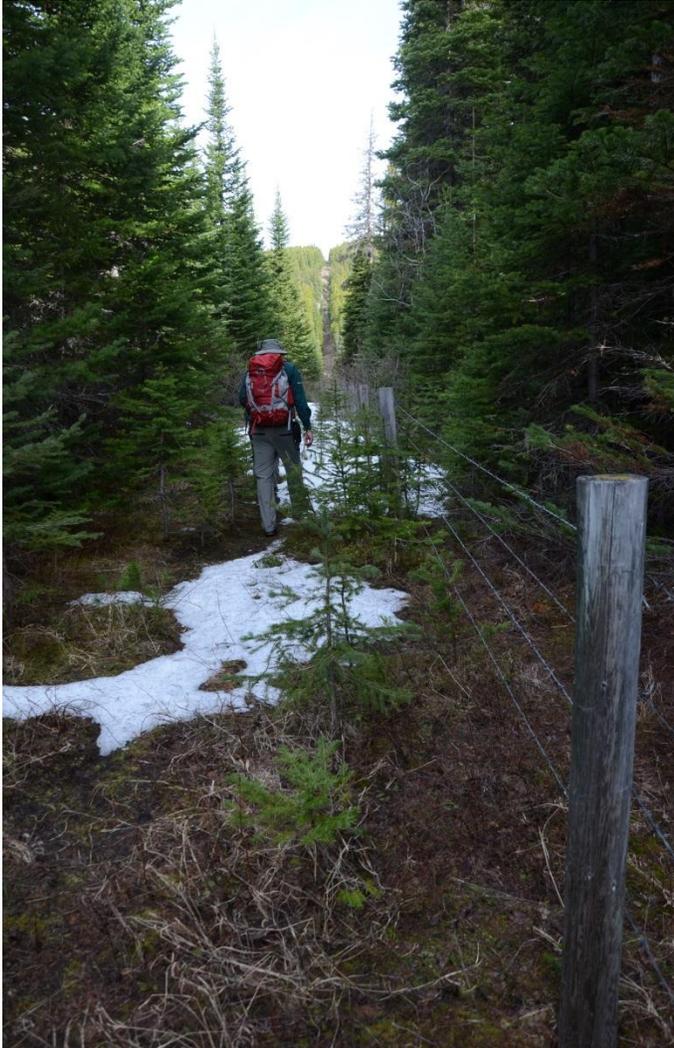
Moderate Brushing – Numerous trees and brush, fence can be indistinct, walking is noticeably slowed.

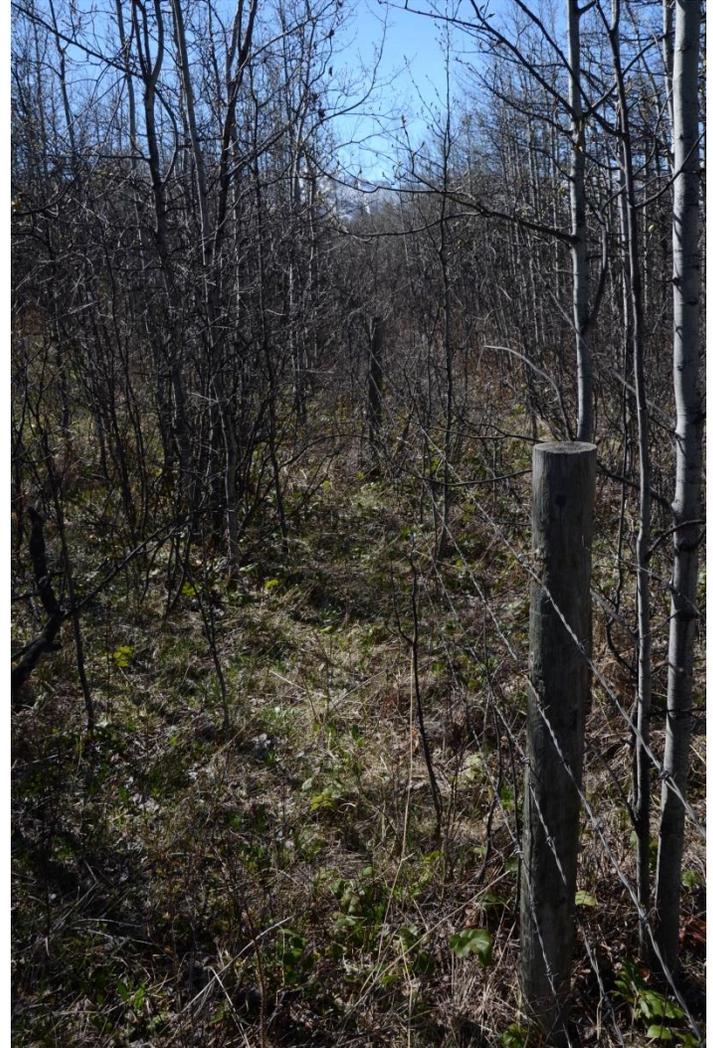
Heavy Brushing – Fence is completely overgrown, sight is limited to a few meters, difficult to walk through.
