PUBLIC WORKS AND GOVERNMENT SERVICES
 ON BEHALF OF TRANSPORT CANADA
 WHITEHORSE INTERNATIONAL AIRPORT
 316-75 BARKLEY GROW CRESCENT
 WHITEHORSE, YUKON

2016 NORTH APRON REMEDIAL EXCAVATION

WORK DESCRIPTION

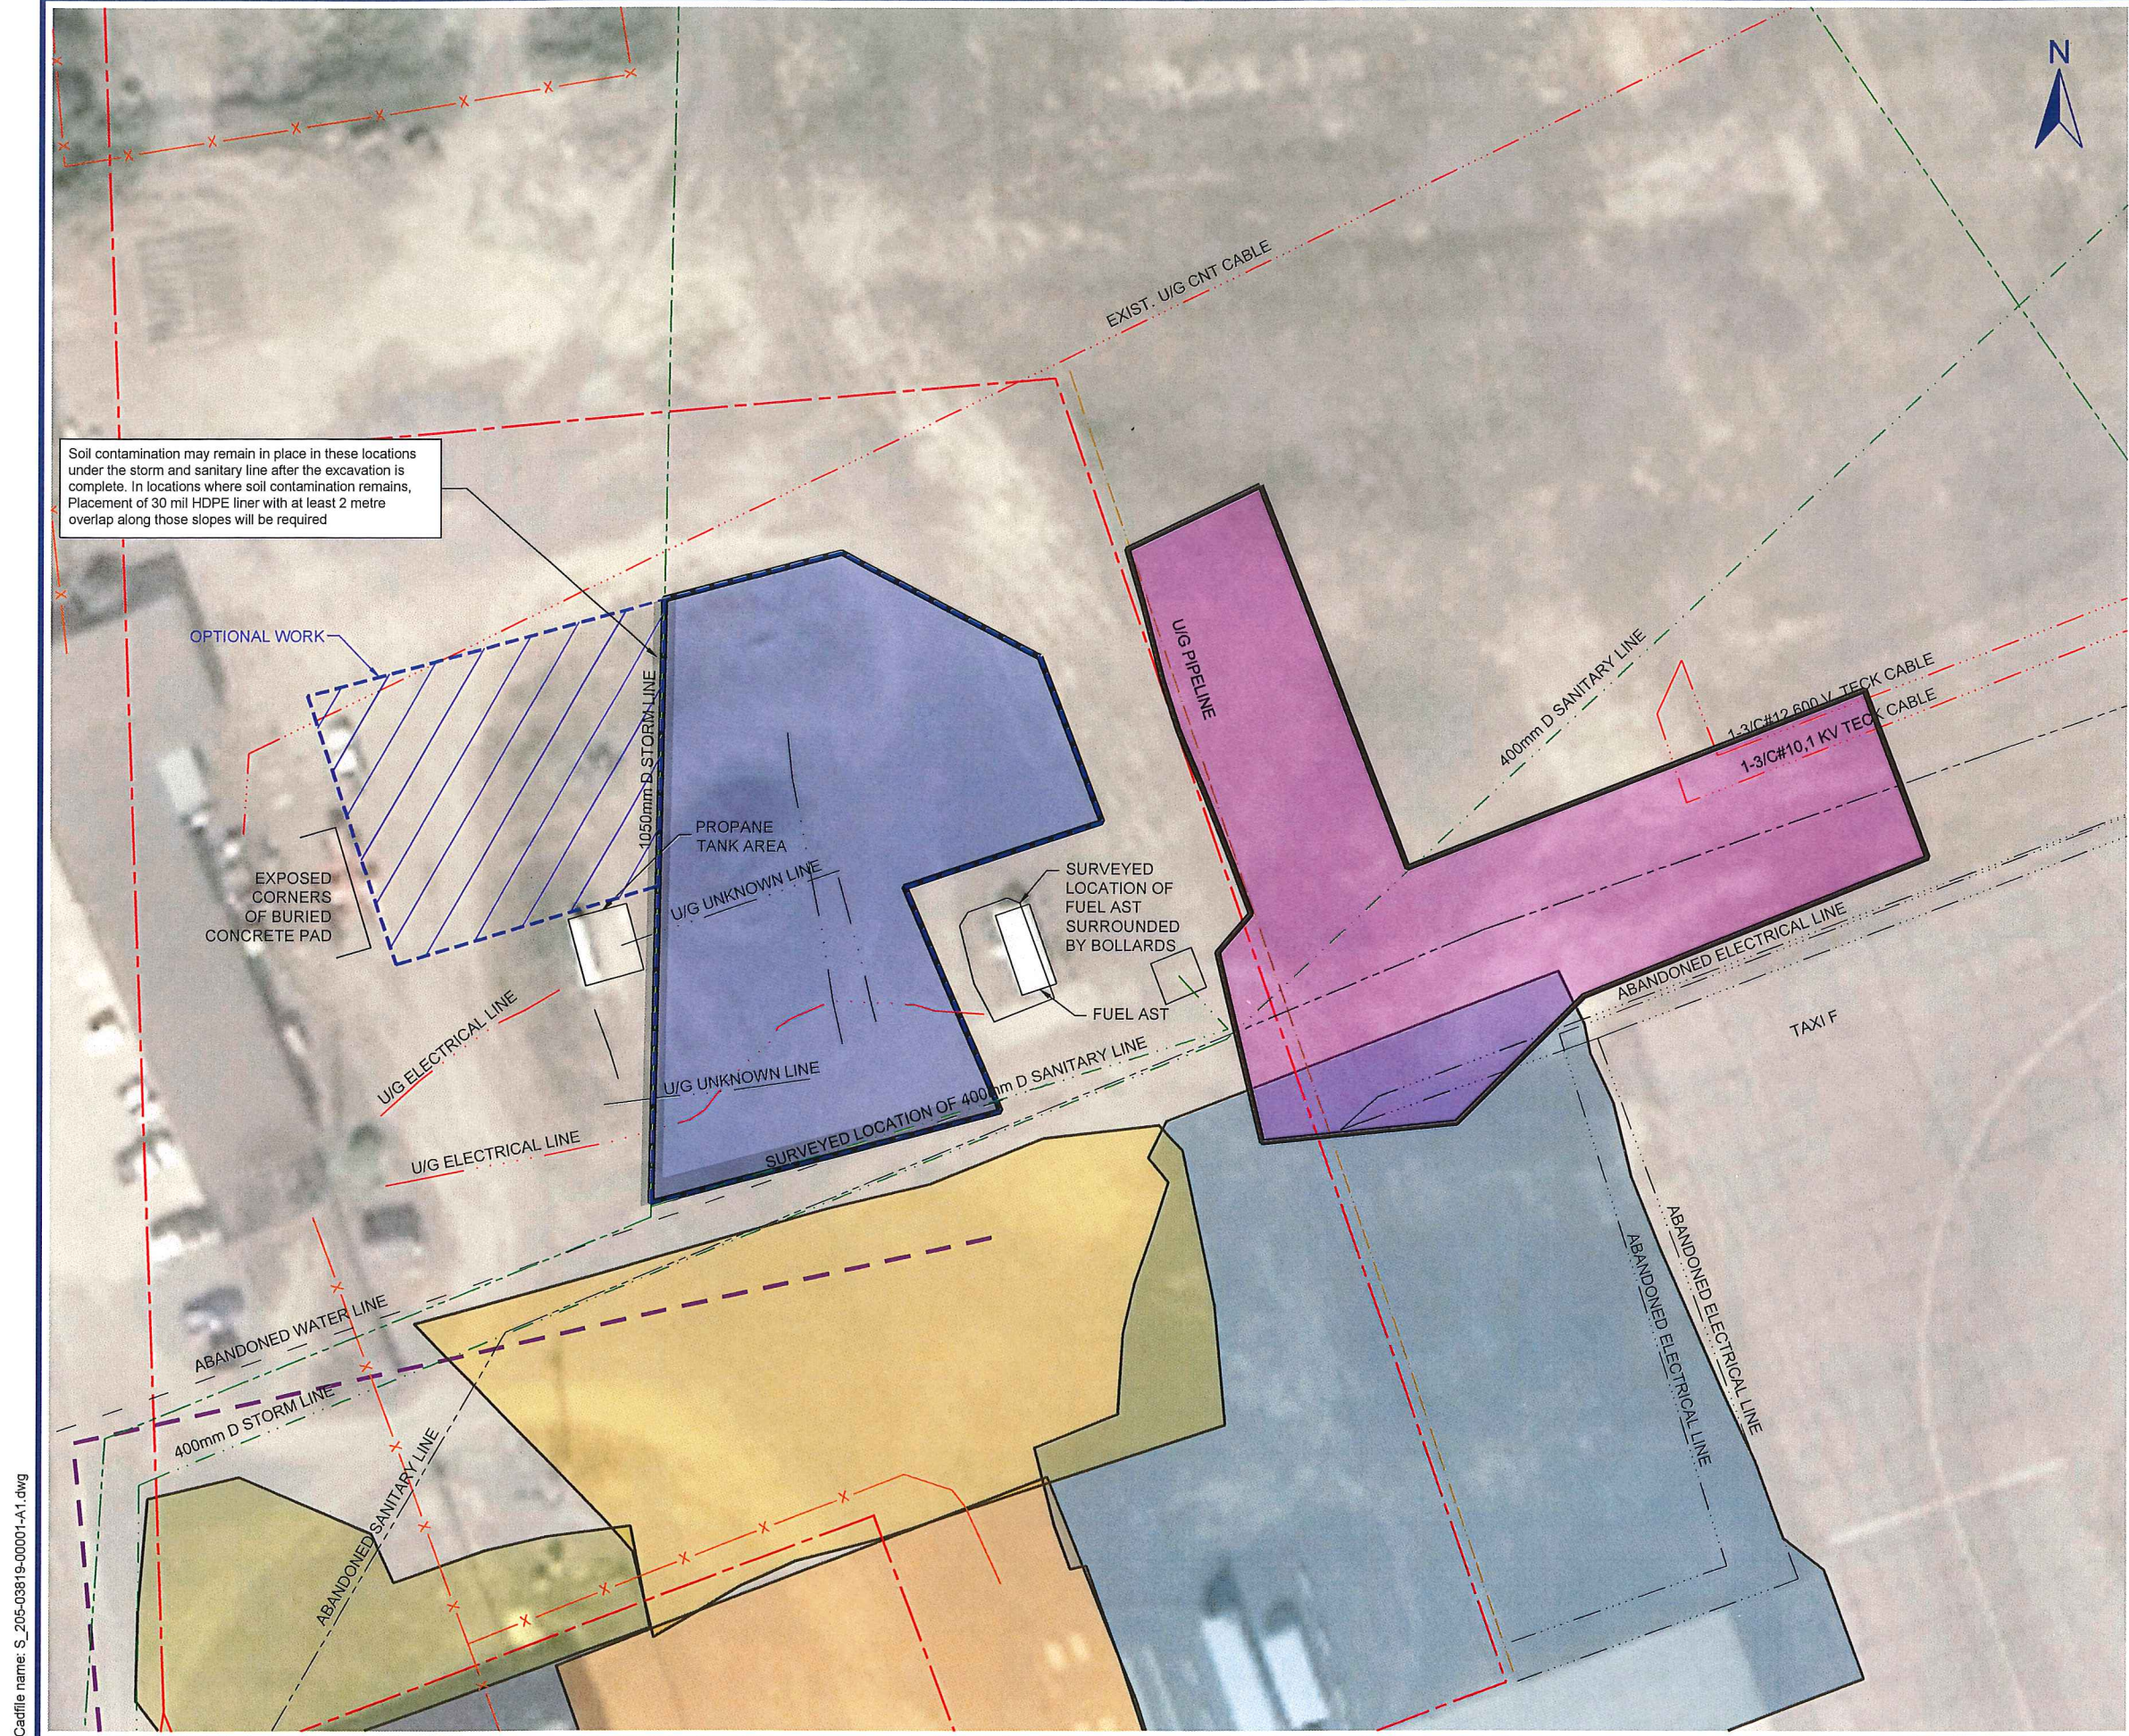
KNOWN UTILITIES

Soil contamination may remain in place in these locations under the storm and sanitary line after the excavation is complete. In locations where soil contamination remains, Placement of 30 mil HDPE liner with at least 2 metre overlap along those slopes will be required

UTILITY LOCATIONS ARE APPROXIMATE.
 UTILITIES ON THIS SITE ARE BASED OFF UTILITY MAPS AS SUCH UTILITIES ARE NOT VERIFIED FOR CURRENT CONFIGURATION AND MUST BE PROPERLY LOCATED IN THE FIELD
