Repulse Bay RCMP Detachment

Lot L94-95, PO Box 31, Repulse Bay. Nunavut

Appendix B: Concentric RCMP/SNC Tank Inspection Report.

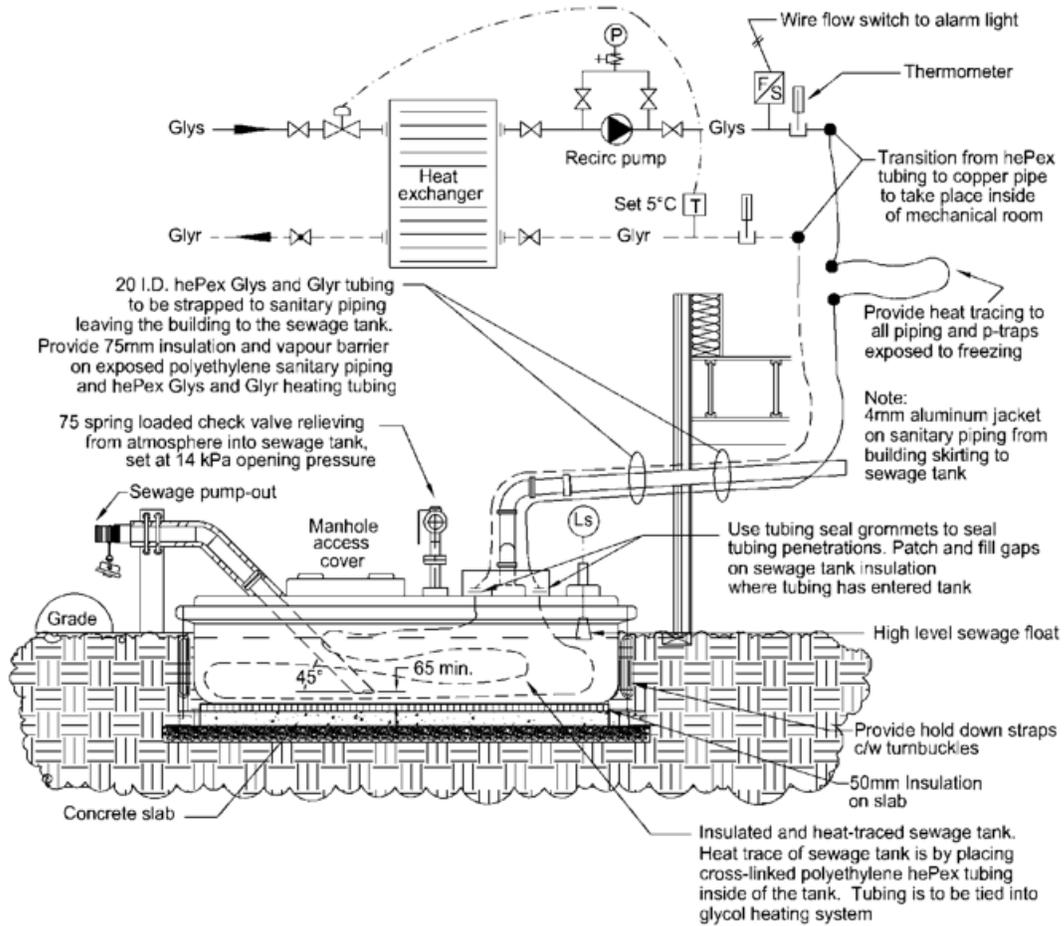
Figure 4-5: Sewage Tank Outside

If contractor determines new tank is required, installed outside of Triodetic foundation and partially buried, then installation must be as per GNWT Good Building Practice for Northern Facilities 2011, Oct 18 2012 update. (See Appendix A for document excerpt.)

If tank is partially buried, location must be authorized by Asset Management. If tank is partially buried, vehicular protection bollards or large rocks are required to prevent damage/access from vehicles.

If tank is partially buried, sanitary lines from exterior side of building to tank must be insulated and covered with additional protection to prevent birds from picking at pipe insulation wrap.

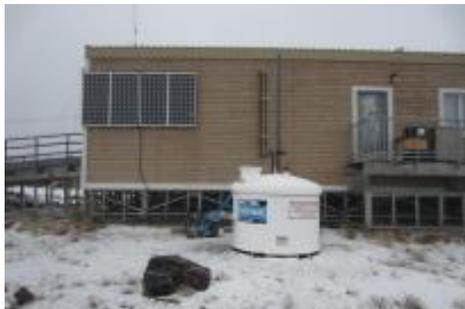
| Code Issues | |
|---|--|
| CSA B139 (09) 7.3.8 | Issue: A tank shall be installed on rigid, non-combustible supports constructed of materials having a fire-resistance rating of not less than 2h. There is no base existing; just the metal support stands integral to the tank. Recommendation: A new base should be installed, either a concrete pad, or pressure treated wood flush with grade and tank support should be fastened to it. |

- Install new base either a concrete pad, or pressure treated wood flush with grade or tank support should be fastened to it.
- Recommendation is concrete pad.
- Gravel base under concrete pad to be higher than existing grade to eliminate snowmelt/water accumulation at base.
- Exterior Fuel tank - replace existing overflow pipe with correctly sized pipe, with no sags.
- Exterior Fuel tank piping (tank to building) - any pipe greater than 1 meter is to be supported by hangers (attached to building) or supported from underneath.

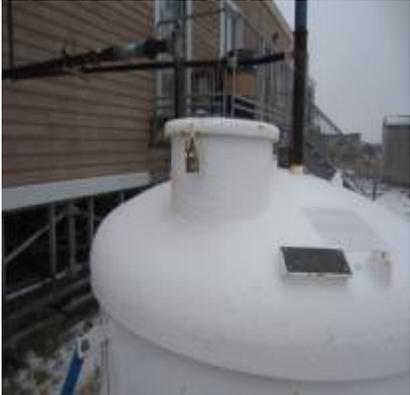
| Code Issues | |
|---|---|
| <p>CSA B139 (09) 7.9.2.3</p> | <p>Issue: The overflow pipe should be at least twice the cross sectional area of the supply line and not less than 2", and should be installed without sags or traps. Recommendation: Replace existing overflow pipe with properly sized pipe with no sags present.</p> |

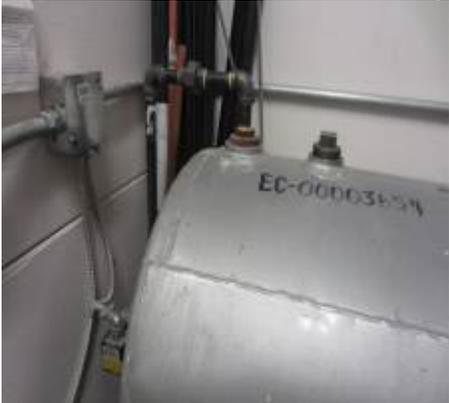
| Code Issues | |
|---|---|
| <p>CSA B139 (09) 7.10.2</p> | <p>Issue: Tanks installed inside must be provided with a gauge to determine liquid level. Recommendation: Install code approved gauge on tank.</p> |

- Fuel tank (interior) requires fuel gauge.
- The vacuum on interior fuel tank has been lost. This could be an indication of tank failure. The vacuum should be redrawn, and if it does not hold, replace tank. Replacement tank to be Vilco d/w fiberglass. Alternative d/w tank may be considered based on available room within mechanical room.
- Replace fuel oil filter
- Fuel tank (exterior) provide liquid and vapour tight seal over tank opening.
- Exterior fuel tank shall be installed on rigid, non-combustible supports constructed of materials having a fire-resistance rating of not less than 2h. There is no base existing; just the metal support stands integral to the tank.

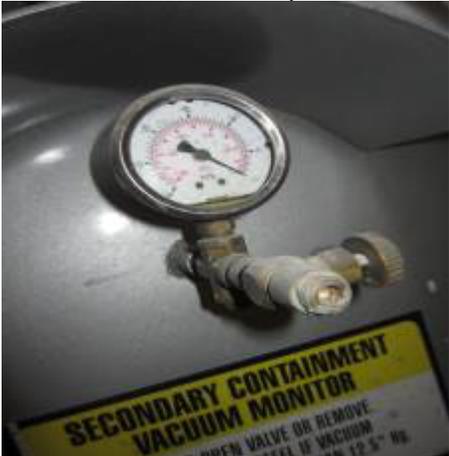
| Code Issues | |
|---|---|
| <p>Observation</p> | <p>The vacuum on the tank has been lost. This could be an indication of tank failure. The vacuum should be redrawn, and if it does not hold, the tank should be replaced.</p> |

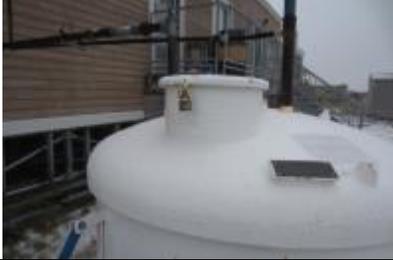
| Code Issues | |
|--|---|
| <p>CSA B139 (09) 9.4.1</p> | |

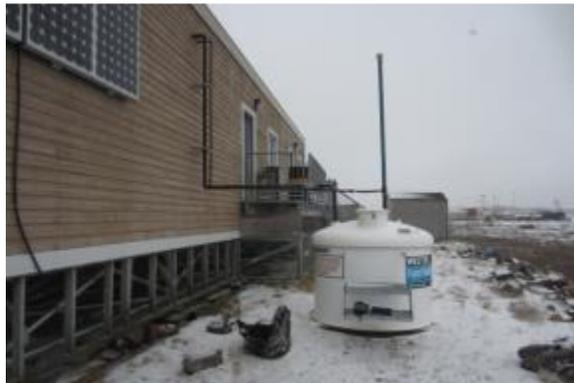
Photo 1: Outdoor above ground fuel tank

| Exterior Assessment | |
|--|---|
| Tank Type | Westeel, Fuel vault vacuum monitored, 2272L capacity, Serial No. 63030535., ModelB – 520034, Manufactured 2003. |
| Tank Condition | Good; no signs of corrosion or leaking. |

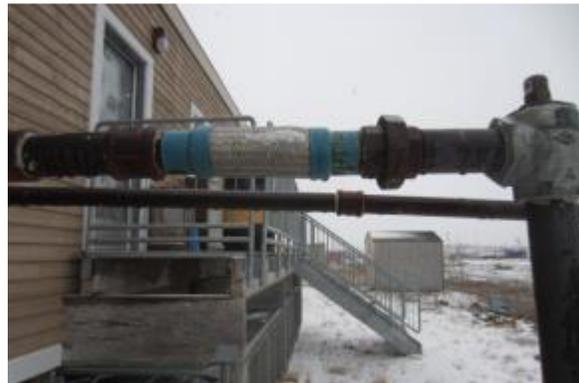
Photo 2: Exterior piping

| Exterior Assessment | |
|--|---|
| Exterior Piping | 2" and 1" steel piping with flexible connection. Good/Fair condition; surface corrosion developing. |

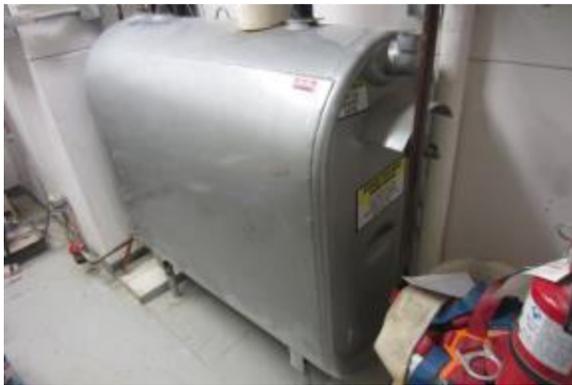
Photo 7: Interior Tank

| Interior Assessment | |
|--|--|
| Tank Type | Westeel, double wall vacuum monitored, nameplate damaged. Approximately 1110L capacity. Serial number 67033497, no visible model number, manufactured 1998. |
| Tank Condition | Good; no signs of corrosion. |

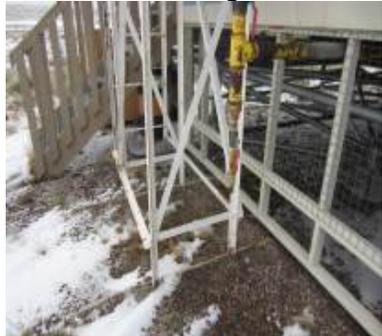
| Code Issues | |
|--|---|
| <p>CSA B139 (09) 7.3.8</p> | <p>Issue: A tank shall be installed on rigid, non-combustible supports constructed of materials having a fire-resistance rating of not less than 2h. New tank should be installed with concrete pad, or pressure treated wood flush with grade.</p> |

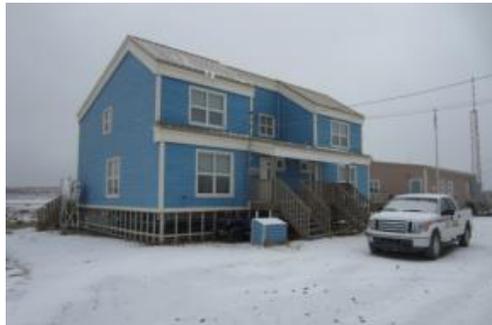
| Code Issues | |
|--|---|
| <p>CSA B139 (09) 7.5.6</p> | <p>Issue: Tanks installed in an area not separated by vehicles needs to be protected by good engineering practices. Protective bollards to be installed for new tank to prevent accidental vehicle collision.</p> |

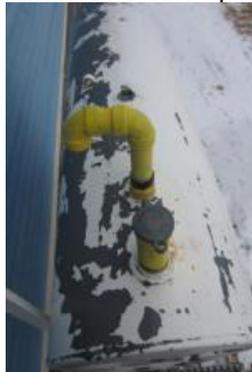
| Code Issues | |
|--|---|
| <p>CSA B139 (09) 7.8.2</p> | <p>Issue: Each fill opening and each entry to a fill pipe shall be provided with a weather tight cover designed to prevent tampering. New tank to be provided with code approved, weather tight cover.</p> |

| <p>CSA B139 (09) 7.8.4</p> | <p>Issue: A fill opening shall be designed to avoid spillage. (see photo above) New tank should be installed with certified spill containment box.</p> |
| <p>CSA B139 (09) 7.9.1.7</p> | <p>Issue: Vent must terminate a minimum of 6" above fill. (see photo above) New vent to extend a minimum of 6" above fill.</p> |
| <p>CSA B139 (09) 7.9.1.7</p> | <p>Issue: Vent must be c/w a weatherproof hood. The vent hood or cap shall prevent ingress of objects. (see photo above) New tank vent to terminate in code approved hood.</p> |

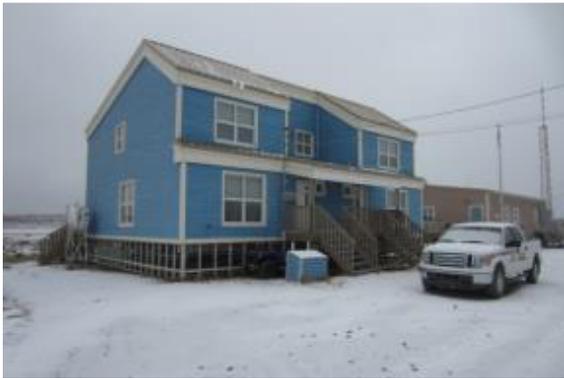
Photo 1: Outdoor above ground fuel tank

| Exterior Assessment | |
|--|---|
| Tank Type | Granby, Single wall tank, 1135 L capacity. Model 11901, Serial No. 17126-C. Manufactured 2002. |
| Tank Condition | Fair/poor; only minor surface corrosion. Paint peeling away. Received rating due to the tank being single wall. |

| Code Issues | |
|--|---|
| <p>Code violations are listed below. The overall recommendation for this site since the tank is single wall is to replace the system with new.</p> | |

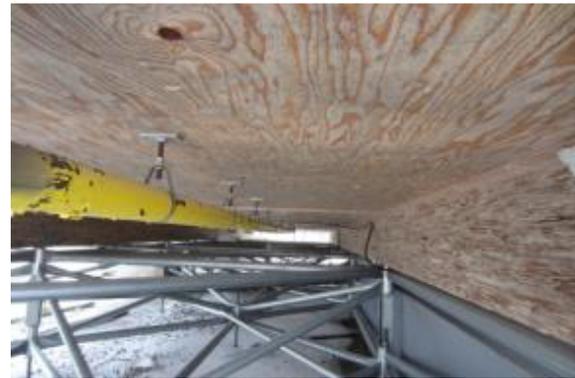
Photo 4: Exterior piping below building

| Exterior Assessment | |
|--|---|
| Exterior Piping | 2" steel piping with flexible connection. Good/Fair condition; painted, surface corrosion developing. |

| <p>CSA B139 (09) 9.3.1.5</p> | <p>Issue: Piping shall be supported and protected against physical damage such as foot traffic, vehicles, and snow and ice damage. Protective covering over new piping recommended to prevent falling ice and snow from damaging piping.</p> |

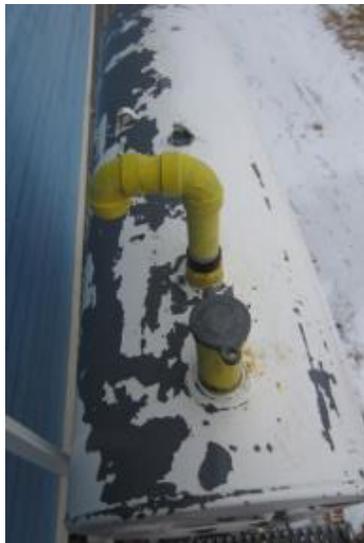
Photo 5: Fill and Vent Terminations

| Exterior Assessment | |
|--|---|
| Tank Venting | 1 1/2" PVC pipe with two 90° elbows . Terminates level with fill connection. |
