WSP Project No. 161-06021

**Subject: Environmental Services – Mould Investigation
Citadel Hill Service Tunnel, Halifax, Nova Scotia**

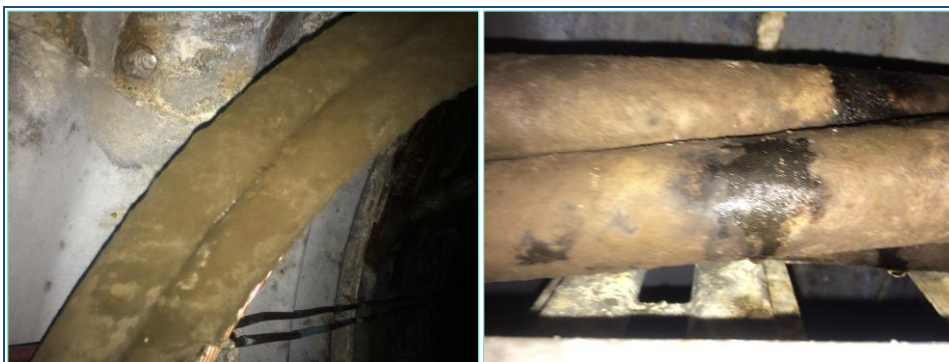
- A fibrous growth was observed along a dual cable, which travels most of the length of the service tunnel. The location of the cable has been identified in Figure 1, above.

Photo 1 (left) and **Photo 2** (right): growth observed along dual unidentified cable, as collected in tape lift sample Tape1, and bulk sample Bulk1

- d. All water damaged and/or mould-affected materials should be removed, and the back-side of the materials should be inspected for visible mould growth. If mould growth is found on the back-side of removed materials, these materials should be removed two (2) feet beyond the visible mould presence.

- i. All water damaged and/or mould-affected materials should be removed from the area as mould waste, and if visible mould growth is observed, material should be removed to a radius of two (2) feet away from the visible mould.

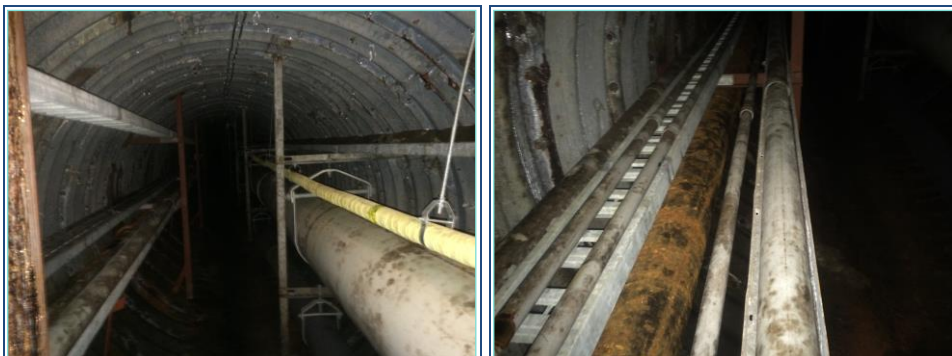
- Visible mould staining was observed along multiple surfaces within the service tunnel, including the storm and sanitary sewers lines as indicated in Photos 3 and 4 below.

Photo 3 (left) and **Photo 4** (right): staining observed along the pipes within the service tunnel as sampled in tape lift sample Tape4

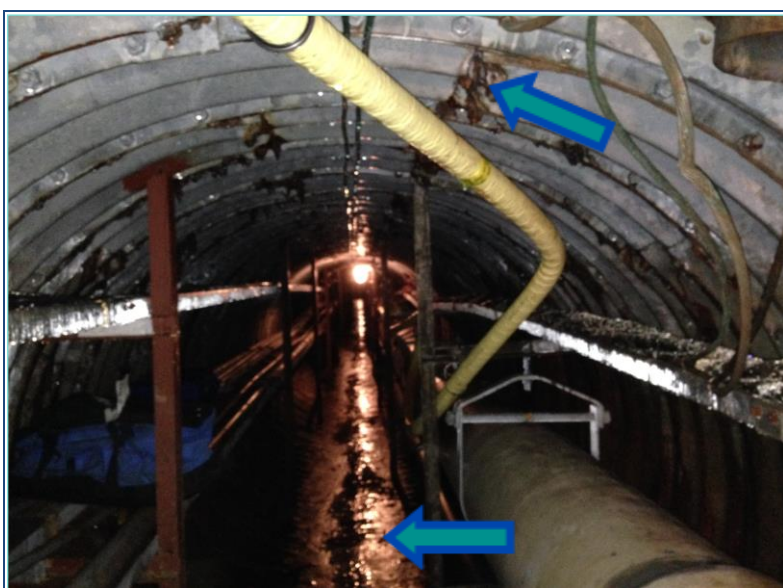
- Damp conditions, including visible pooled water at the base of the tunnel during the May 2016 site visit, and evidence of precipitation of metals was also observed, as indicated by the arrows in Photo 5 below; a musty odour was also noted.

Photo 5: visible pooled water at the base of the tunnel during the May 2016 site visit, and precipitation along the tunnel walls are indicated by arrows in the photo above

- iii. Clearance air sampling should be conducted to document airborne levels of mould prior to installation of any interior finishes.
2. As water intrusion and moisture generation appear to be an inherent feature of the service tunnel, water and moisture controls should be put into place in order to prevent future mould growth from occurring. For example, adequate ventilation should be put in place and regular inspections should be done in order to monitor water intrusion and moisture levels. Should the issue persist, all future persons entering into the service
