Grise Fiord RCMP Detachment

Plan 487, Partial Lots 47, 51, 52, 55. PO Box 82, Grise Fiord. Nunavut

Introduction

Appendix A: Concentric RCMP/SNC Tank Inspection Report.

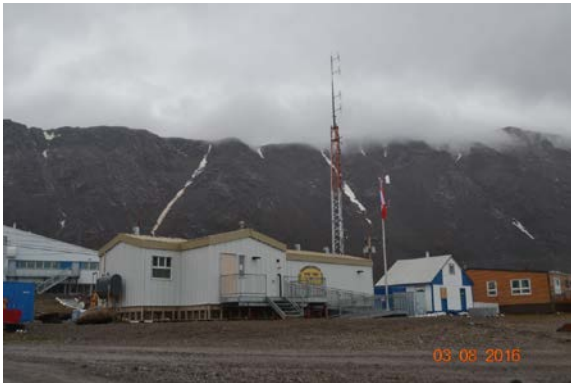
V294 Grise Fiord Detachment – (arctic vent)

- Install Arctic Vent on sewer stack.
 - i. On/off switch to be installed in suitable location in detachment, with label to indicate to turn on in winter/off in spring.

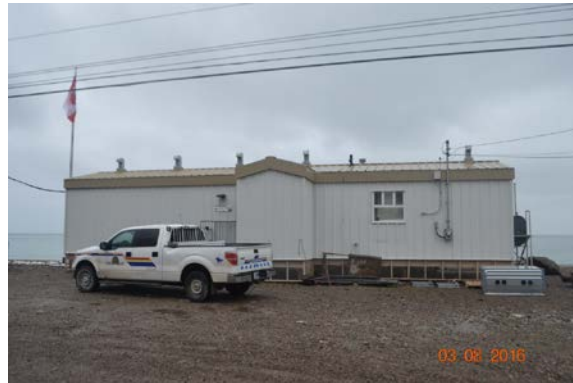
V122 Workshop – missing roofing sections

- Supply and install plenums on warm air furnace.
 - Repairs to chimney collar/flashing
 - Replace/repair sections of roof sheet/cladding. Does not have to match. Repair area sufficiently to prevent leaks into storage. (See photos)

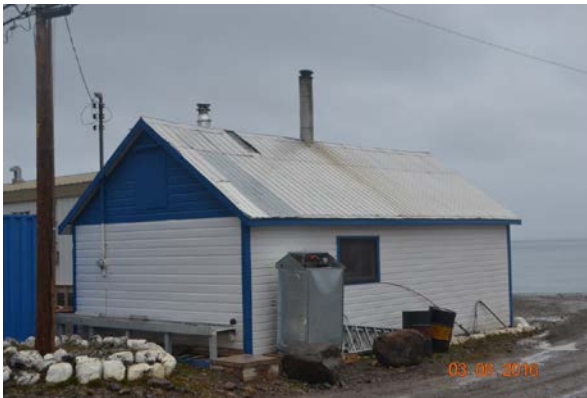
V122 Workshop, missing roof, requires patching

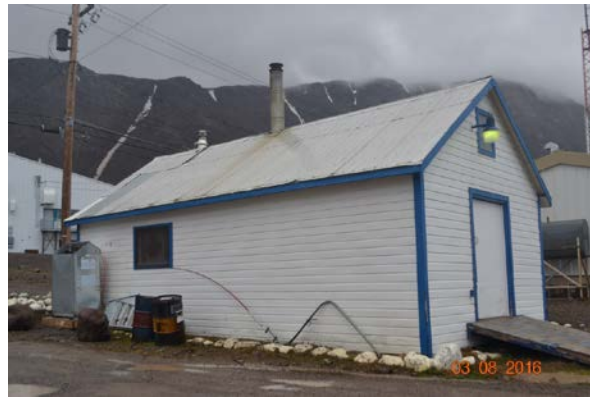
V122 workshop, missing roofing, Repair flashing on roof around new chimney

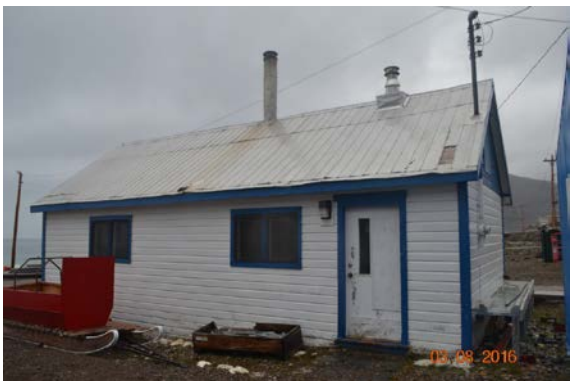
V122 – workshop – supply and install plenums, replace 4 light fixtures.

- Install tiger loop on furnace & water heater
- V122 Storage/Warehouse
 - Supply and install four (4) wet/damp LED 4’ fixtures. Surface mount, Recommend Lithonia XWLED. Supply bulbs.

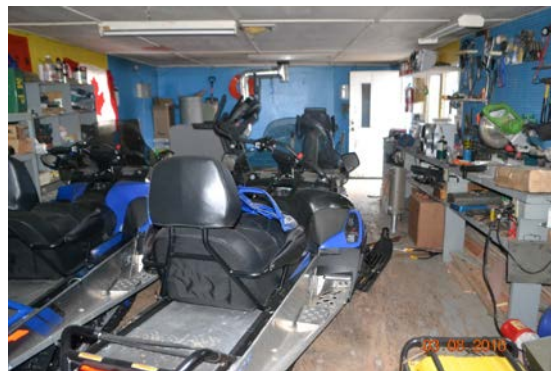
V008 Grise Fiord House

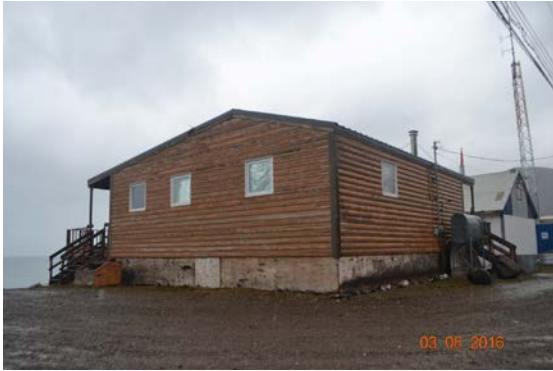
V008 House

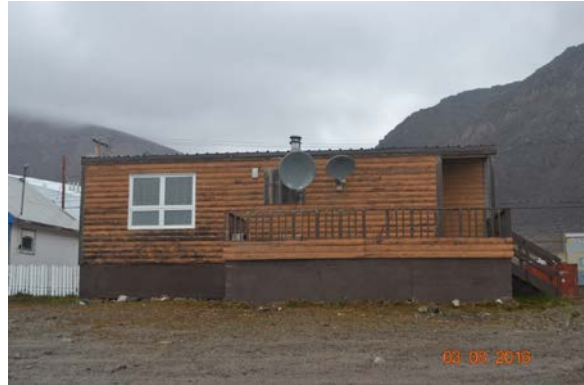
V008 – House, repair flashing on roof

- V008 – Residential House on RCMP compound
 - Supply and install new furnace and chimney
 - Replace chimney
 - Ensure new chimney is supported on roof (tied-down), install storm-flashing/weather proof collar at connection point to roof and caulk with appropriate weather/heat resistant exterior sealant.

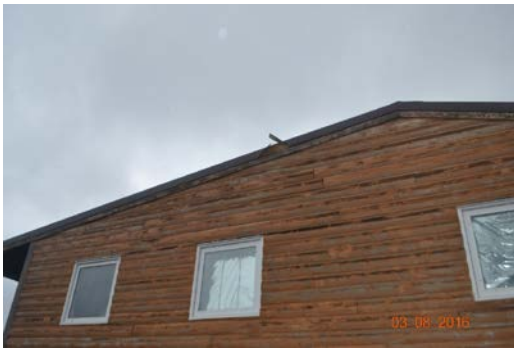
V008 house, chimney requires supports/tie downs.

- Ensure chimney cap is secured using additional supports or connectors as required.
 - Replace vent connectors & draft regulators.
 - Replace oil-fired/warm air furnace.

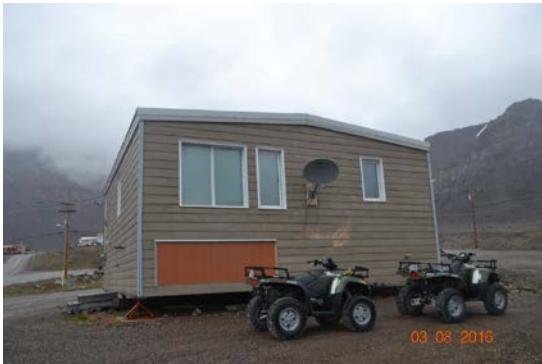
G007 – replace taps. Hand sink & bathtub

- Supply & install
- Supply & Install new kitchen, hand-sink and bathroom faucets
 - Moen brand, no substitutions
 - Single lever unit only
 - Sprayer required on kitchen faucet

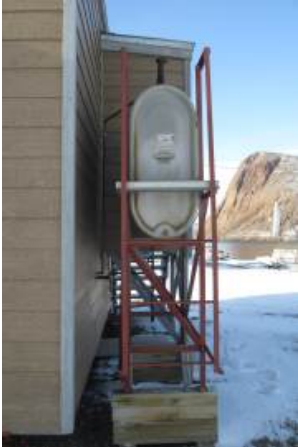
Code Issues	
Code violations are listed below. The overall recommendation for this site due to the deficiencies, condition, and age of the tank is to replace the system.	
CSA B139 (09) 7.3.8	<p>Issue: A tank shall be installed on rigid, non-combustible supports constructed of materials having a fire-resistance rating of not less than 2h. New tank stand to be constructed of non-combustible material</p>

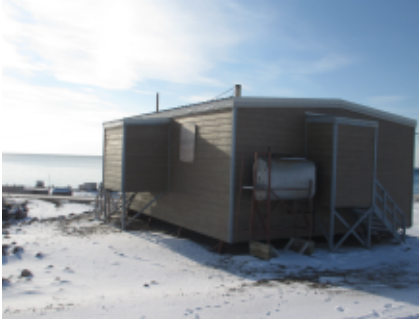
CSA B139 (09) 7.5.5	<p>Issue: Outdoor tanks need secondary containment, or need to be double walled/bottom with interstitial monitoring. Existing tank is single wall and needs to be replaced.</p>
CSA B139 (09) 7.5.6	<p>Issue: Tanks installed in an area not separated by vehicles needs to be protected by good engineering practices. New tank should be provided with protective bollards.</p>

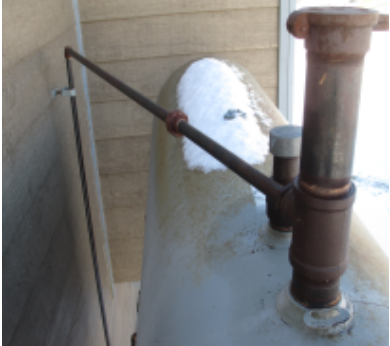
CSA B139 (09) 7.8.2	<p>Issue: Each fill opening and each entry to a fill pipe shall be provided with a weather tight cover designed to prevent tampering. New tank to be provided with weather tight cover.</p>

Code Issues	
CSA B139 (09) 7.8.4	Issue: A fill opening shall be designed to avoid spillage. New tank should be installed with certified spill containment box. (see photo above)
CSA B139 (09) 7.9.1.7	Issue: Vent must terminate a minimum of 6" above fill. (see photo above)
CSA B139 (09) 7.9.1.7	Issue: Vent must be c/w a weatherproof hood. The vent hood or cap shall prevent ingress of objects. New tank vent to terminate in code approved hood. (see photo above)
CSA B139 (09) 9.3.1.5	Issue: Piping shall be supported and protected against physical damage such as foot traffic, vehicles, and snow and ice damage.

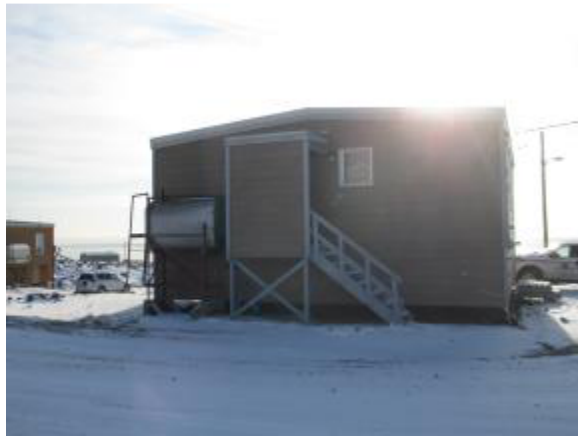
Photo 1: Outdoor above ground fuel tank and stand

Exterior Assessment	
Tank Type	Westeel, single wall tank, approximate capacity 1100L capacity. No visible name plate on tank.
Tank Condition	Fair/Poor; Corrosion beginning to penetrate surface.
Tank Location	Outdoors; east side of building. Co-ordinates: 76.419559,-82.904955
Clearance	16" to exterior wall.
Stand Type	Steel stand on stacked 2x6 wood base.
Stand Condition	Fair; Covered in surface corrosion.
Exterior Piping	2" steel piping off of tank then transitions to 1" steel pipe into building. 3/4" return piping from building tied into fill at top of the tank. Good/Fair condition; surface corrosion developing.
Exterior Valves & Accessories	Shutoff valve at tank.
Tank Venting	1-1/4" steel pipe with vented cap. Terminates approximately 5" below fill connection.
Spare Tanks	None.

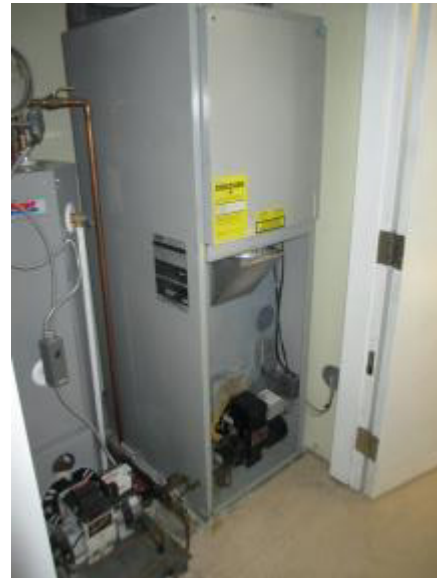
Photo 2: Furnace

Interior Assessment	
Equipment #1	Furnace: DMO Industries, Model WTL-100H, Serial No. 38719WTNLU, Capacity 100 MBH, Firing rate 0.85 GPH, Manufactured date unknown. Burner: Beckett, Model AJ-514684, Serial No. unknown, Firing rate unknown.
Equipment #2	Water Heater: Heil, Model CM-32, Serial No. D051034221, Capacity 70 MBH, Firing rate 0.65 GPH, Manufactured date unknown. Burner: Beckett, Model AFG-65BO, Serial No. 100405-23765, Firing rate 0.5-3.0 GPH.
Interior Piping	1/2" and 3/8" soft copper tubing. Good condition.
Interior Valves & Accessories	Furnace: Common oil filter and flame arrestor, check valve in return line. Water Heater: Common oil filter and flame arrestor, check valve in return line.
Fuel Pumps	None.
Spill Trays	None.
Spill Kits	None.
Fire Extinguisher	Fire Extinguisher: 4A:60B:C type extinguisher located on wall.
Precision Leak Test	No records on site.

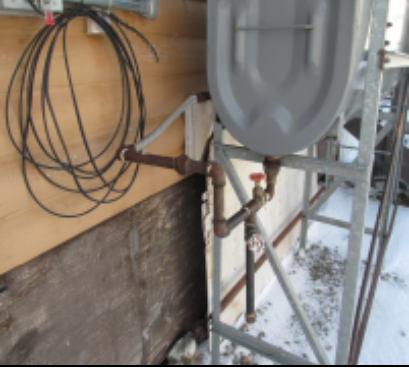
Code Issues	
Code violations are listed below. The overall recommendation for this site due to the deficiencies, condition, and age of the tank is to replace the system.	
CSA B139 (09) 4.1.1	<p>Issue: All components shall be certified and shall be installed for its intended use. Existing shut off valves are not code compliant.</p>

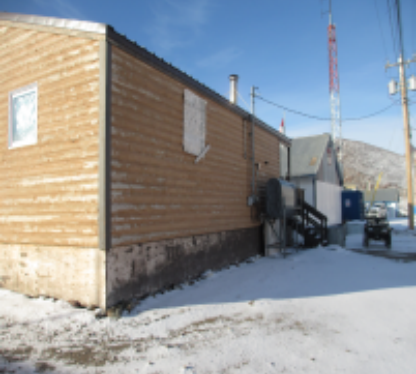
CSA B139 (09) 7.5.5	<p>Issue: Outdoor tanks need secondary containment, or need to be double walled/bottom with interstitial monitoring. Existing tank is single wall and needs to be replaced.</p>
CSA B139 (09) 7.5.6	<p>Issue: Tanks installed in an area not separated by vehicles needs to be protected by good engineering practices. New tank to be provided with protective bollards.</p>

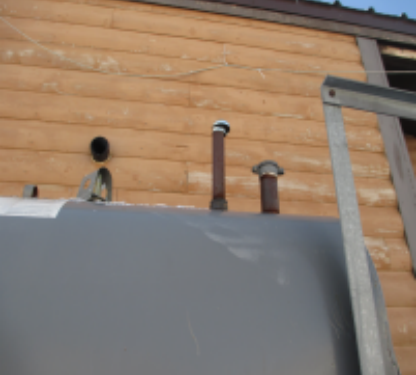
CSA B139 (09) 7.8.2	<p>Issue: Each fill opening and each entry to a fill pipe shall be provided with a weather tight cover designed to prevent tampering. New tank to be provided with weather tight cover.</p>

CSA B139 (09) 7.8.4	Issue: A fill opening shall be designed to avoid spillage. New tank should be installed with certified spill containment box. (see photo above)
CSA B139 (09) 7.9.1.7	Issue: Vent must terminate a minimum of 6" above fill. (see photo above)
CSA B139 (09) 7.9.1.7	Issue: Vent must be c/w a weatherproof hood. The vent hood or cap shall prevent ingress of objects. New tank vent to terminate in code approved hood. (see photo above)
CSA B139 (09) 9.3.1.5	Issue: Piping shall be supported and protected against physical damage such as foot traffic, vehicles, and snow and ice damage.

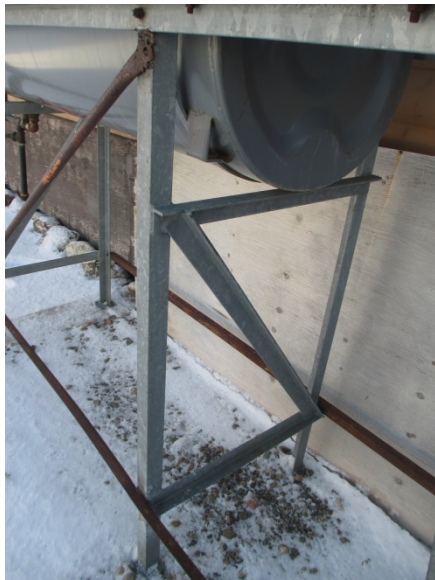
Photo 1: Outdoor above ground fuel tank and stand

Exterior Assessment	
Tank Type	Granby, Single wall, 1111 L capacity. Model 115003, Serial No. D-022419. Manufactured 2008.
Tank Condition	Fair/Poor; Tank is in relatively good condition, but since it is single wall, the recommendation is to replace the tank.
Tank Location	Outdoors; on the north east side of building. Co-ordinates: 76.417687,-82.898661
Clearance	9" to exterior wall.
Stand Type	Steel stand on 6x6 wood base.
Stand Condition	Good.
Exterior Piping	1" steel piping. Fair condition; covered in surface corrosion.
Exterior Valves & Accessories	Shutoff and drain valves at tank.
Tank Venting	1-1/4" steel pipe with vented cap. Terminates approximately 5" above fill connection.
Spare Tanks	None.

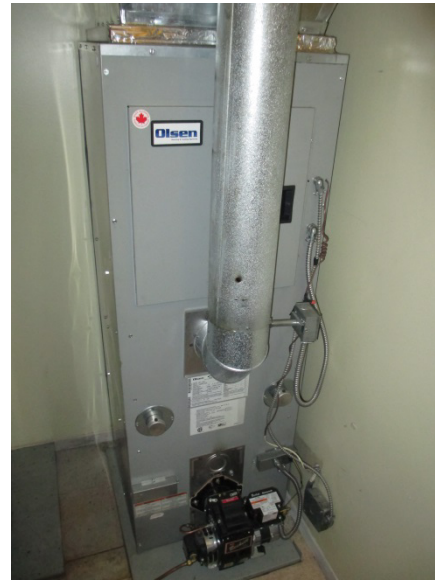
Photo 2: Furnace

Interior Assessment	
Equipment #1	Furnace: Olsen, Model MPL 120B, Serial No. 3308A015204, Capacity 85.5-123 MBH, Firing rate 0.75-1.10 GPH, Manufactured 2008. Burner: Beckett, Model AF65XN, Serial No. 080610-59975, Firing rate 0.4-3.0 GPH.
Equipment #2	Water Heater: Heil, Model CM-32, Serial No. D051034248, Capacity 70 MBH, Firing rate 0.65 GPH, Manufactured date unknown. Burner: Beckett, Model AFG-65BO, Serial No. 100405-23764, Firing rate 0.5-3.0 GPH.
Interior Piping	1/2" and 3/8" soft copper tubing. Good condition.
Interior Valves & Accessories	Furnace: Common filter and flame arrestor. Water heater: Common filter and flame arrestor.
Fuel Pumps	None.
Spill Trays	Spill trays under filter and flame arrestor.
Spill Kits	None.
Fire Extinguisher	Fire Extinguisher: 4A:60B:C type extinguisher located on floor.
Precision Leak Test	No records on site.

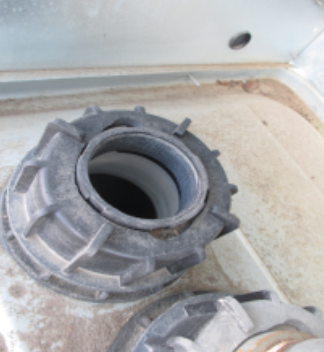
Code Issues	
CSA B139 (09) 7.2.1.4	<p>Issue: Any unused openings in a tank shall be sealed vapour and liquid tight. Recommendation: Provide liquid and vapour tight seal over tank opening.</p>

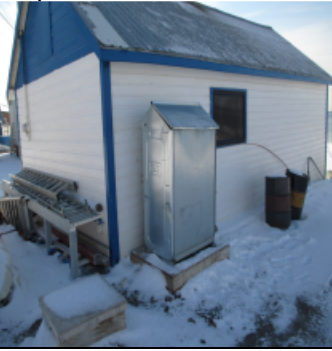
CSA B139 (09) 7.3.8	<p>Issue: A tank shall be installed on rigid, noncombustible supports constructed of materials having a fire-resistance rating of not less than 2h. Recommendation: Current base should be replaced with concrete pad, or pressure treated wood flush with grade.</p>

CSA B139 (09) 7.3.8	<p>Issue: A tank shall be securely supported to prevent settling, sliding, toppling, or lifting. (see photo above) Recommendation: Secure tank to new stand to prevent toppling from wind exposure.</p>
CSA B139 (09) 7.5.6	<p>Issue: Tanks installed in an area not separated by vehicles needs to be protected by good engineering practices. Recommendation: Install bollards to prevent accidental vehicle collision.</p>

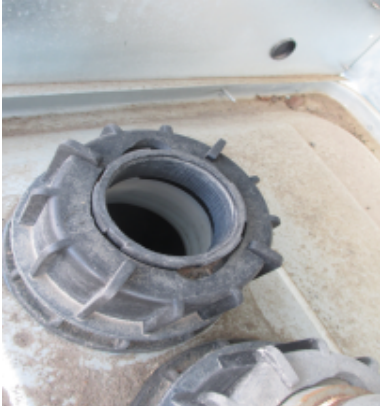
Code Issues	
CSA B139 (09) 7.8.2	<p>Issue: Each fill opening and each entry to a fill pipe shall be provided with a weather tight cover designed to prevent tampering. Recommendation: Install code approved, weather tight cover.</p>

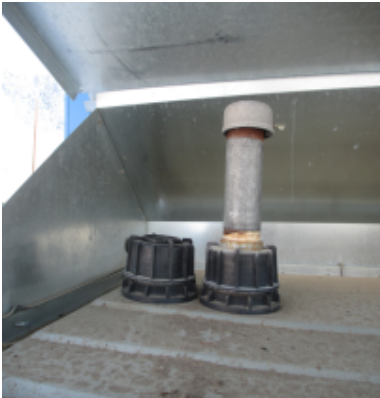
CSA B139 (09) 7.9.1.7	<p>Issue: Vent must terminate a minimum of 6" above fill. Recommendation: Replace the existing hood with new Roth retrofit hood and extend the existing vent pipe up a minimum of 6" above fill.</p>

CSA B139 (09) 7.9.1.7	<p>Issue: Vent must be c/w a weatherproof hood. The vent hood or cap shall prevent ingress of objects. (see photo above) Recommendation: Modify existing vent to terminate in code approved hood.</p>
CSA B139 (09) 9.3.1.5	<p>Issue: Piping shall be supported and protected against physical damage such as foot traffic, vehicles, and snow and ice damage. Recommendation: Protective covering over piping is recommended to prevent falling ice and snow from damaging piping.</p>

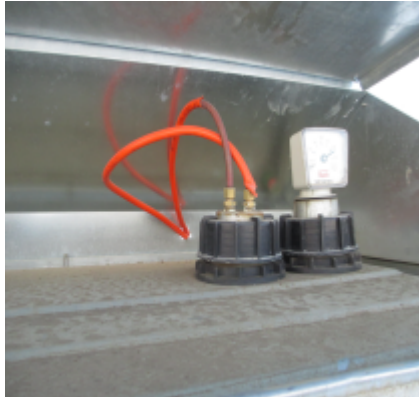
Code Issues	
CSA B139 (09) 9.3.1.9	Issue: Piping or tubing passing through exterior wall shall be sealed weather tight. Recommendation: Provide weather tight seal at exterior penetration.
CSA B139 (09) 9.4.1	Issue: Shut off valve must be installed as near as practicable to the exit from the supply tank. Recommendation: Modify piping and install code approved shut off valve at fuel tank.

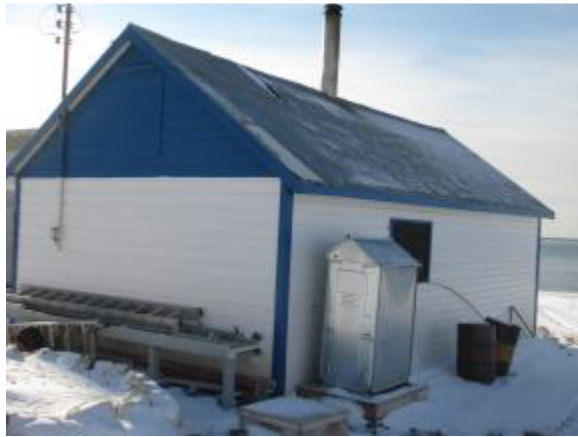
Photo 1: Outdoor above ground fuel tank

Exterior Assessment	
Tank Type	Roth, Double wall with secondary containment, 1000 L capacity. Serial No. 085510053 31443. Manufactured 2010.
Tank Condition	Good; no signs of corrosion or leaking.
Tank Location	Outdoors; North side of building. Co-ordinates: 76.417969, -82.899915
Clearance	9" to exterior wall.
Stand Type	Wood stand sitting on gravel.
Stand Condition	Poor.
Exterior Piping	½" soft copper tubing. Good condition.
Exterior Valves & Accessories	None, soft copper piping off the top of the tank, penetrates hood and then through exterior wall.
Tank Venting	2" steel pipe with cap, terminates approximately 4" above fill.
Spare Tanks	None.

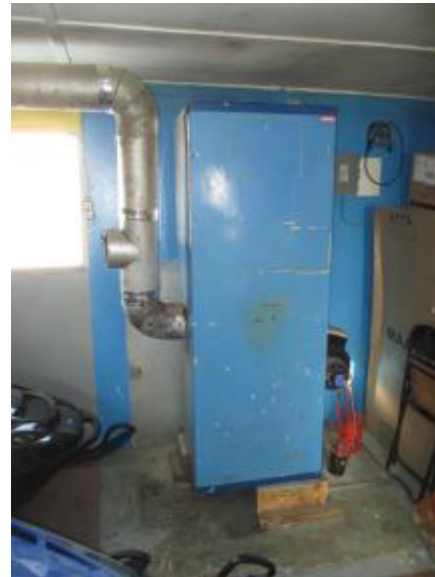
Photo 2: Furnace

Interior Assessment	
Equipment #1	Furnace: Old Metroheat unit, no visible name plate.. Burner: Metroheat, Model A1-CM, Serial No. 3059, Firing rate unknown.
Interior Piping	½" and 3/8" soft copper tubing. Good condition.
Interior Valves & Accessories	Furnace: Oil filter.
Fuel Pumps	None.
Spill Trays	Spill trays under filter.
Spill Kits	None.
Fire Extinguisher	None.
Precision Leak Test	No records on site.

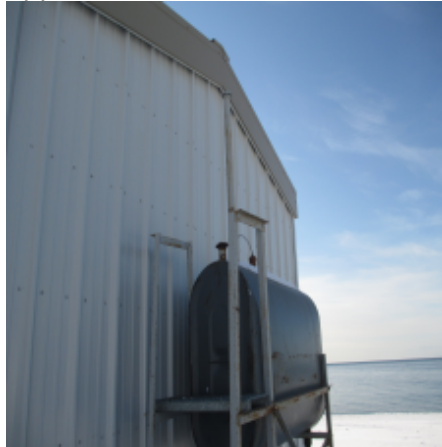
**CSA B139
(09) 7.9.1.7**

Issue: Vent must be c/w a weatherproof hood. The vent hood or cap shall prevent ingress of objects. New vent to terminate in code approved hood.

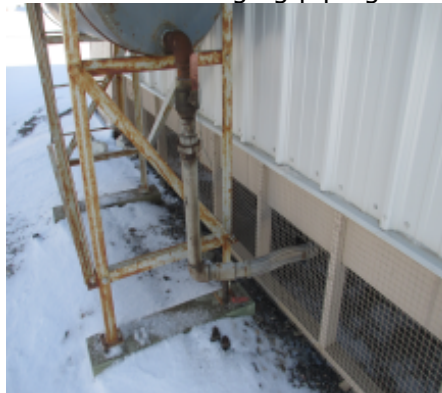
**CSA B139
(09) 9.3.1.5**

Issue: Piping shall be supported and protected against physical damage such as foot traffic, vehicles, and snow and ice damage. New system should have protective covering over piping to prevent falling ice and snow from damaging piping.

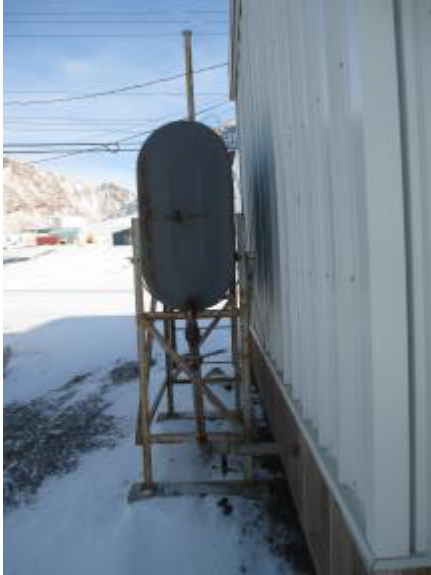
Photo 1: Outdoor tank

Exterior Assessment	
Tank Type	Single wall tank with no visible name plate. Approximate size of the tank is 1100 L.
Tank Condition	Fair/Poor; Corrosion beginning to penetrate surface, pitting beginning to occur.
Tank Location	Outdoors; North west side of building. Co-ordinates: 76.417871,-82.899741
Clearance	12" to exterior wall.
Stand Type	Steel stand on 6x6 wood base.
Stand Condition	Fair; Covered in surface corrosion.
Exterior Piping	2" steel piping with flexible connection. Fair condition; painted, surface corrosion developing.
Exterior Valves & Accessories	Shutoff valve and union at tank.
Tank Venting	2" steel pipe with vented cap. Terminates approximately 36" above fill connection.
Spare Tanks	Roth 1000L double wall tank in crate behind the building.

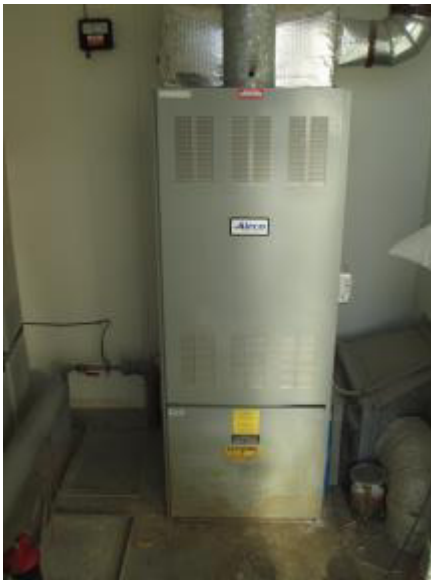
Photo 3: Furnace

Interior Assessment	
Equipment Tank 1	
Equipment #1	Furnace: Olsen, Model HTL-100C, Serial No. HTUL66474, Capacity 101.0 MBH, Firing rate 0.85 GPH, Manufactured 1987. Burner: Beckett, Model AF65XN, Serial No. 000221-20903, Firing rate 0.75-1.25 GPH.
Interior Piping	2", & 1/2" steel piping, 1/2"& 3/8" soft copper tubing. Good condition.
Interior Valves & Accessories	Furnace: Shutoff valve, fuel warmer, oil filter, flame arrestor and fuel levelometer
Fuel Pumps	None.
Spill Trays	Spill trays under fuel filter only.
Spill Kits	None.
Fire Extinguisher	Fire Extinguisher: 4A:60B:C type extinguisher located on floor.
Precision Leak Test	No records on site.
