Project No.: 209.40380.00000

**RE: DATA GAP ASSESSMENT  
GARDEN RIVER OLD DUMP SITES, GARDEN RIVER, ALBERTA**

DATA GAP ASSESSMENT REPORT

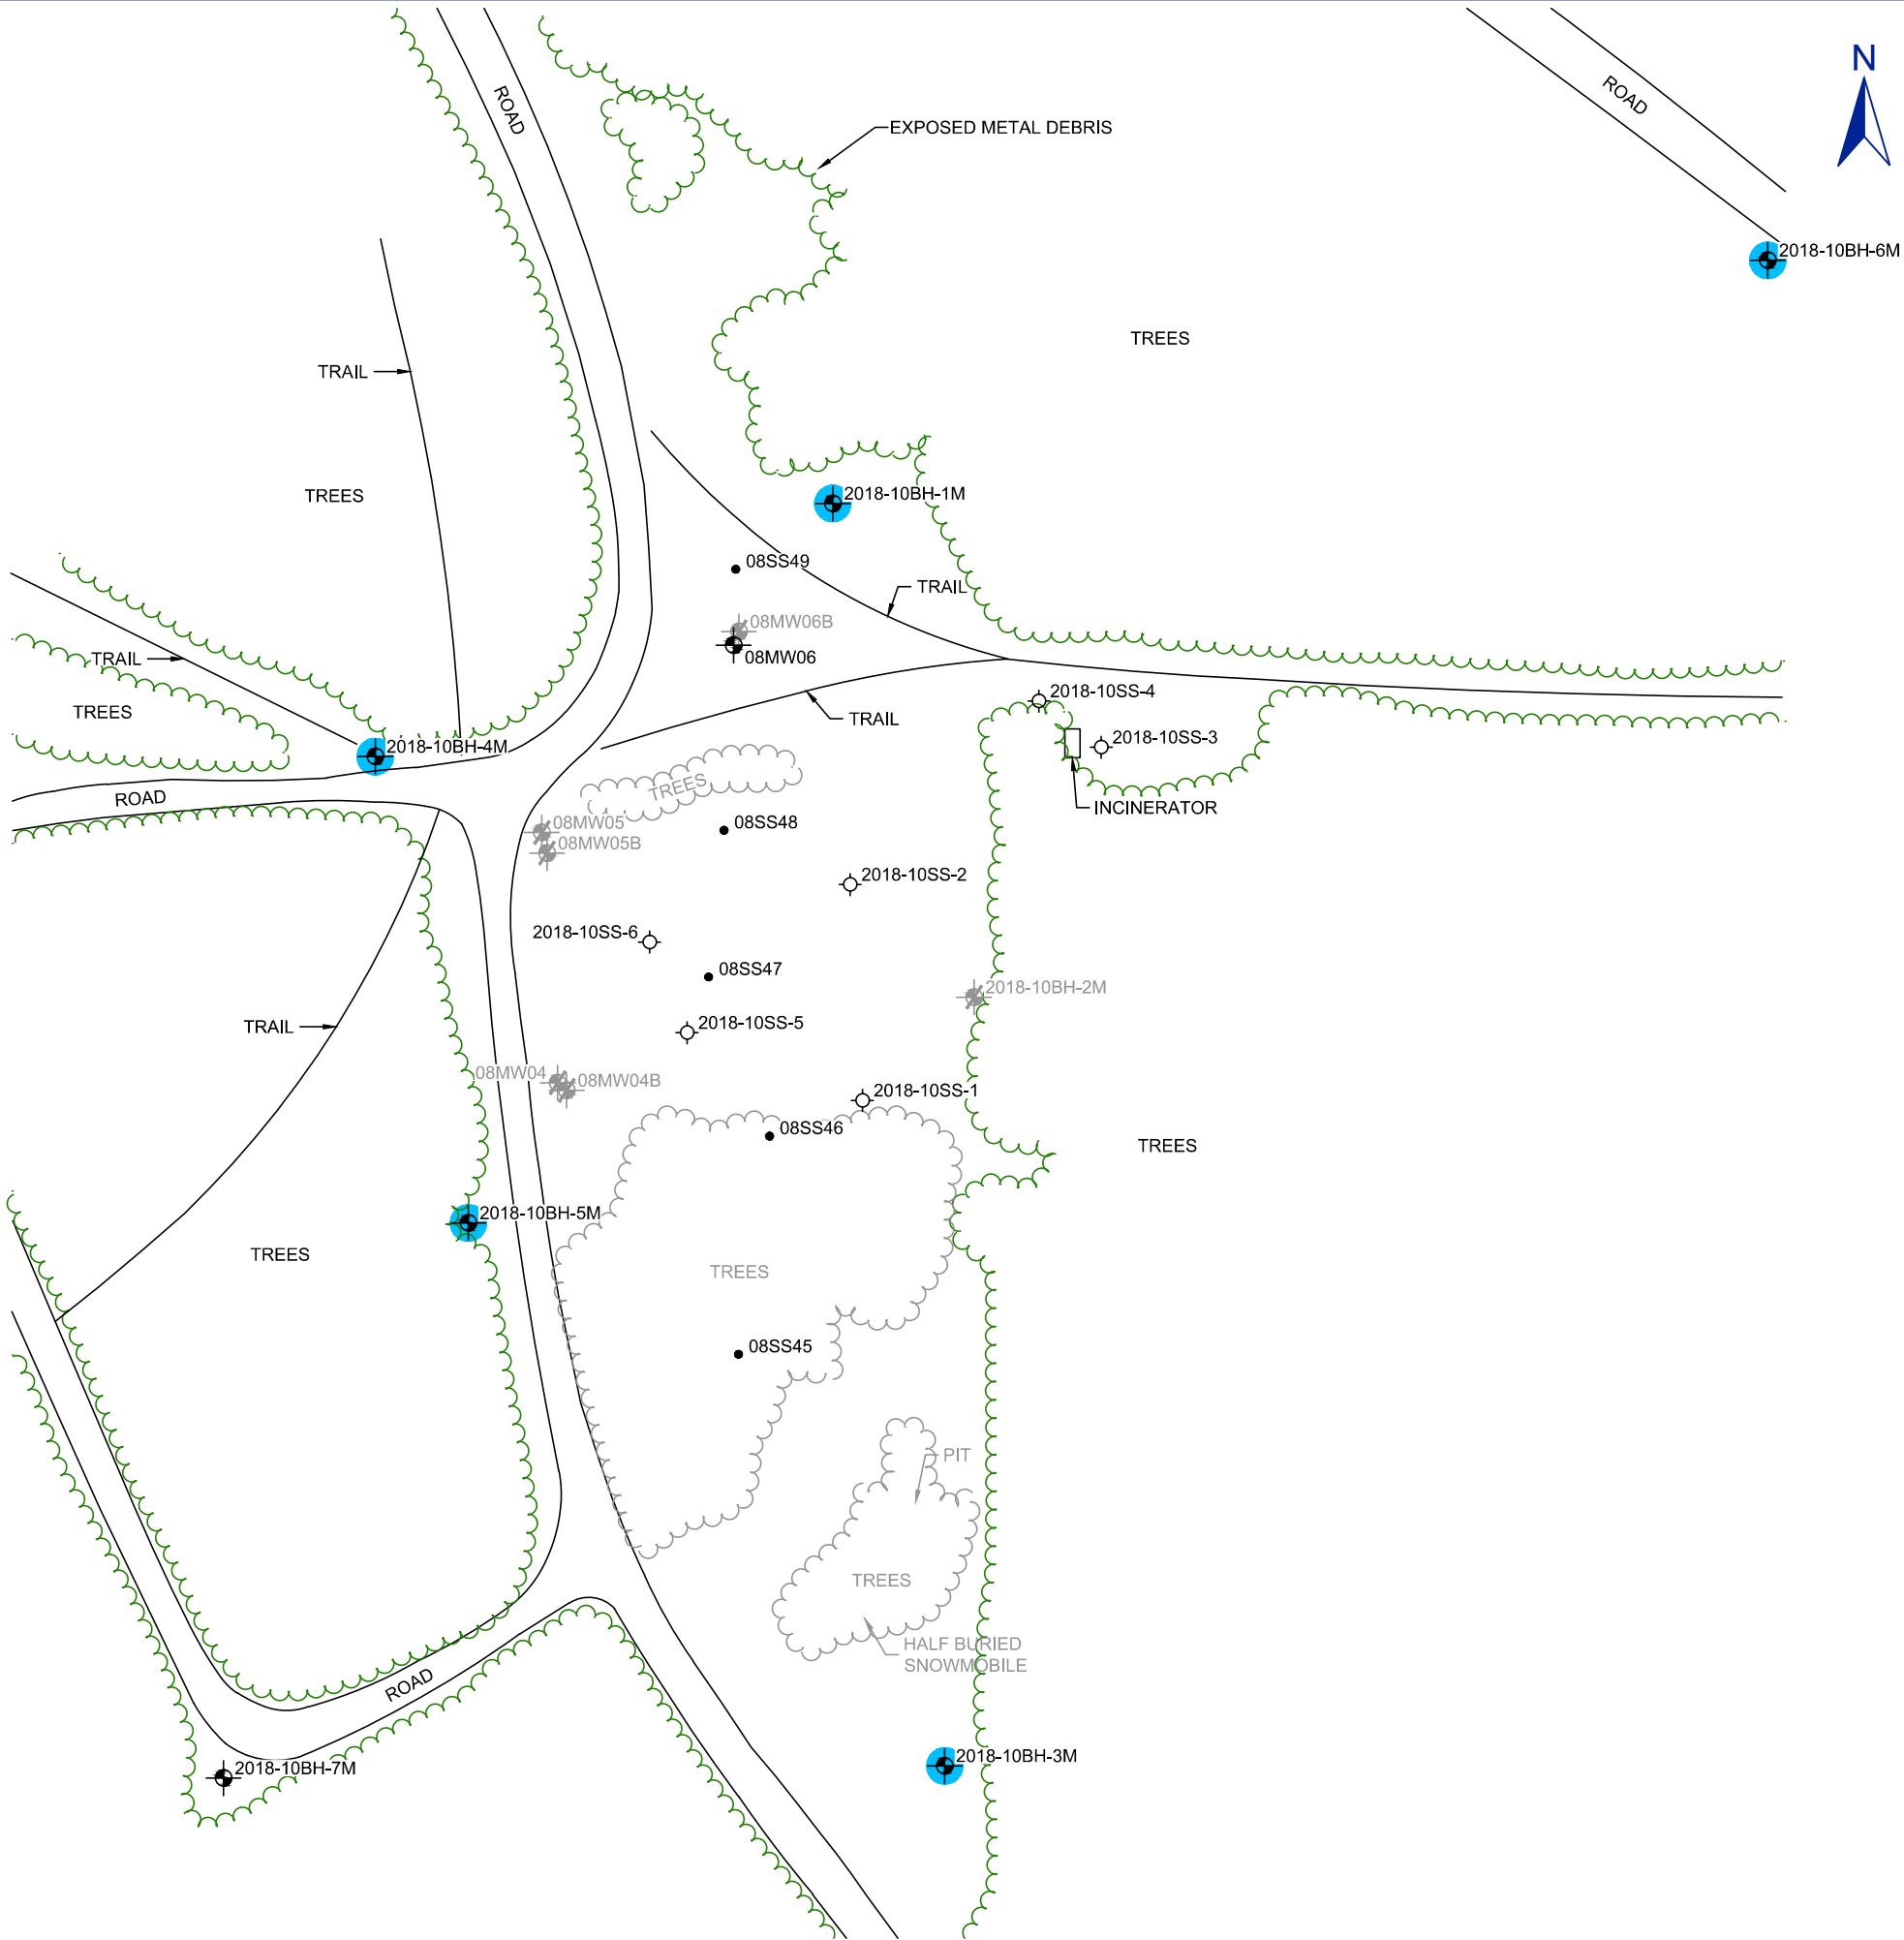
MONITORING WELL LOCATION PLAN

Groundwater monitoring results are summarized in Table 1. Groundwater monitoring identified that seven of thirteen monitoring wells located at the Old Dump site were suitable for monitoring. Of the seven wells, five (2018-10BH-1M, 2018-10BH-4M, 2018-10BH-5M, 2018-10BH-3M, and 2018-10BH-6M) were in good enough condition to allow for groundwater sampling to be conducted in the future. One well, 08MW06 was dry and should be decommissioned. The seventh well, 2018-10BH-7M, was suitable for groundwater monitoring, but was blocked, limiting its usefulness for groundwater sampling. Monitoring wells suitable for use in a future monitoring program at the site are indicated on Drawing 1.

- Monitoring wells located at the Old Dump should be surveyed for elevations to allow for their inclusion into the long term groundwater monitoring well network for the site; and
- Monitoring well 08MW06 was found to be dry during the monitoring program and should be decommissioned.

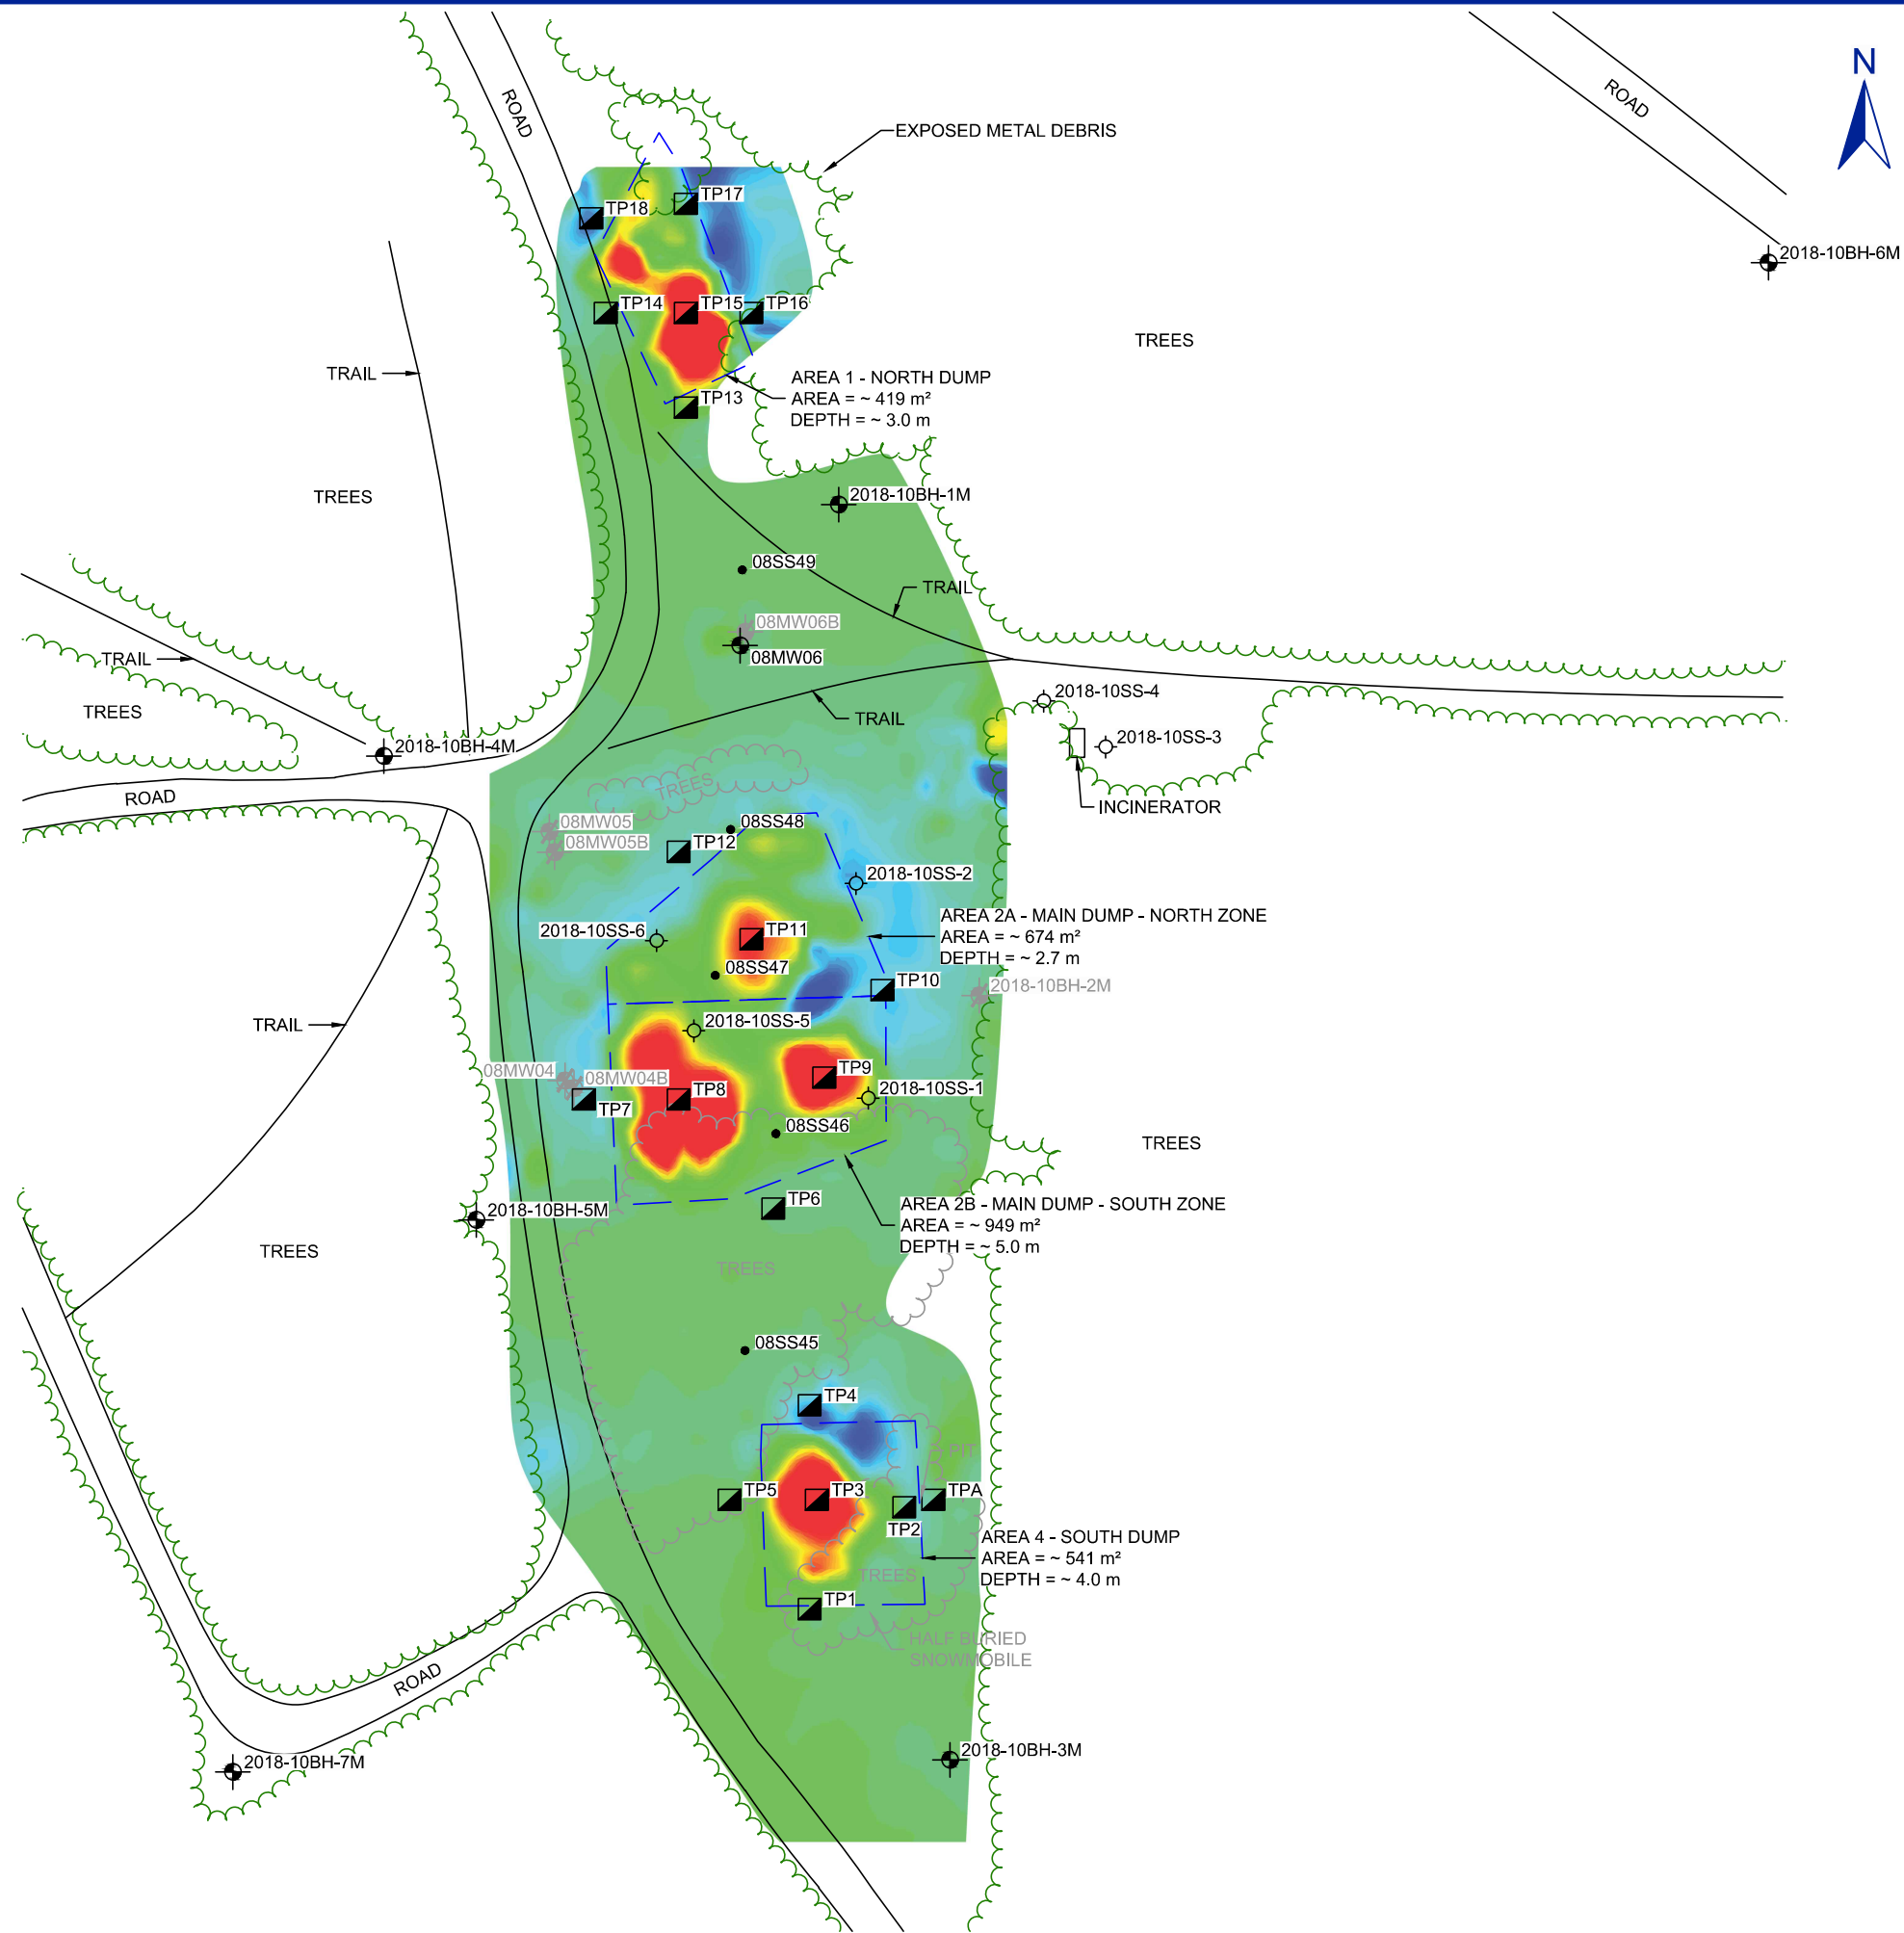
**TEST PIT LOCATION PLAN**

Test pits completed as part of the program are summarized in Table 2. The locations of the test pits are shown on Drawing 2. Photographs of the material encountered during the test pit program are provided in Appendix B.

Based on TP9 and results of the EM38 survey, for purposes of volume estimating, the Main Dump has been divided into the southern and northern zones as shown on Drawing 2. The depth of material requiring excavation in the north zone is estimated to be 2.7 m (waste depth plus adjacent soil) and in the south zone is estimated to be 5.0 m.

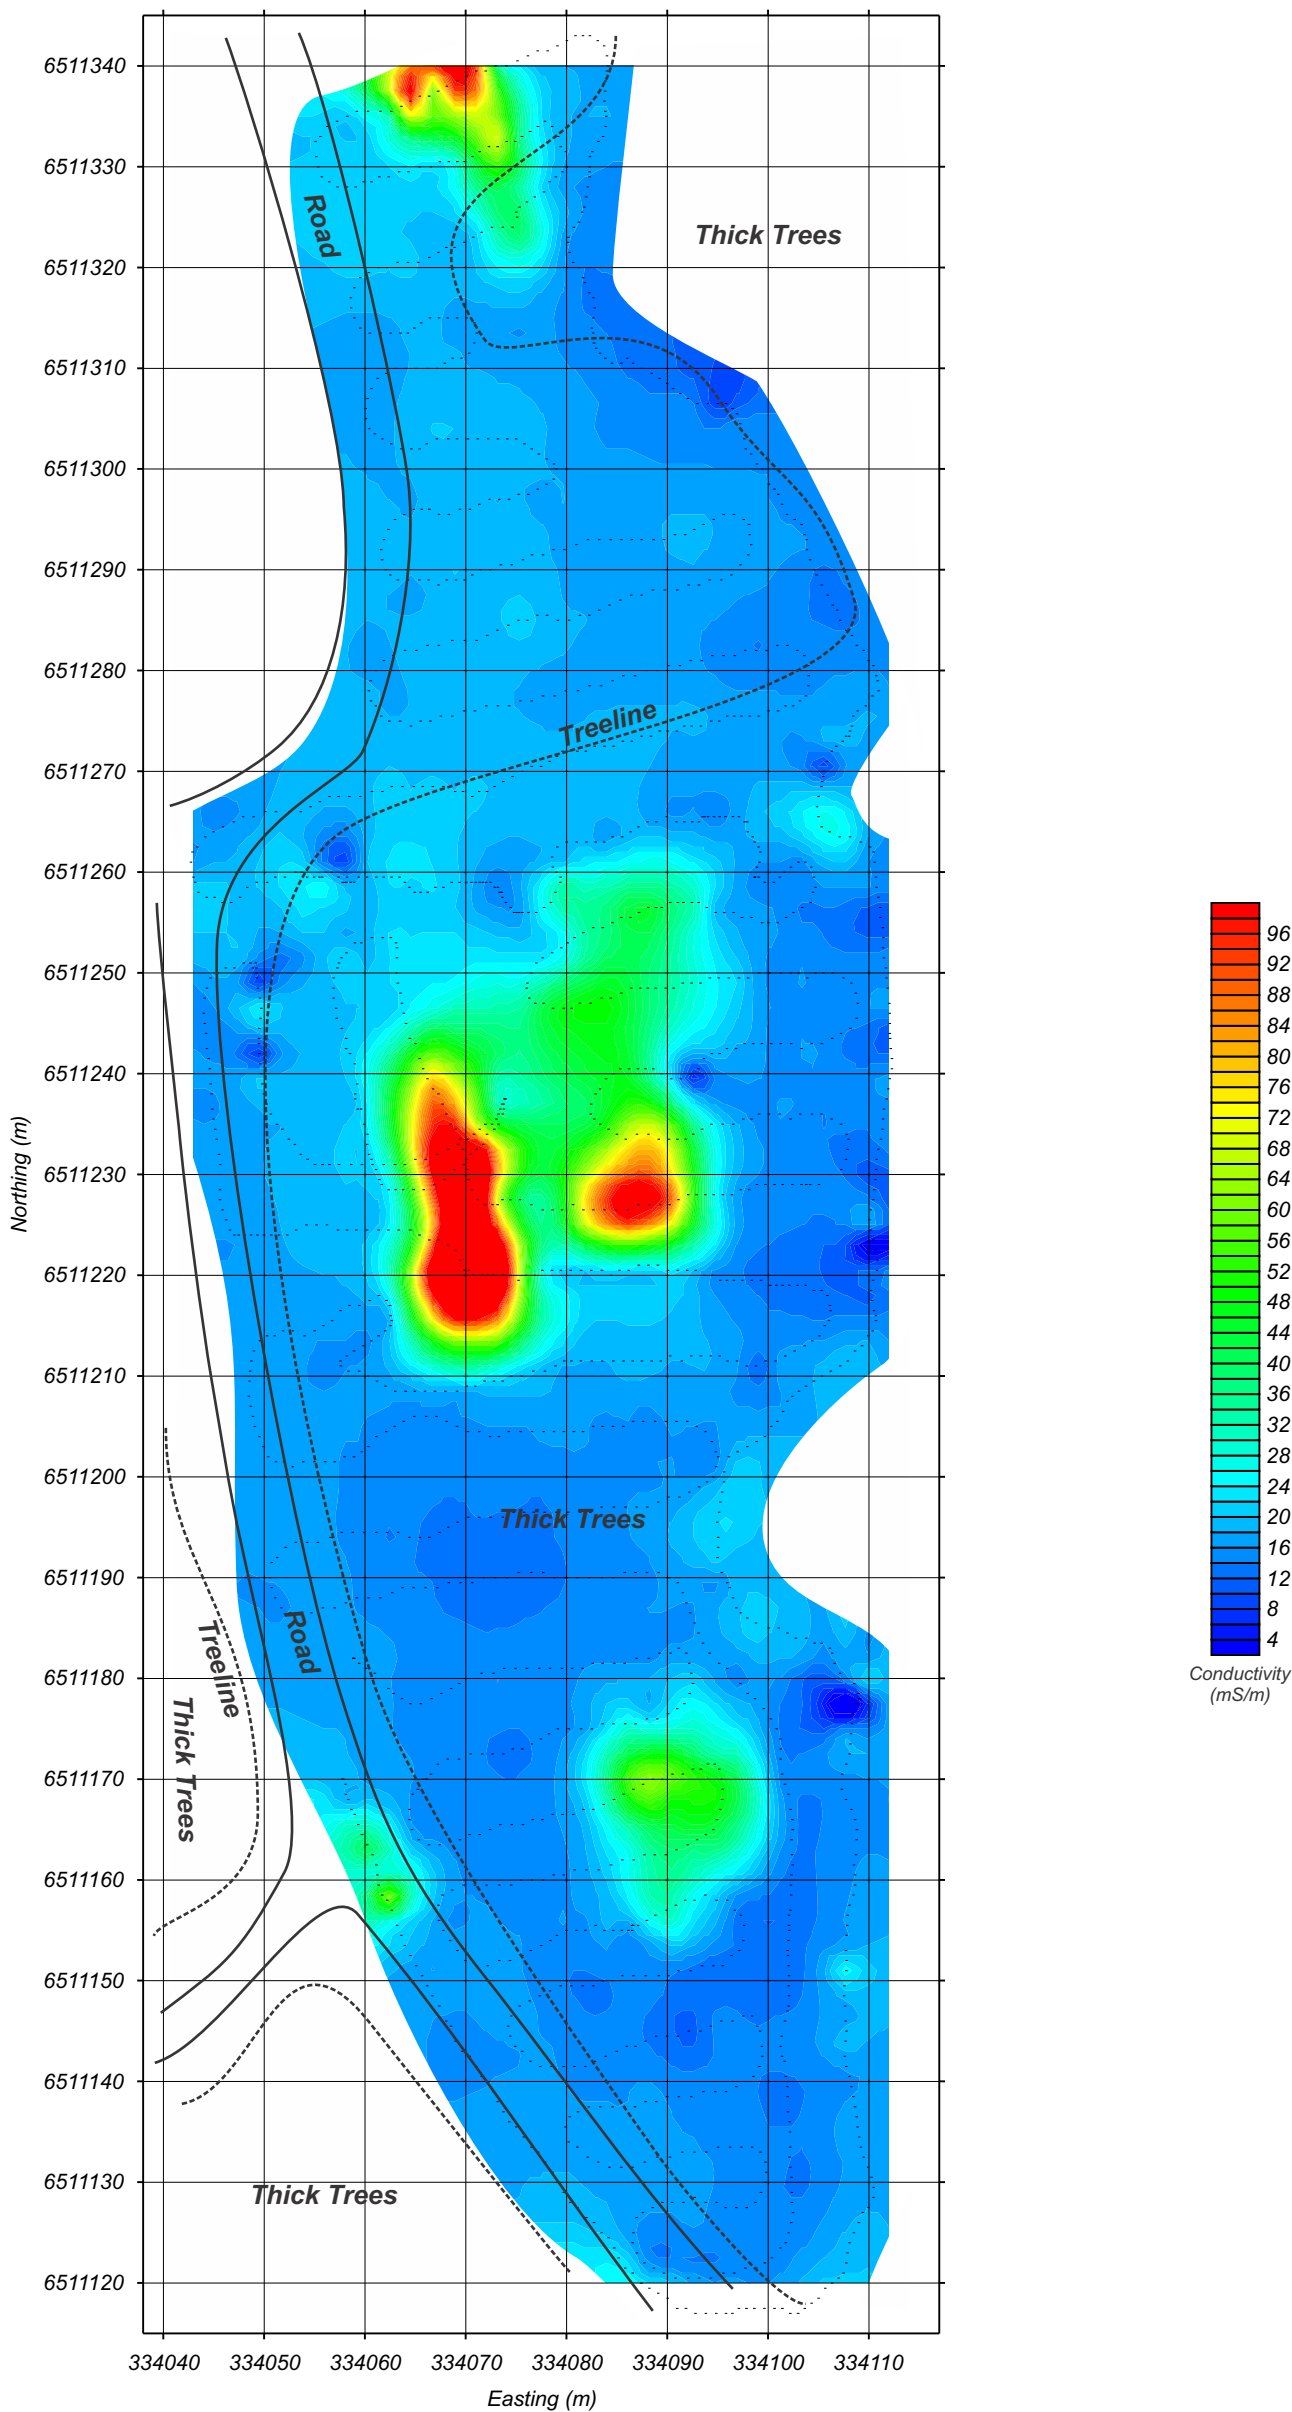
EM31 CONDUCTIVITY DATA 08-07-112-23 W4M GARDEN CREEK, ALBERTA	Prepared by:	Client:	Drawn by:	Reviewed by:
			Job No. 1877	Scale 1:750
			Dwg. No. 1	Survey: July 14, 2016

The Geonics EM31SH (referred to as EM31) and EM38 electromagnetic survey instruments provide terrain (or bulk) conductivity information to depths of approximately 4 m and 1.5 m below ground surface, respectively. All EM instruments operate on the principle of electromagnetic induction. A primary, alternating electromagnetic field is introduced into the subsurface by a transmitting coil. The primary field induces electrical currents to flow in the ground, thus creating a secondary electromagnetic field. Under specific conditions, the ratio of the primary to the quadrature component of the secondary field is equivalent to the ground conductivity, in units of millisiemens per metre (mS/m).

The introduction of metal debris into the subsurface greatly increases the ground conductivity and the instrument response is no longer linear. Thus, in areas of buried metal, conductivity values may appear as a mixture of positive and negative values. This response is diagnostic of buried metal debris or electromagnetic interference.

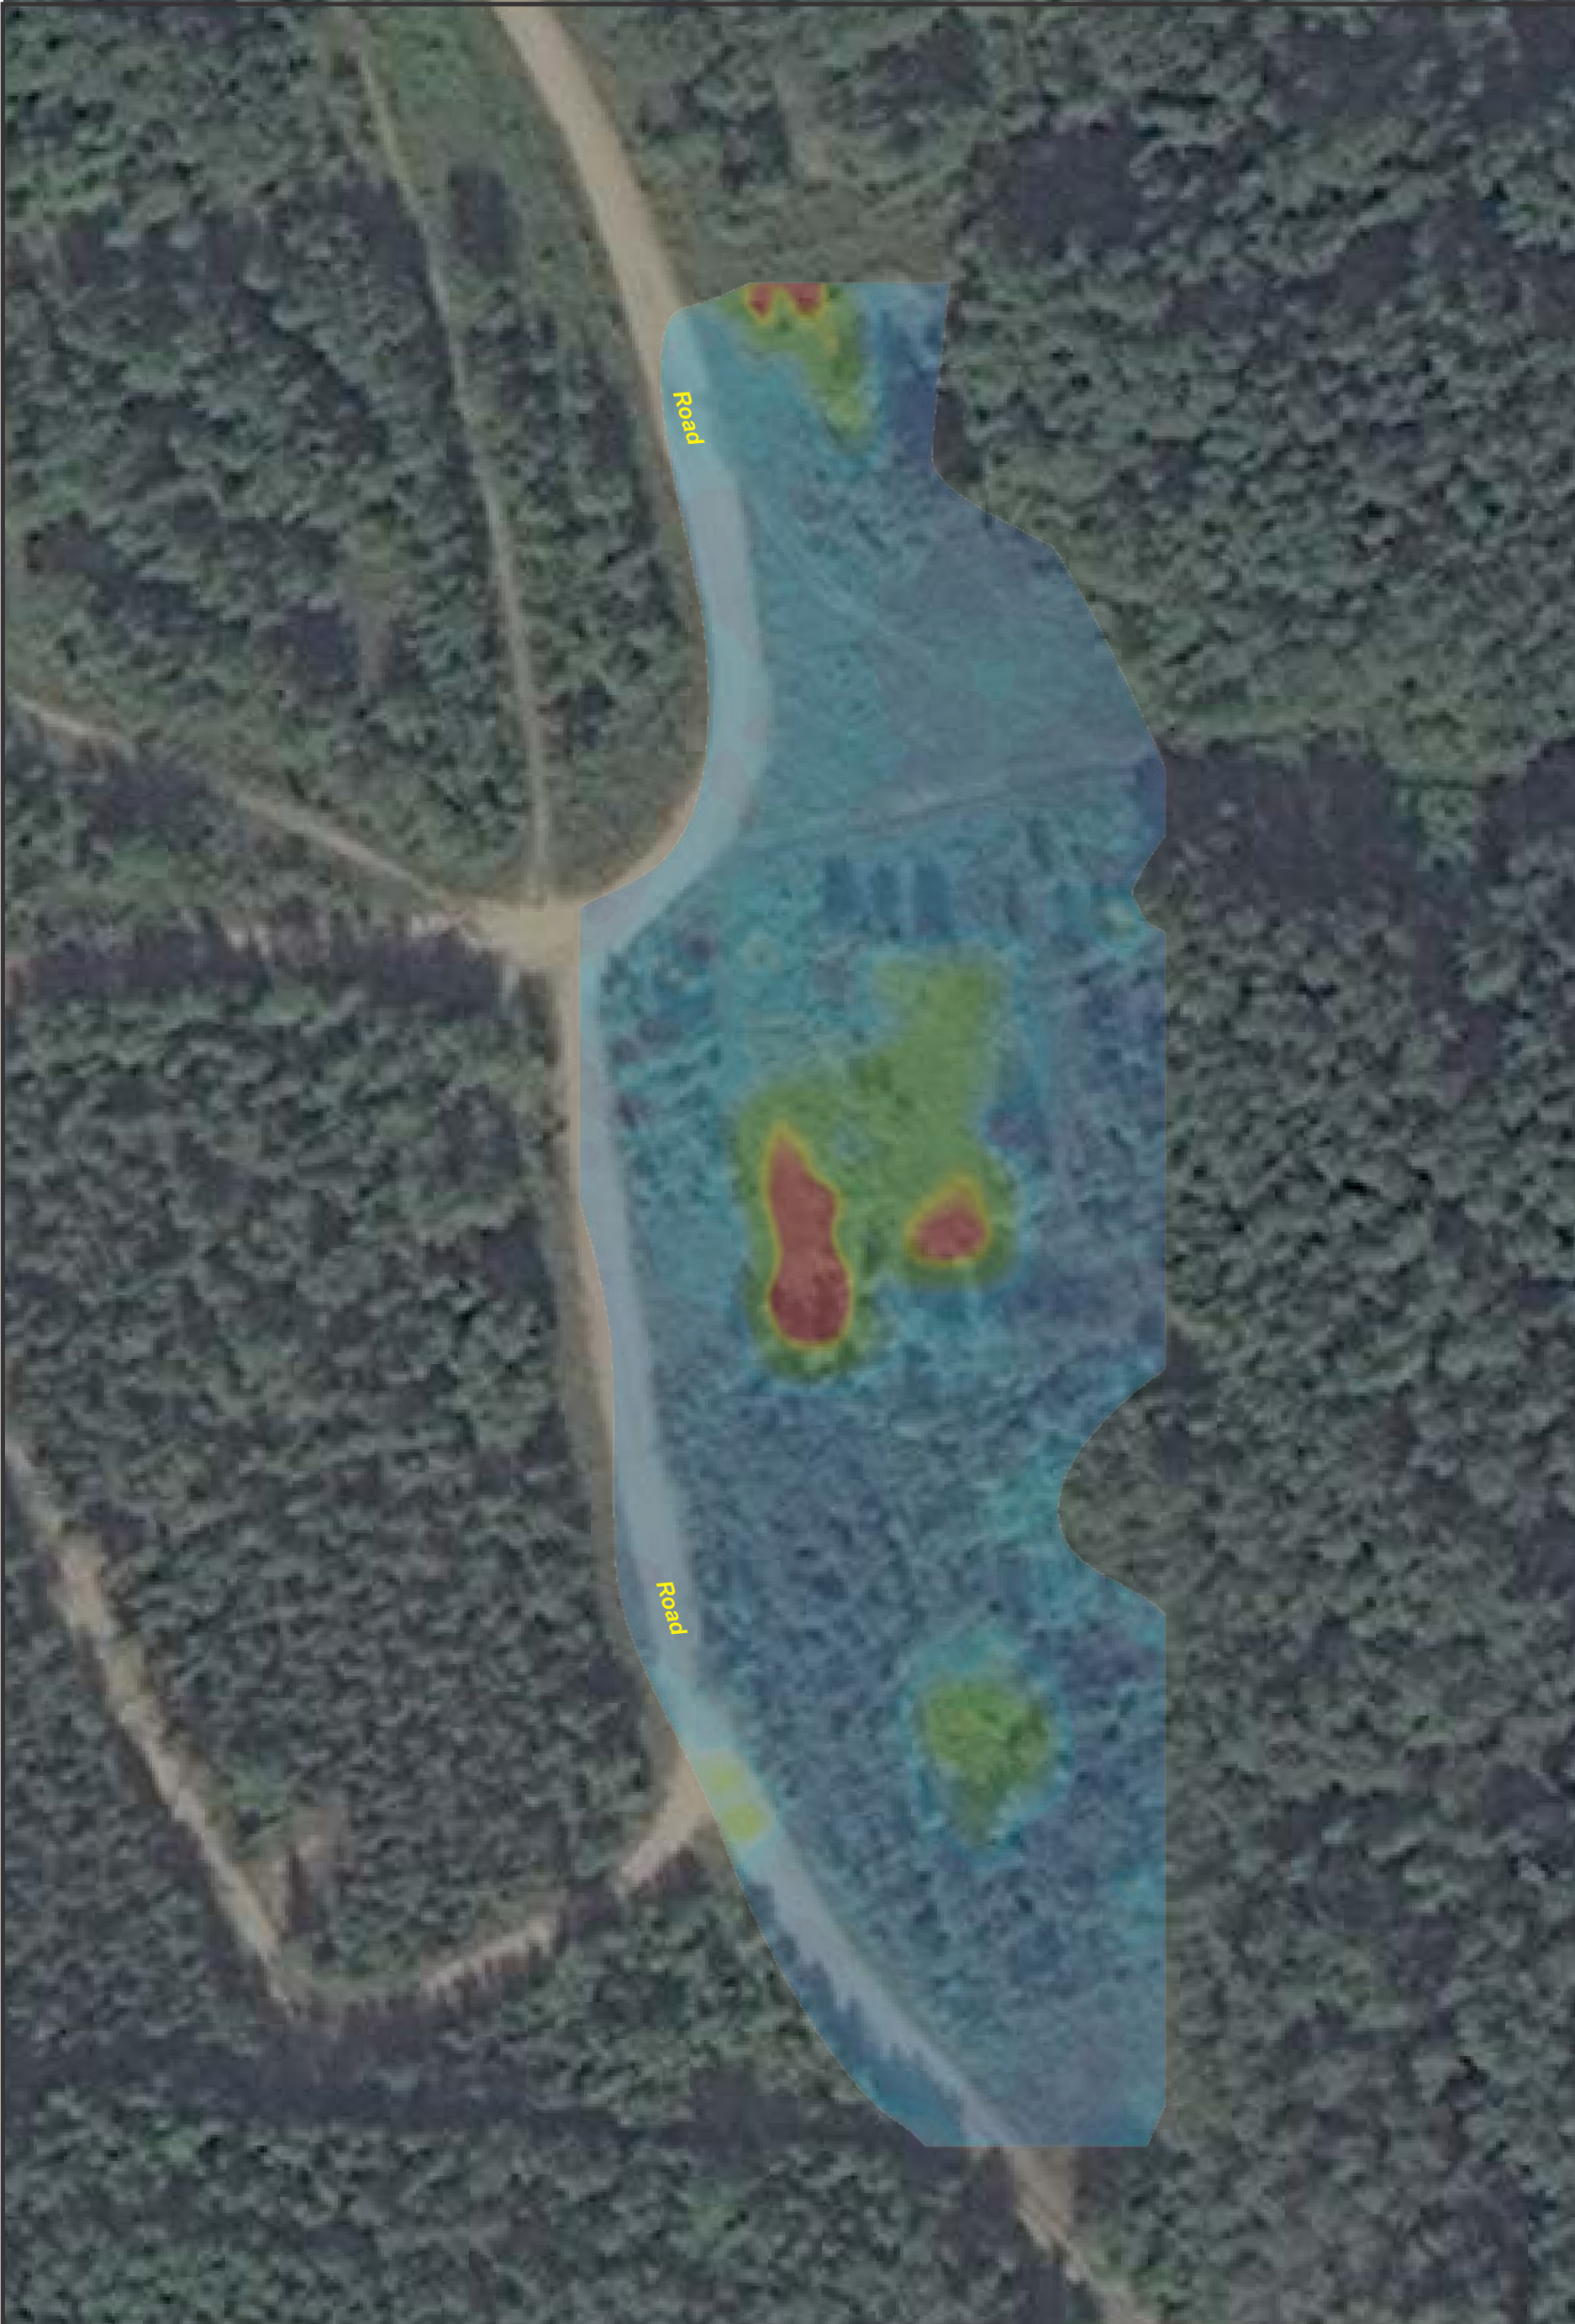
EM31 DATA OVERLAID ON AERIAL PHOTO 08-07-112-23 W4M GARDEN CREEK, ALBERTA	<div>Prepared by:</div> <div></div>	<div>Client:</div> <div></div>	<div>Drawn by:</div> <div></div>	<div>Reviewed by:</div> <div></div>
			Job No. 1877	Scale 1:750
			Dwg. No. 3	Survey: July 14, 2016

The geophysical surveys identify three main anomalies corresponding to the previously identified Old Dump Site (referred to as Area 2 by previous consultants), north debris area (Area 1) and south debris area (Area 4). A geophysical anomaly was not identified in the area previously referred to as “scattered surface debris” (Area 3), immediately south of the main Old Dump Site.

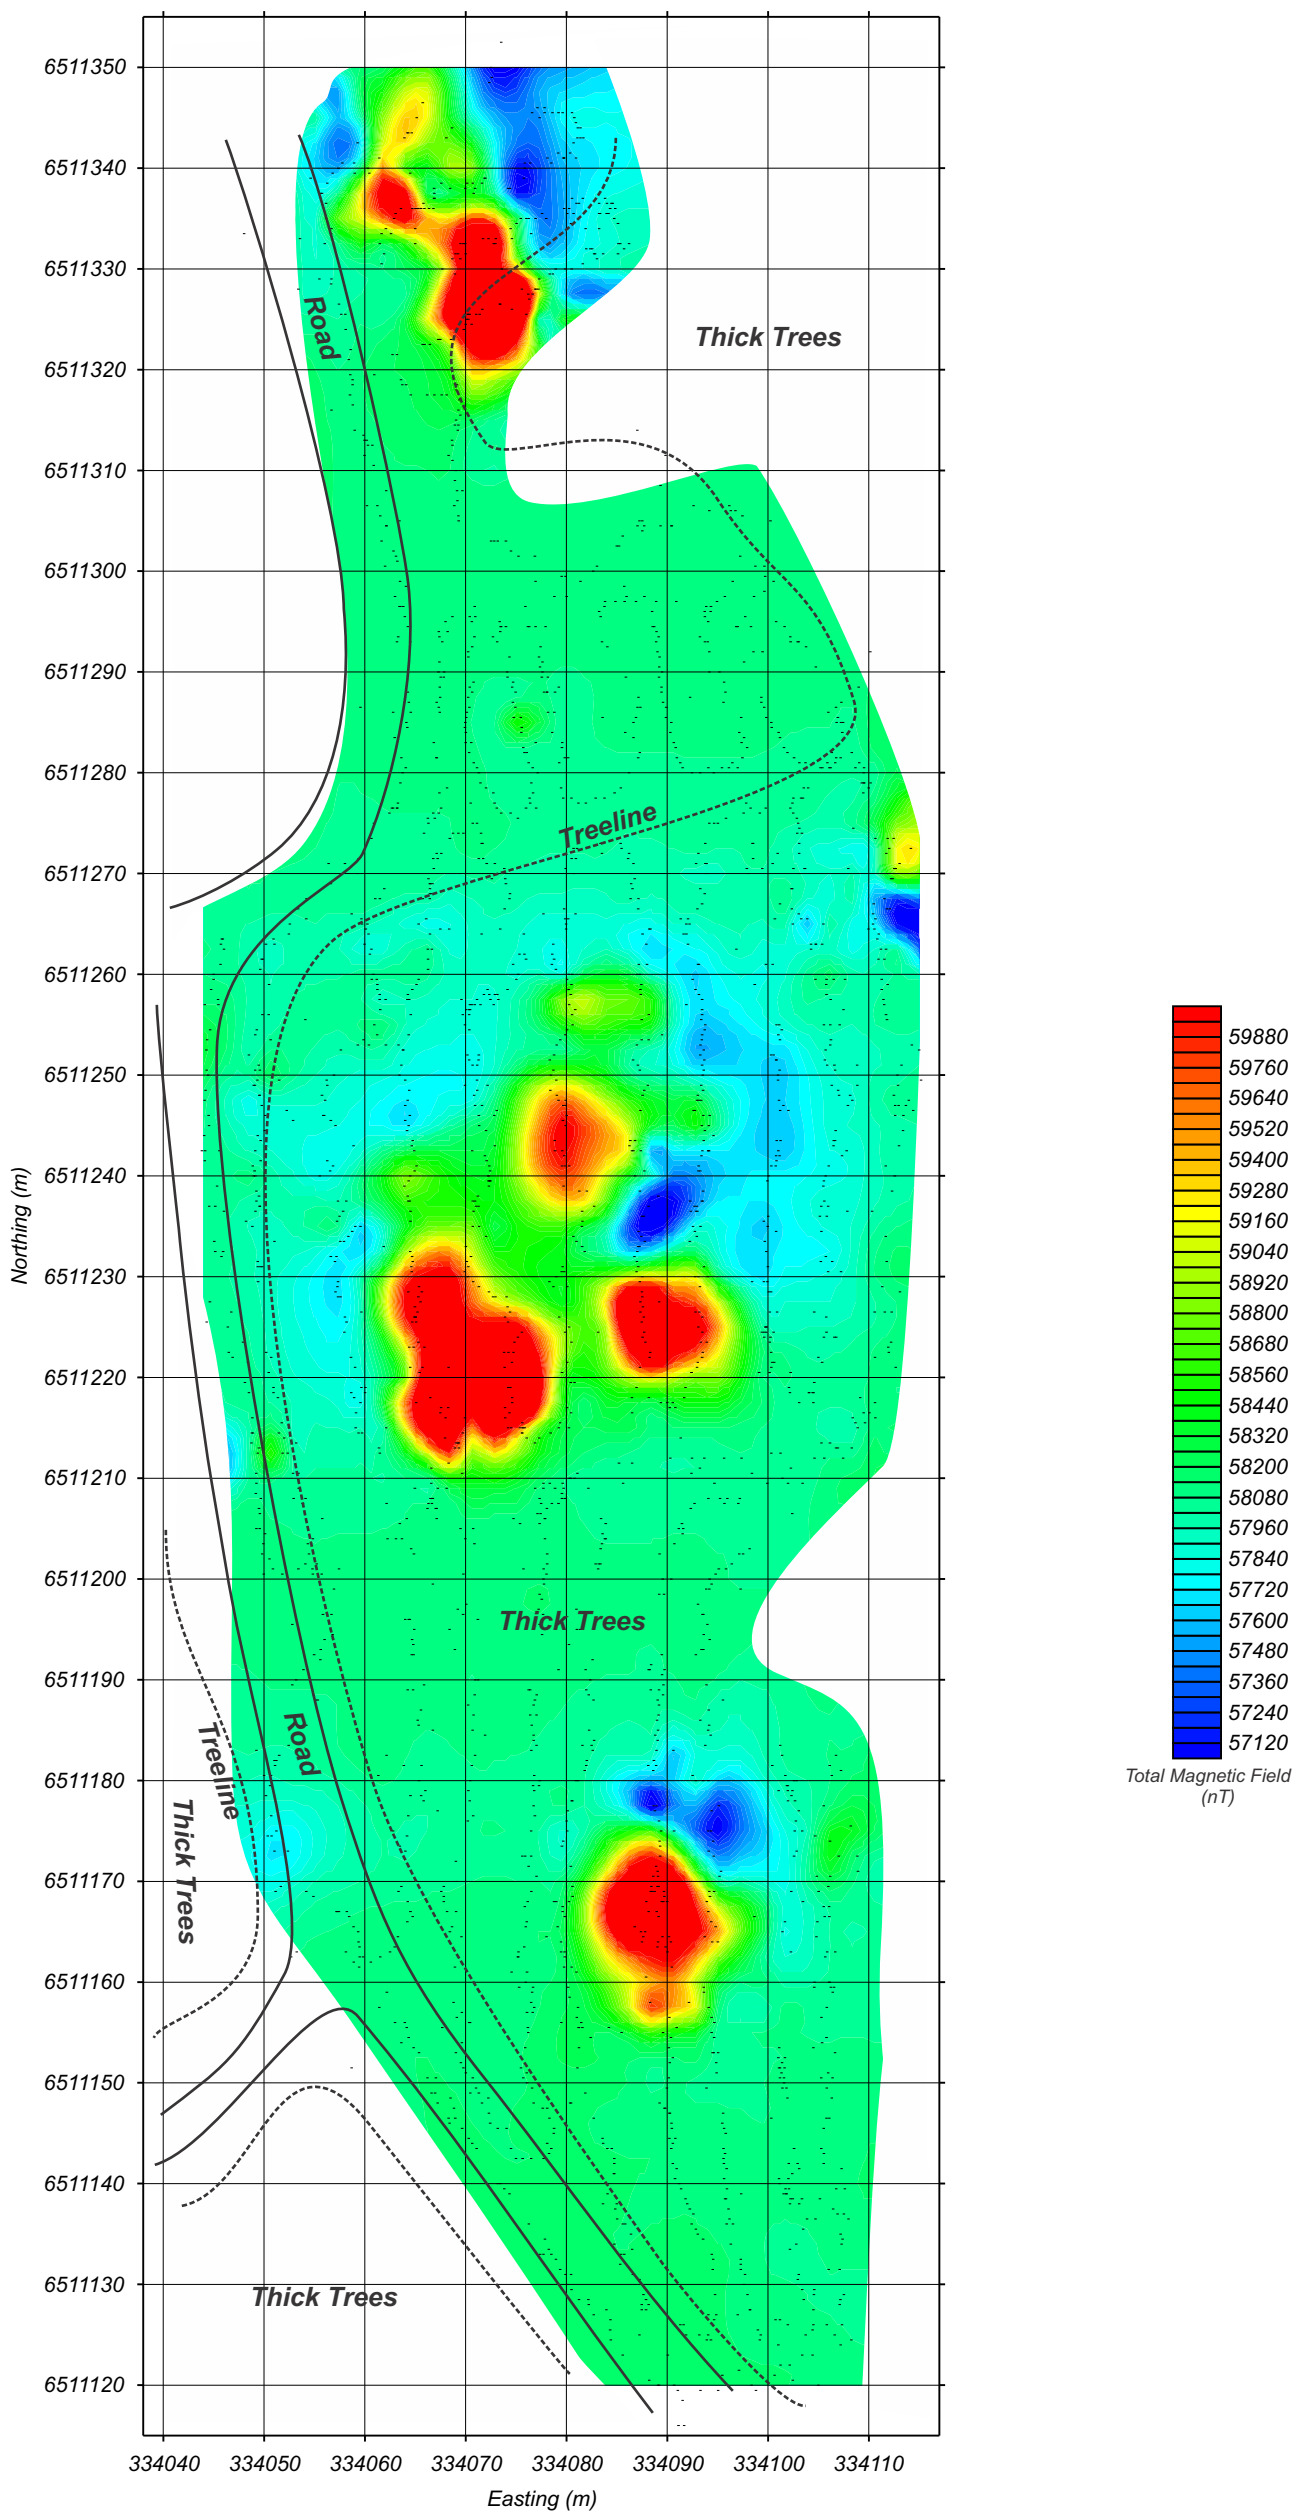
MAGNETIC GRADIENT DATA  
08-07-112-23 W4M  
GARDEN CREEK, ALBERTA

Total field magnetic intensity is a scalar measurement of the Earth's magnetic field. Anomalies within this field are due to two types of magnetism: induced and remnant. Induced magnetism results in the enhancement of the ambient field due to action of the field on a material that causes it to act as a magnet. Resulting magnetism is directly proportional to the intensity of the ambient field and the ability of the material to enhance the local field (magnetic susceptibility). Remnant magnetism is a permanent magnetism of the material that depends on the metallurgical properties and the thermal, mechanical and magnetic history of the material. It is independent of the field in which it is measured.

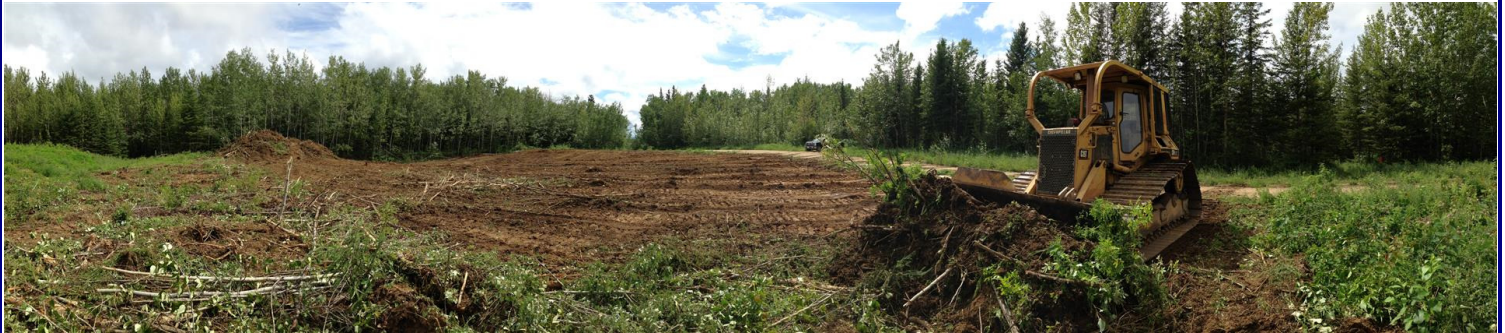
**Photo 1:** Panoramic view of site after tree clearing. Mounded soil associated with the south dump area is visible in the background of the photo.

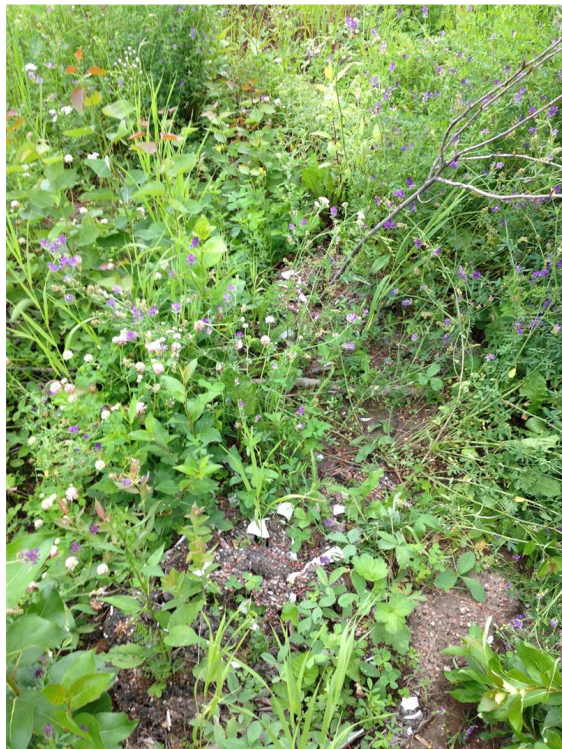
**Photo 2:** View of destroyed monitoring wells 08-MW04 and 08-MW04B

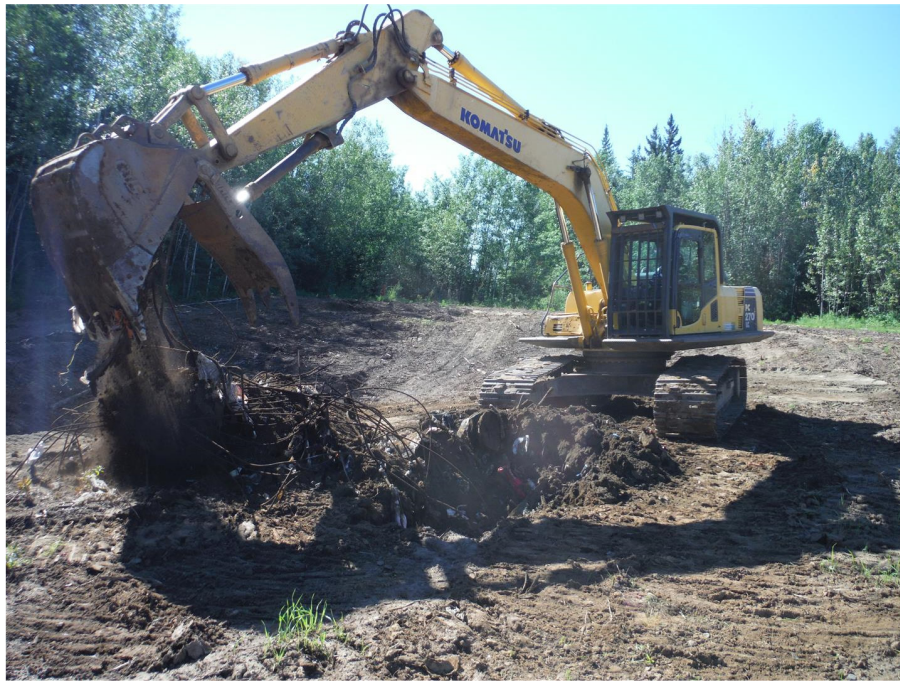
TP3 completed in the centre of the geophysical anomaly encountered waste a depth of 3.7 m bgs followed by native soil consisting of silty sand. The waste included household garbage and evidence of scrapped cars.

**Photo 3:** View of material removed from test pit TP3 completed in south dump area, including re-bar.

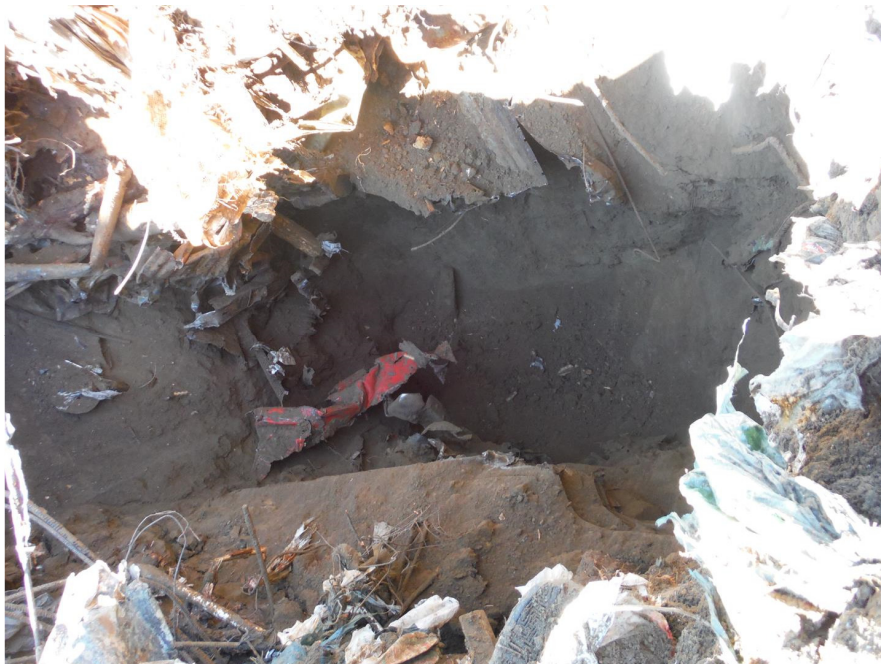
**Photo 4:** View of material in base and side of test pit TP3 showing metals scrap, including car bodies and parts.

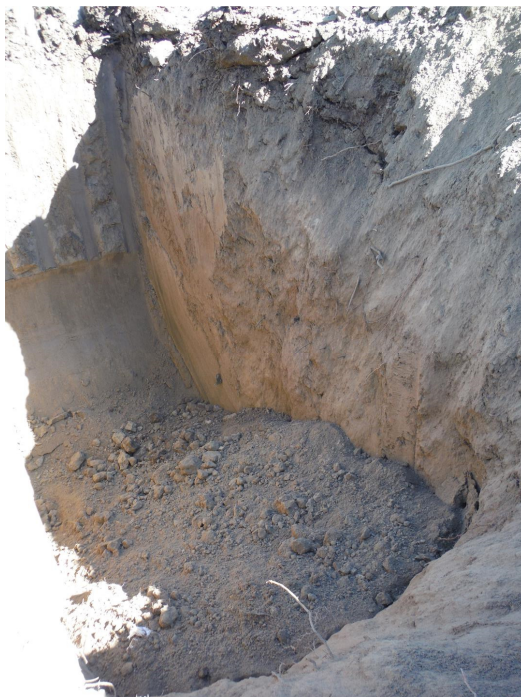
**Photo 5:** View of test pit TP4 showing typical native soil profile encountered in test pits surrounding the dump areas.

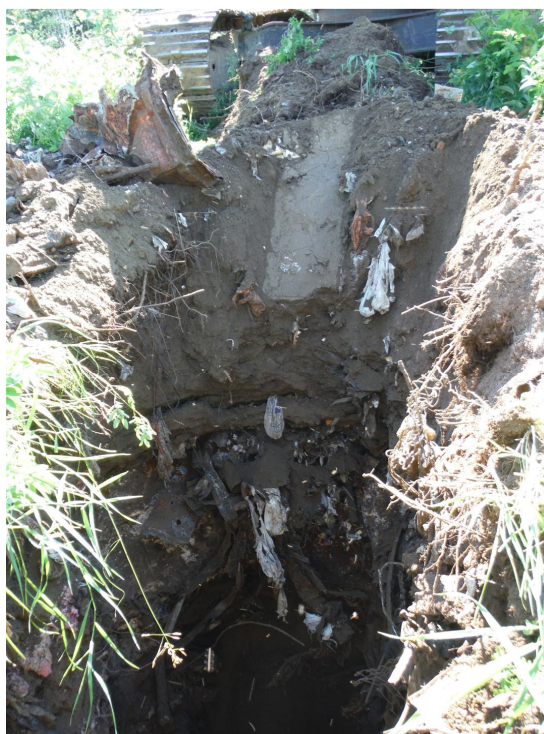
TP 8, TP9, and TP11 encountered waste ranging in thickness from 2.4 m in TP9 to greater than 4.6 m (the maximum reach of the excavator) in TP11. The waste consisted of household waste, car parts, re-bar and scrap metal.

**Photo 6:** View of test pit TP8 showing typical profile of domestic waste encountered in main dump area.

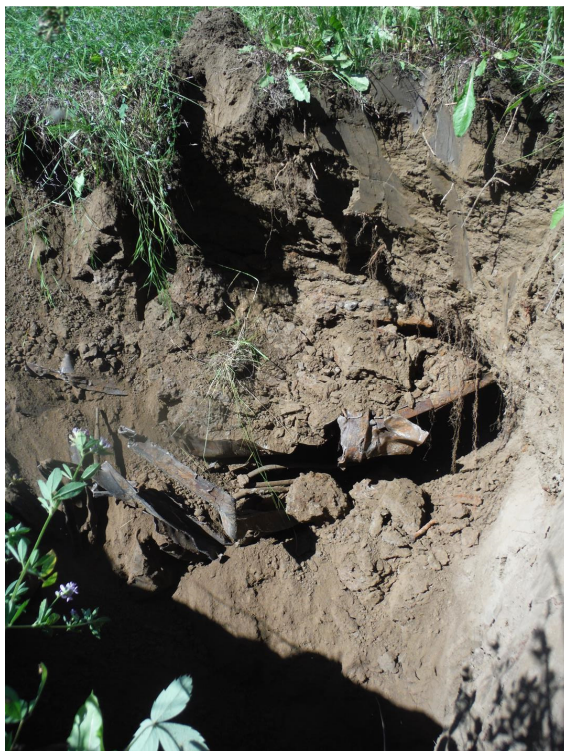
The north area was assessed through 6 test pits (TP13 through TP18). TP13, TP14, TP16, and TP18 completed around the anomaly did not encounter any waste. TP15 and TP17 encountered waste that consisted of predominantly scrap metal. The scrap metal appeared consistent with the source of the waste being a former camp (construction trailers). The maximum depth of waste encountered was 2.7 m in TP 17.

**Photo 7:** View of test pit TP15 completed in the north debris area. Metal encountered appeared to be a construction camp trailer.
