Project No.: 209.40380.00000

**RE: DATA GAP ASSESSMENT  
GARDEN RIVER OLD DUMP SITES, GARDEN RIVER, ALBERTA**

DATA GAP ASSESSMENT REPORT

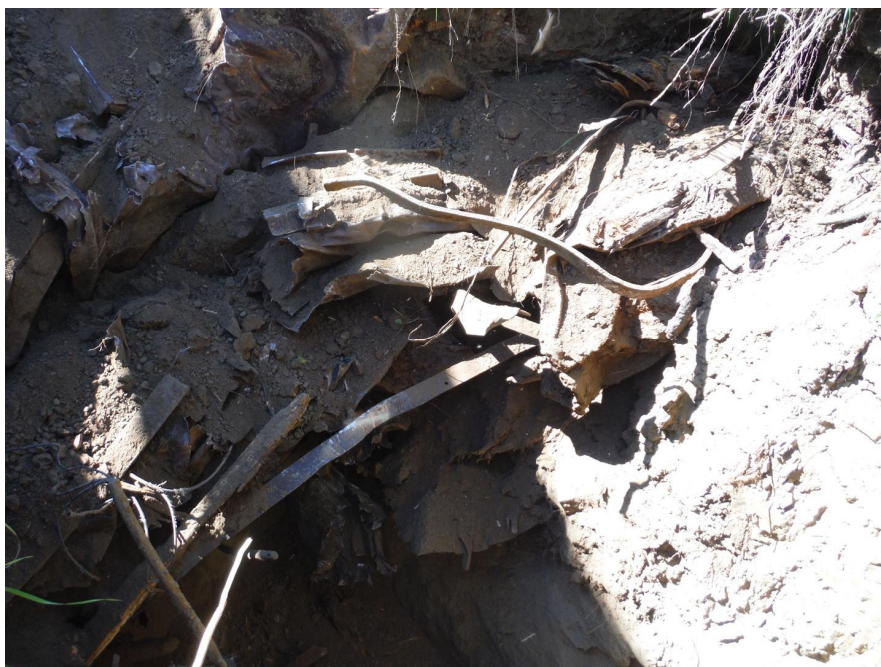
The north area was assessed through 6 test pits (TP13 through TP18). TP13, TP14, TP16, and TP18 completed around the anomaly did not encounter any waste. TP15 and TP17 encountered waste that consisted of predominantly scrap metal. The scrap metal appeared consistent with the source of the waste being a former camp (construction trailers). The maximum depth of waste encountered was 2.7 m in TP 17.

Based on TP17, the depth of waste and soil requiring disposal from the North Dump is 3.0 m (waste depth plus adjacent soil).

**Photo 8:** View of test pit TP17 at the edge of the north debris area showing scrap metal encountered in this area.
