**Factual Report  
Geotechnical Investigation  
Proposed Gully and Channel Dredging**

Pigeon Hill, New Brunswick  
December 1, 2016

Prepared for Public Works and Government Services  
Canada  
**Project No. 90015.02 – R01**

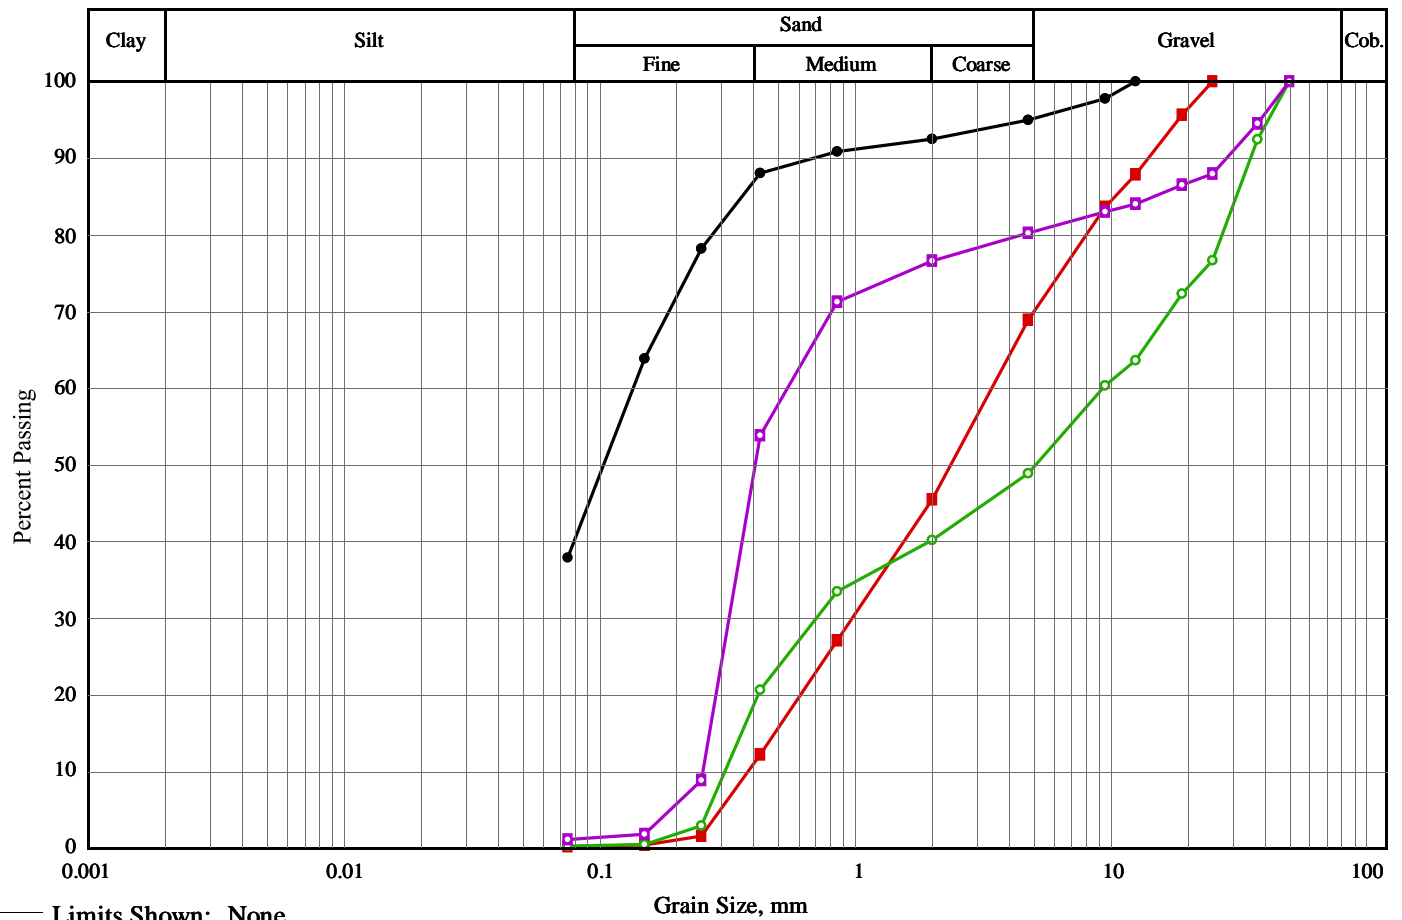
# Soils Grading Chart

Line Symbol	Description	Borehole/ Test Pit	Sample Number	Depth	% Cob.+ Gravel	% Sand	% Silt	% Clay	Date Sampled
—●—	Sand	TP16-6	1	1.1 m	5.0	57.1	37.9		16/11/23
—■—	Sand	TP16-13	1	0.1 m	31.1	68.7	0.2		16/11/23
—○—	Gravel	TP16-4	1	1.0 m	51.1	48.6	0.3		16/11/23
—□—	Sand	TP16-9	1	1.0 m	19.8	79.1	1.1		16/11/23

Line Symbol	Sample Description	ASTM	D <sub>10</sub>	D <sub>15</sub>	D <sub>50</sub>	D <sub>85</sub>	% 5-75µm
—●—	silty sand	SM	---	---	0.10	0.36	---
—■—	sand with gravel	SP	0.38	0.48	2.36	10.39	---
—○—	gravel with sand	GP	0.31	0.36	5.08	30.98	---
—□—	sand with gravel	SW	0.25	0.27	0.41	14.76	---

Laboratory index testing undertaken on five representative samples of the sand deposit shows less than 1% to 31% Gravel, 57% to 83% Sand, and less than 1% to 38% Silt and Clay sized particles.

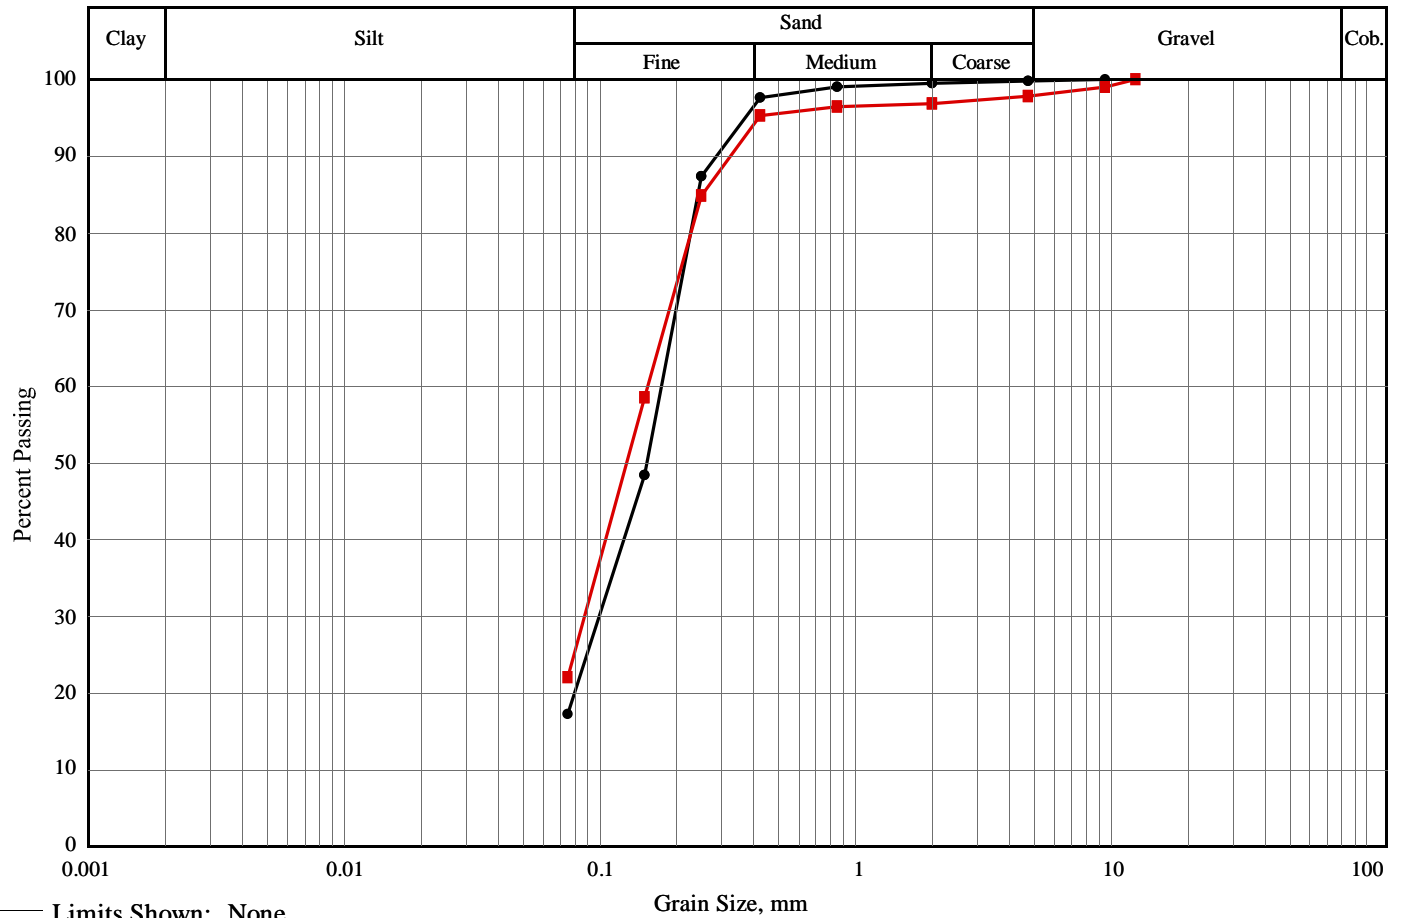
# Soils Grading Chart

Line Symbol	Description	Borehole/ Test Pit	Sample Number	Depth	% Cob.+ Gravel	% Sand	% Silt	% Clay	Date Sampled
—●—	Sand	TP16-14	1	0.2 m	0.2	82.6	17.2		16/11/23
—■—	Sand	TP16-1	1	1.1 m	2.2	75.8	22.0		16/11/28

Line Symbol	Sample Description	ASTM	D <sub>10</sub>	D <sub>15</sub>	D <sub>50</sub>	D <sub>85</sub>	% 5-75µm
—●—	silty sand	SM	---	---	0.15	0.24	---
—■—	silty sand	SM	---	---	0.13	0.25	---

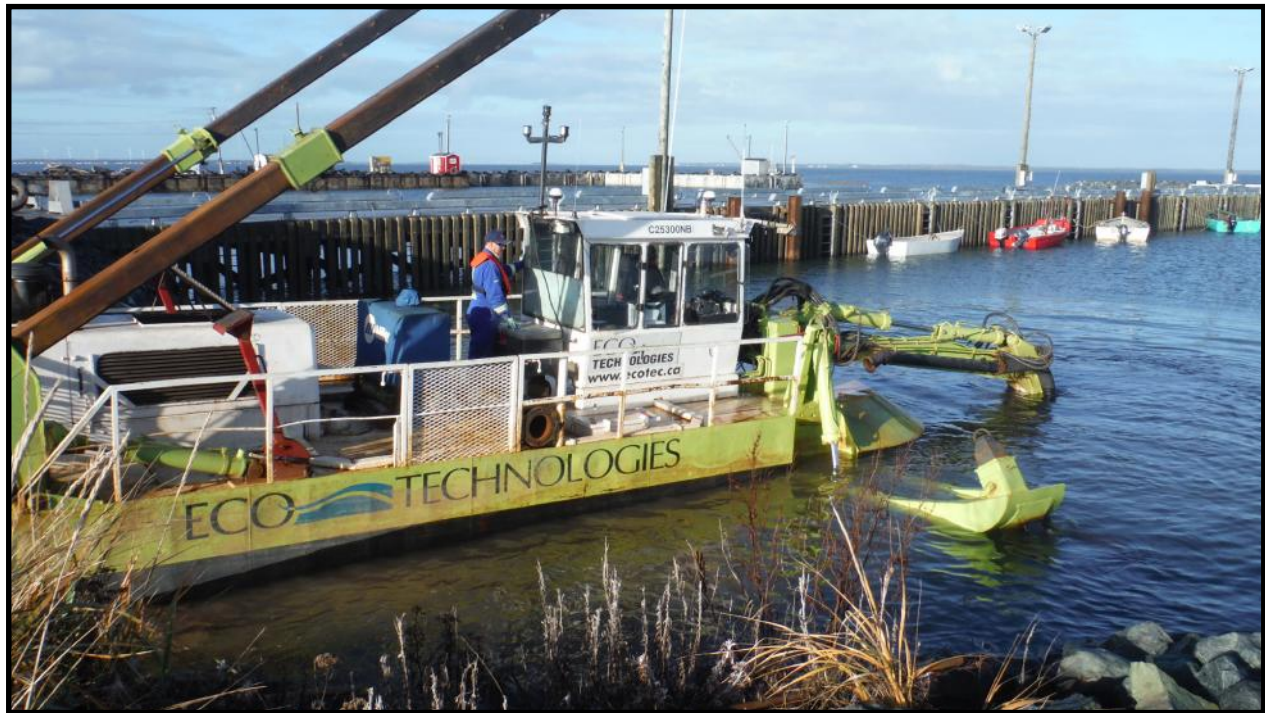
ECO Technologies Amphibious Excavator. November 21, 2016.

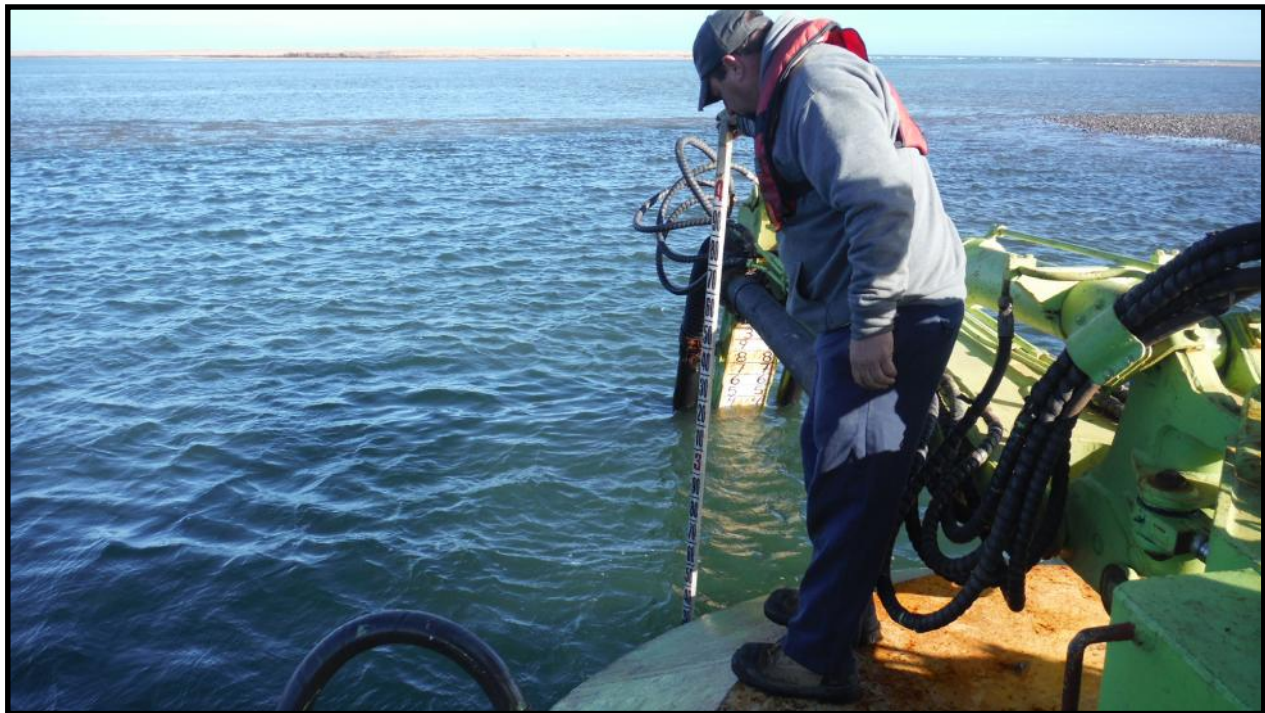
Measuring depth to ground surface. November 21, 2016.

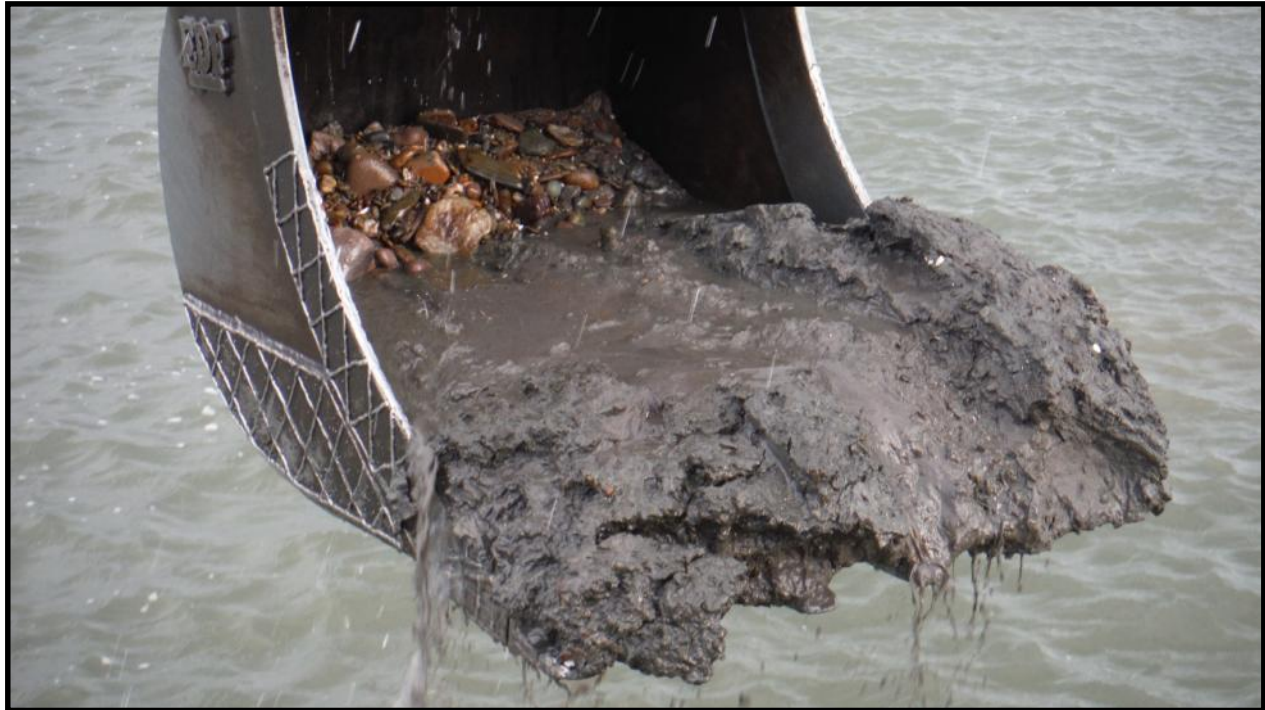
Test Pit TP16-14. November 21, 2016.

0			(R&S)	mm		0.10	<b>GRAVEL</b> Brown clean gravel	-2.30
1	G					0.30	<b>SAND</b> Grey silty sand, trace gravel and organics (shells)	-2.50
<b>End of Test Pit at Chart Elevation -2.5 m</b>

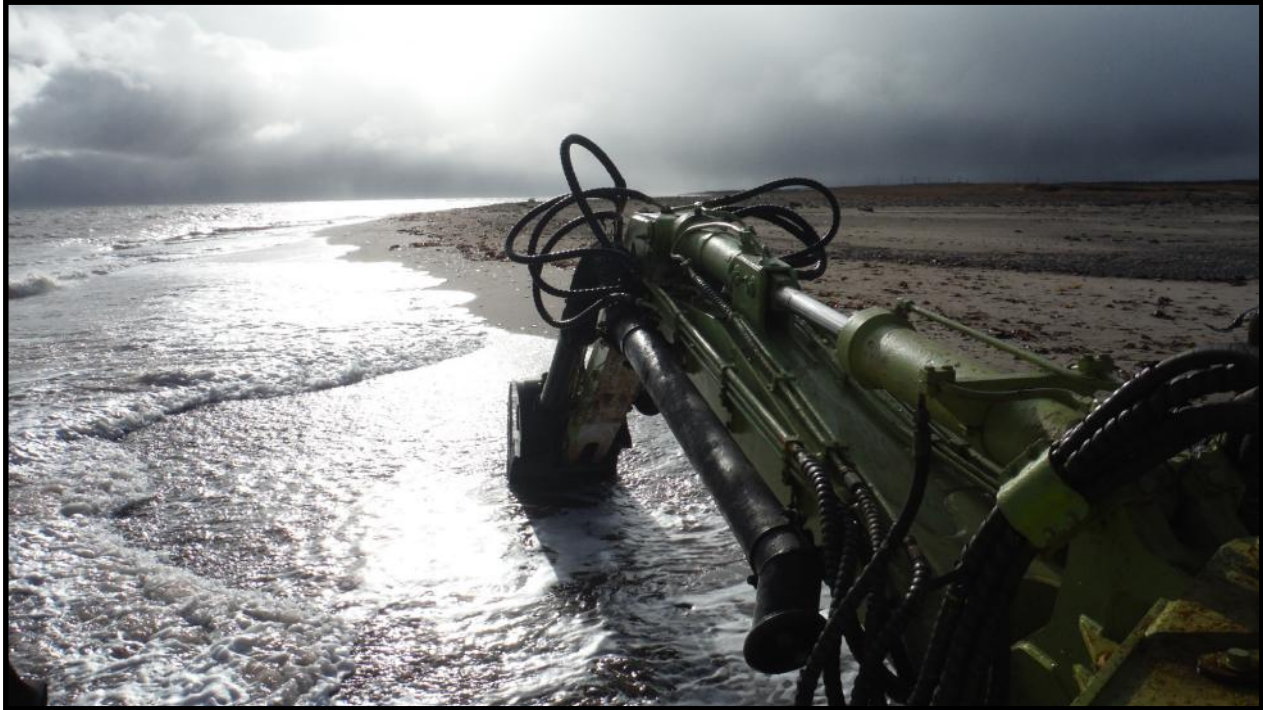
View of Test Pit TP16-16 location and excavation. November 25, 2016.
