**SPECIFICATIONS FOR  
BUILDING DEMOLITION  
TUKTOYAKTUK, NT**

Department of Fisheries & Oceans  
Real Property, Safety and Security  
Central & Arctic Region  
Winnipeg, Manitoba

**January 2017**

- .1 Work of this Contract comprises hazardous materials abatement and demolition of a warehouse building and skid shed, and the removal of materials stored in proximity to the warehouse building located in Tuktoyaktuk, Northwest Territories.
  - .1 Warehouse building, single story consisting of a warehouse with laboratory spaces, approximately 140 m<sup>2</sup>.
  - .2 Skid shed, located in proximity to Warehouse building, approximately 6 m<sup>2</sup>.
  - .3 Removal and disposal of wooden sampling box and various materials stored outside the Warehouse building.
- .2 Work of this Contract also comprises restoration of the property. This shall include backfilling and grading.

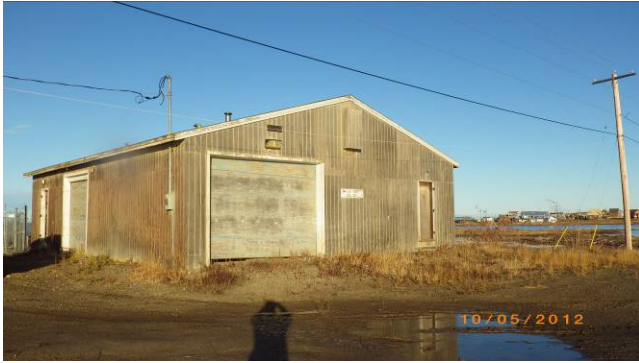
Photo 1. Looking west at on-site building including view of overhead power lines and sample locations TK-TH8 (east of garage door) and TK-TH-LP-1 (garage door).

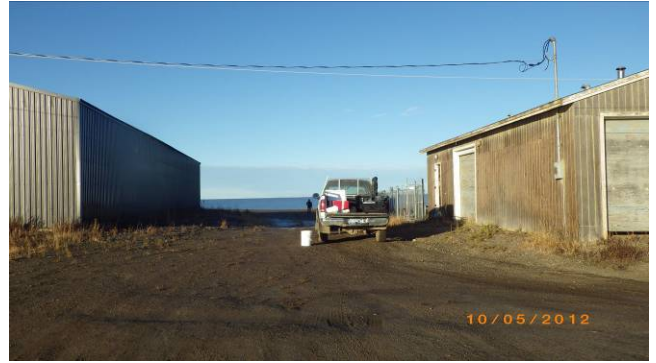
Photo 2. Looking west between on-site building and NRCAN Cold Storage Building. Includes view of Beaufort Sea to the west. Location of samples TK-TH1 to TK-TH4 along south perimeter of building.

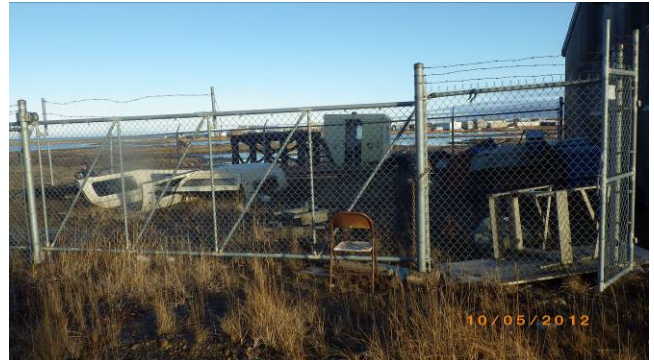
Photo 10. Looking north at fenced-in area at subject property located immediately west of on-site building. Location of soil samples TK-TH9 to TK-TH12 inside fenced-in area.

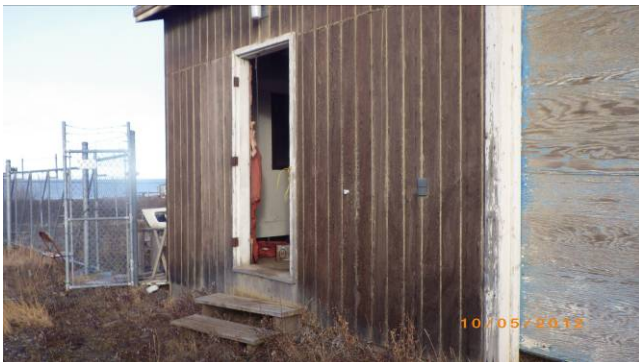
Photo 11. Looking north into the subject building. Note absence of the door (sample location TK-LP-2).

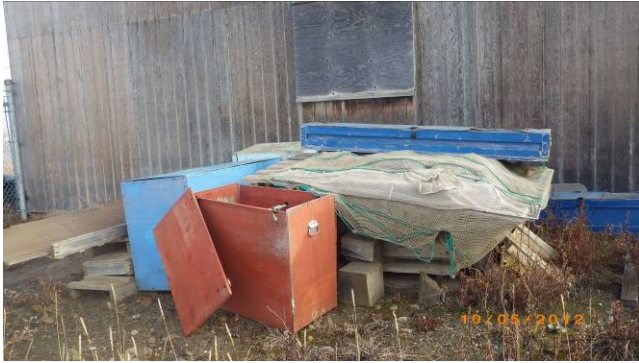
Photo 13. View of various wooden sample boxes located within fenced-in area west of the on-site building. Sample locations TK-LP-7 to TK-LP-9.

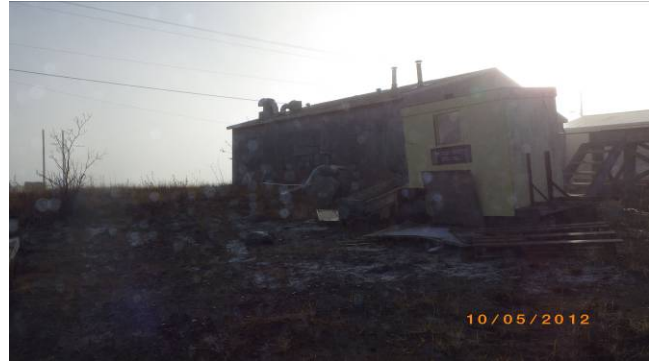
Photo 14. View of old skid shed and other debris on the south side of the subject building, looking east-southeast. Sample locations TK-LP-5 (skid shed) and TK-TH6 and TK-TH7 (soil).

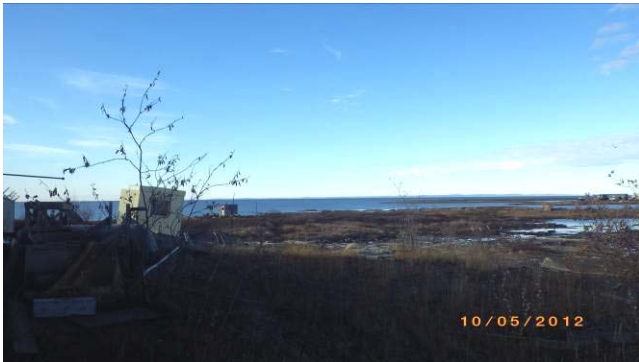
Photo 15. Looking west towards old skid shed (sample TK-LP-5) and debris at the subject property, north of building.

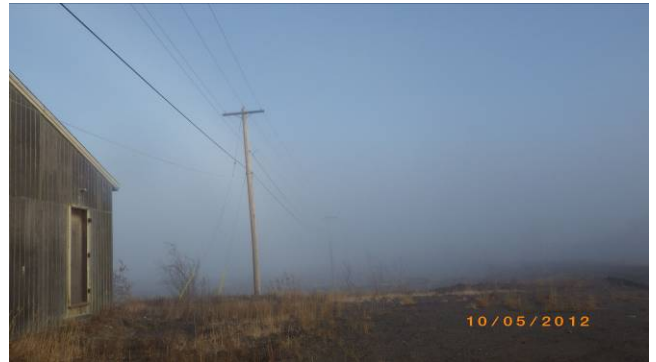
Photo 16. Looking north from the southeast corner of subject property including view of overhead lines. Sample location TK-TH8 adjacent to building.

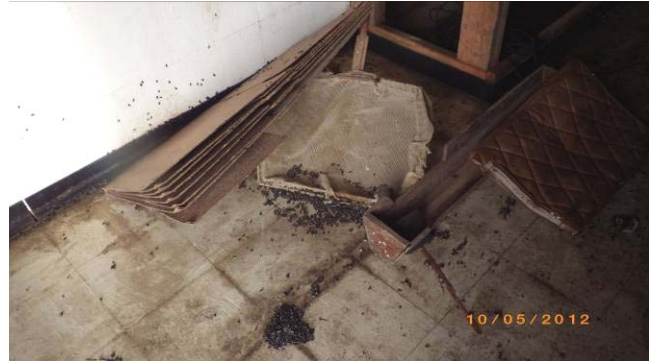
Photo 20. Interior view of the subject building looking north (sample location TK-LP-3). Large amounts of dead flies on the floor inside the subject building.

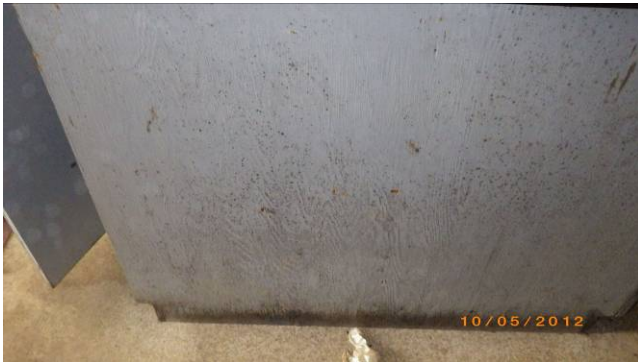
Photo 27. Close up view of mould on cabinets inside subject building (laboratory area).

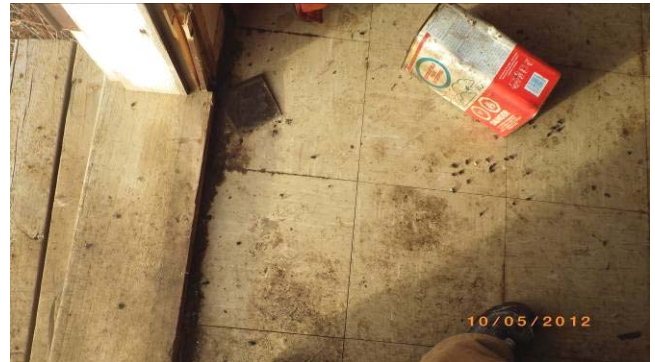
Photo 28. Close up view of dead flies, general debris and floor linoleum (Sample TK-ACM-3).

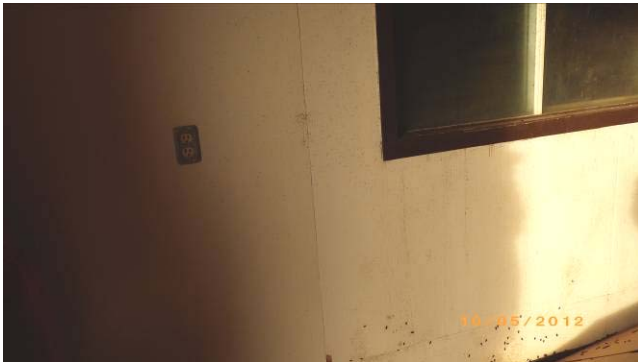
Photo 29. Close up view of mould on the wall inside the subject building.

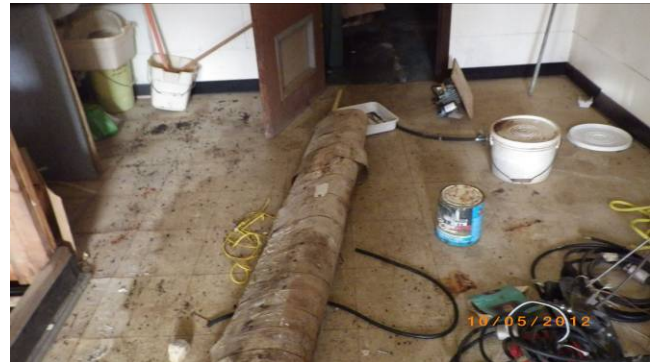
Photo 30. View of debris inside subject building including pipe lagging (Sample TK-ACM-2) and general debris.

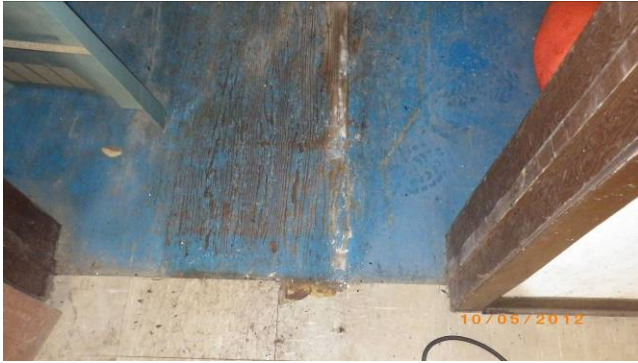
Photo 31. View of two types of flooring inside subject building. Samples TK-ACM-3 (beige vinyl flooring) and TK-LP-4 (dark blue paint on wooden flooring).

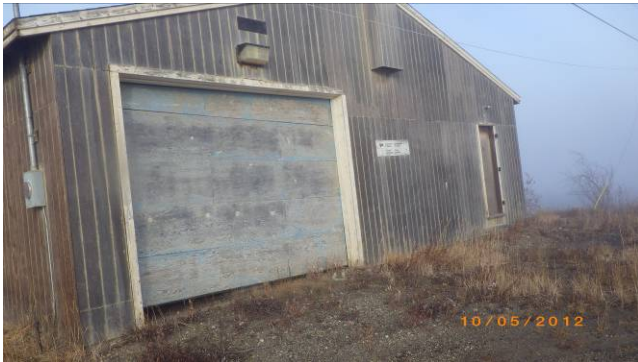
Photo 33. Looking west at on-site building and location of samples TK-LP-1 (garage door) and TK-TH8 (soil).

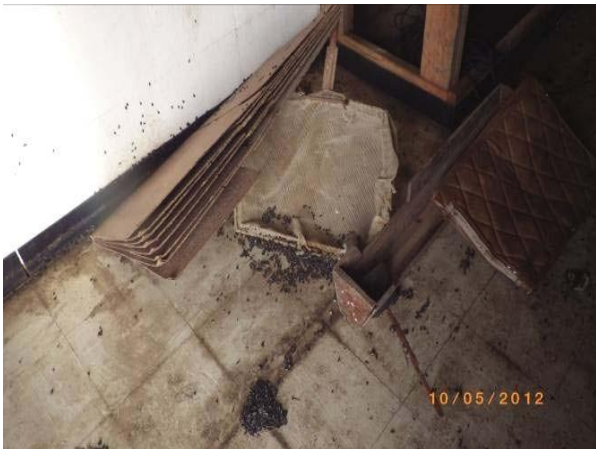
**Photo 9:** View of vinyl floor tile.

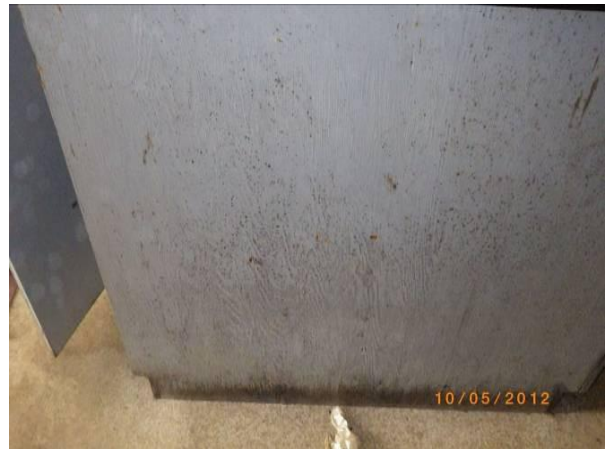
**Photo 10:** Close up view of mould on cabinets inside lab and storage building.

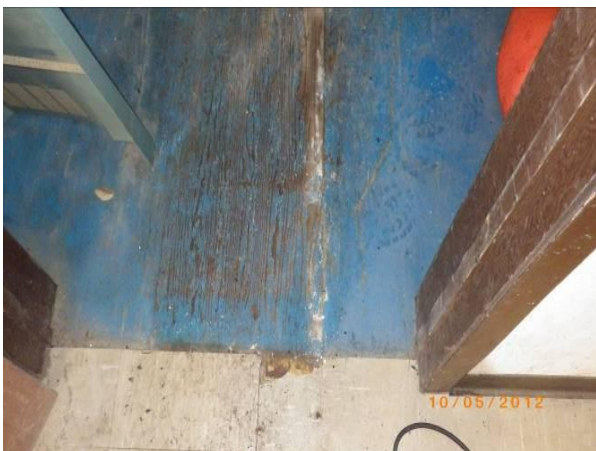
**Photo 11:** View of transition between vinyl floor tile section in SW room and blue painted wooden flooring in NW room/utility room (2012).

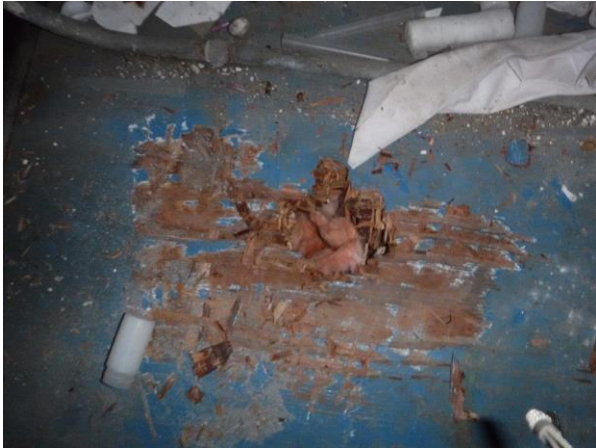
**Photo 73:** Insulation below blue painted wooden flooring (2016).

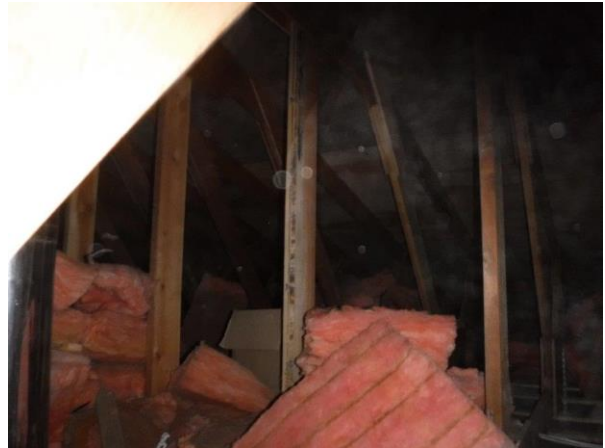
**Photo 16:** Insulation in attic and roofing (2016).

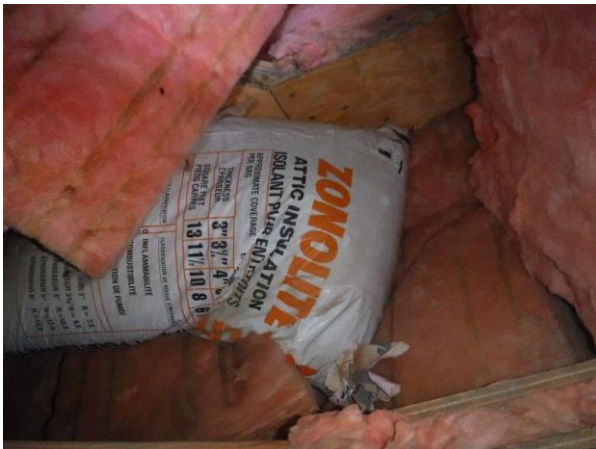
**Photo 17:** Bag of vermiculite observed in attic (2016).

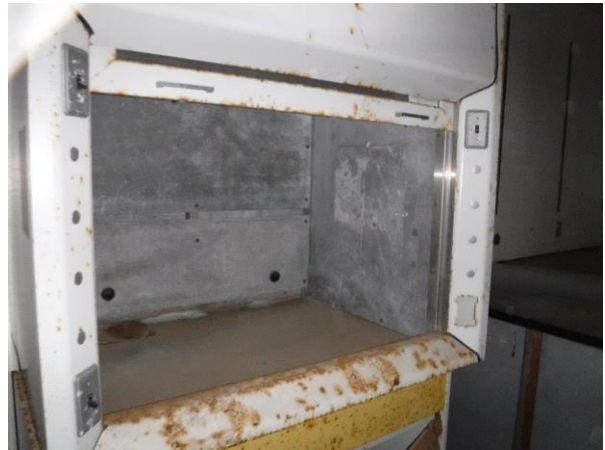
**Photo 20:** View of fumehood located in NE room/lab (2016). Cementitious panels within fumehood were none detected for asbestos fibres.

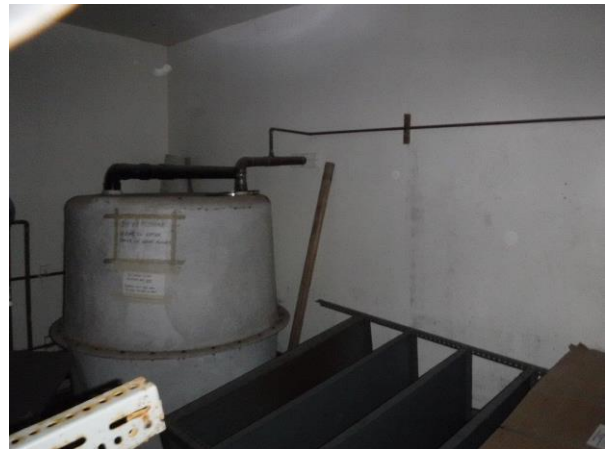
**Photo 22:** View of lines running from miscellaneous tanks in NW room/utility room.

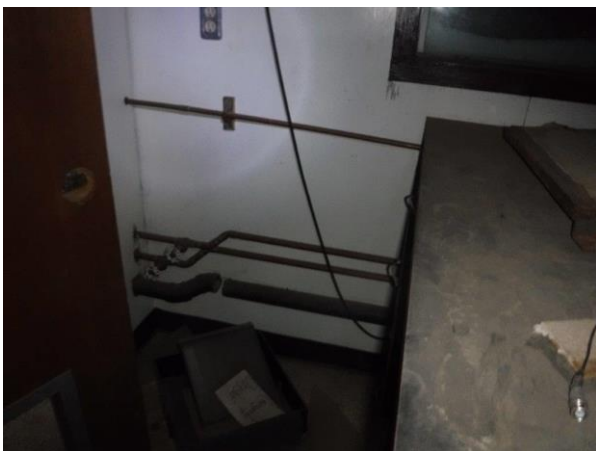
**Photo 23:** View of lines running from miscellaneous tanks inside lab and storage building.
