STRUCTURE CONDITION REPORT

Norman Well, NWT, CCG Wharf

DATE: July 28, 2015 &
July 29, 2015

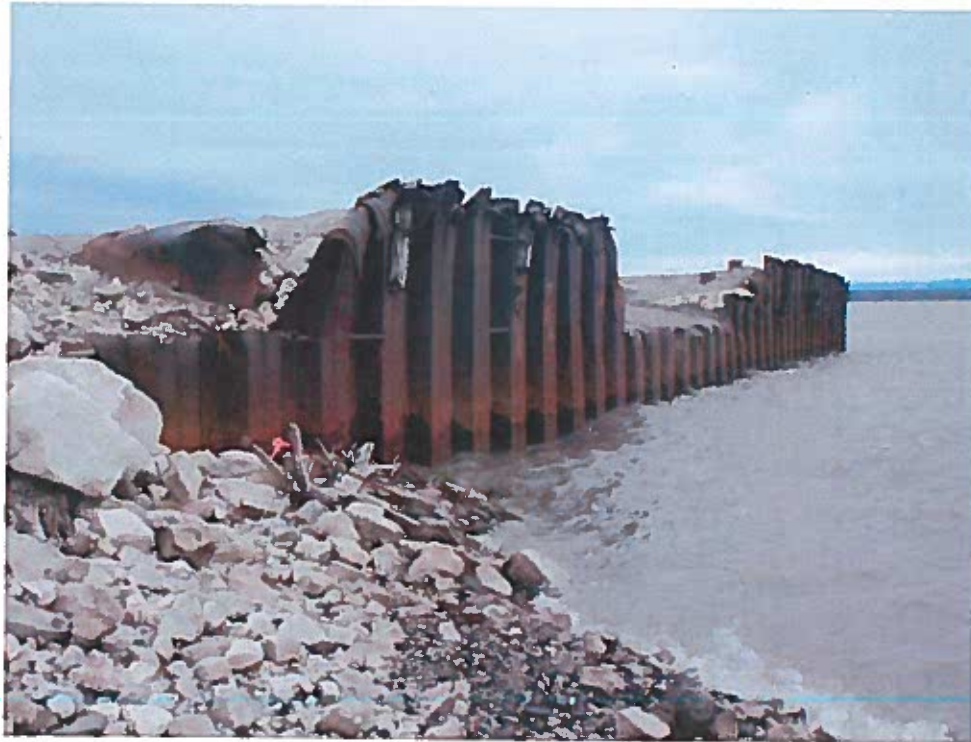
Photo 1: West side of the wharf.

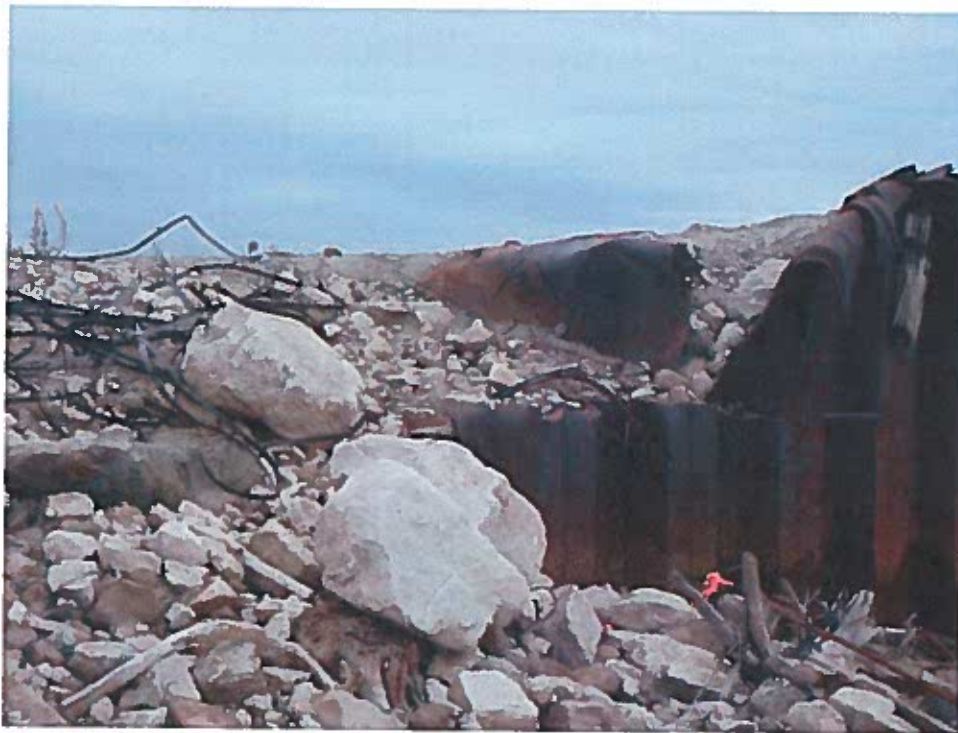
Photo 2: Northwest corner of the wharf

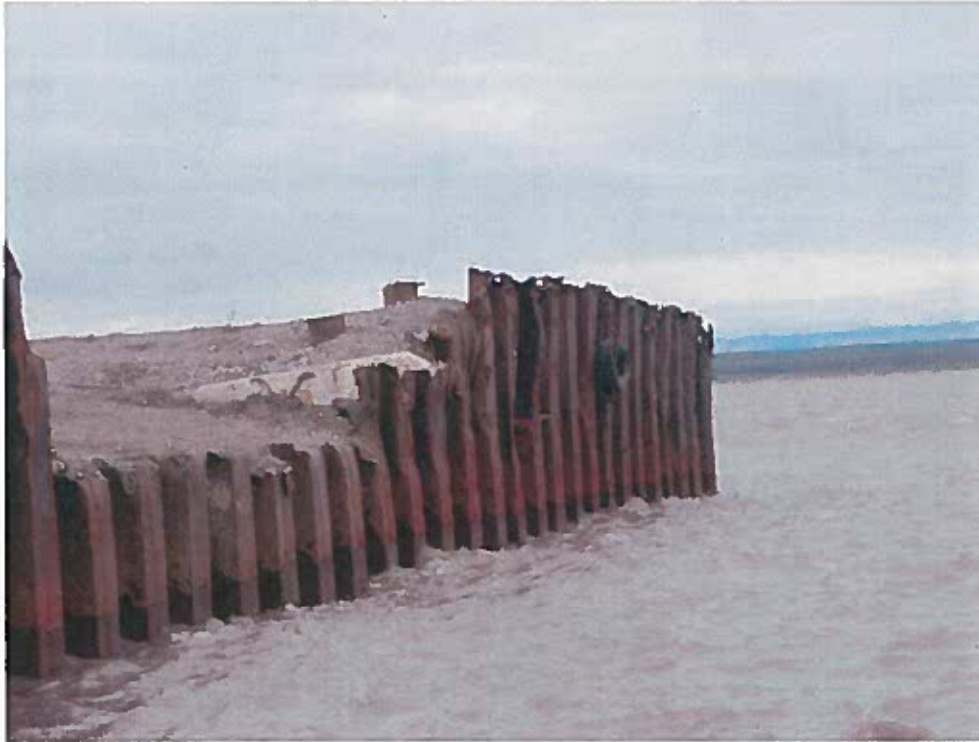
Photo3: Sheet pile cut out for ramp access

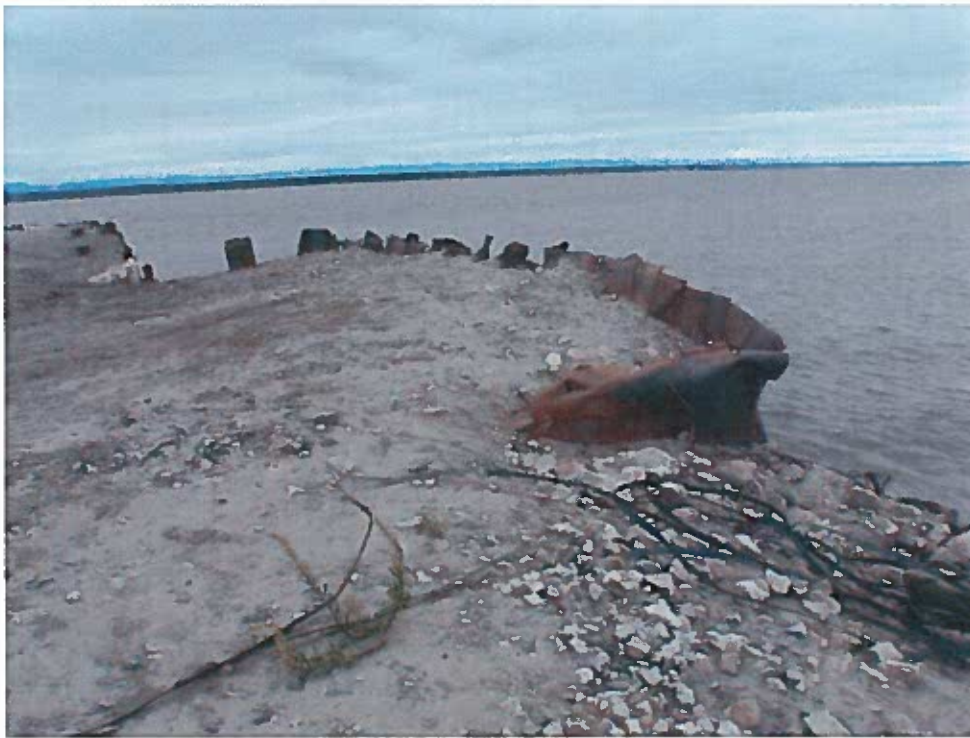
Photo4: Deck view of west side of the wharf

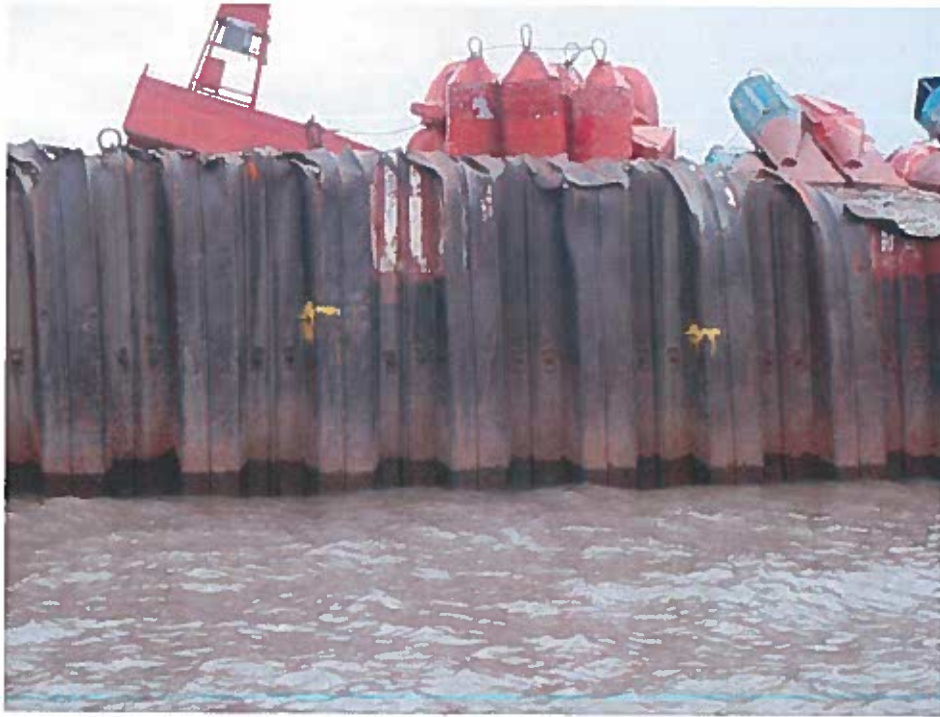
Generally, the top 2m of the steel sheet piles are in extremely poor condition. Either the tops have been bent due to the ice force or sections cut out due to the damage. A majority of the area shows that the top 300mm of the sheet piles folds over 90 degrees. This would indicate that the elevation of the fill would have dropped by 300mm possibility due to scouring from the ice flows. This seems to be in agreement with AECOM's Inspection report dated February 6, 2009 which estimates a loss of deck elevation of approximately 300mm. Approximately 30m of the sheet pile wall on the south face have been cut lower by approximately 840mm. Similarly, approximately 8.5m of the west face have been cut lower by approximately 1.8m and concrete blocks added to both sides of the lower end of the ramp. Generally, there are damages up to 2m below the current deck elevation along the face of the wharf with the worst damage on the southeast corner of the wharf and the southwest corner of the wharf which have extensive damages up to 3.5m below the top of the steel sheet piles.

Photo 5: South face of the wharf. Note bent sheet piles at the top

1. Repair the top section of the steel sheet piles as recommended by AECOM's inspection report dated February 6, 2009 using "Option A". A copy of the report is attached in the Appendix D. In most cases, the top 2.0m of steel pile section will need to be replaced (not 1.0m as suggested by AECOM) as the damages have extended to near 2.0m below the top of the sheet pile wall. In addition, replace top 3.5m of a section of the sheet pile (approx. 2.5m) at the southeast corner of the wharf.
2. Restore the wharf to its original elevation (i.e. 300mm higher than the current deck elevation)
3. Cap concrete deck with reinforced concrete slab overlay.
4. Replace all the steel bollards
5. Reinforce the ramp area on the west side of the wharf
6. Install a large rock berm upstream of the Southeast corner of the wharf to deflect the ice impact on the wharf.

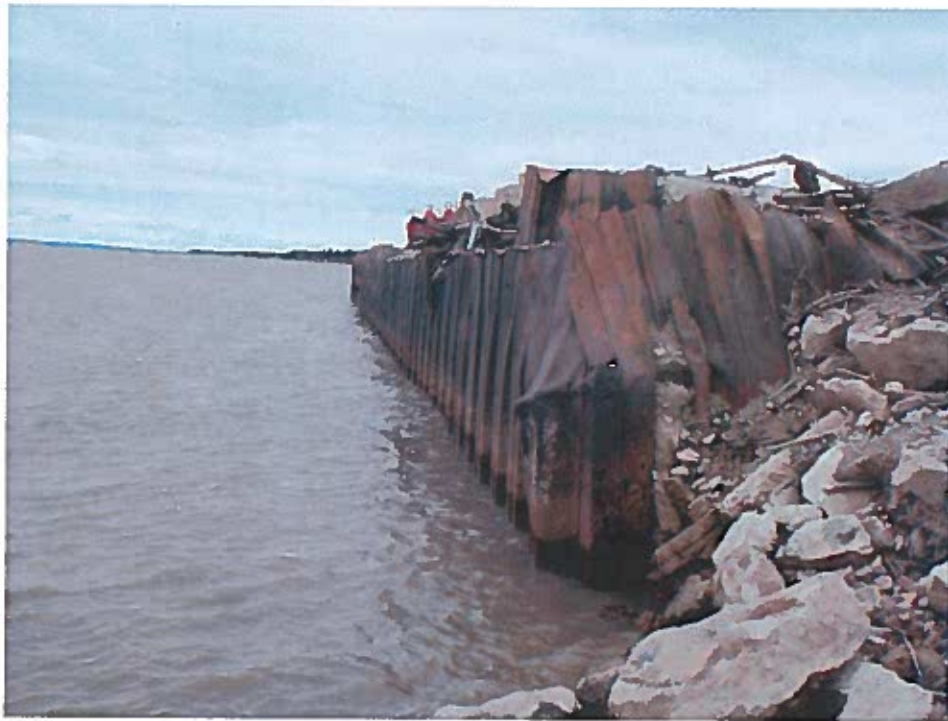
Photo 6: Extensive damage on Southeast corner of the wharf. East wall buried in debris

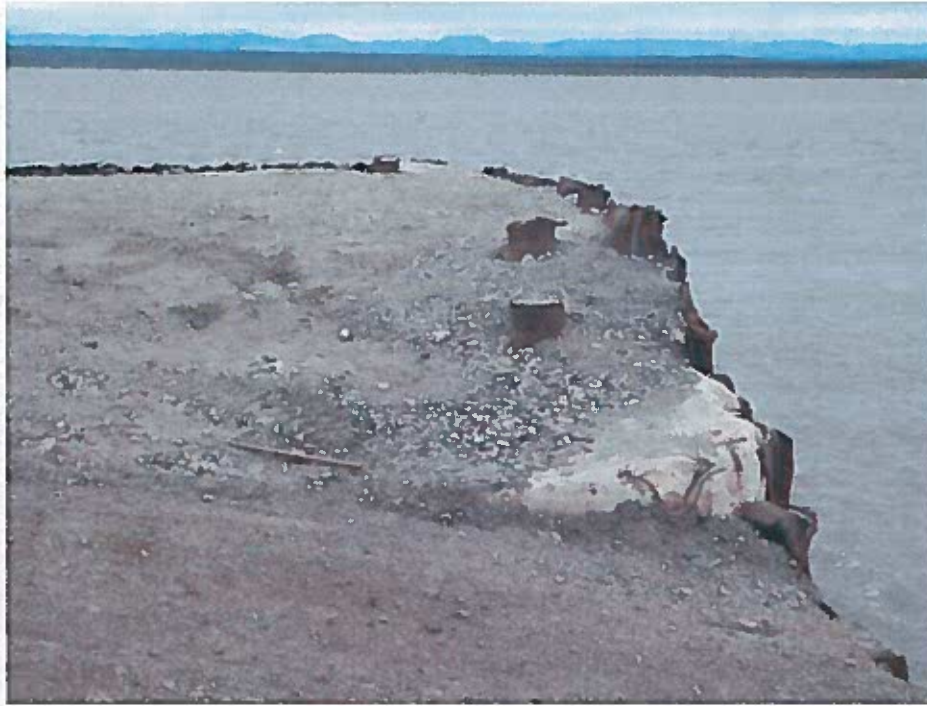
The heights of the 7 bollards on the wharf range from 0mm above wharf elevation to approximately 400mm above the wharf deck elevation. A majority of these bollards are too low to be any use. At least 3 of these bollards are not level, indicating either failure or bend in the pipe pile. The bollard on the steel caisson has failed.

Photo 7: Bollards on the west face of the wharf

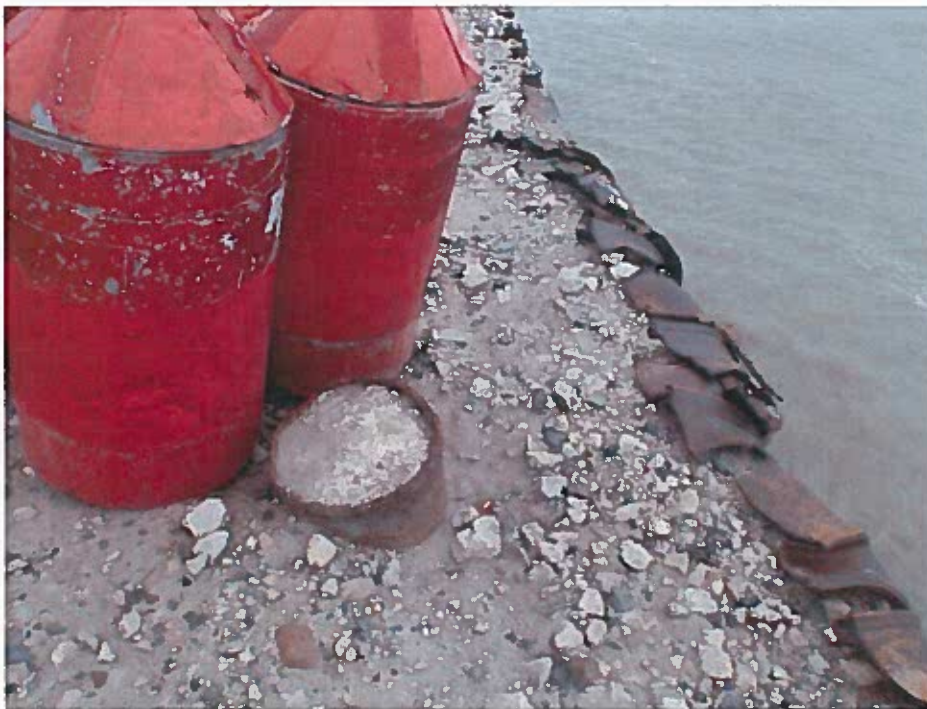
Photo 8: Typical bollard on the south face of the wharf

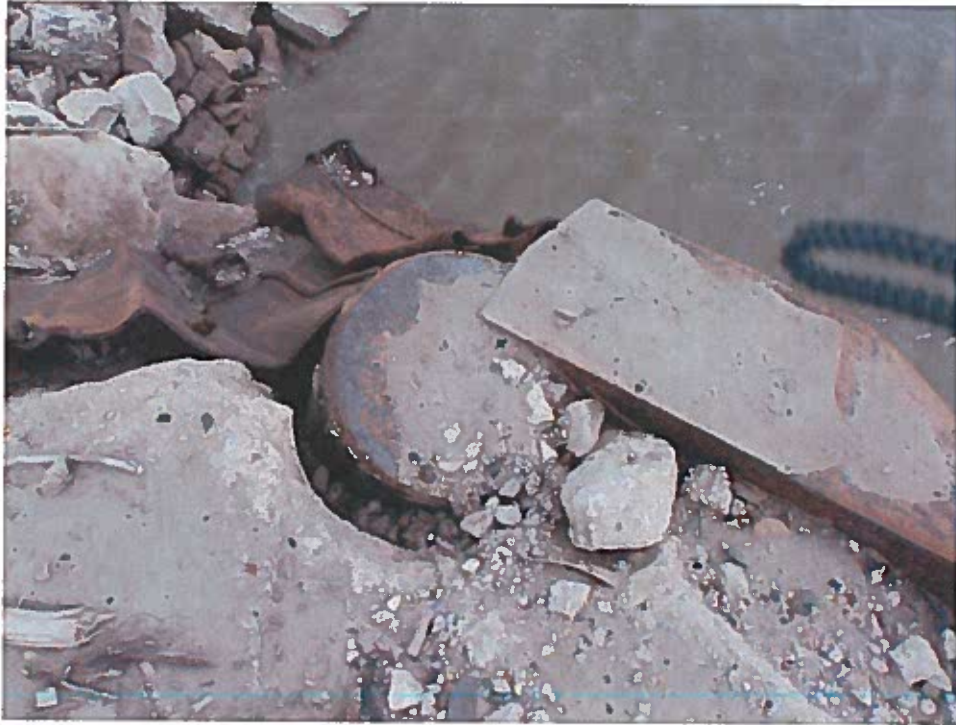
Photo 9: Bollard on the southeast corner of the wharf

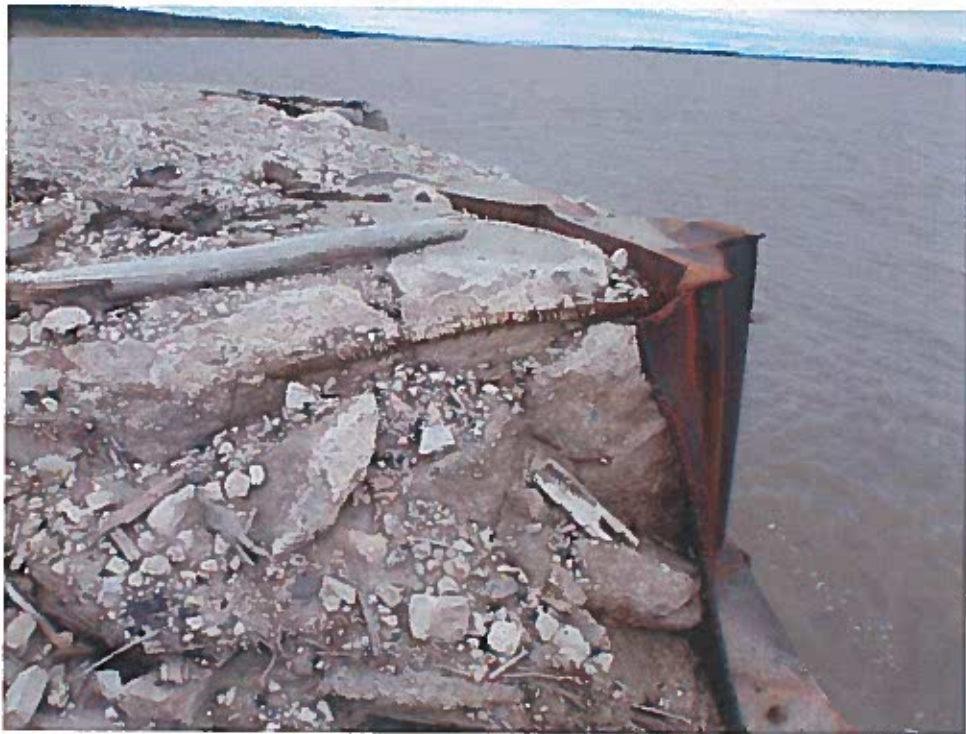
The concrete blocks on the southeast corner and the southwest corner of the wharf are in poor condition. Steel anchor bolts are exposed on the concrete block at the southeast corner. Similarly, the concrete blocks at the lower end of both sides of the ramp on the west face of the wharf are in poor condition as well.

Photo 10: Concrete block/deck on southeast corner of the wharf in poor condition

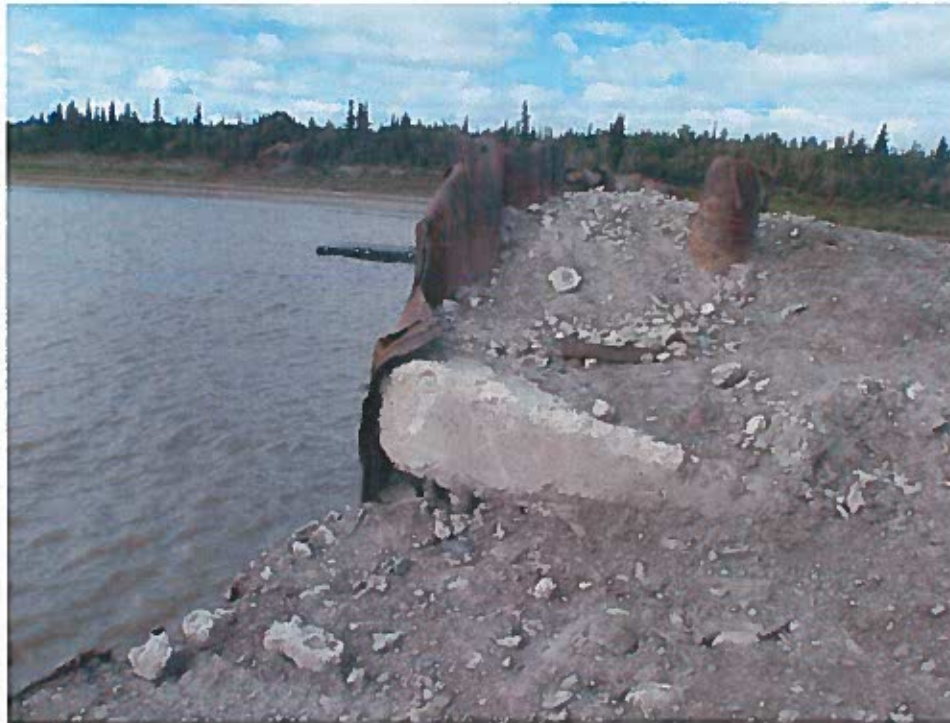
Photo 11: Concrete block on north edge of access ramp on West face of the wharf

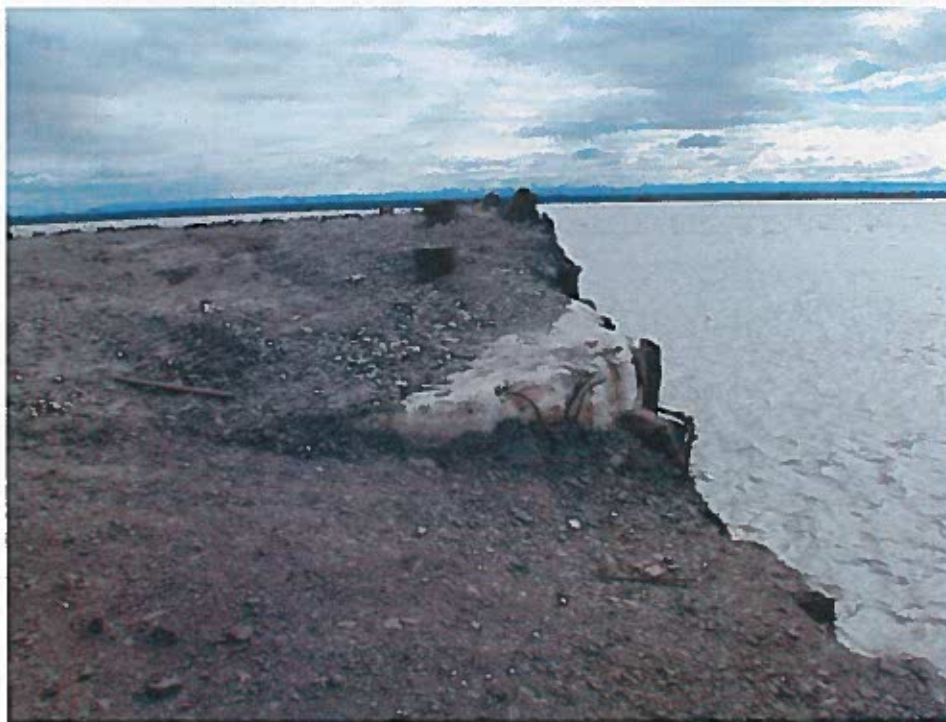
Photo 12: Concrete block on south edge of access ramp on West face of the wharf

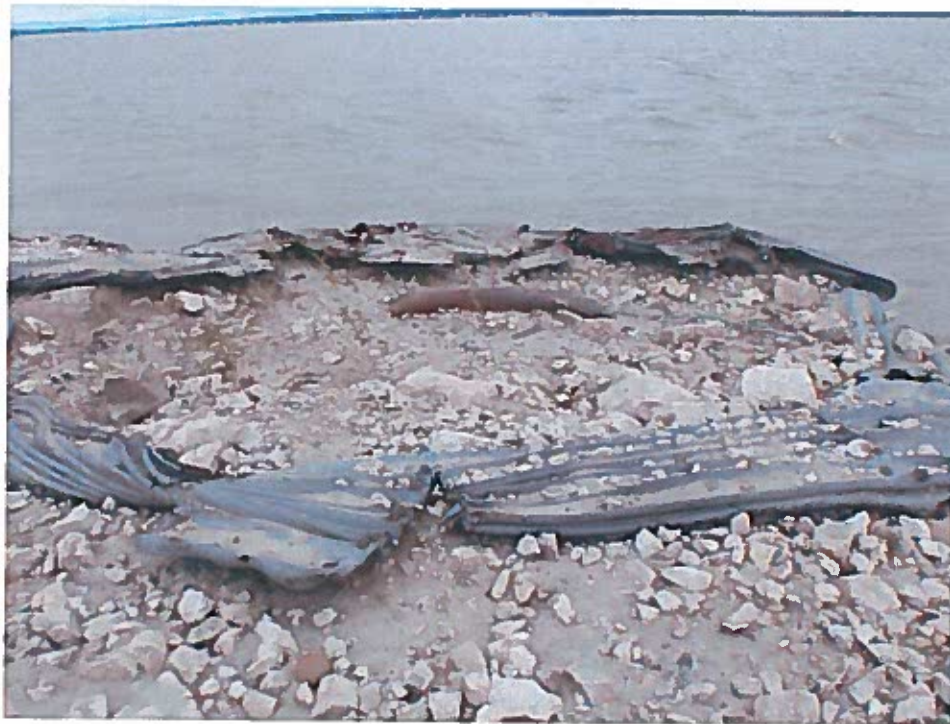
Photo 14: Failed bollard on the center of the steel caisson

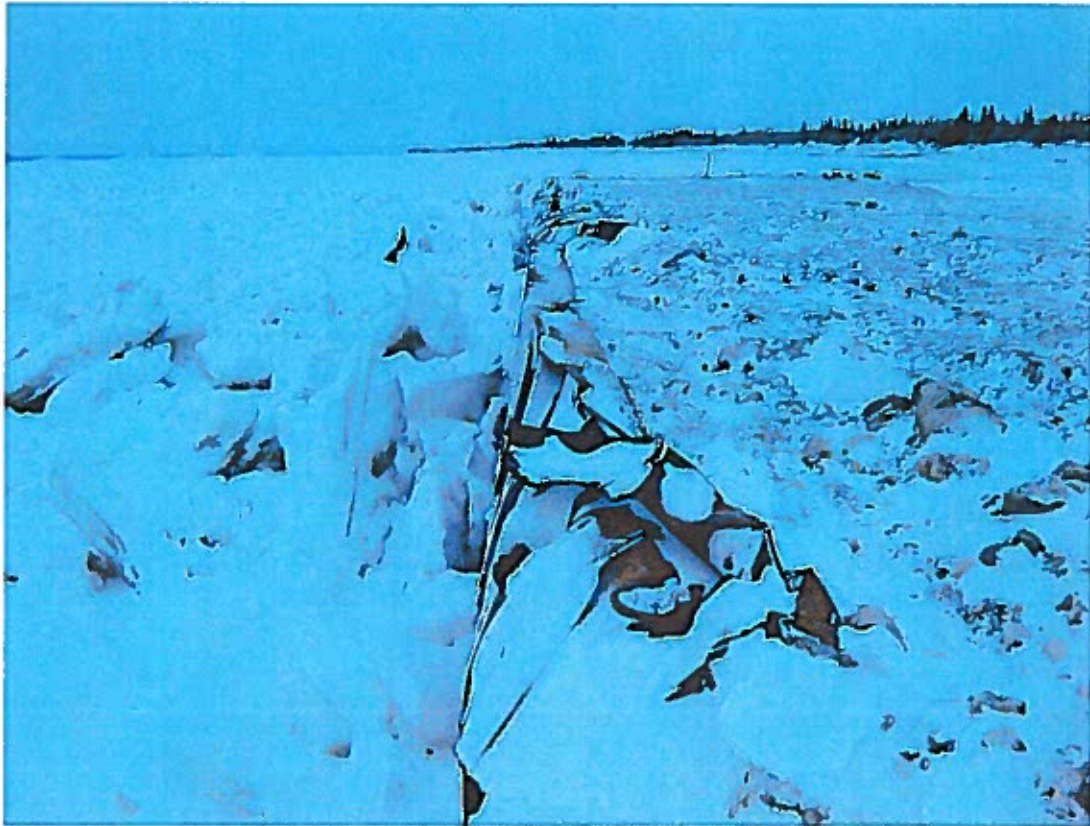
2008-12-03DFO Wharf Norman WellsP011.JPG - Looking west along riverside sheet piling, damaged areas extend down piles ~1.0m throughout.

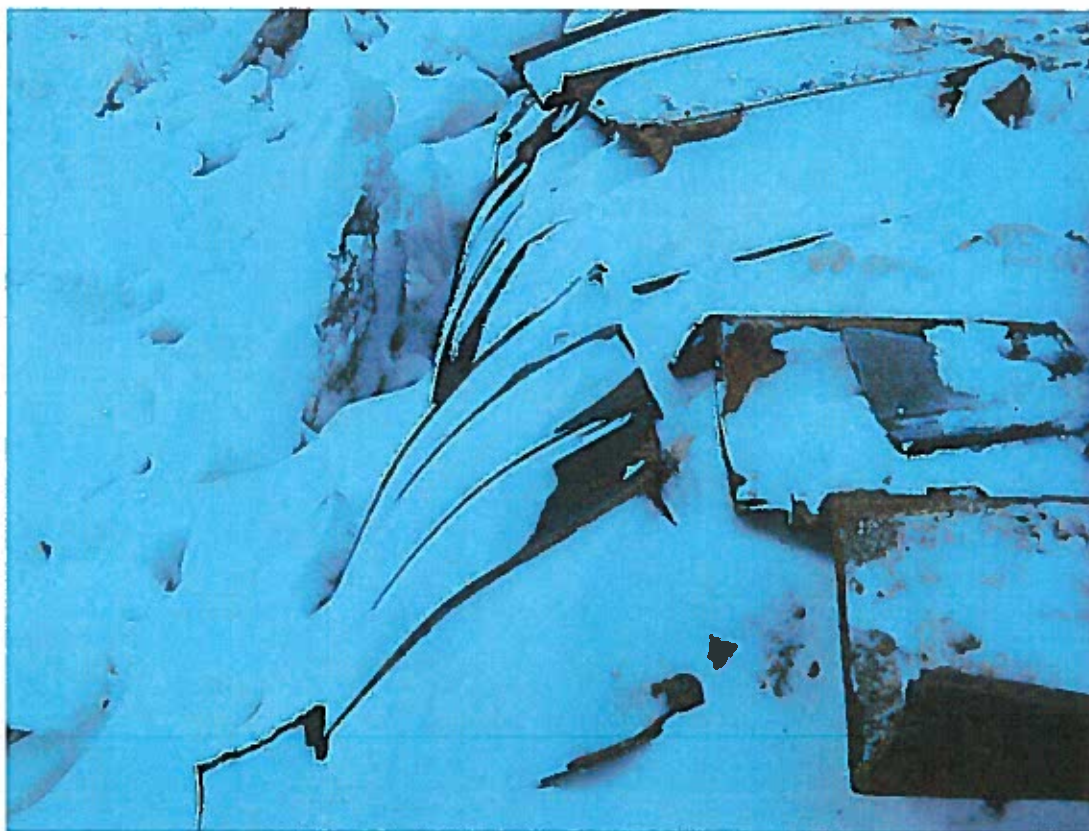
2008-12-03DFO Wharf Norman WellsP014.JPG - Typical ice damage to tops of piles, top ~1.0m distorted ~400mm, local information indicates that ~100mm of infill is added each year.

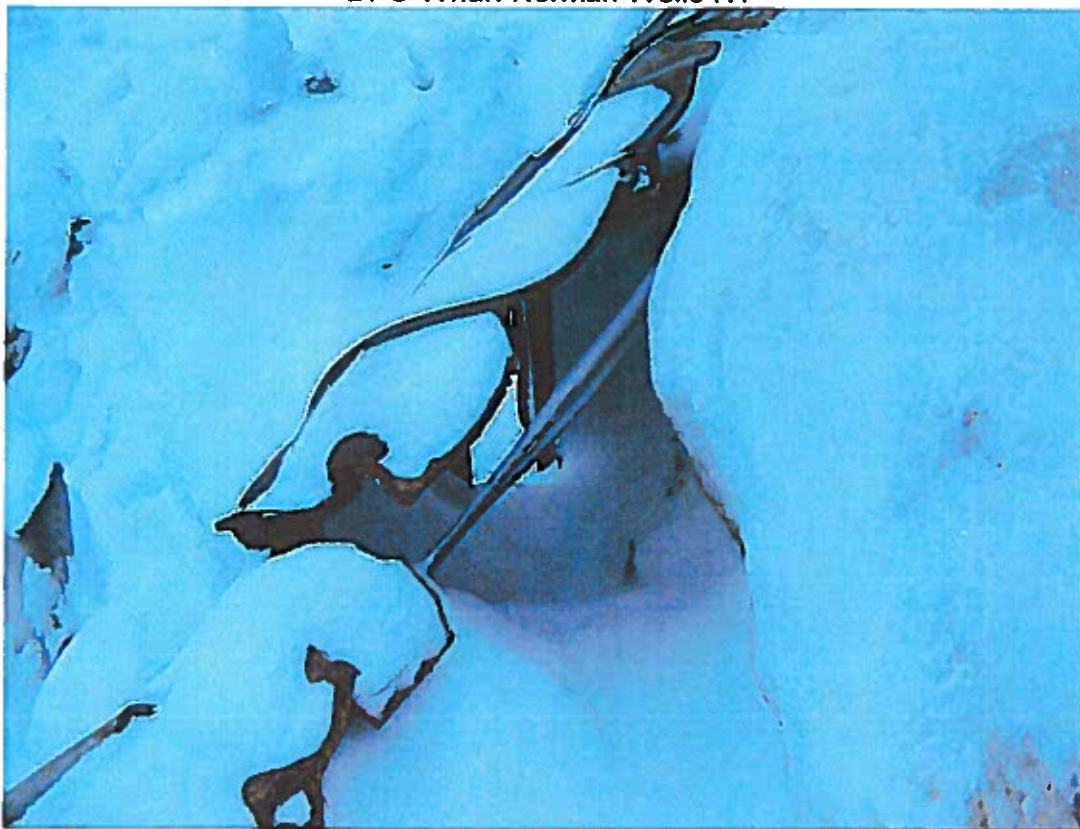
2008-12-03DFO Wharf Norman WellsP015.JPG - Separations between and tears to piles up to ~300mm wide losing fill at 3 locations, also note exposed tie back cables ~100mm below fill at this location.

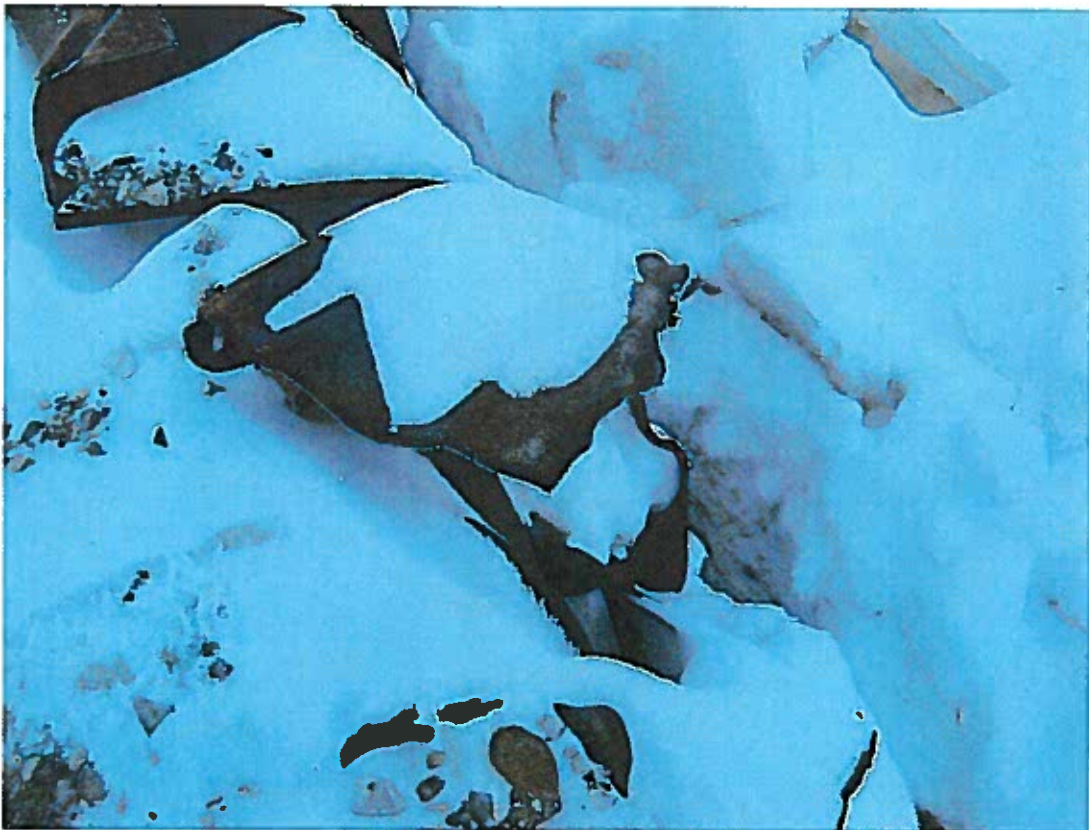
2008-12-03DFO Wharf Norman WellsP018.JPG - One of 3 locations with bad separations or tears in south riverside wall, ~1.0m deep and separated/torn ~300mm.

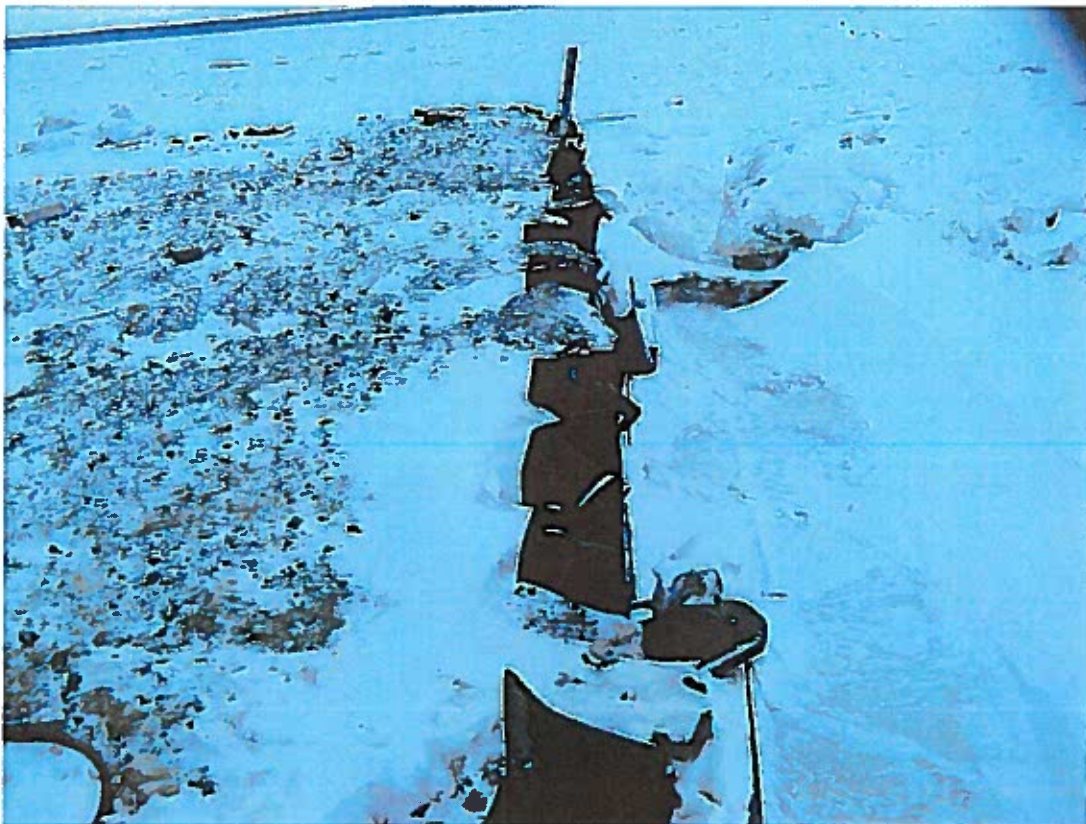
2008-12-03DFO Wharf Norman WellsP020.JPG - Looking north along downstream (west) wall, distorted ~100-200mm throughout at tops.

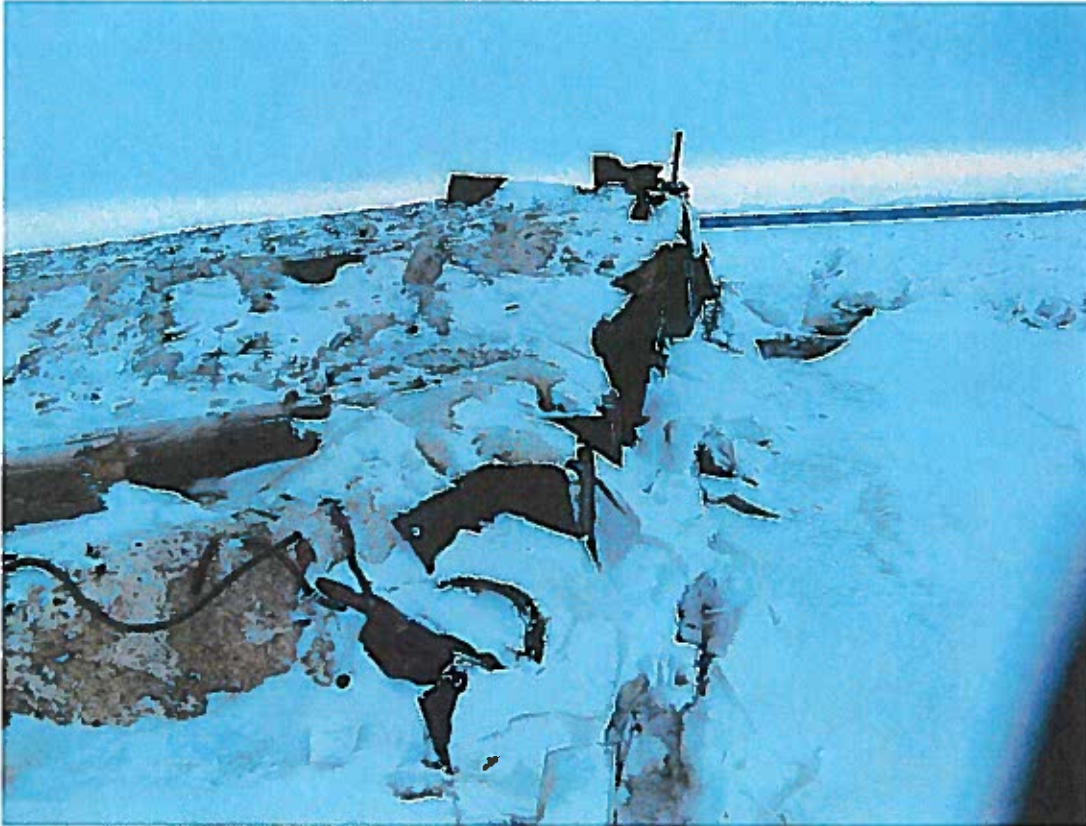
2008-12-03DFO Wharf Norman WellsP021.JPG - Looking south along downstream (west) wall, distortion and buckling for top ~1.0m of piles, also note deterioration of concrete with exposed corroded rebar.

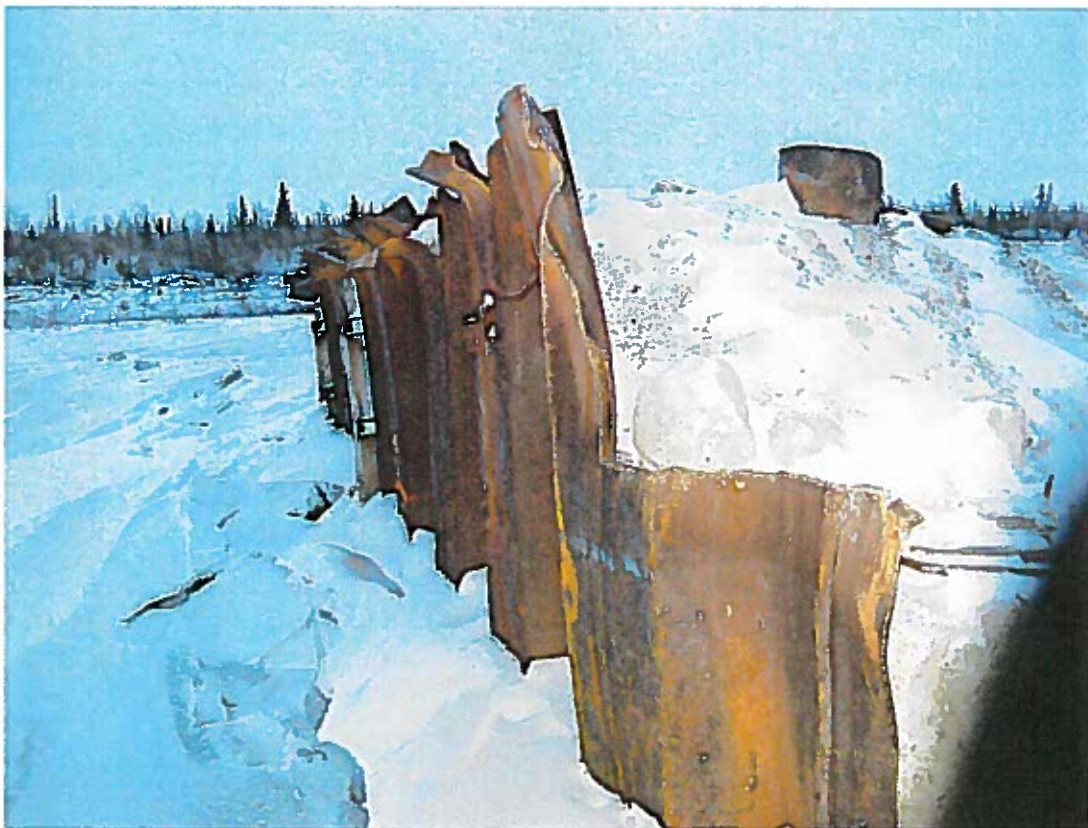
2008-12-03DFO Wharf Norman WellsP022.JPG - Looking north along downstream wharf to north side of loading ramp area, top ~1.0m of piles distorted.

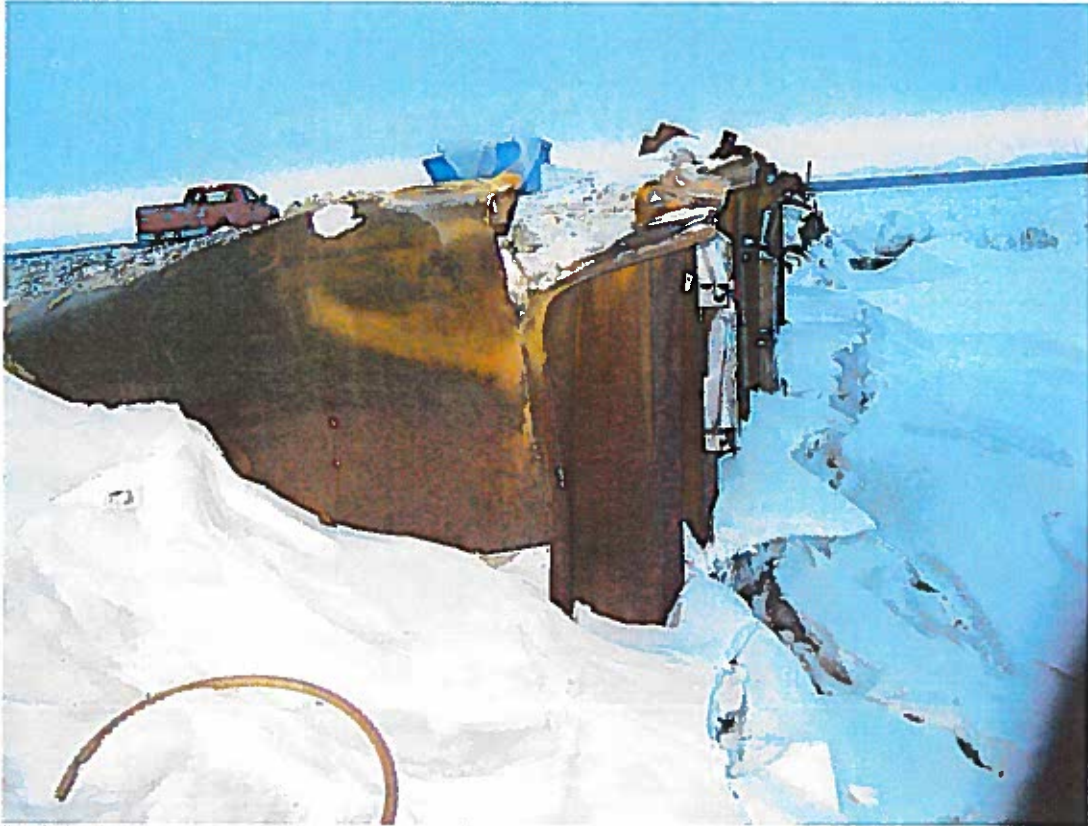
2008-12-03DFO Wharf Norman WellsP023.JPG - Looking south at downstream wharf to north of loading ramp area, buckling and distortions throughout.

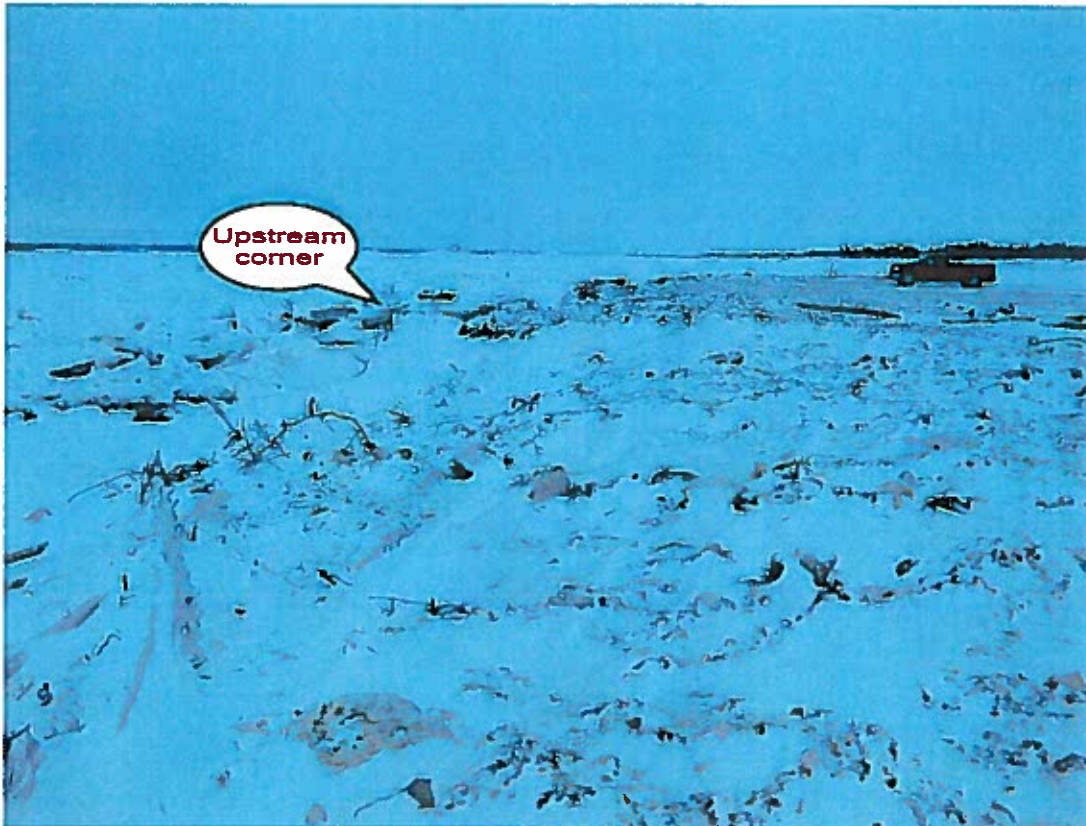
2008-12-03DFO Wharf Norman WellsP025.jpg - Looking southwest at upstream corner, this corner will likely be damaged to some degree during next ice flow.

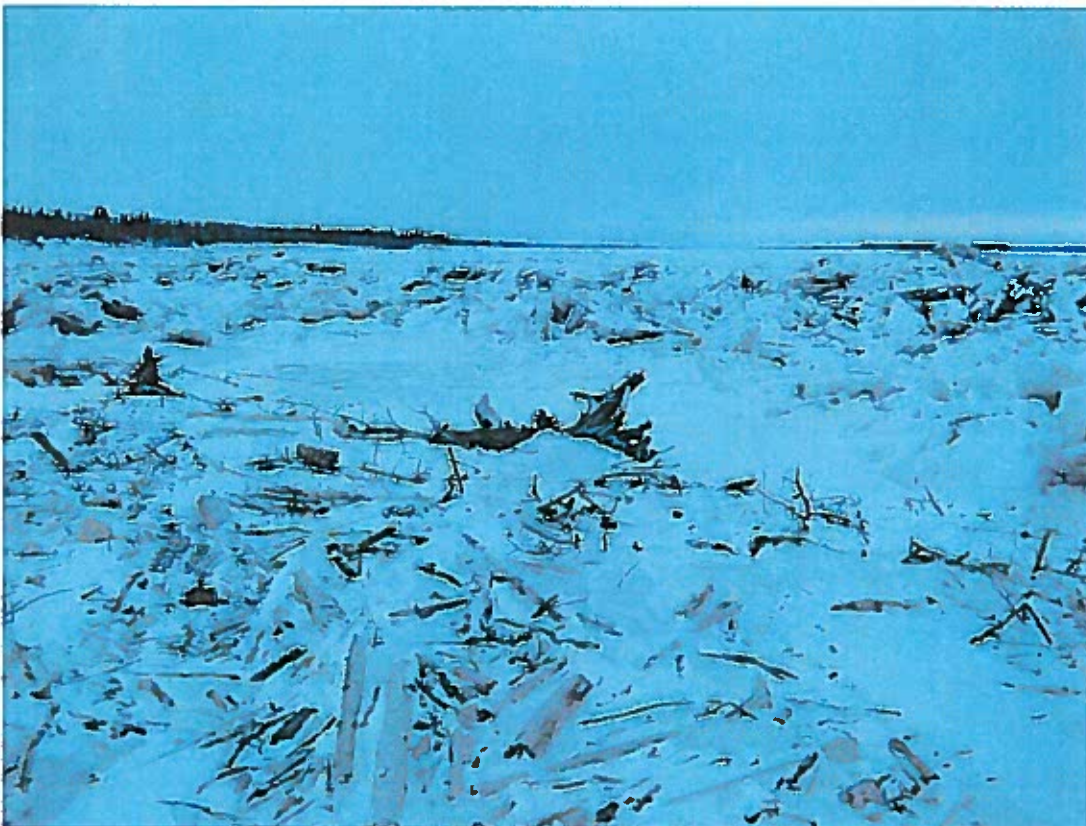
2008-12-03DFO Wharf Norman WellsP026.JPG - Looking east at upstream ice buildup that will impact the upstream southeast corner.
