FISHERIES AND OCEANS CANADA
REAL PROPERTY AND SAFETY AND SECURITY

FACILITY OVERVIEW AND RECONSTRUCTION ITEMS AT DFO SAR FACILITY TOFINO, B.C.

APPROACH, HELIPAD & WHARFHEAD
CROSS SECTION DETAIL
DFO SAR FACILITY
TOFINO, B.C.

TIMBER FLOAT
CROSS SECTION DETAIL
DFO SAR FACILITY
TOFINO, B.C.

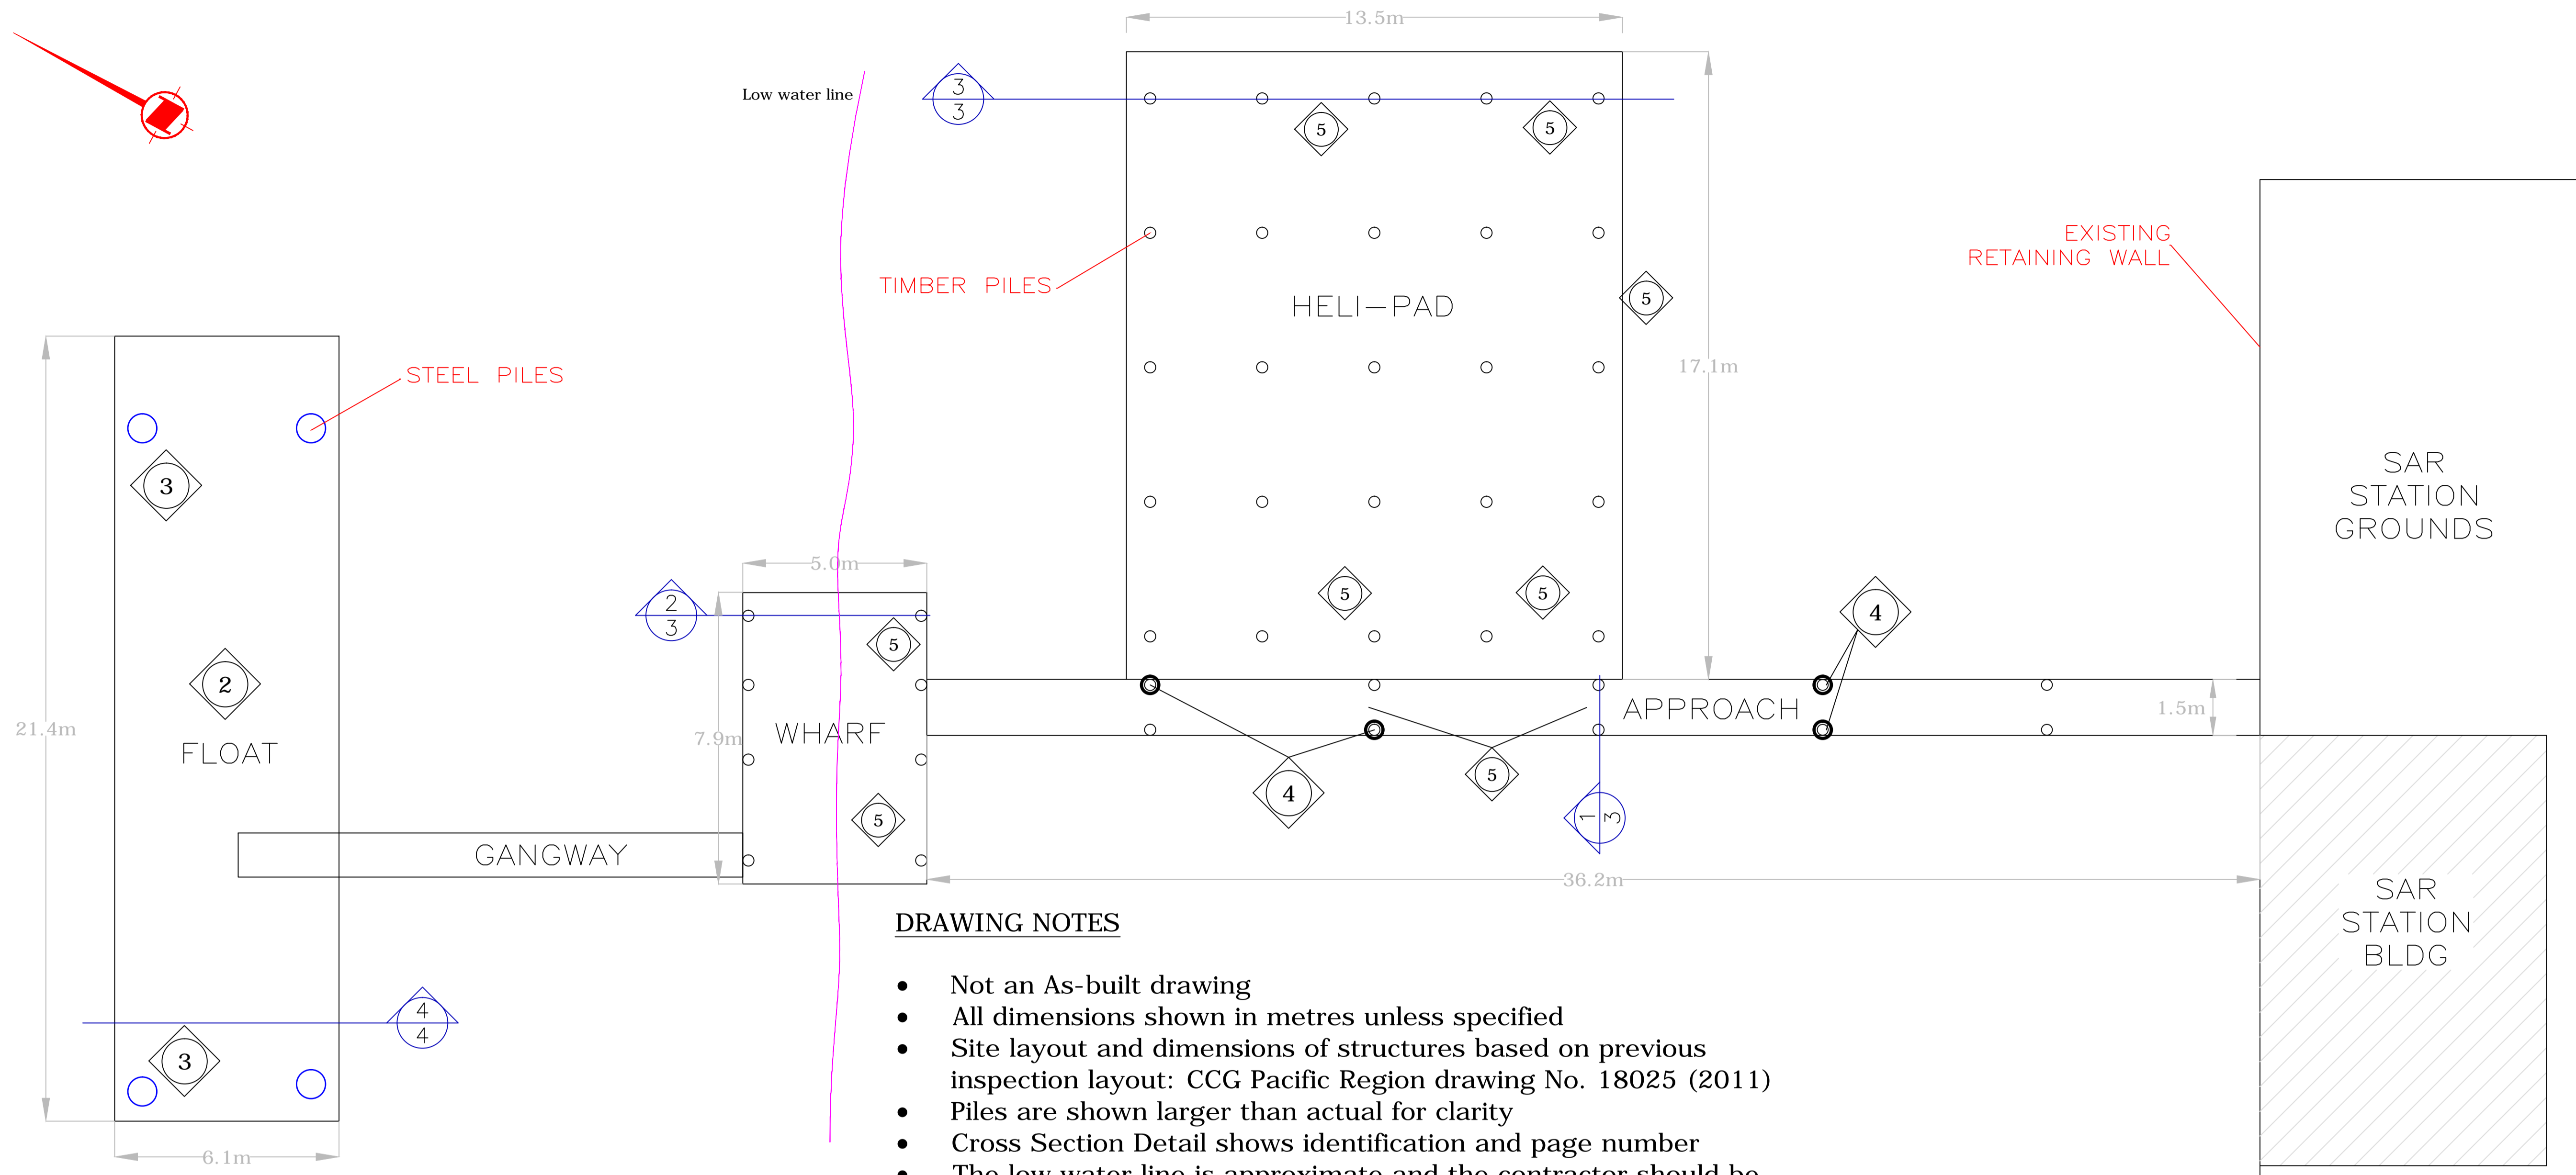
- Not an As-built drawing
- All dimensions shown in metres unless specified
- Site layout and dimensions of structures based on previous inspection layout: CCG Pacific Region drawing No. 18025 (2011)
- Piles are shown larger than actual for clarity
- Cross Section Detail shows identification and page number
- The low water line is approximate and the contractor should be aware that at low tide, majority of the structure will be above water as shown in photos below

-   Float Decking Repairs
-   Flotation Repairs
-   Replacement of Timber Bearing Piles
-   Cross Brace Replacement
-   Cross Section Detail

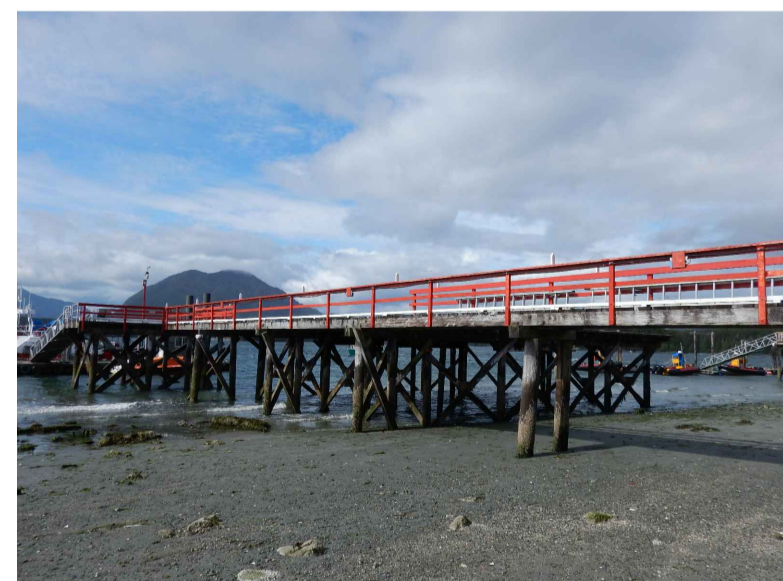
A. West side of the Approach

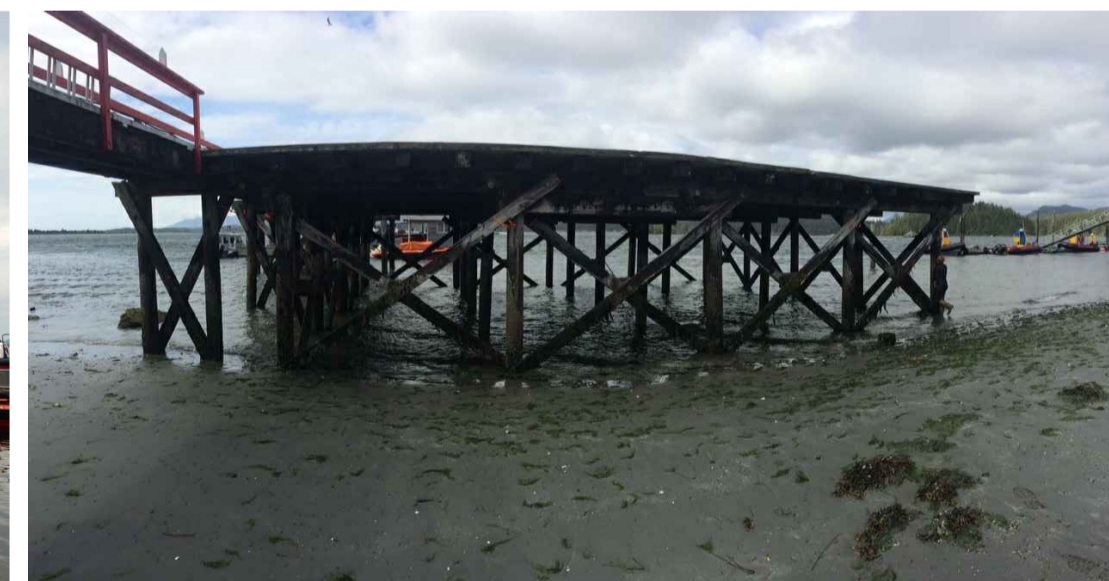
C. Southern edge of the Heli-pad

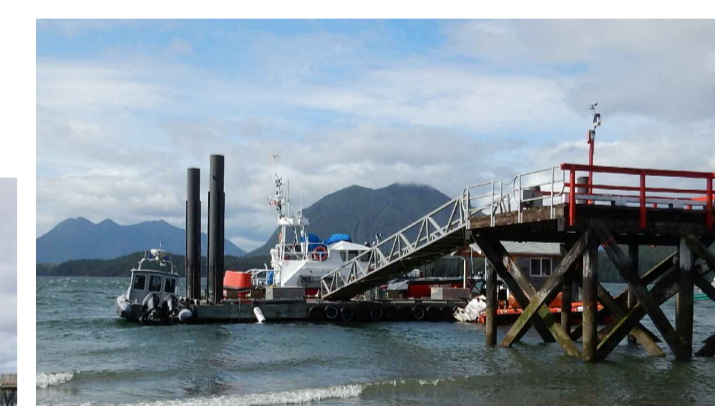
D. Float overview including wharhead and gangway

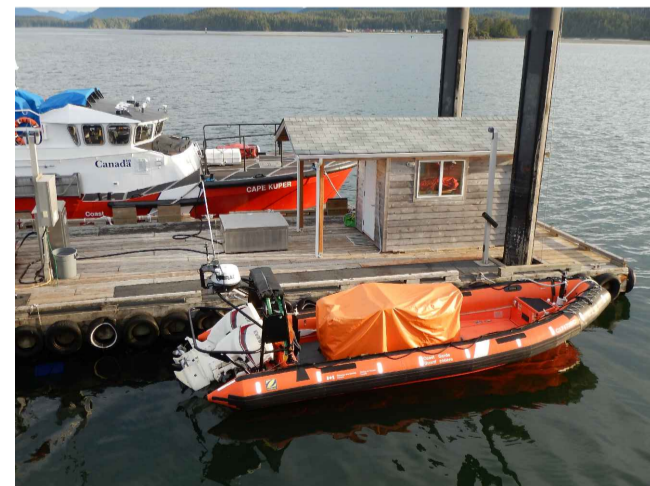
A. East side of float

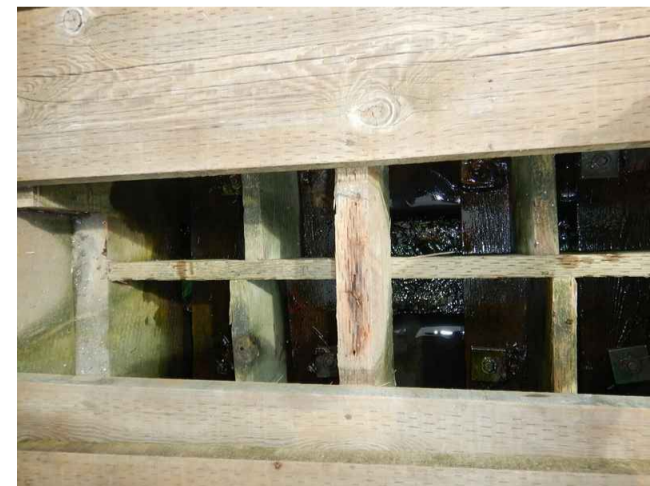
C. Cross section showing upper cross tie and internal blocking timbers

- Additional timbers do exist within this structure and are not shown for clarity. These timbers exist at the stringer's elevation and can be seen in Photo C below creating boxes above each set of flotation units.

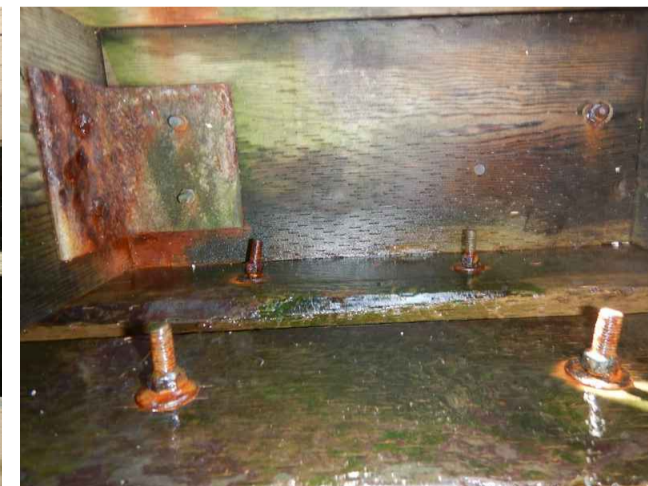
D. Lower cross ties and flotation attachment hardware
