**Screening Level Risk Assessment and  
Remedial Option Feasibility Study -  
Former UST Area, 16 Tauvette Street, Ottawa, Ontario  
NCC Property Asset No. 6976**

Prepared for:  
National Capital Commission  
202-40 Elgin Street  
Ottawa, Ontario K1P 1C7

Intera Engineering Ltd.  
1 Raymond Street, Suite 200  
Ottawa, Ontario K1R 1A2

July 29, 2008

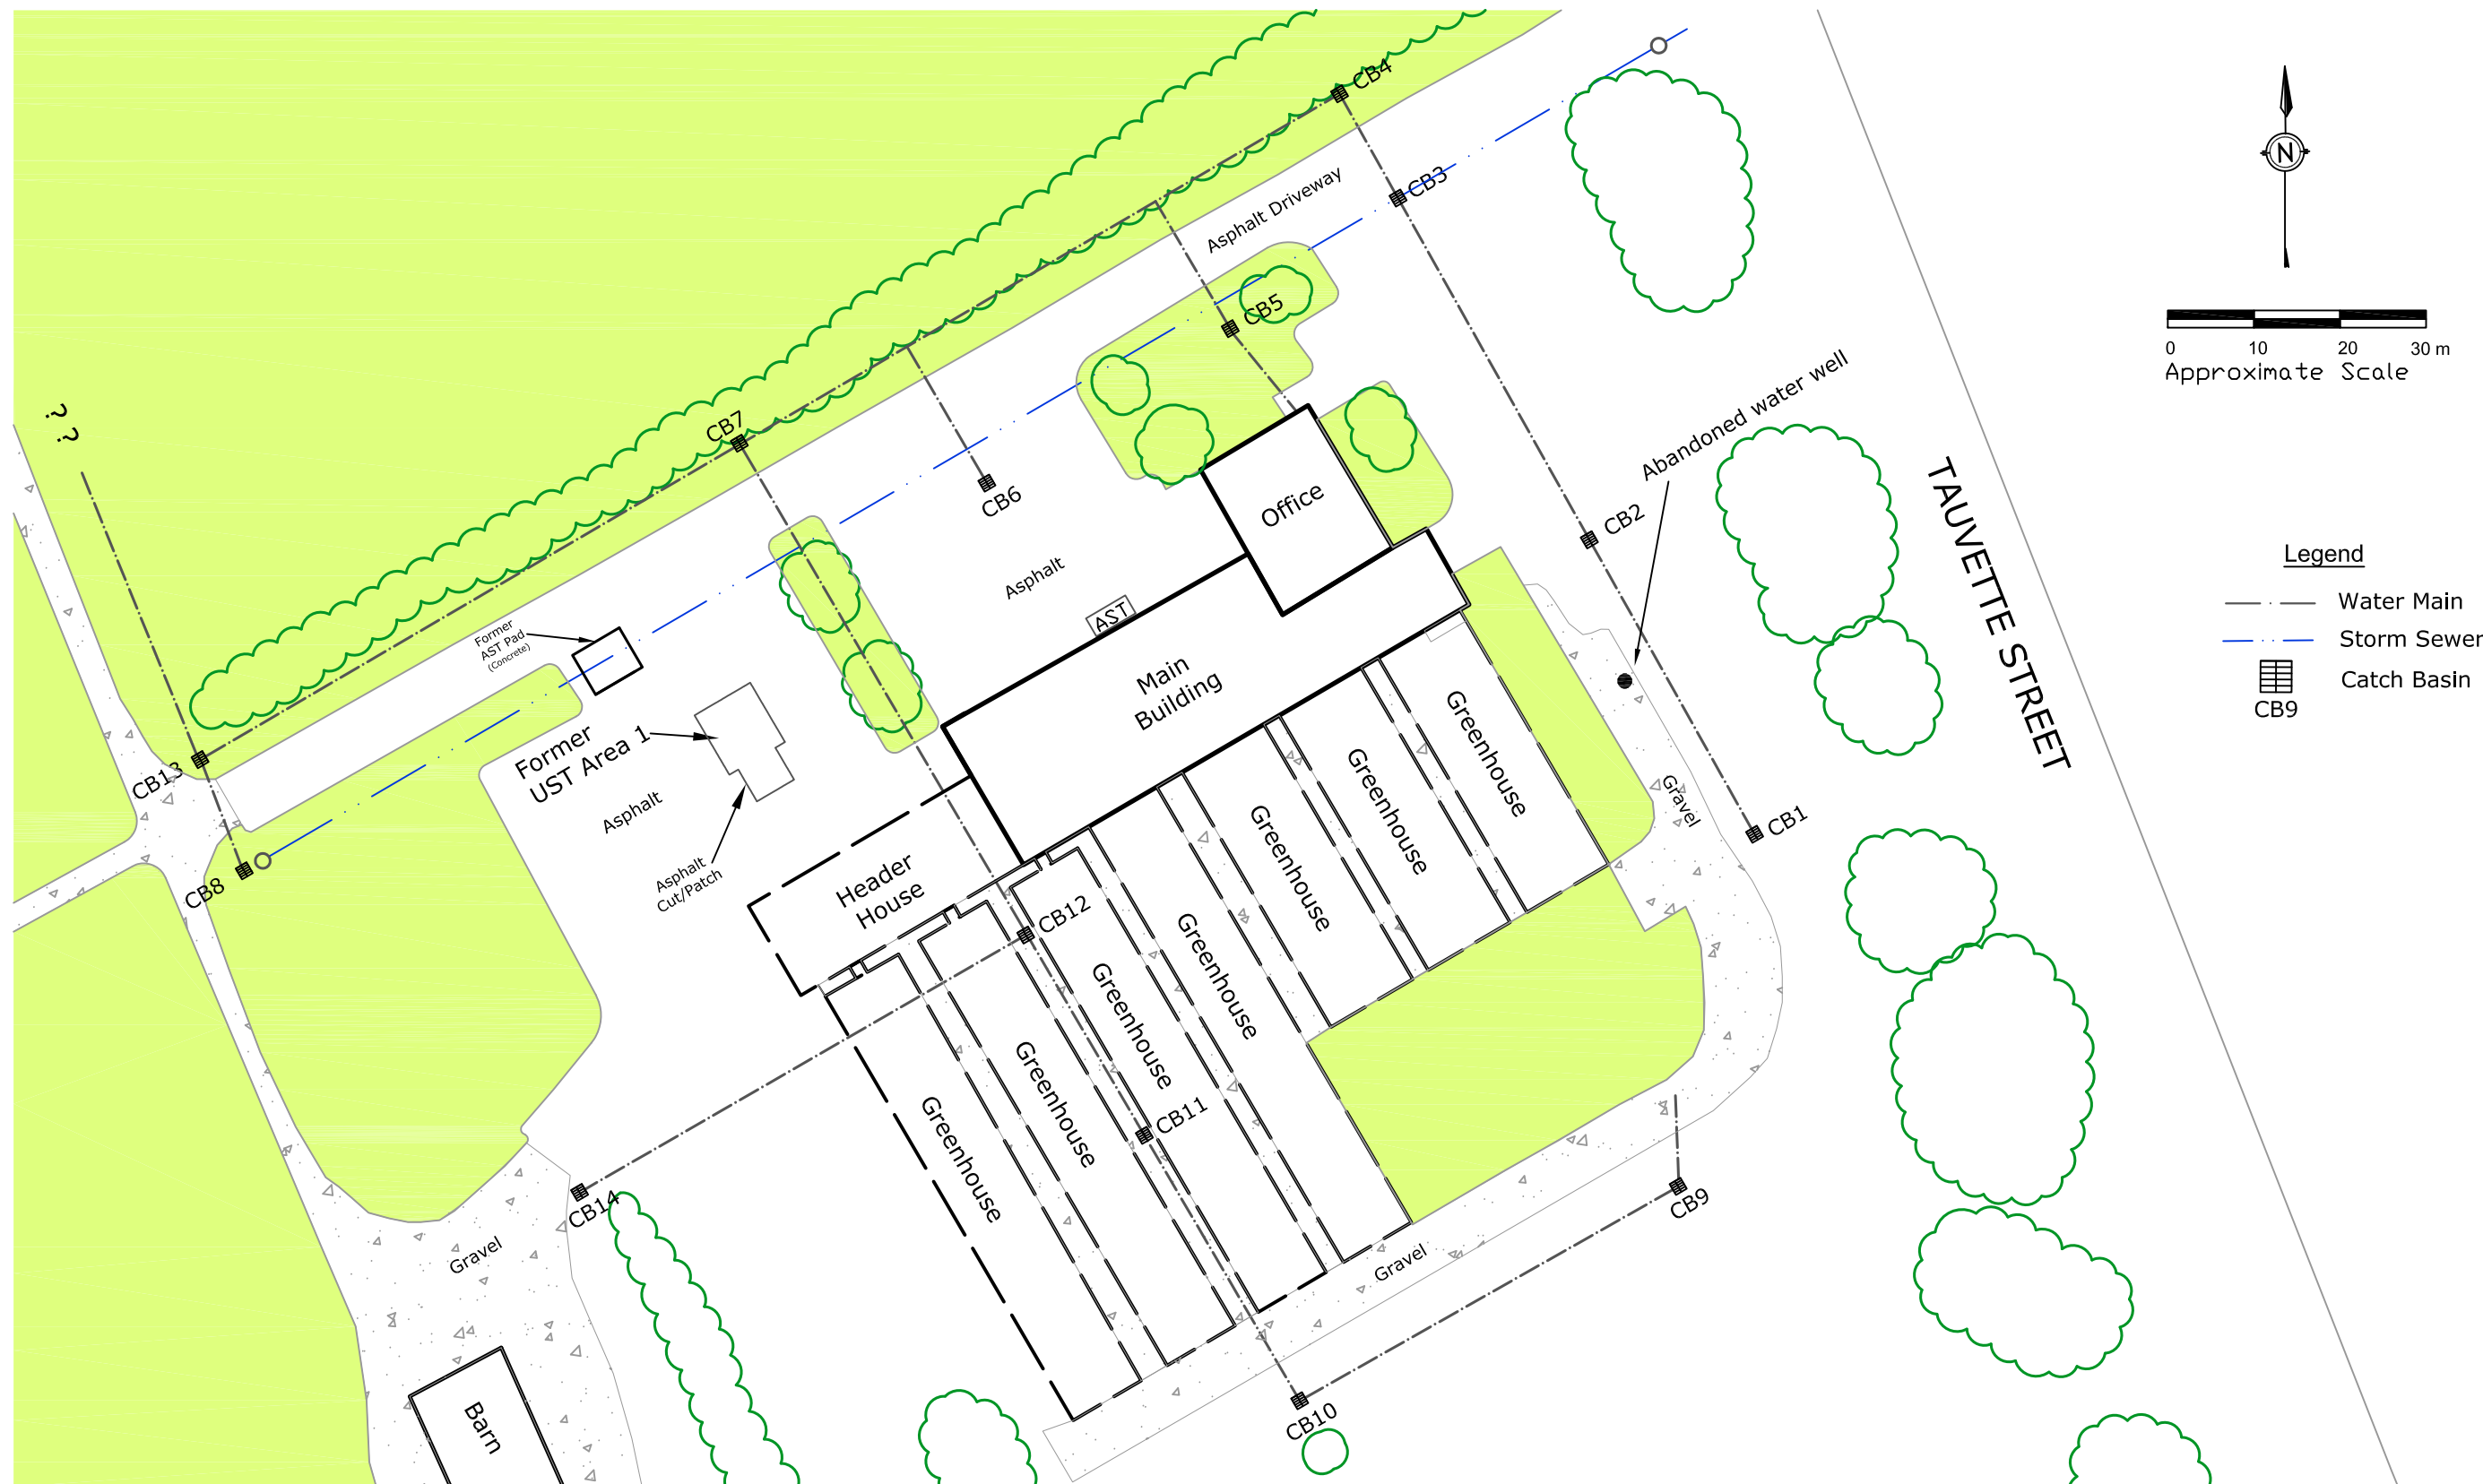
Site Layout  
SLRA and Remedial Option Feasibility Study - 16 Tauvette St., Ottawa, Ontario

Three storm sewer samples were collected to determine whether PHC/BTEX compounds are currently being leaking to the storm sewer/foundation drain system. At the time of sampling, it was raining and there was a low volume of flow through the storm sewers. The storm sewer samples were collected on October 19, 2007, from catchbasins located to the north and south of the header house/greenhouse and the former UST area (CB7 and CB12, respectively). Catchbasin locations are shown on Figure 1.2.

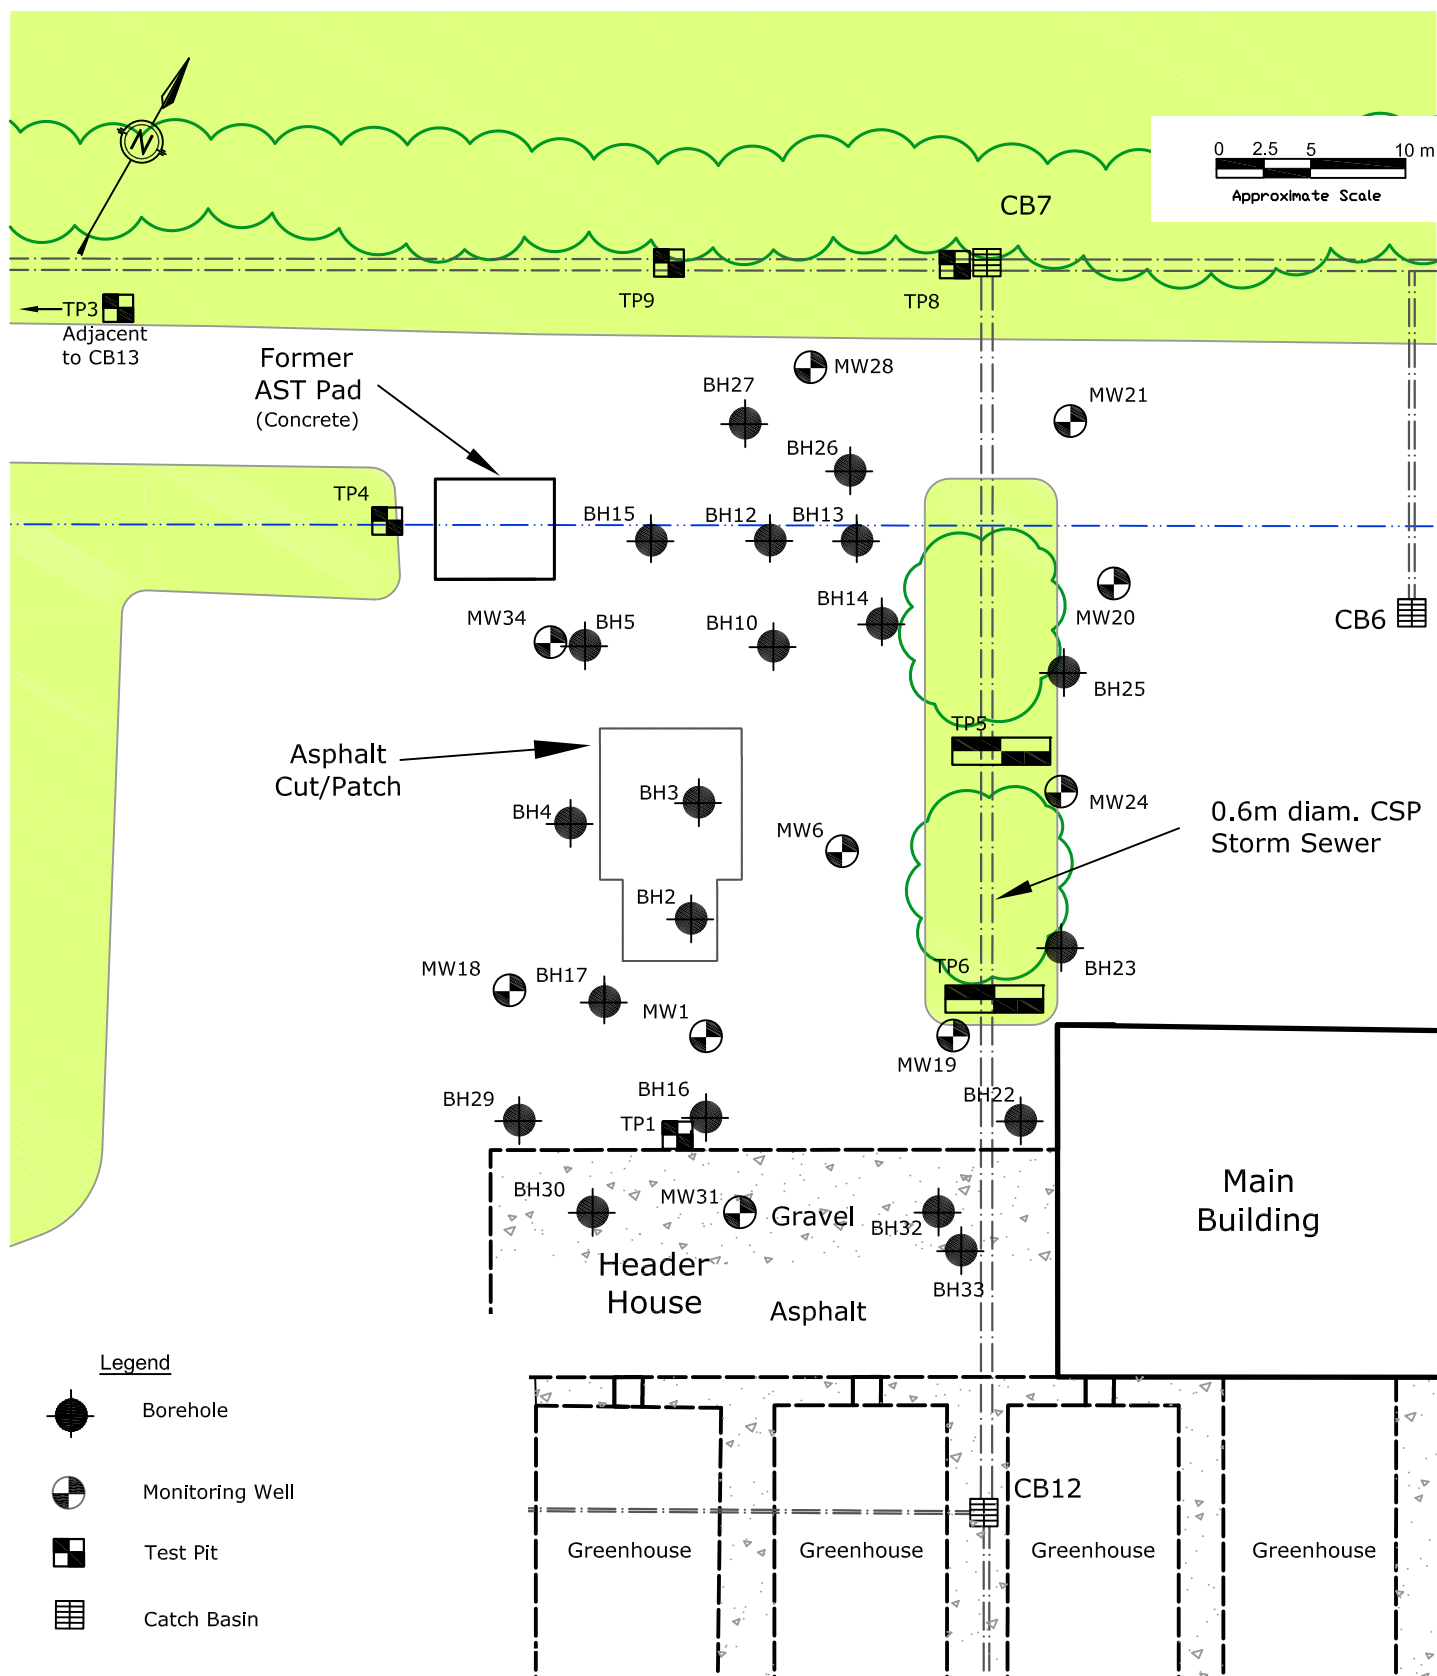
FIGURE 2.1

Borehole and Monitoring Well Locations  
SLRA and Remedial Option Feasibility Study -  
16 Tauvette St., Ottawa, Ontario

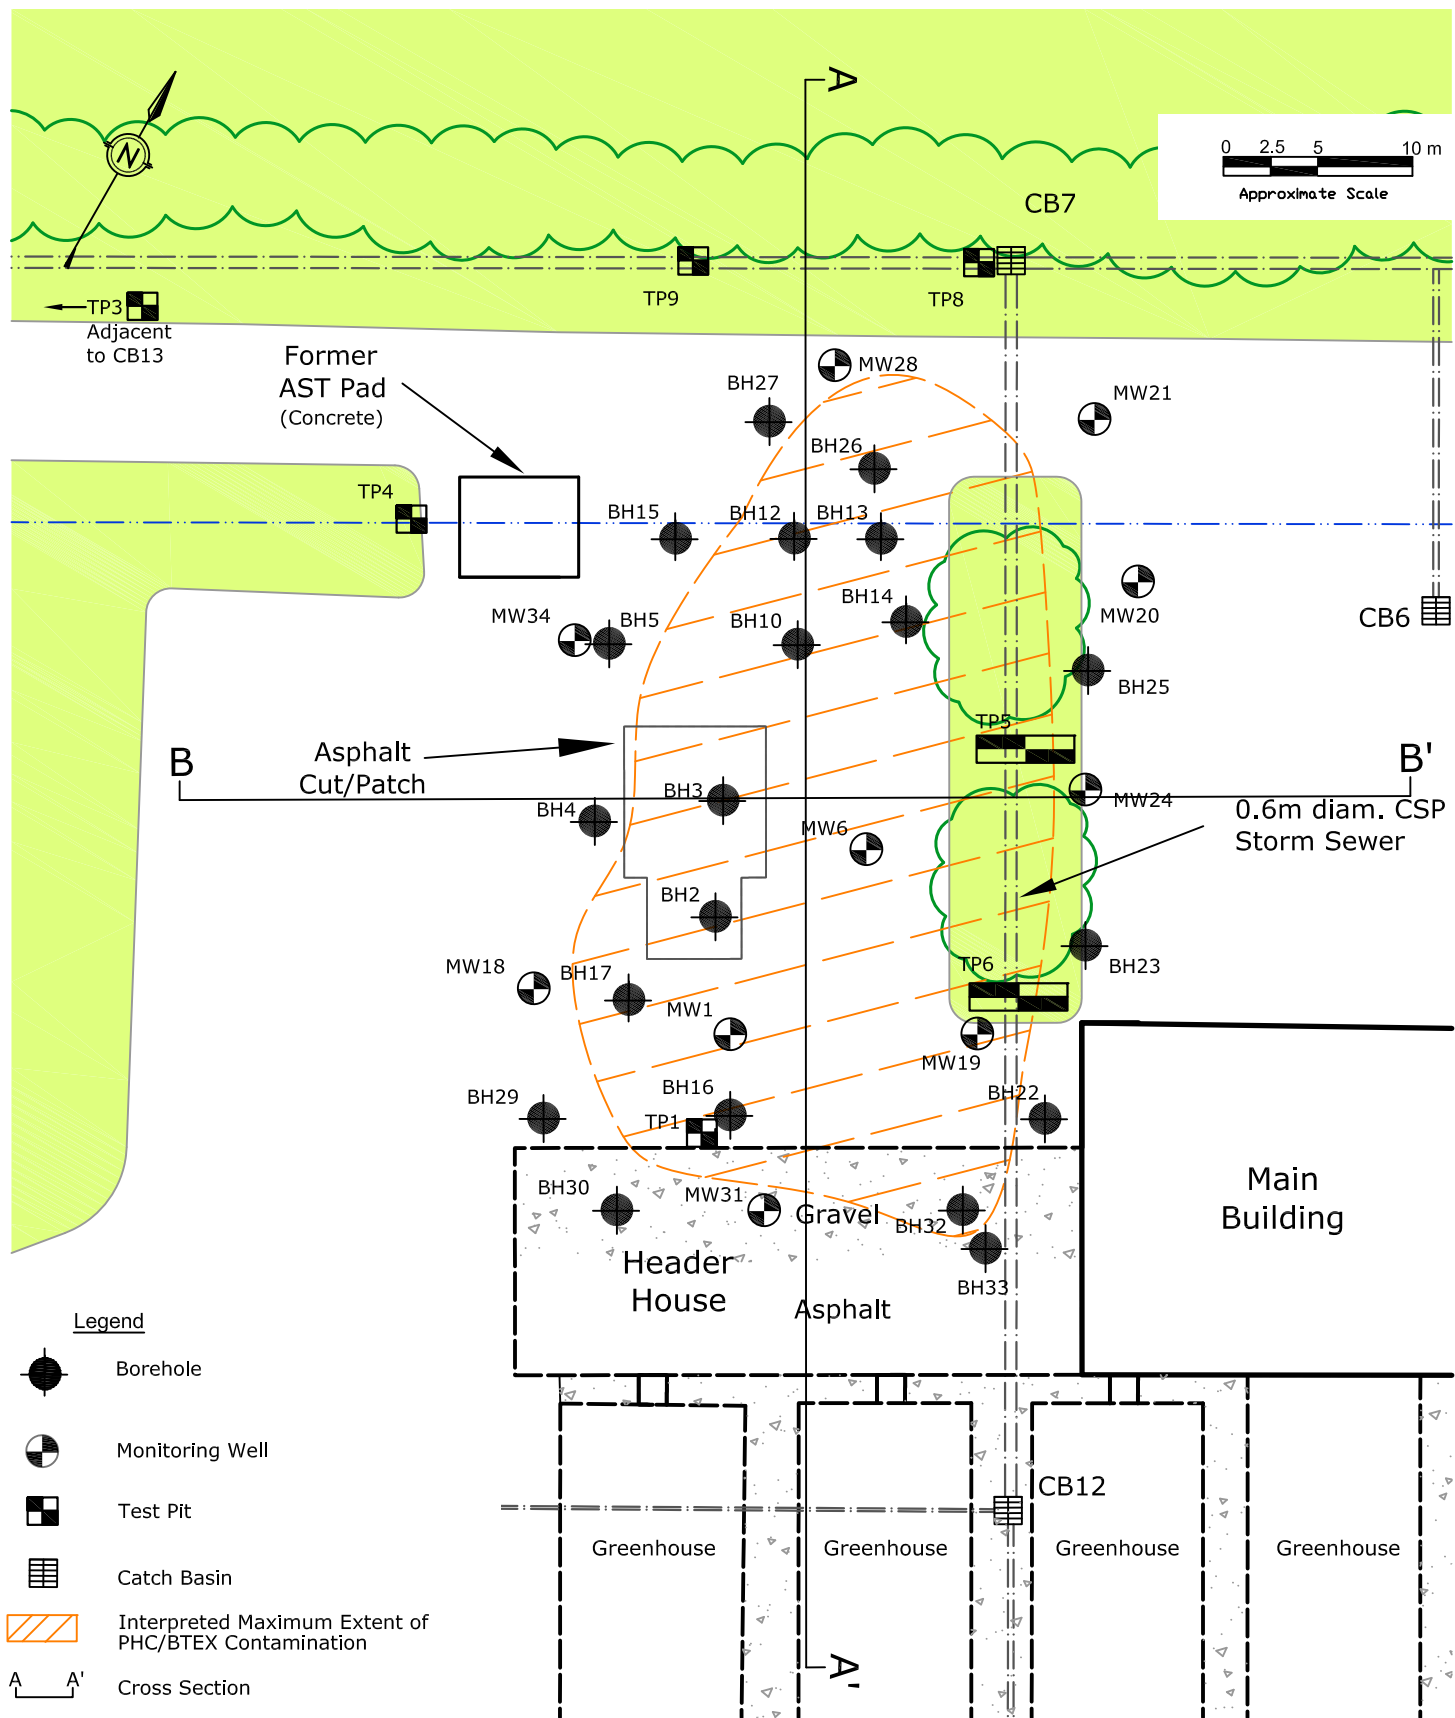
Cross Sections and Extent of PHC/BTEX Soil Contamination  
SLRA and Remedial Option Feasibility Study -  
16 Tauvette St., Ottawa, Ontario

While these commercial land use exposure scenarios are appropriate for the 16 Tauvette St. site, they do not consider less common exposure scenarios that may create human exposure and health risk. These less common exposure scenarios include future excavation remediation of the remnant soil contamination and occasional servicing or repair of the shallow water main and storm sewer lines that cross the area of identified COC contamination outlined in Figure 3.1.

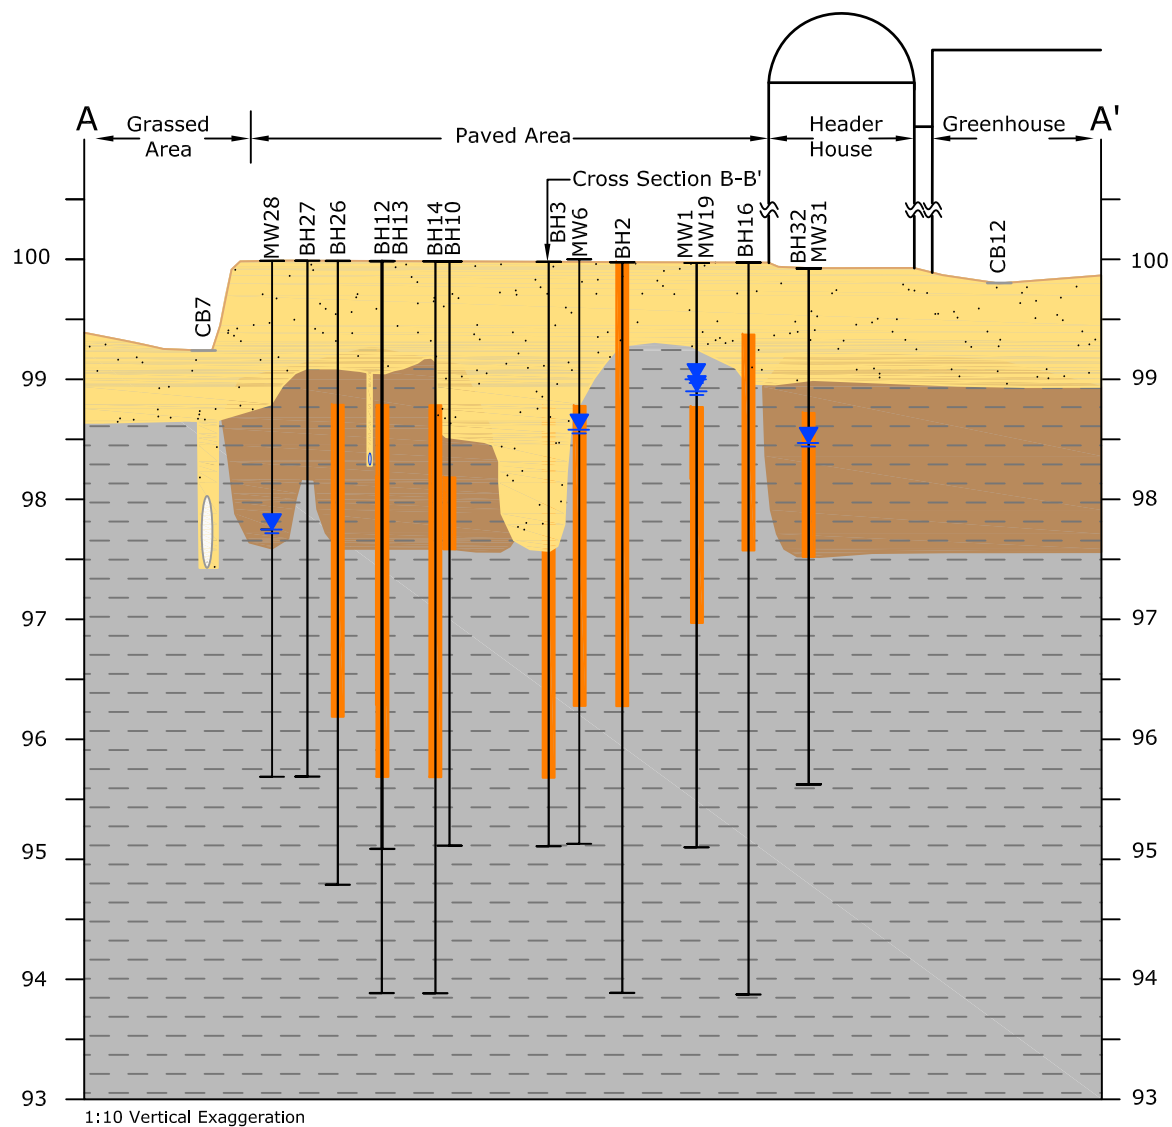
FIGURE 3.2

Cross Section A - A'  
SLRA and Remedial Option Feasibility Study -  
16 Tavette St., Ottawa, Ontario

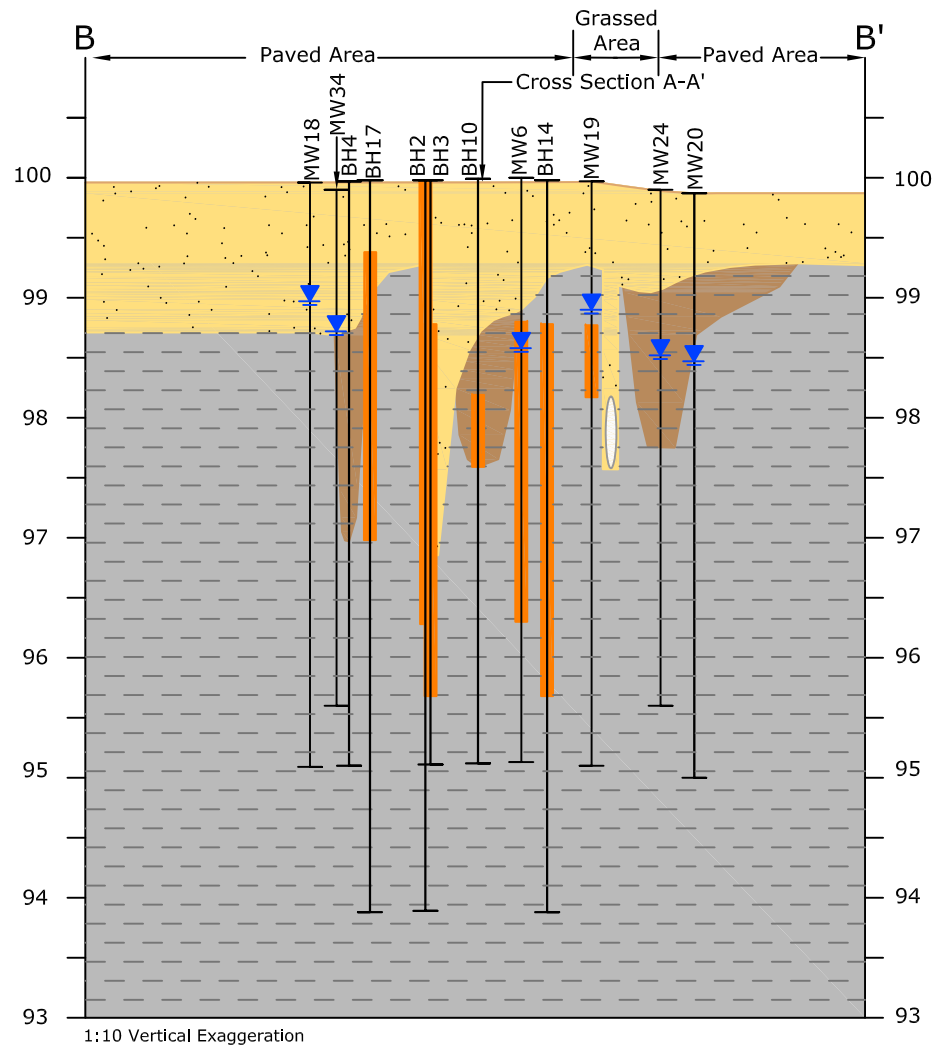
FIGURE 3.3

Cross Section B - B'  
SLRA and Remedial Option Feasibility Study -  
16 Tauvette St., Ottawa, Ontario

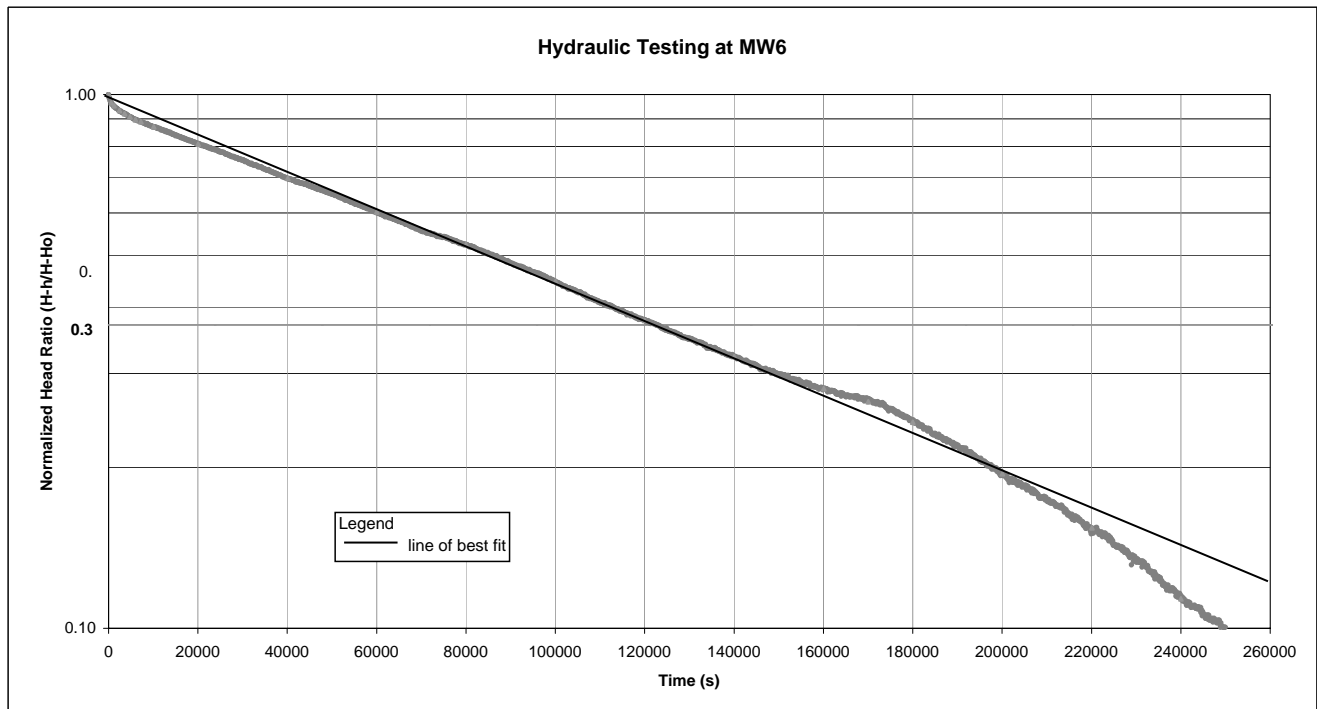
$$K = \frac{r_c^2 \ln \left( \frac{L}{R} \right)}{2 L T_o}$$

<b>K =</b>	<b>2.01E-09</b>	<b>m/s</b>
R (borehole radius)	0.0415	m
L (interval length)	3.392	m
r <sub>c</sub> (radius of well casing)	0.0195	m
T <sub>0</sub> (T = 63% recovery)	122500	s

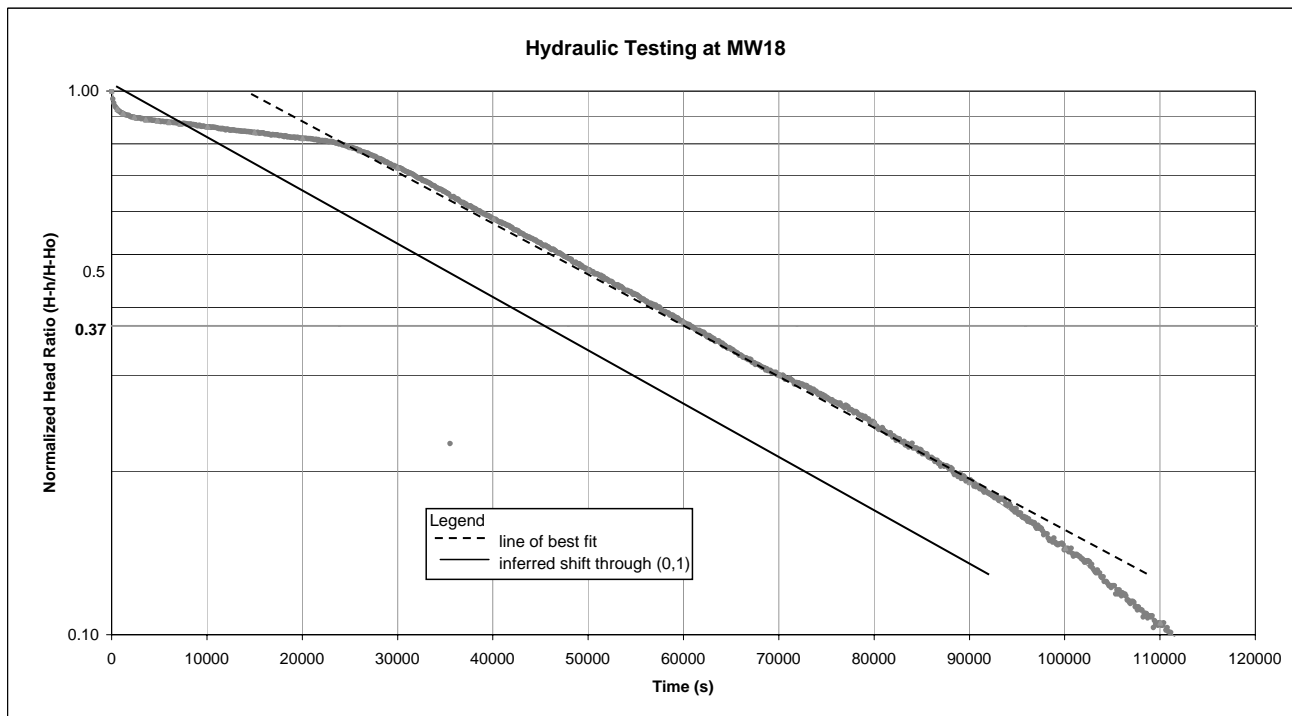
# BHWM18

## Hvorslev Bail-Test Method

$$K = \frac{r_c^2 \ln \left( \frac{L}{R} \right)}{2 L T_o}$$

<b>K =</b>	<b>4.38E-09</b>	<b>m/s</b>
R (borehole radius)	0.0415	m
L (interval length)	2.669	m
r <sub>c</sub> (radius of well casing)	0.0159	m
T <sub>0</sub> (T = 63% recovery)	45000	s

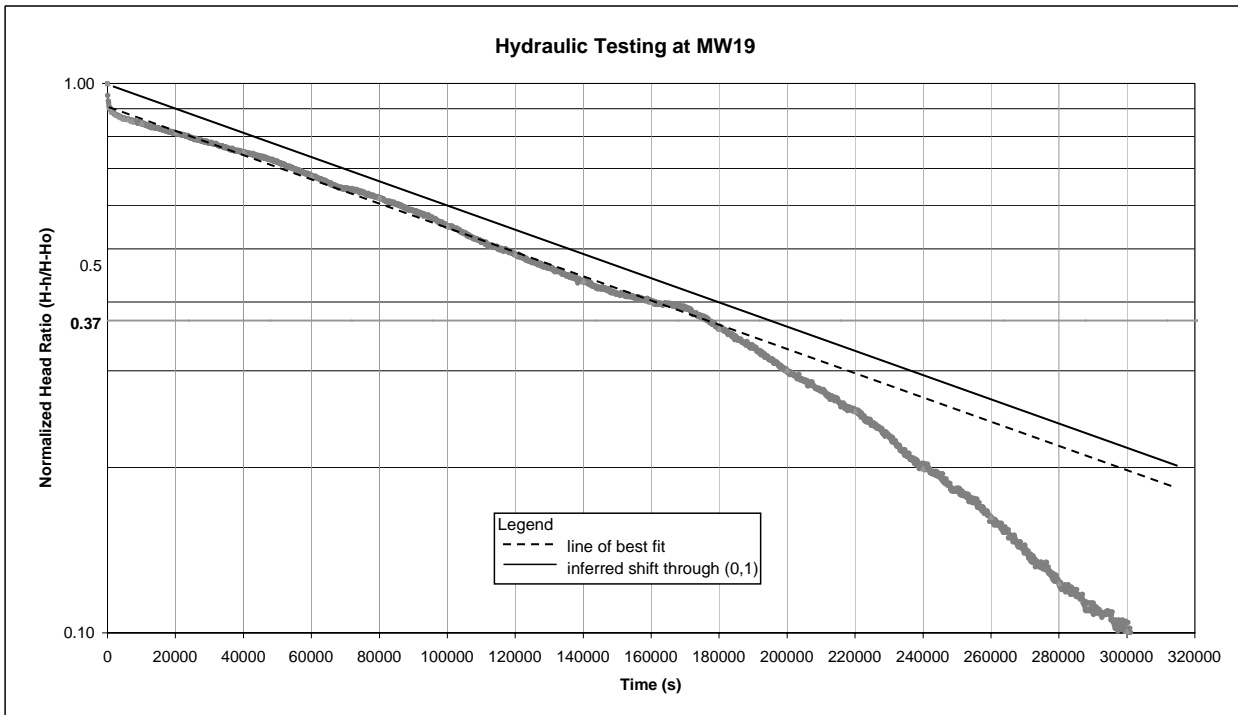
# BHMW19

## Hvorslev Bail-Test Method

$$K = \frac{r_c^2 \ln \left( \frac{L}{R} \right)}{2 L T_o}$$

<b>K =</b>	1.06E-09	m/s
R (borehole radius)	0.0415	m
L (interval length)	2.498	m
r <sub>c</sub> (radius of well casing)	0.0159	m
T <sub>o</sub> (T = 63% recovery)	195000	s

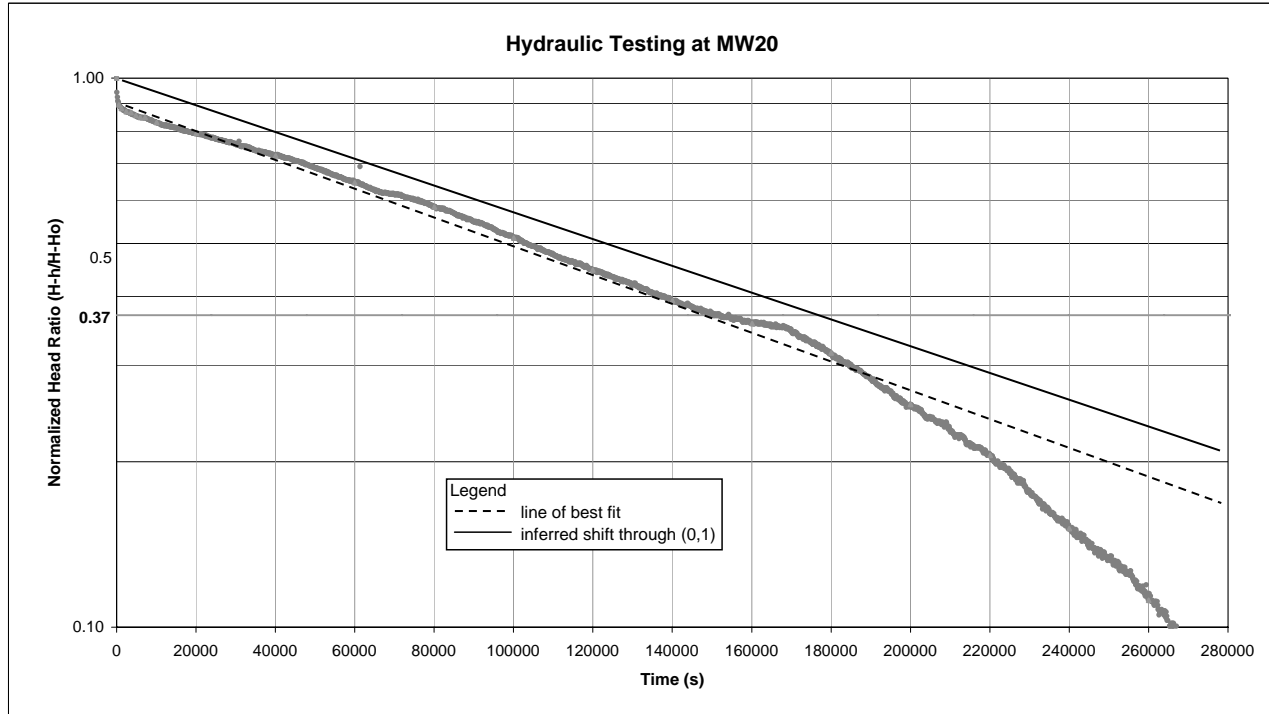
# BHMW20

## Hvorslev Bail-Test Method

$$K = \frac{r_c^2 \ln \left( \frac{L}{R} \right)}{2 L T_o}$$

<b>K =</b>	1.27E-09	m/s
R (borehole radius)	0.0415 m	
L (interval length)	2.292 m	
r <sub>c</sub> (radius of well casing)	0.0159 m	
T <sub>0</sub> (T = 63% recovery)	174000 s

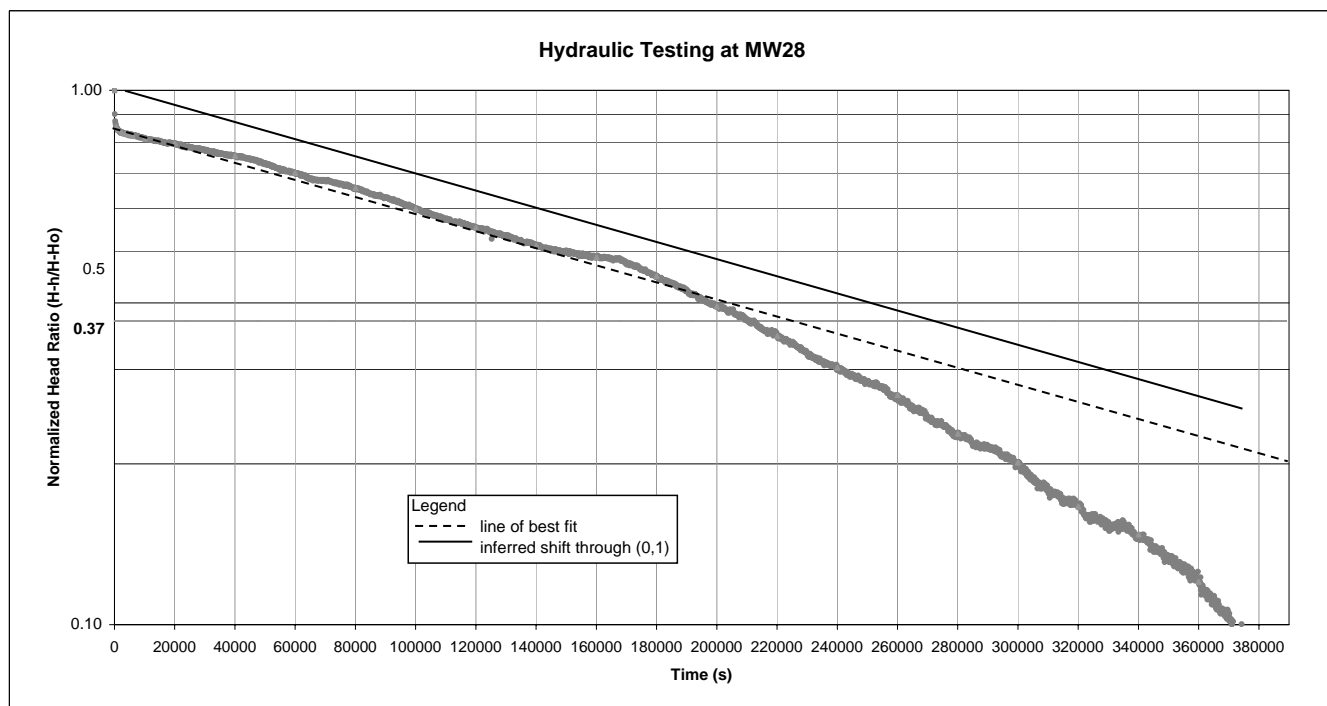
# BHMW28

## Hvorslev Bail-Test Method

$$K = \frac{r_c^2 \ln \left( \frac{L}{R} \right)}{2 L T_o}$$

<b>K =</b>	9.39E-10	m/s
R (borehole radius)	0.0415	m
L (interval length)	1.908	m
r <sub>c</sub> (radius of well casing)	0.0159	m
T <sub>o</sub> (T = 63% recovery)	270000	s

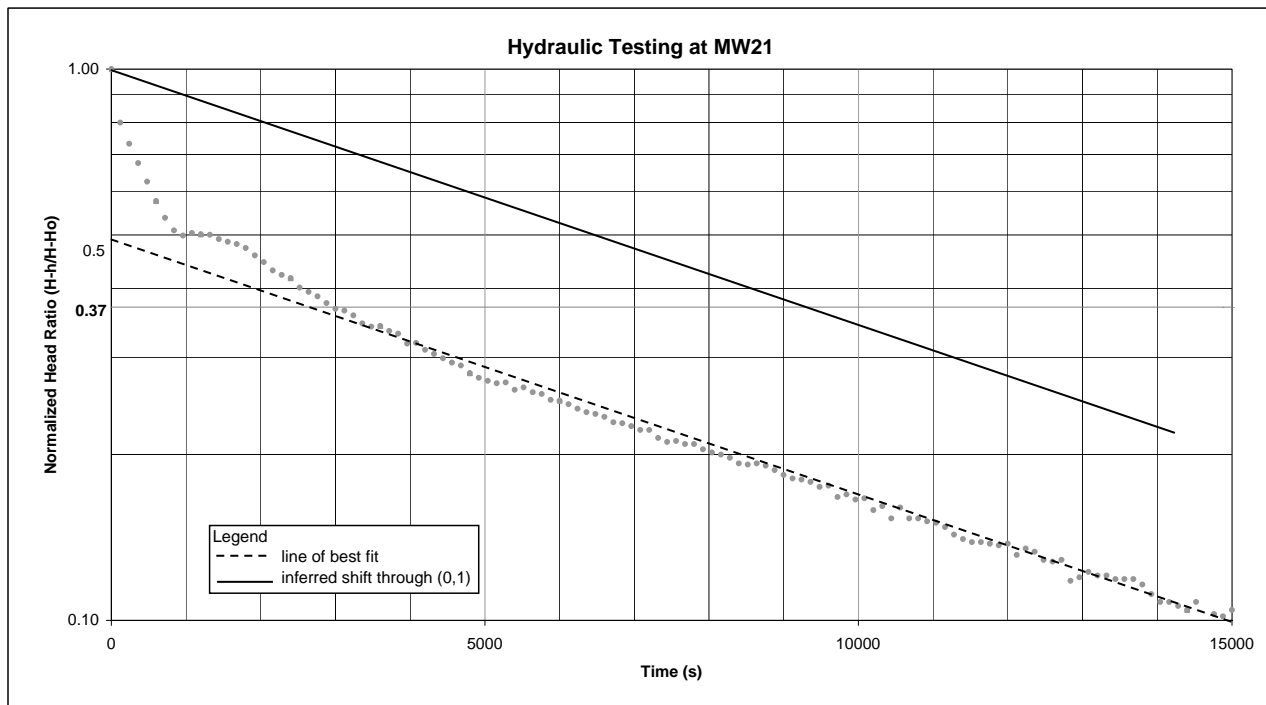
# BHMW21

## Hvorslev Slug-Test Method

$$K = \frac{r_c^2 \ln \left( \frac{L}{R} \right)}{2 L T_o}$$

<b>K =</b>	<b>4.33E-08</b>	<b>m/s</b>
R (borehole radius)	0.0415	m
L (interval length)	1.00	m
r <sub>c</sub> (radius of well casin)	0.0159	m
T <sub>o</sub> (T = 63% recovery)	9300	s

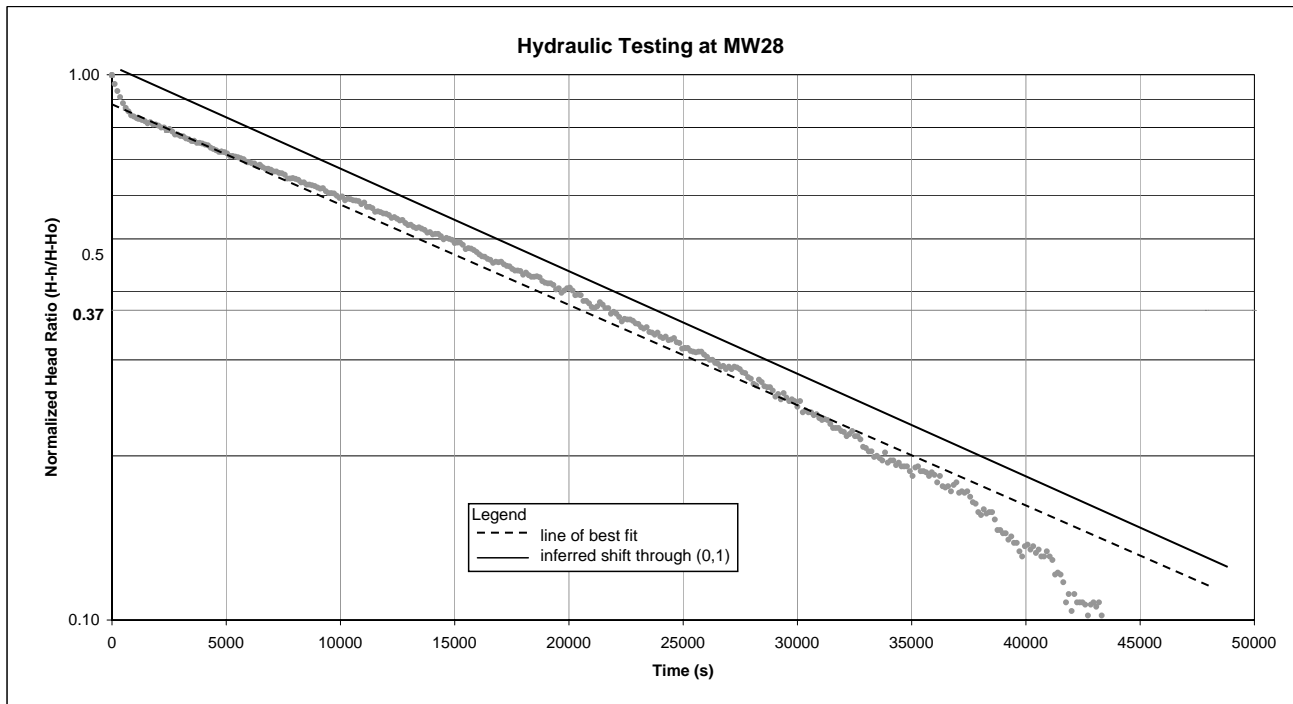
# BHMW28

## Hvorslev Slug-Test Method

$$K = \frac{r_c^2 \ln \left( \frac{L}{R} \right)}{2 L T_o}$$

<b>K =</b>	<b>1.69E-08</b>	<b>m/s</b>
R (borehole radius)	0.0415 m	
L (interval length)	1.00 m	
r <sub>c</sub> (radius of well casing)	0.0159 m	
T <sub>o</sub> (T = 63% recovery)	23800 s

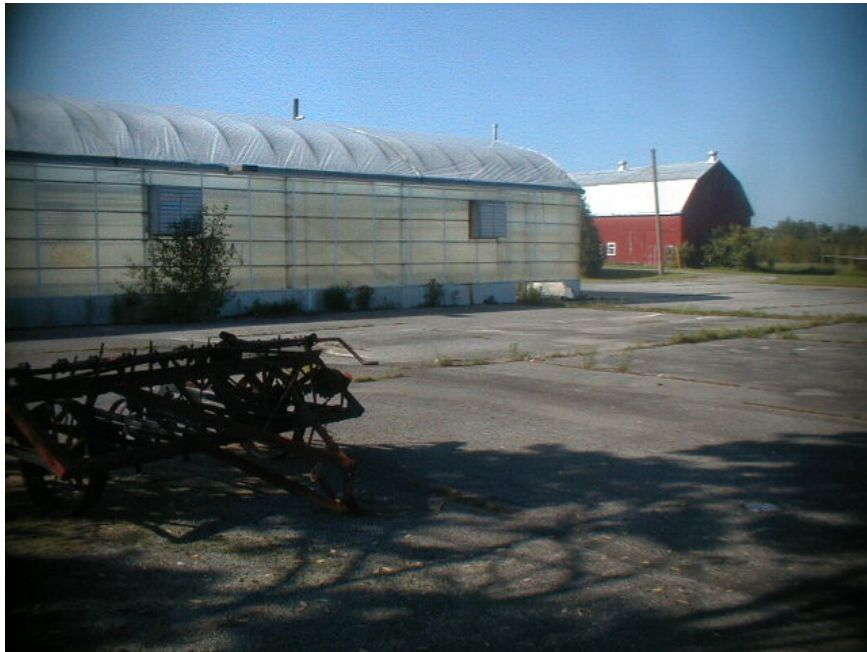
Header House Former UST Area, looking southwest

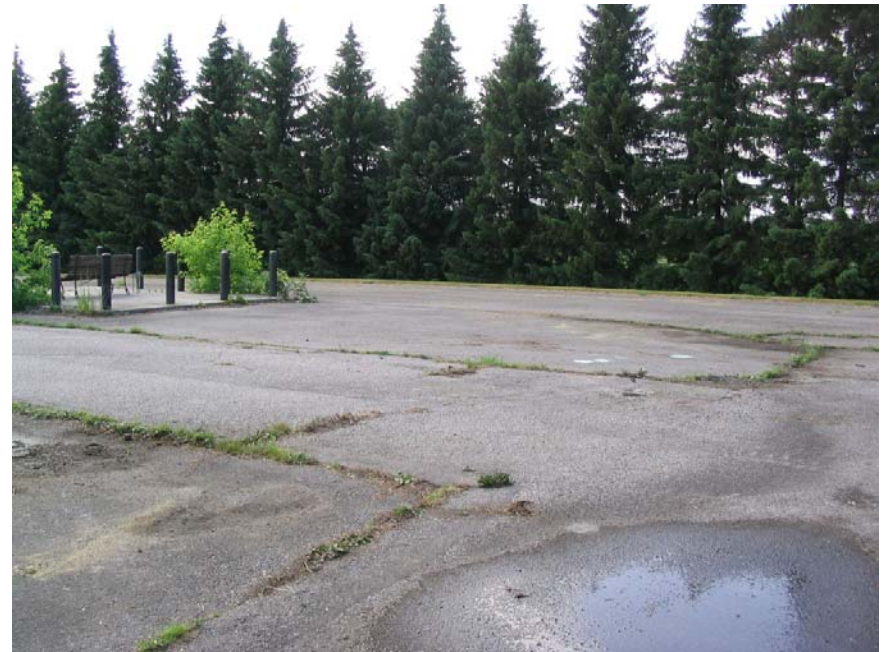
Former UST Area and Former AST Pad, looking northwest

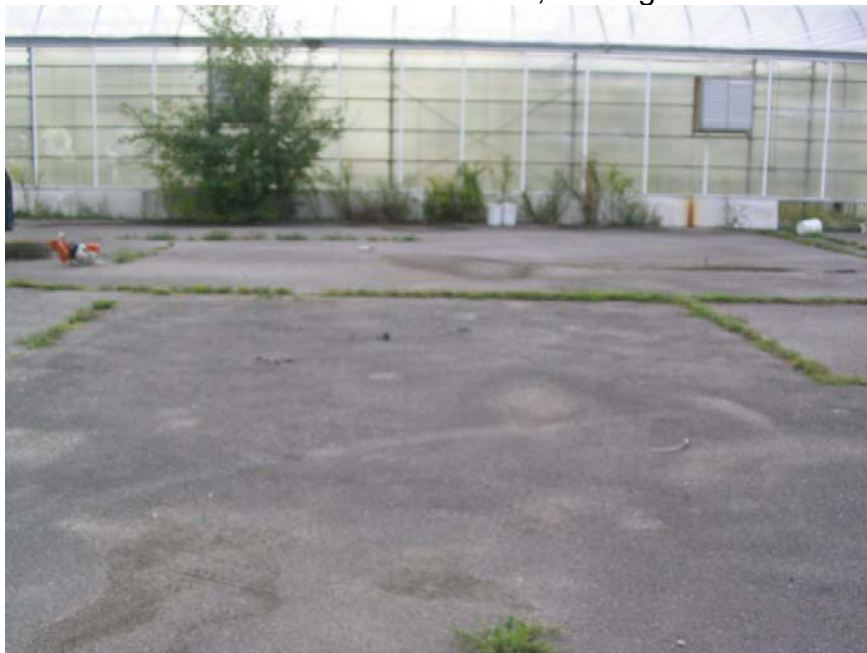
Header House and Former UST Area, looking south  
SLRA and Remedial Option Feasibility Study – 16 Tavette St.

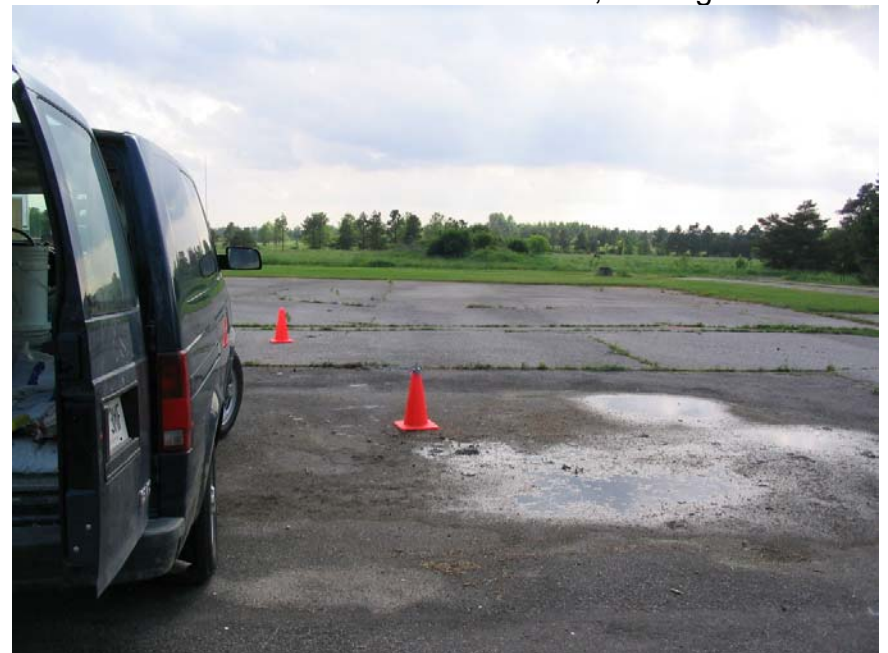
Former UST Area, looking west  
Photos Taken on June 14, 2005 and June 6, 2006
