Geotechnical Investigation

PUBLIC SERVICES AND PROCUREMENT CANADA
Waterfalls Trail – Cap Tourmente National Wildlife Area

FINAL REPORT

Date : March 2017

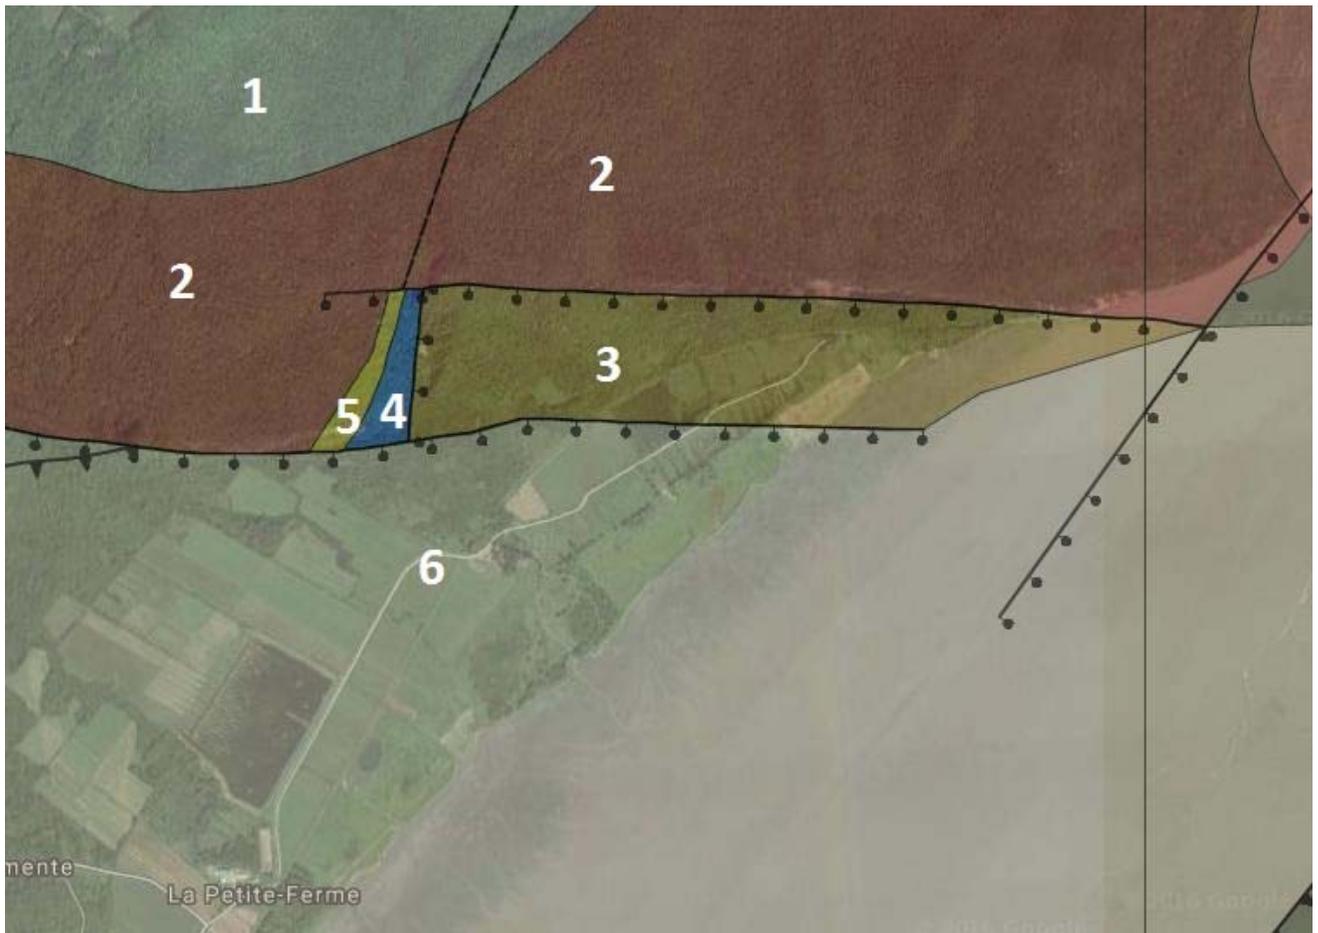
Figure 1 Geology of the area (from SIGEOM, 2016)

Based on the geological maps consulted through the “**système d’information géominière du Québec (SIGÉOM)**” of the ministère de l’Énergie et des Ressources naturelles du Québec, several separate geological units are likely to be intercepted in the project area. The following figure, taken from **SIGÉOM**, illustrates the distribution of the various geological units, which are defined as follows:

1. Quaternary deposits consisting of sand, gravel, silt, till
2. Charnockitic migmatite and associated rocks of the charnockitic complex of Charlevoix
3. Utica calcareous shale
4. Fossiliferous micrite of the Deschambault Formation
5. Sandstone and conglomerate of the Trenton Group
6. Shale with sandstone laminates of the Lotbinière Formation.

Also, note that the site is intersected by several regional faults (lines in bold) oriented mainly east-west, or north-east / south-west.

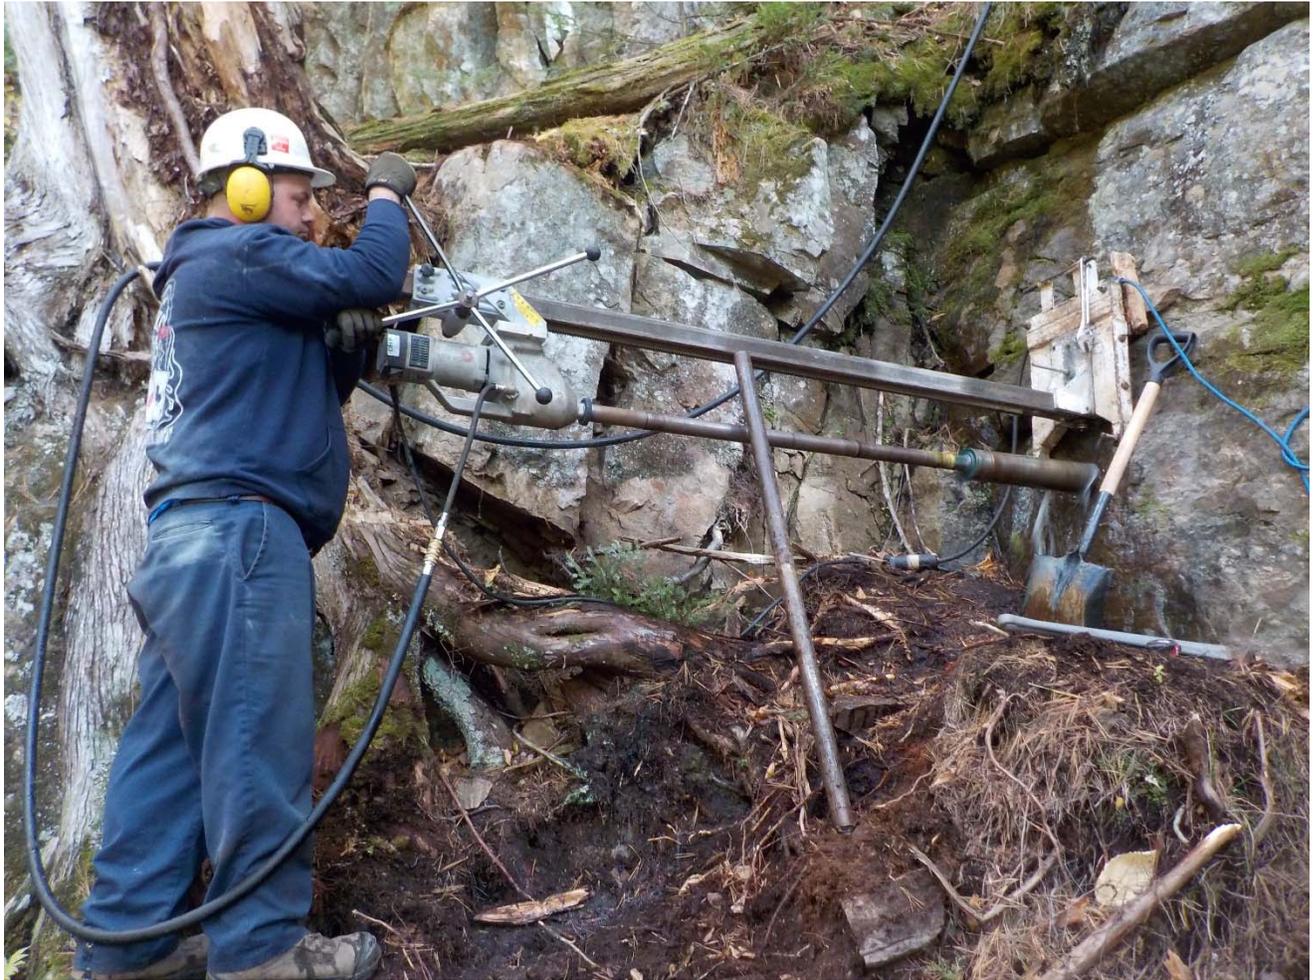
Figure 2 Drilling of a horizontal borehole (BH-03-16)

Drilling was carried out using a WEKA DK-32 and a CARDI T9-475 electric core drill. The boreholes reached a depth of between 2,1 m and 7,2 m. It should be noted that BH-01-16 was drilled vertically while boreholes BH-02-16 and BH-03-16 were drilled horizontally.

The following figure illustrates a typical installation for the borehole drilling.

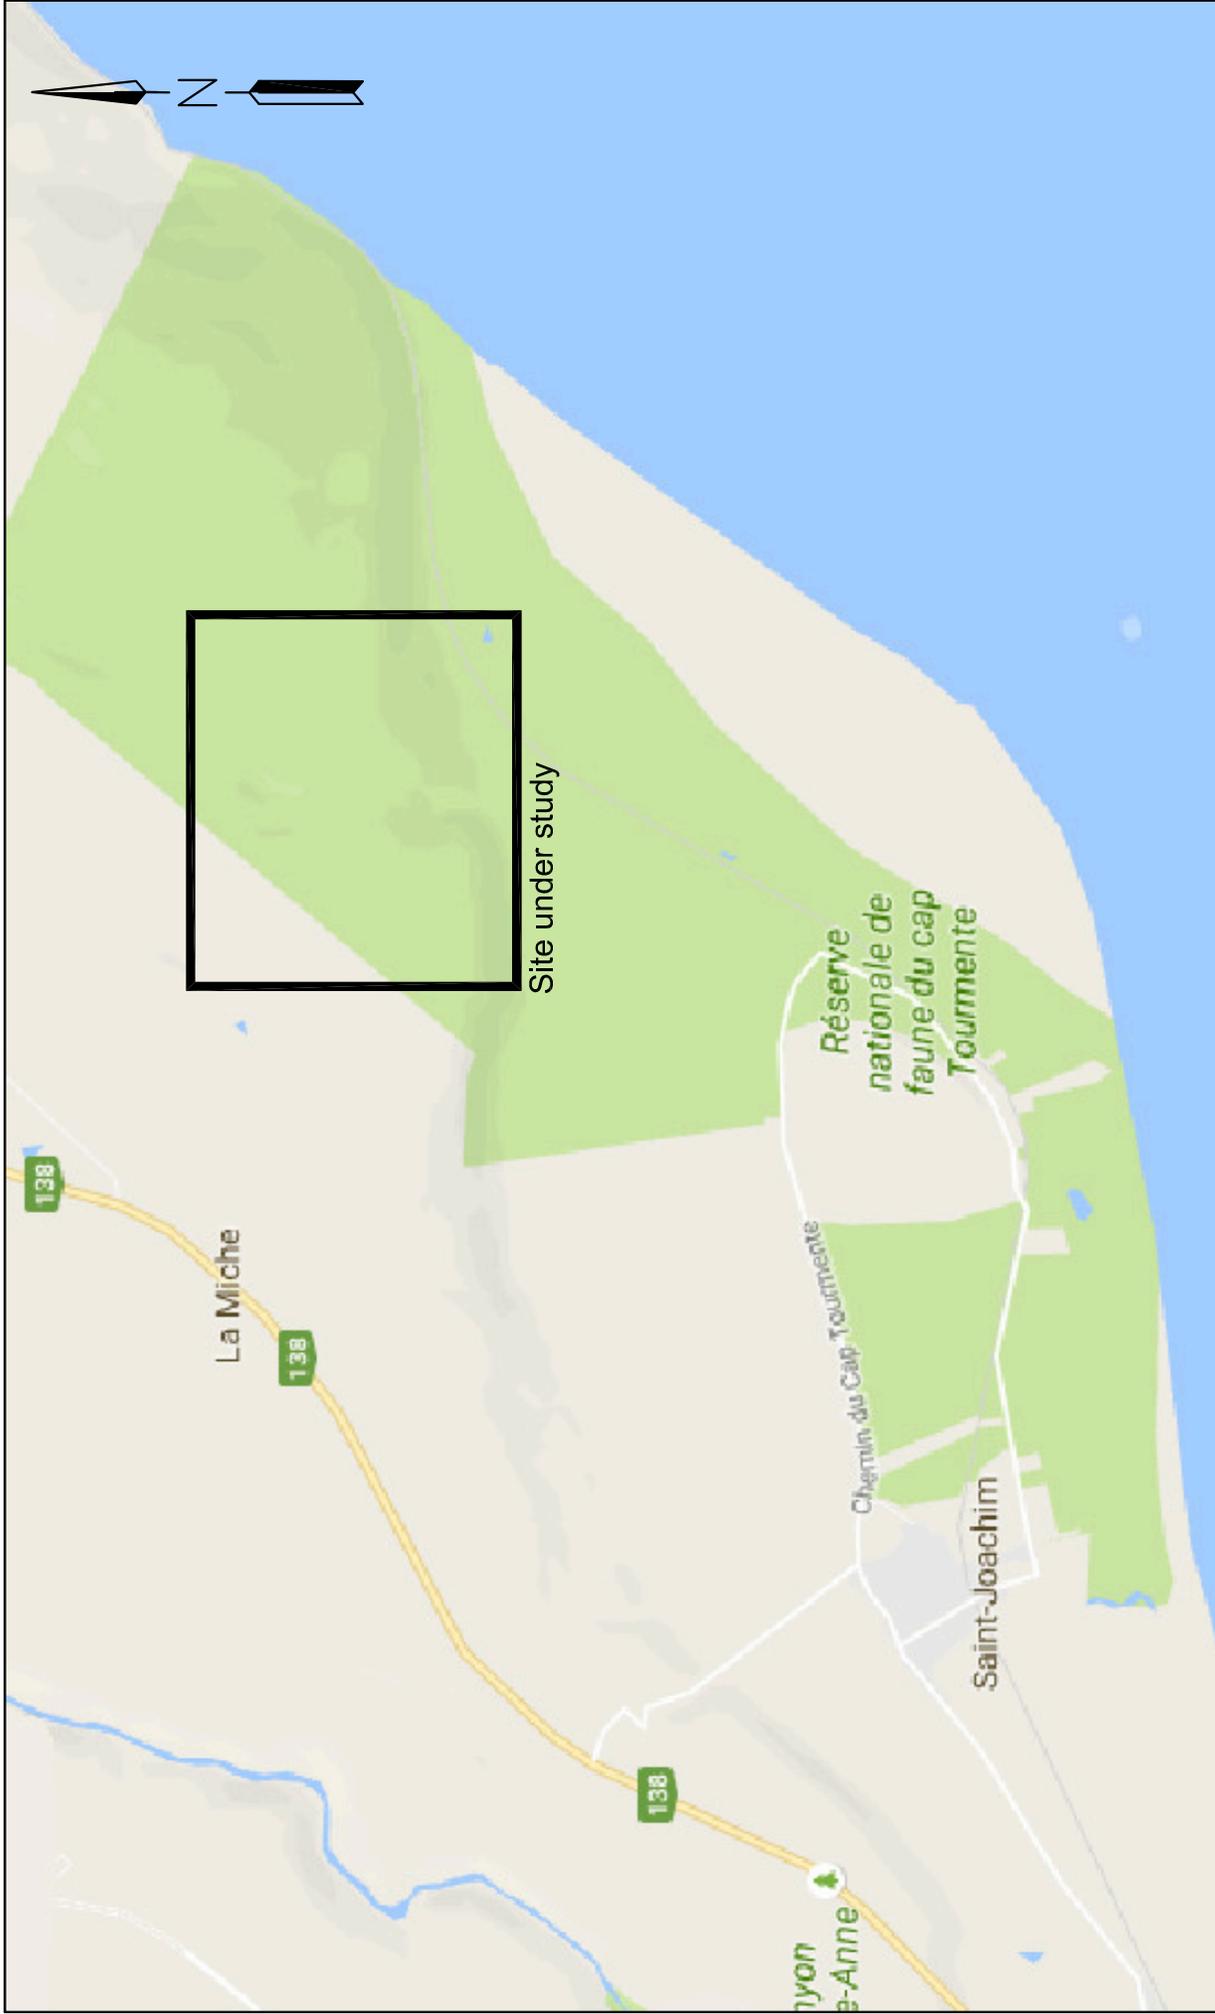
SITE LOCATION
BOREHOLES LOCATION

The location of the boreholes are shown in the figure included in Appendix A.

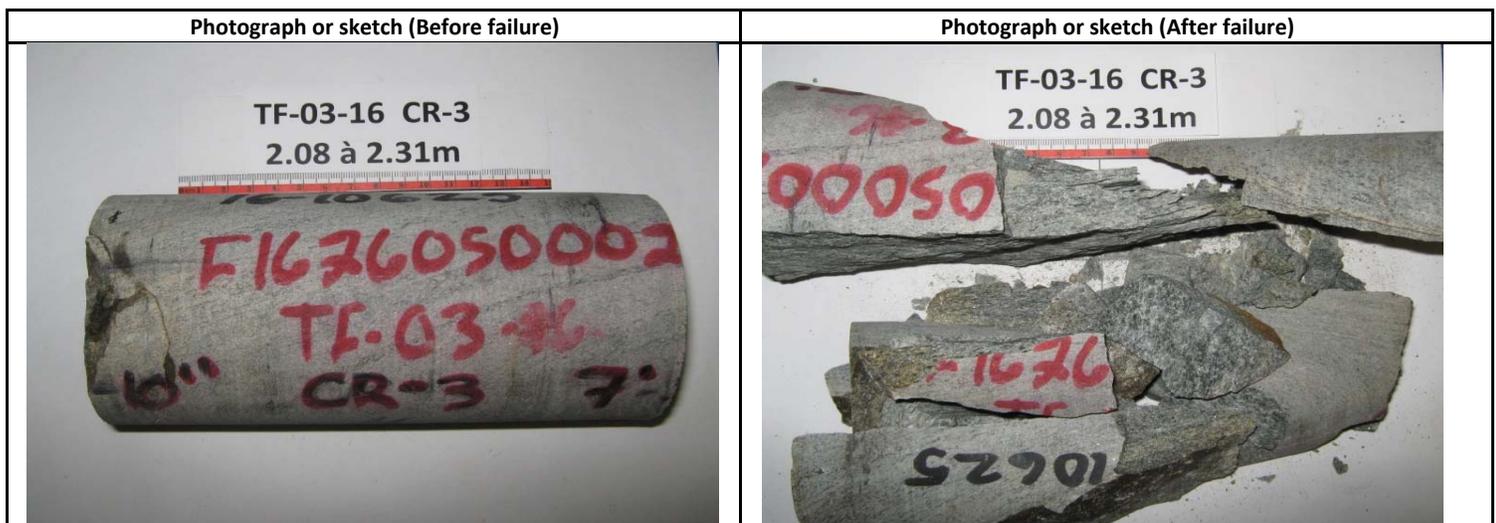
Report No.: 1604607
Laboratory No.: 16-10625
Borehole: BH-03-16
Sample: CR-3
Depth: 2.08 to 2.31m

Result			Remarks
Average diameter	(mm)	84,14	
Height	(mm)	174,1	
Height/Diameter Ratio		2,07	
Load	(kN)	547,70	
Compressive strength	(MPa)	98,5	
Time to failure	(S)	5,17	
Loading rate	(kN/s)	105,9	
Volumic Mass	(kg/m ³)	2656

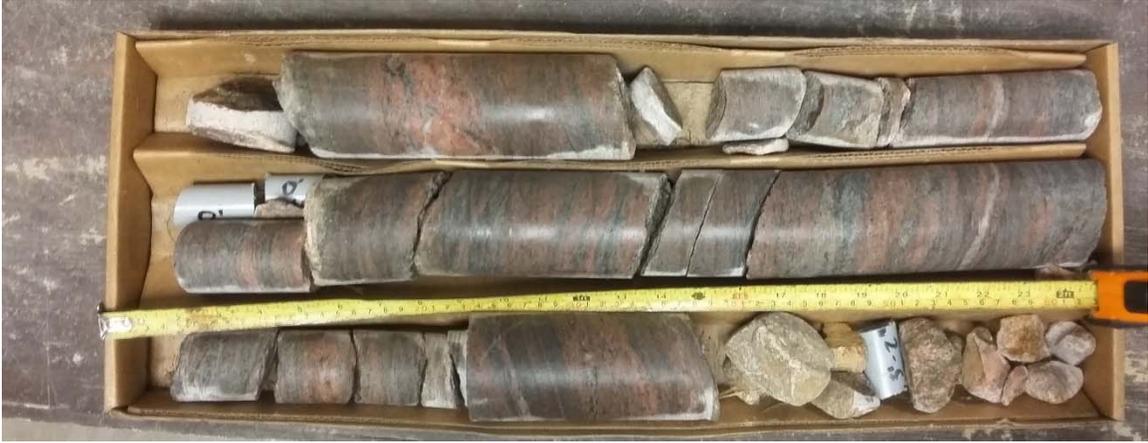
Photo 1 Borehole BH-01-16 (box 1 of 3)

At borehole BH-01-16, the quality of the rock mass is described as very poor with a RQD (Rock Quality Designation) of less than 25 % up to a depth of 7,2 m. On the basis of recovered cores, rock quality tends to increase from a depth of ± 7,0 m. We can not, however, confirm its true quality. For BH-02-16 and BH-03-16, the quality is fair to excellent with RQDs generally varying between 56 % and 100 %. However, a horizon with a 0 % RQD was encountered between 1,9 m and 2,1 m at the borehole BH-02-16. It should be noted that, when evaluating the RQD parameter, the cleavage or (unaltered) discontinuities are not considered.
