LEVELTON CONSULTANTS LTD.

August 10, 2015

Project: Drainage Improvements – Parks Canada Maintenance Compound, Rogers Pass, BC

Subject: Pavement Assessment Report

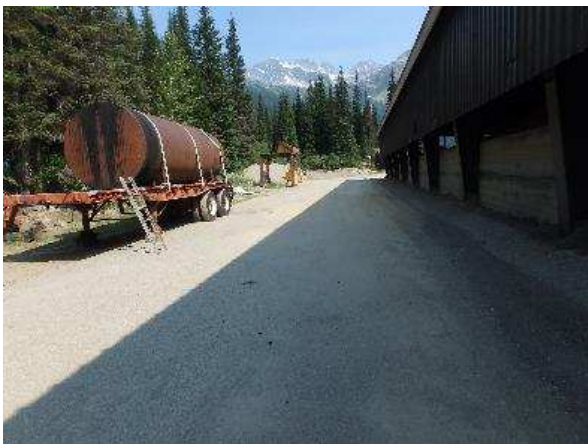
Photo 1 – West of Abrasives Storage Shed

Surface finishes are in place on the east, north and west of the Abrasives Storage Shed. The west and north of the shed building is surfaced with an asphaltic material, while the east side of the shed is a graded gravel area. The asphaltic areas are in highly variable condition, with apparent delamination of this surface lifts in some areas, potholes, and ruts. The asphalt limits are clearly defined at the south end of the west side of the storage shed, and gradually get less defined to the north, with thickening amounts overlying gravels.

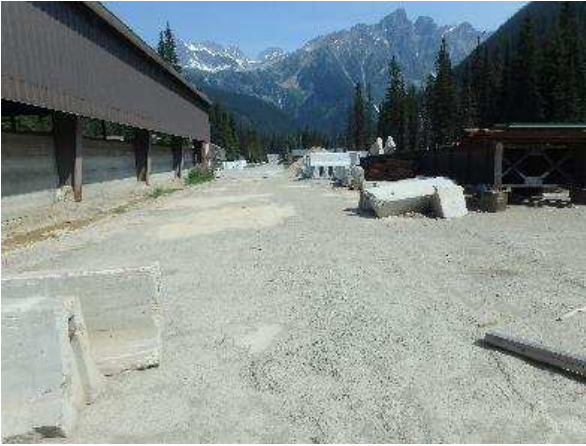
Photo 3 – East of Abrasives Storage Shed

At some point to the north and east of the storage shed, the asphaltic surface terminates and the road structure becomes a gravel surfaced equipment laydown and travel area. The gravel surfacing is rutted with potholes and evidence of ponding water.

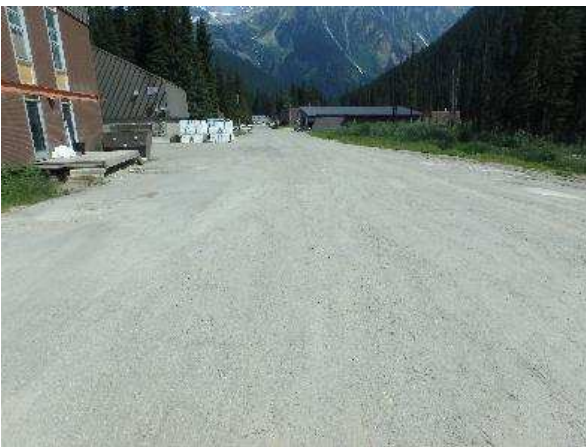
Photo 5 – At Dormitory Rec Building

The main lane travels across the compound from south to north connecting the Abrasives Storage Shed at the south end to the office and garage area near the center of the compound and the dormitory area near the north end of the compound. These areas featured asphalt surface finishes that appear to be conventionally placed hot-mix asphalt. The general condition of the asphalt appears to be fair, with signs of heavy surface wear including exposure of coarse aggregate and physical damage. Some cracking and potholes were observed in localized areas along the lane, as well as utility trench patches.

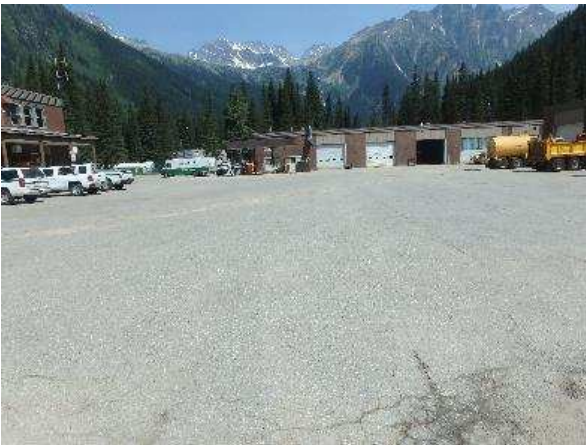
Photo 9 – Compound Courtyard

It appears that hot-mix paving has been conducted in the past through the courtyards area and to the west of the office building. These paved areas are generally in poor condition with extensive cracking, potholes, delamination of surface lifts, and un-patched utility trenches. A number of localized sections in this area, including the gas station and apron features surrounding the Vehicle Storage Buildings, feature concrete surface finishes.

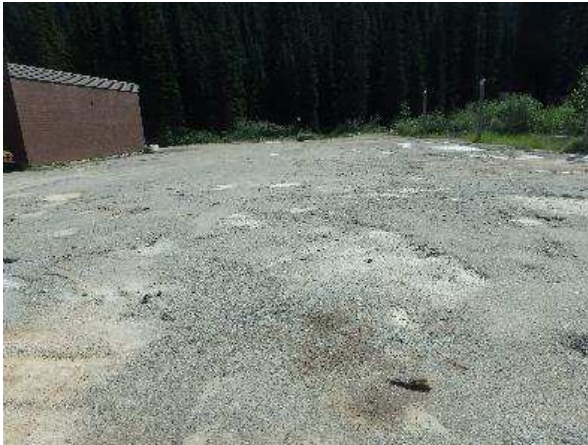
Photo 11 – Southeast of Vehicle Storage Buildings

The compound area to the east of the Vehicle Storage Buildings is a combination of gravel surfacing and asphaltic finishes. Both these surfaces are in very poor condition with extensive potholes, ponding water, and irregular surface grades. The apparent gravel area to the southeast of the Vehicle Storage Buildings had an asphaltic layer just below the gravel surface that was encountered during our test pit investigation.

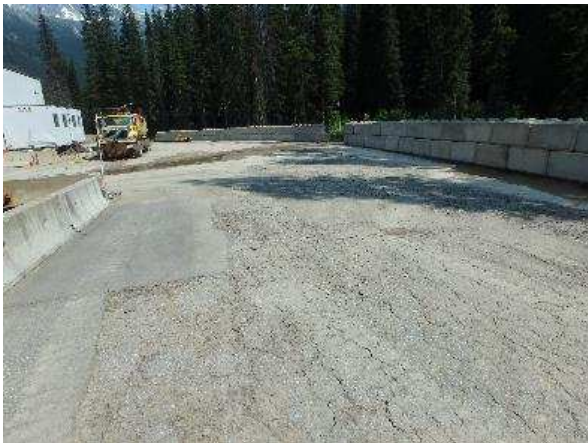
Photo 13 – East of Garage/Office

The compound to the north and east of the garage/office building features asphaltic surface finishes in poor condition. The areas are exhibiting the typical potholing, surface delaminations and evidence of ponding water observed in other areas. Levelton observed percolation of water up through the asphaltic surface at the south end of this area. We understand a known utility leak is causing the percolation. The asphalt surface in this area is heavily damaged, with extensive alligator cracking and potholing as well as ponding surface water.

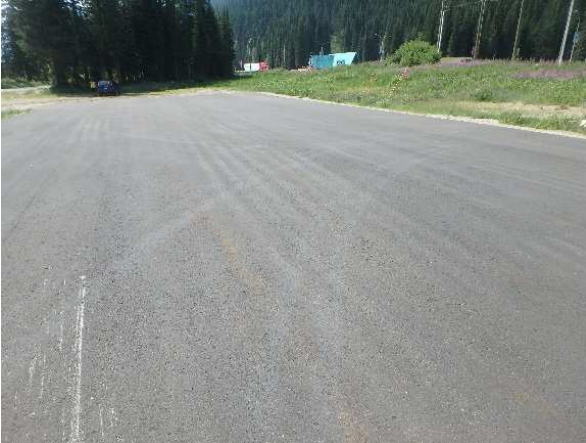
Photo 15 – Helipad / Snow Storage Area

The entrance driveway and Helipad/Snow Storage area have recently been reconstructed and paved with conventional hot-mix asphalt. The paved finishes in these areas are in good condition.
