Geotechnical Investigation Report

Date: December 14, 2016

Reference: Cape Race Access Road

Reference: Geotechnical Investigation, Cape Race Access Road Upgrade, Cape Race, NL

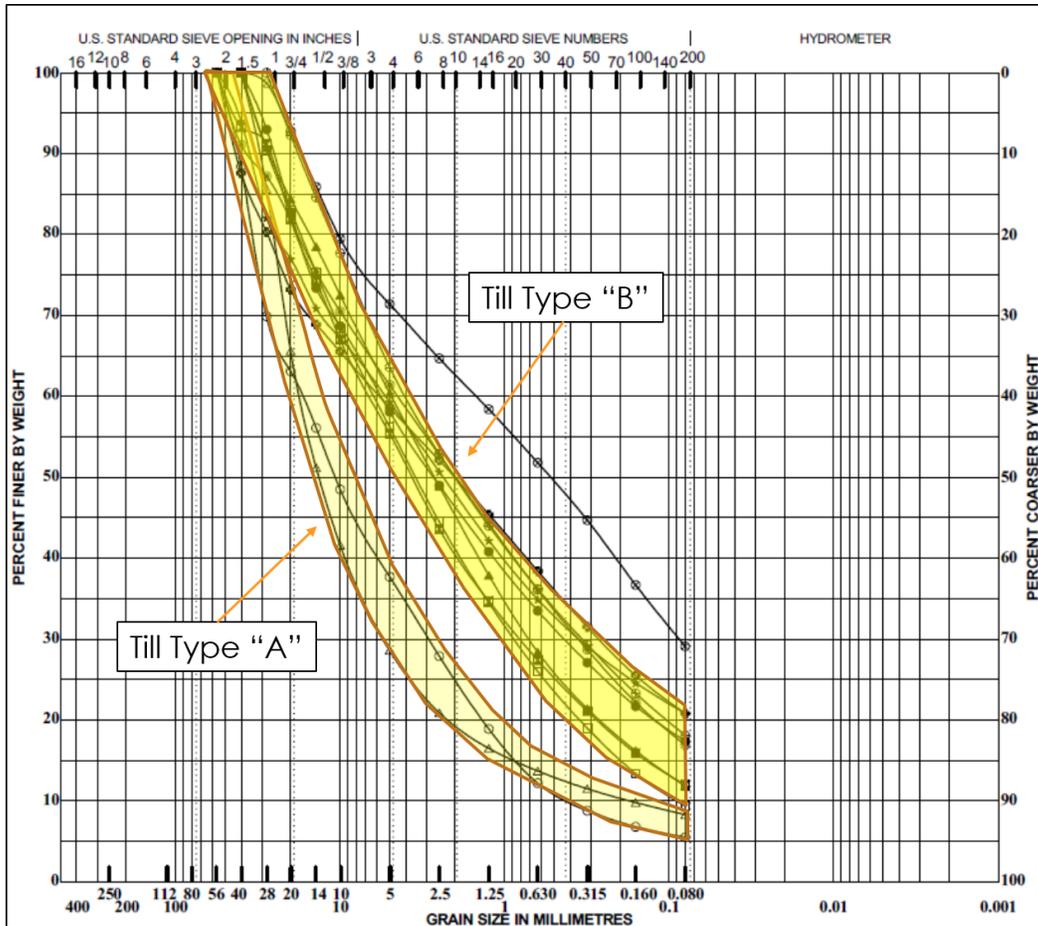
- Figure 1 below shows the gradation analysis for both types of till. In terms of relative density, the till is classified as compact to dense.

Figure 1 - Gradation Curves for till type 'A' and 'B'

- Native glacial till was encountered at all test pit locations except TP-24. In most test pit locations, the upper zones of the till were noted to be weathered. The till layer was encountered at depths ranging from 0.1 to 2.0 m below the ground surface. The glacial till ranged in thickness from 0.2 to 1.9 m. In general, two types of till were observed along the site.
