SOW - MCTS BUILDING DEMOLITION AND SITE REMEDIATION

CCG GROS CAP MCTS

SAULT STE. MARIE, ON

MARITIME AND CIVIL INFRASTRUCTURE

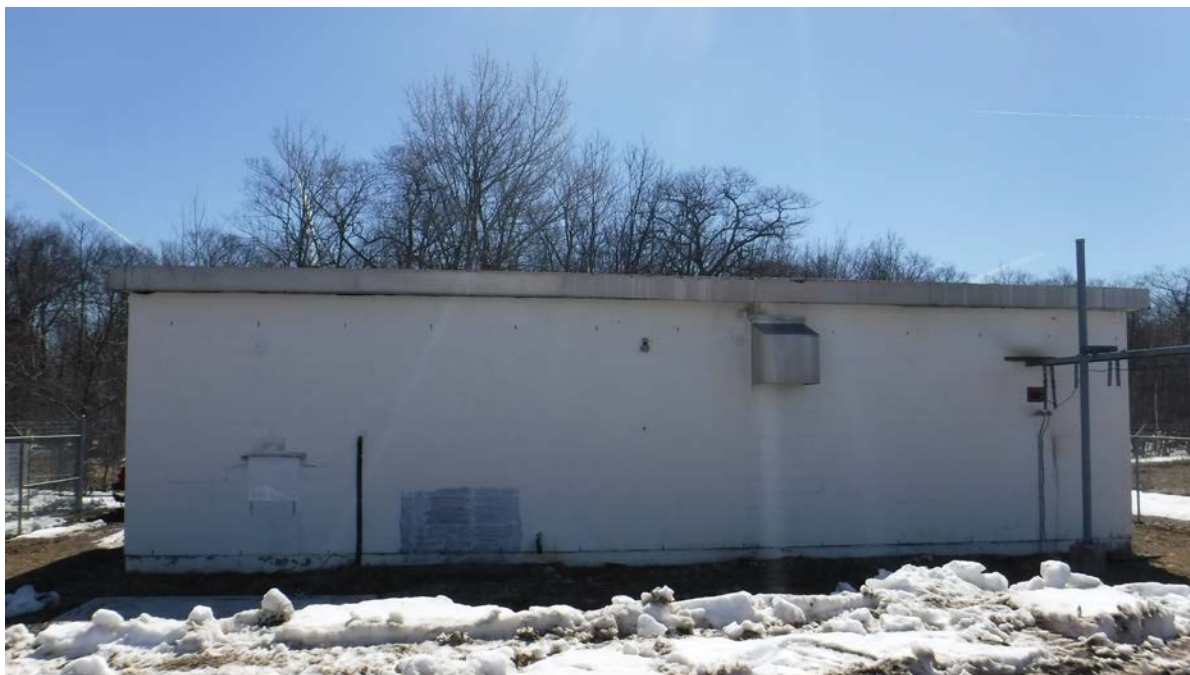
Figure 2: Old radio equipment building [West] (to be demolished)

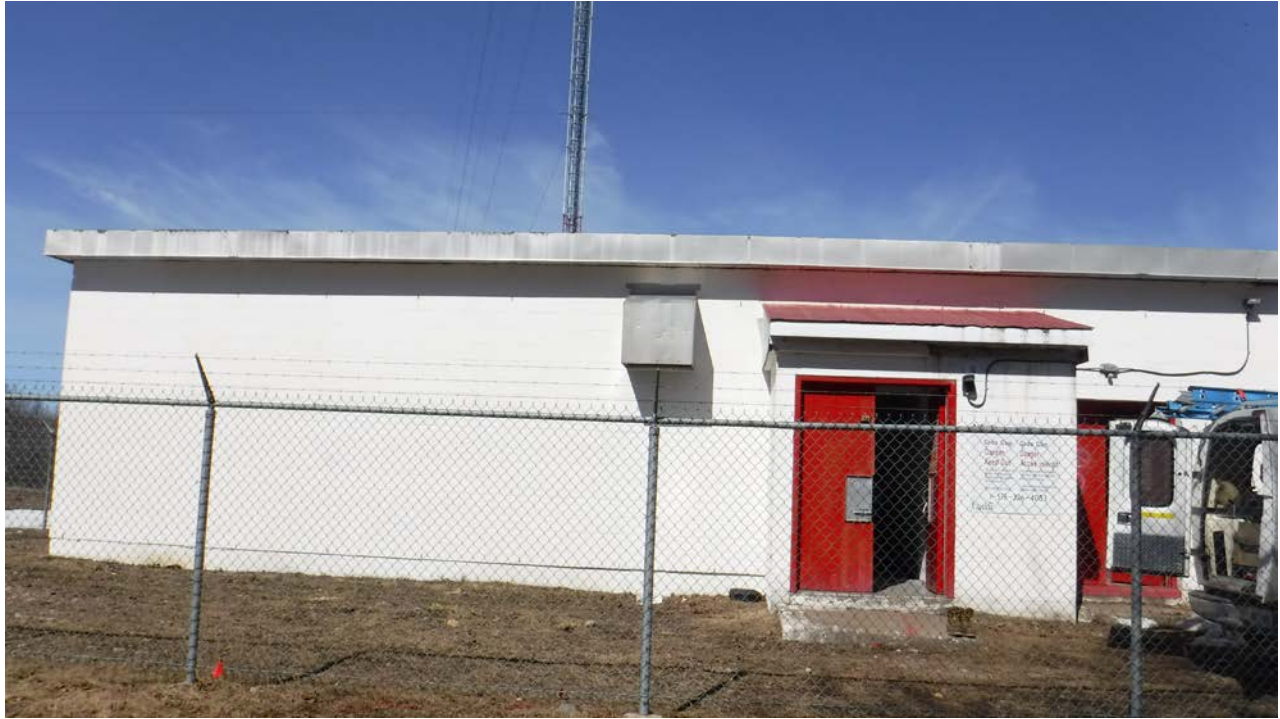
Figure 3: Old radio equipment building facing [East] and entrance porch (to be demolished)

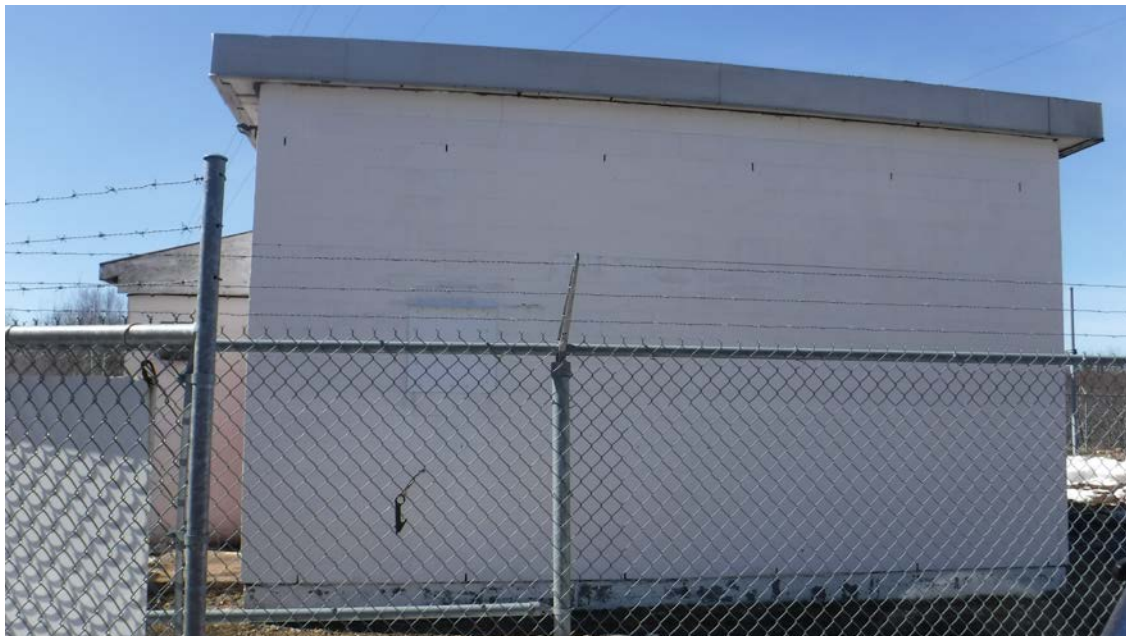
Figure 4: Old radio equipment building facing [North] (to be demolished)

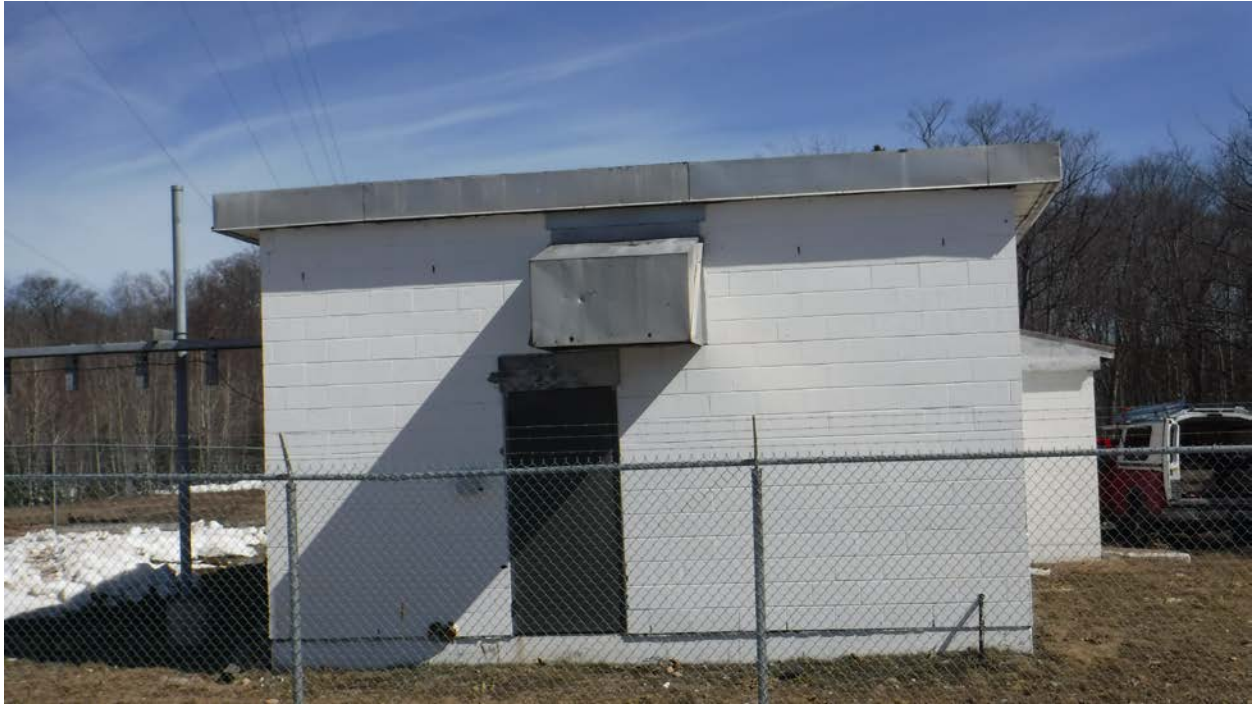
Figure 5: Old equipment building [South] (to be demolished)

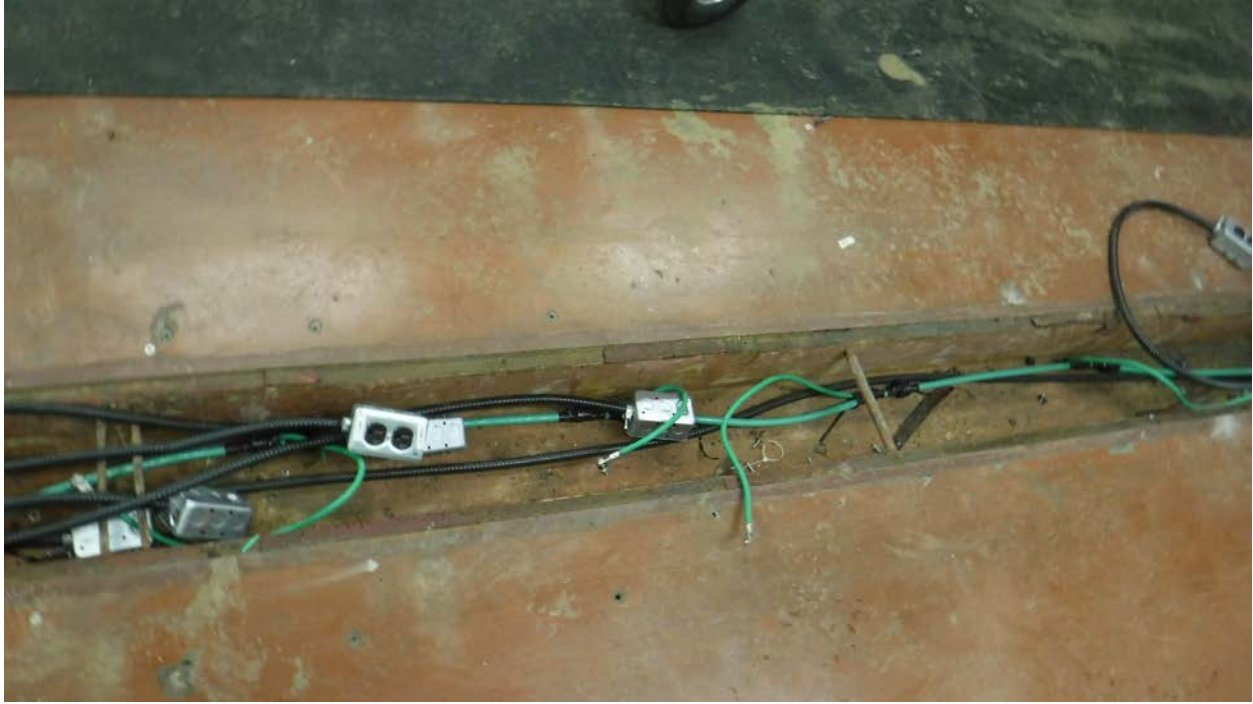
Figure 7: Typical cable troughs (to be demolished)

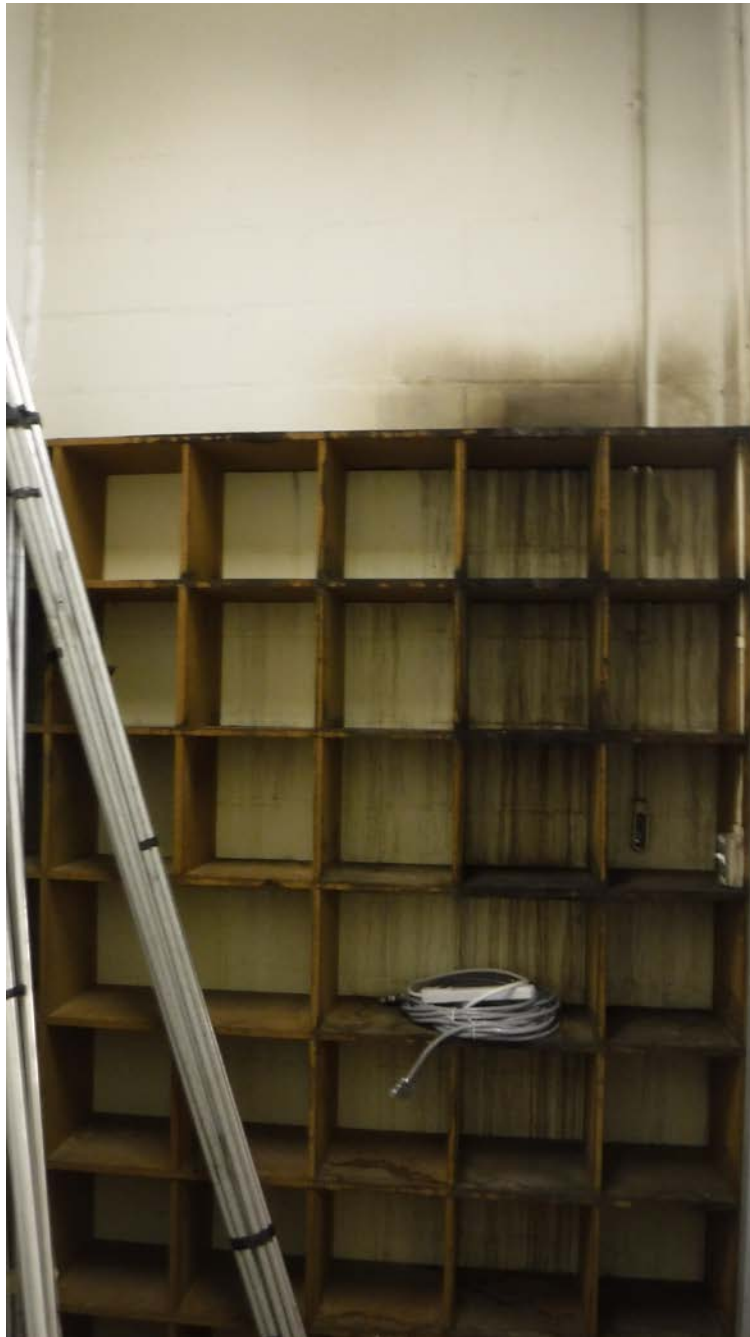
Figure 9: Mould on shelves (to be demolished). See Hazardous Materials Survey in Appendix B4 for removal procedure.

Mould: The OSB shelving in location 3 is water damaged and has mould growth present.

Visible mould growth and water staining was observed on the OSB shelving in Location 3.

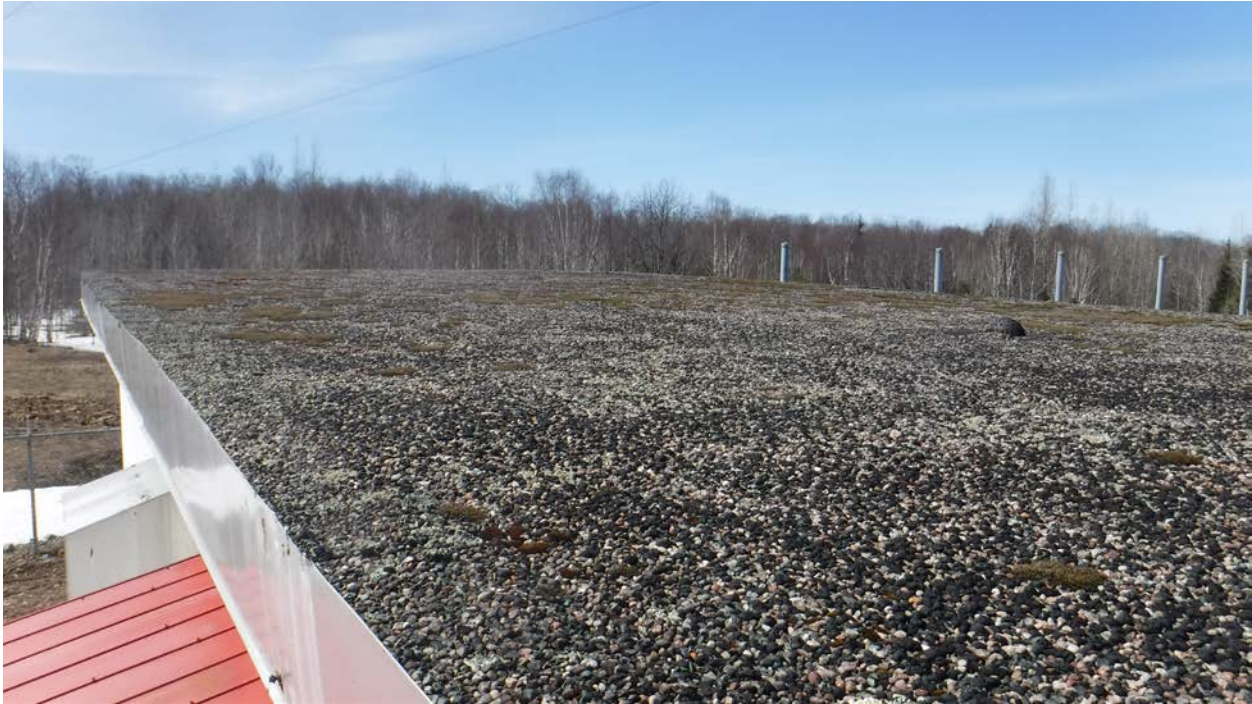
Figure 10: Gravel on Built-up roof (to be demolished)

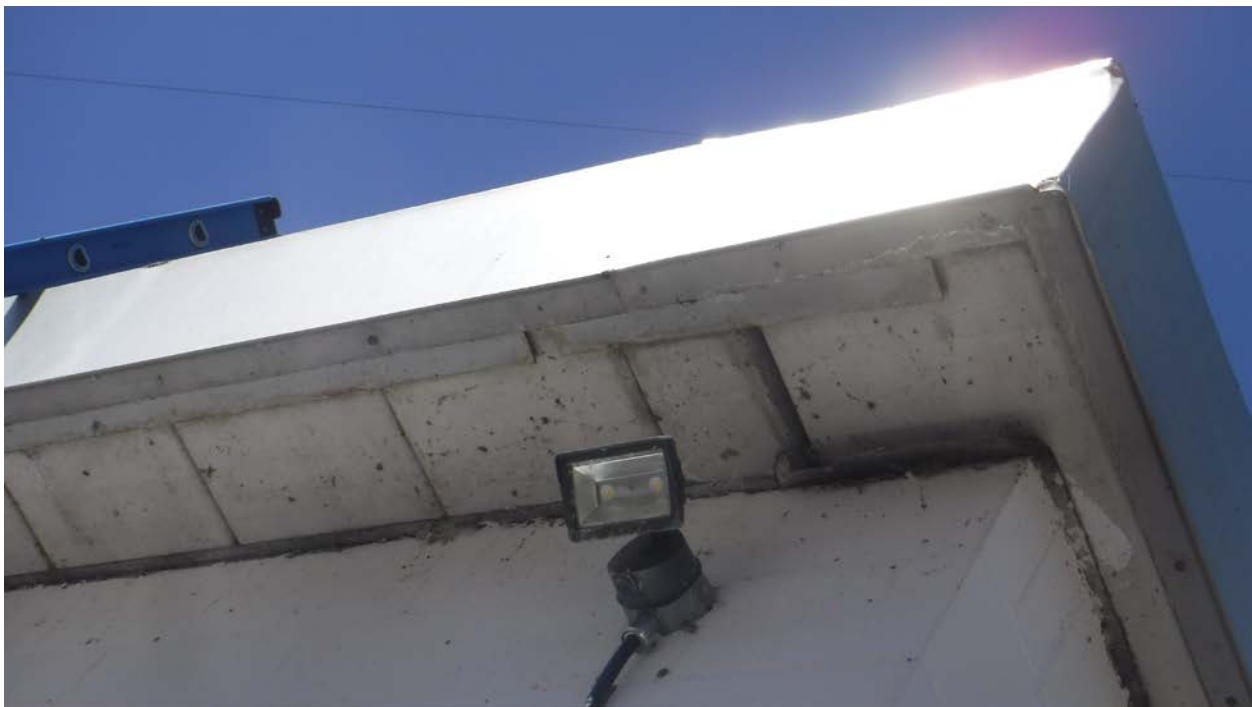
Figure 11: Precast concrete panels on the roof of the building (to be demolished)

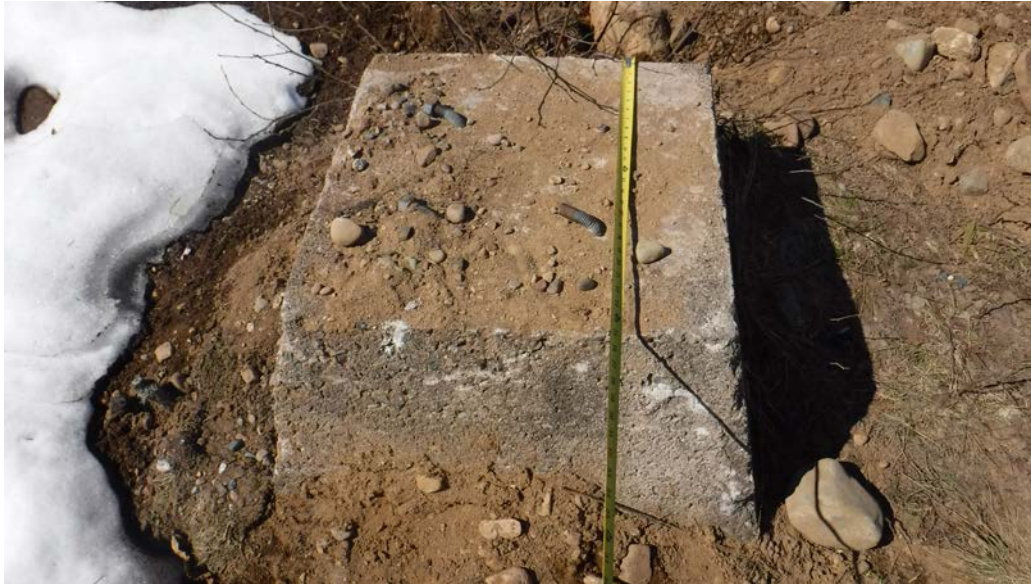
Figure 12: Abandoned concrete anchor (to be demolished)

- .1 Abandoned anchor foundation: remove and dispose one [1] 0.6 m x 0.6 m x 0.6 m [2' x 2' x 2'] abandoned anchor foundation as shown in Appendix B1
 - .2 Abandoned diesel generator foundation: remove and dispose one [1] reinforced concrete foundation, approximately 3 m x 1.5 m x 0.3 m [10' x 5' x 1']

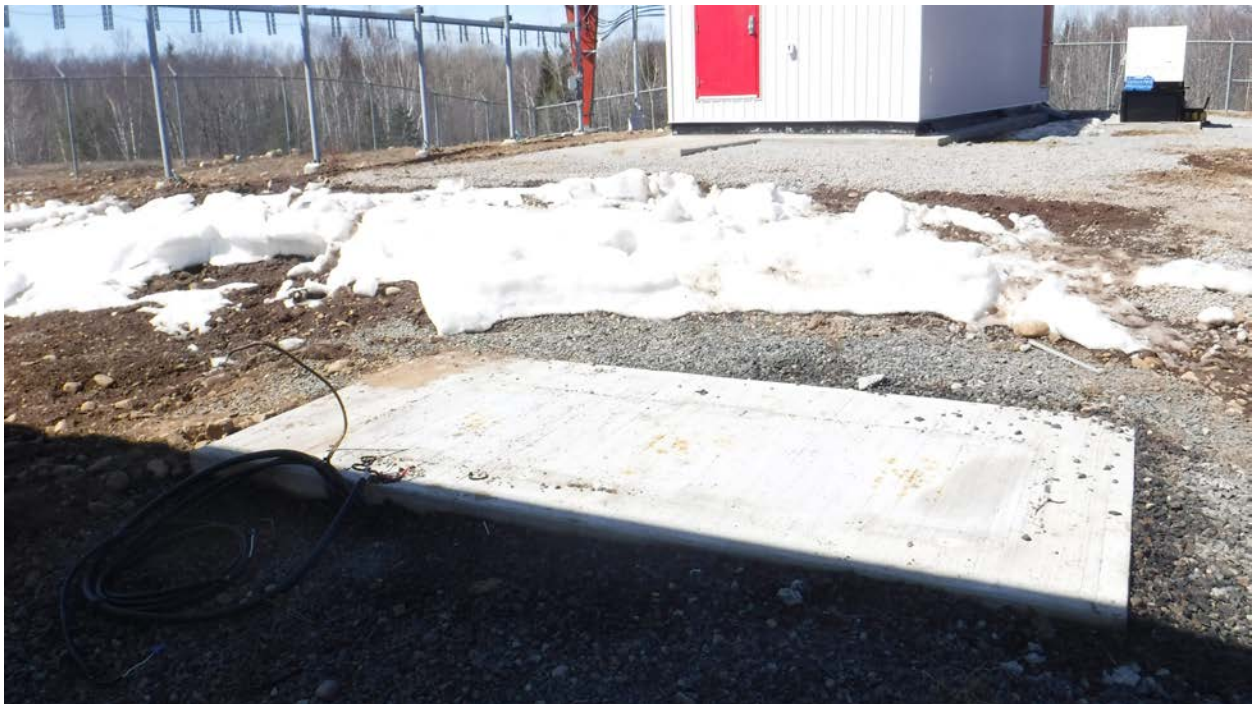
Figure 13: Abandoned diesel generator foundation slab (to be demolished) [bottom of picture].

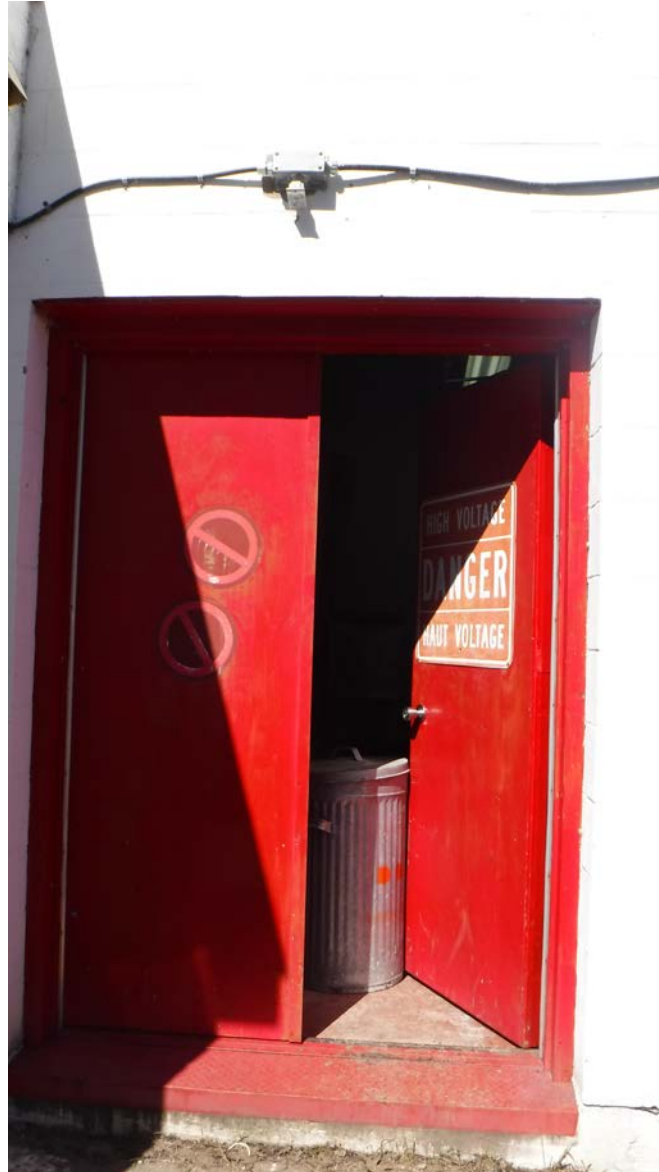
Figure 14: One of the three lead paint containing exterior doors of the building (to be demolished).

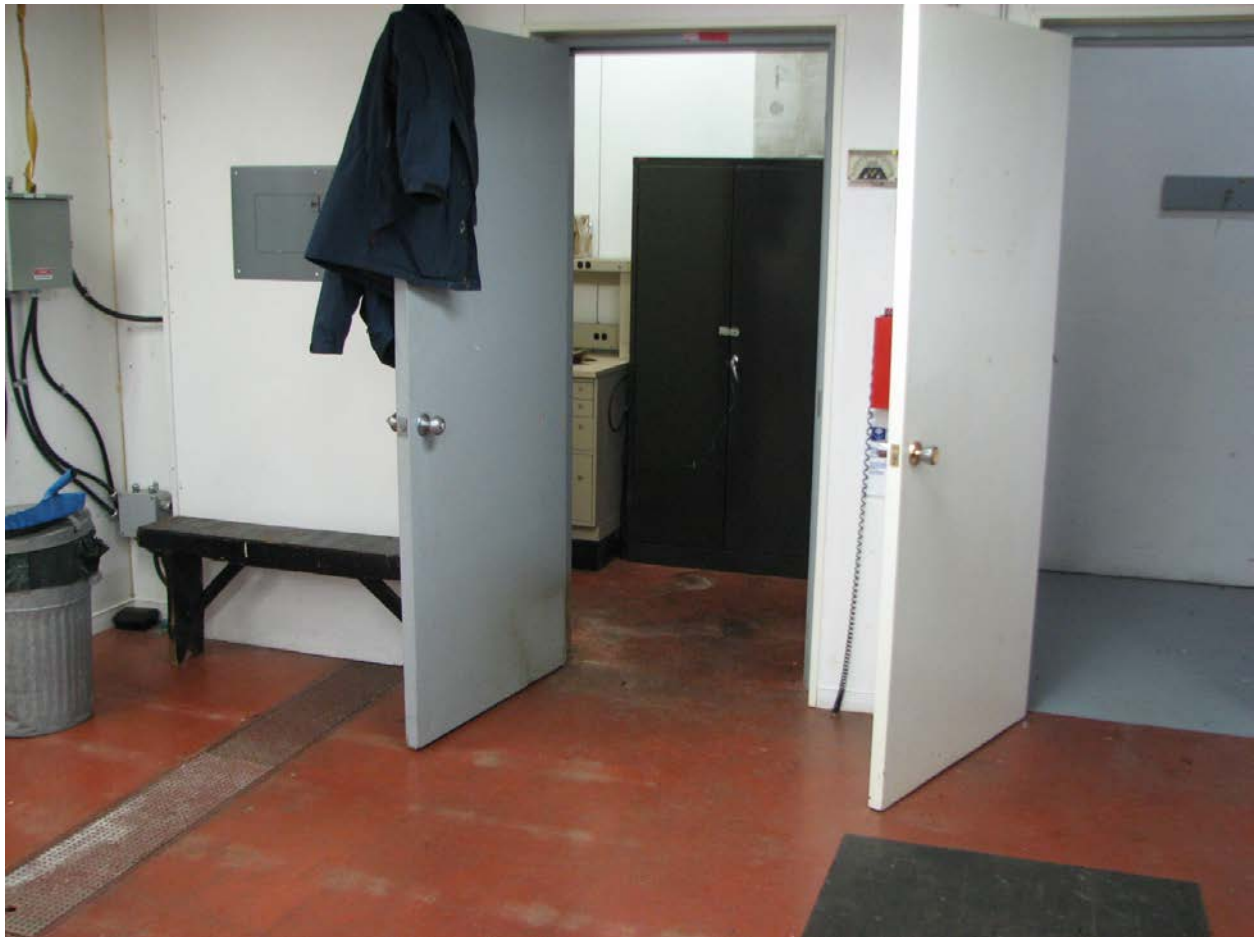
Figure 15: grey door contains lead paint.

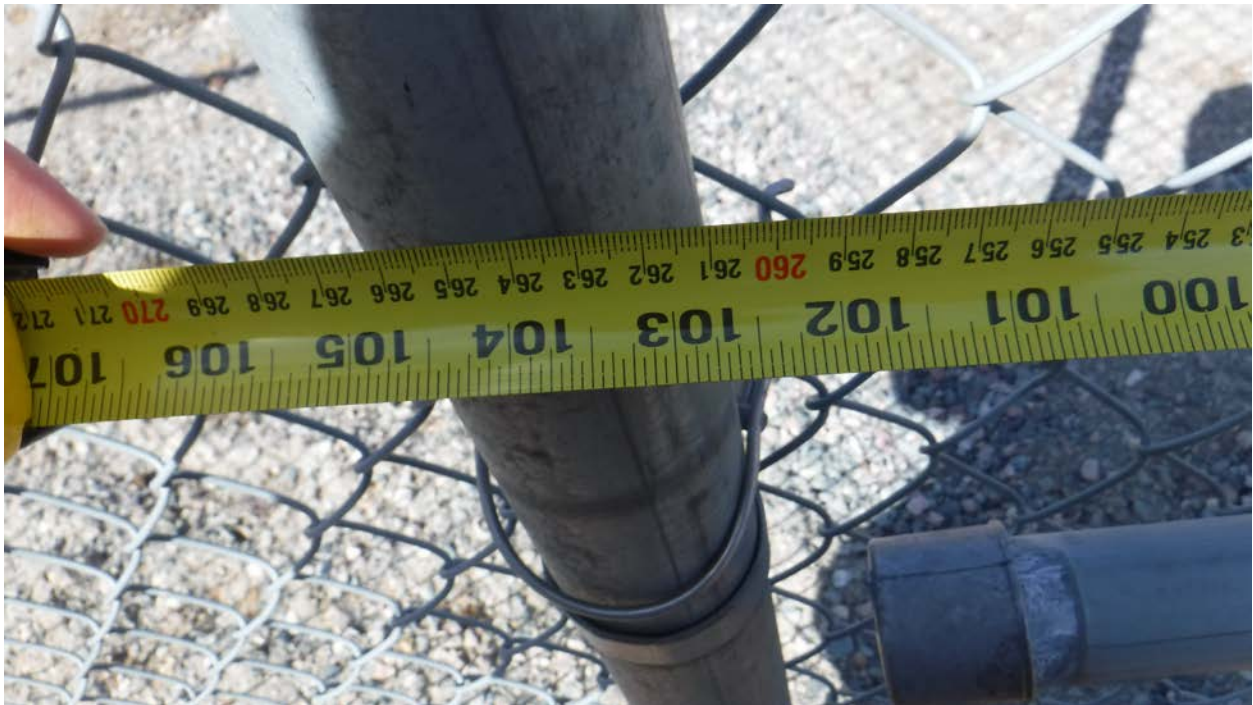
Figure 16: Broken brace. To be repaired.

- .1 Work of this section includes the supply of all labour, material and equipment required to complete:
 - .1 Modification of the existing chain-link fence with barbed wire, including;
 - .1 Addition of approximately 23 m [75' 6"] of fencing; and,
 - .2 Relocation of existing one [1] 4.5 m [15' 9"] single swing gate opening.
 - .2 Repairing of one [1] broken brace on the existing fence

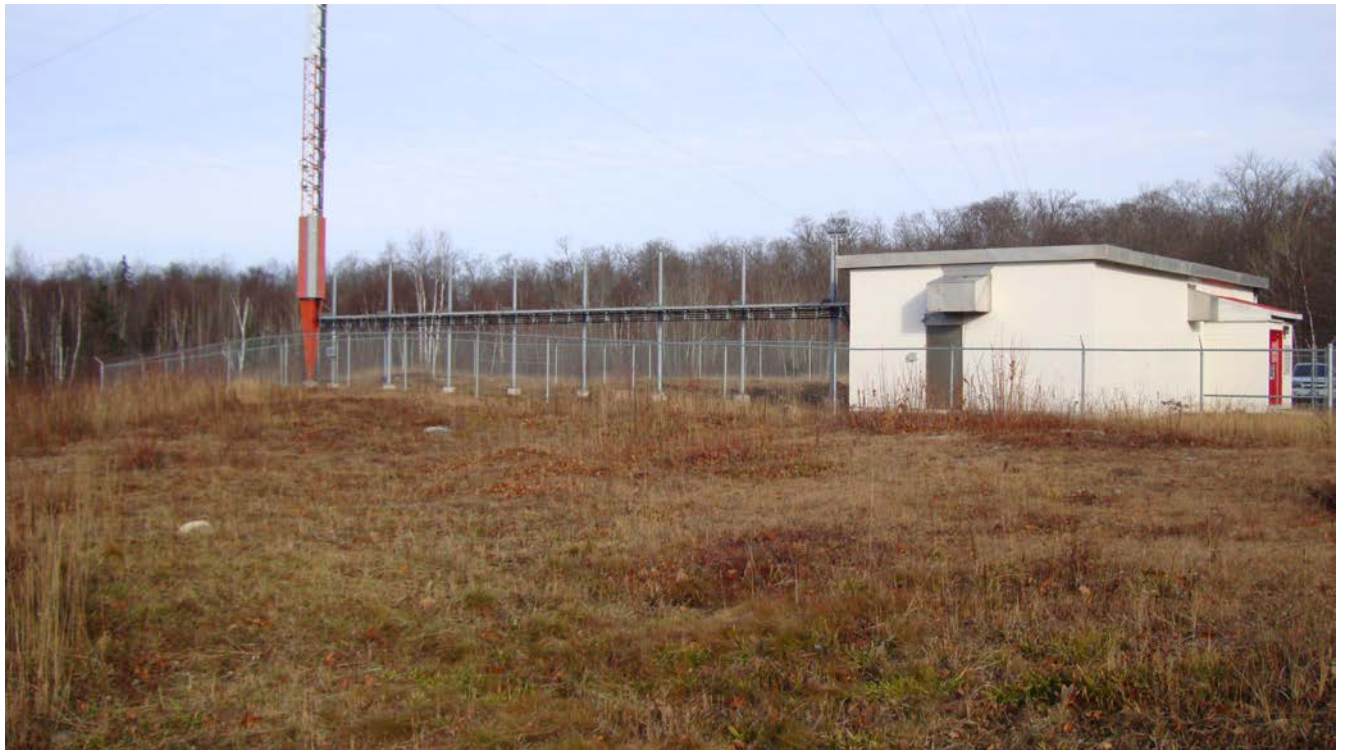
Figure 17: Waveguide Bridge to be demolished. There are 7 posts, the post adjacent to the tower is not to be demolished. New building is not shown in this picture.

- .3 Waveguide's bridge Sonotubes: remove and dispose Seven [7] waveguide bridge Sonotube foundations, 0.406 m [16"] diameter. Drawings are included in Appendix B3.

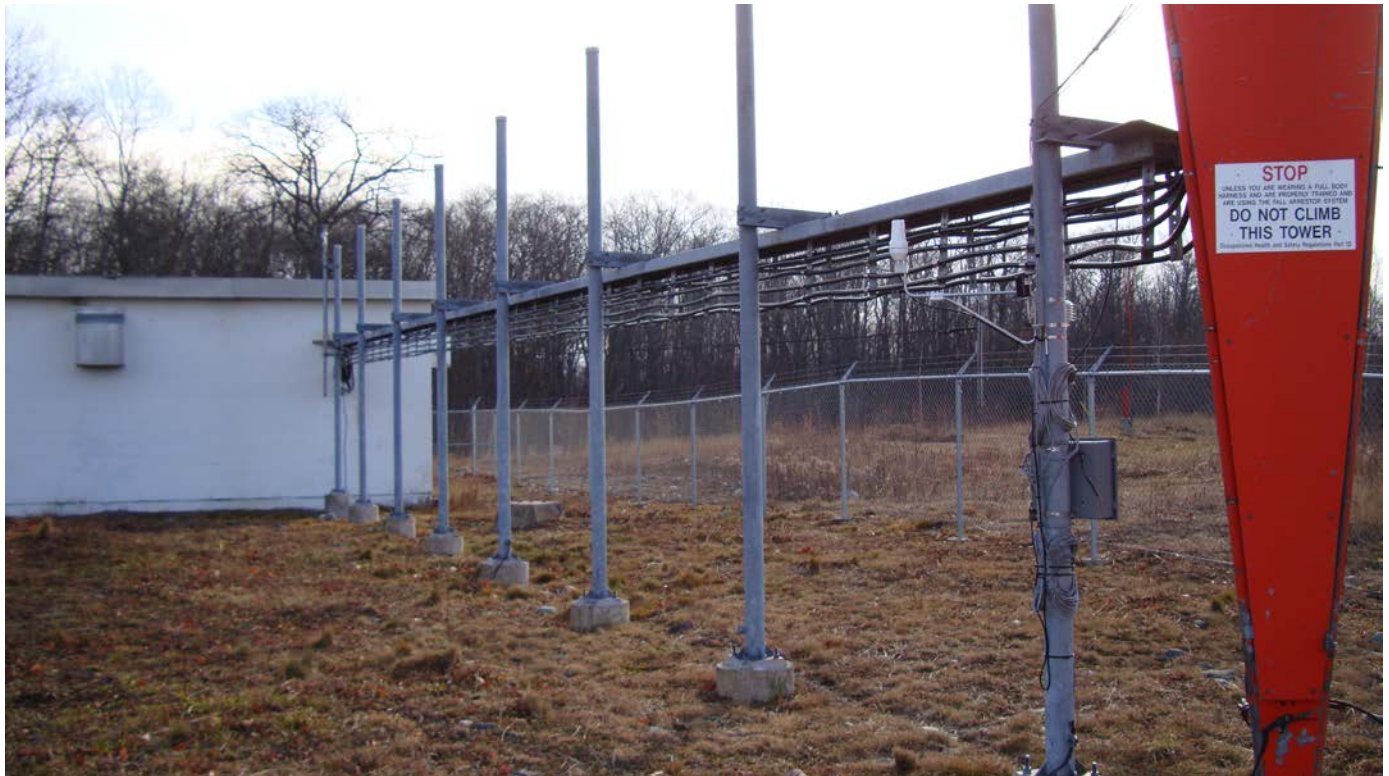
Figure 18: Waveguide bridge to be demolished. The post adjacent to the tower containing equipment is not to be demolished.

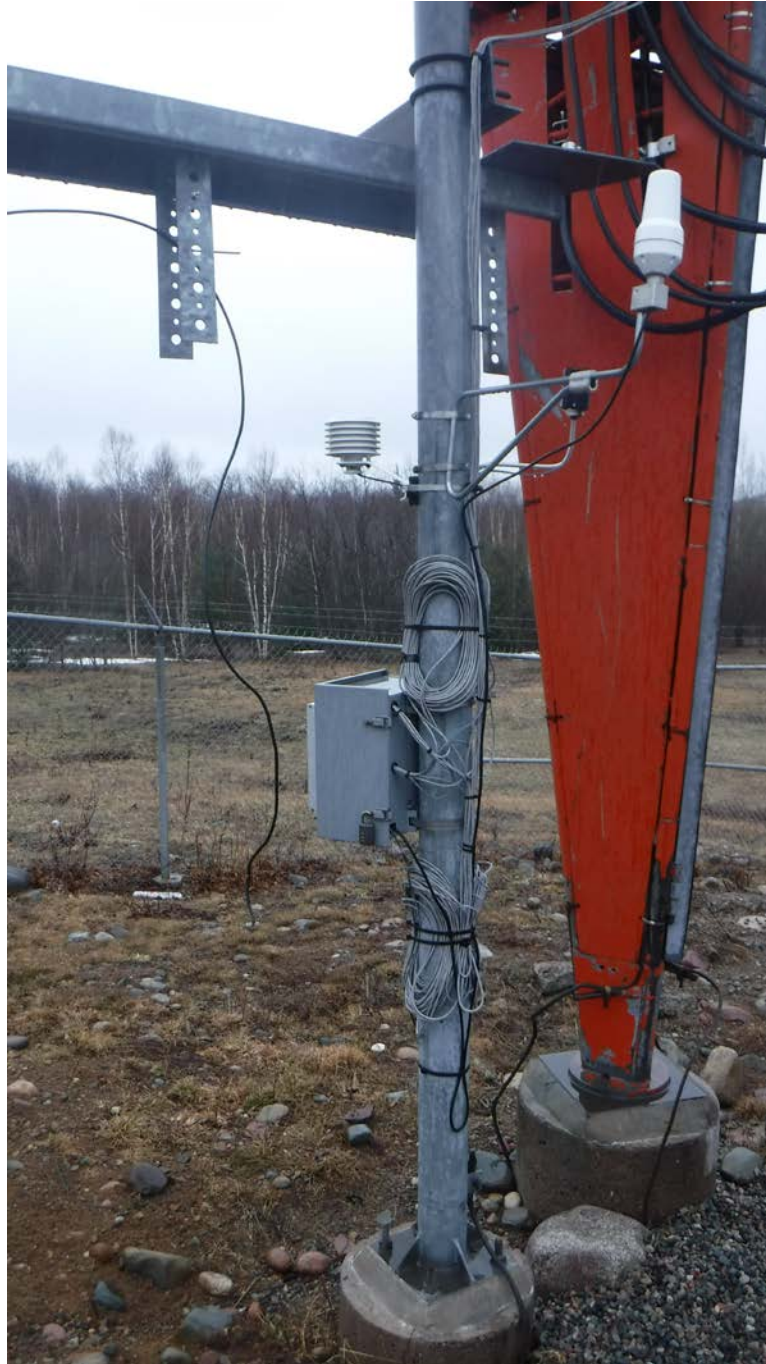
Figure 19: Waveguide bridge post adjacent to the tower with mounted equipment (not to be demolished).

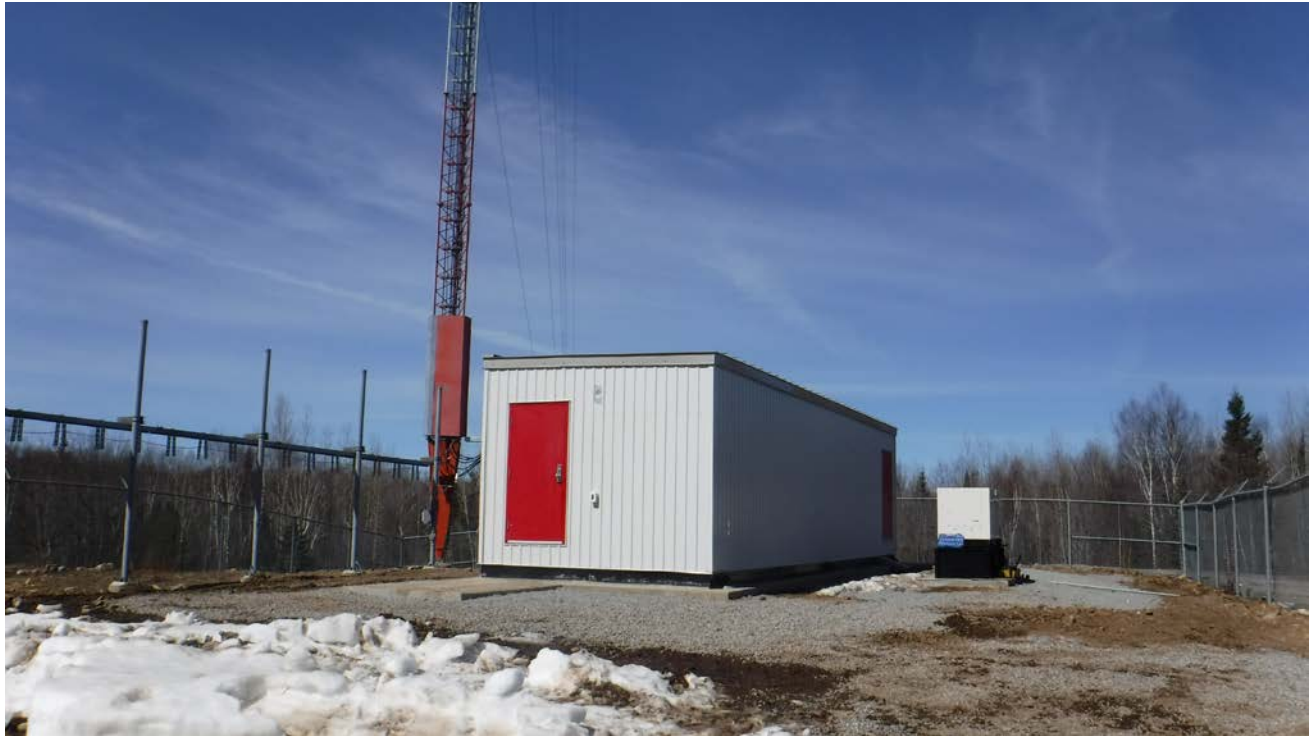
Figure 20: New equipment building (not to be demolished). Stair systems to be installed in front of red doors. Waveguide bridge to the left of the building is to be demolished.

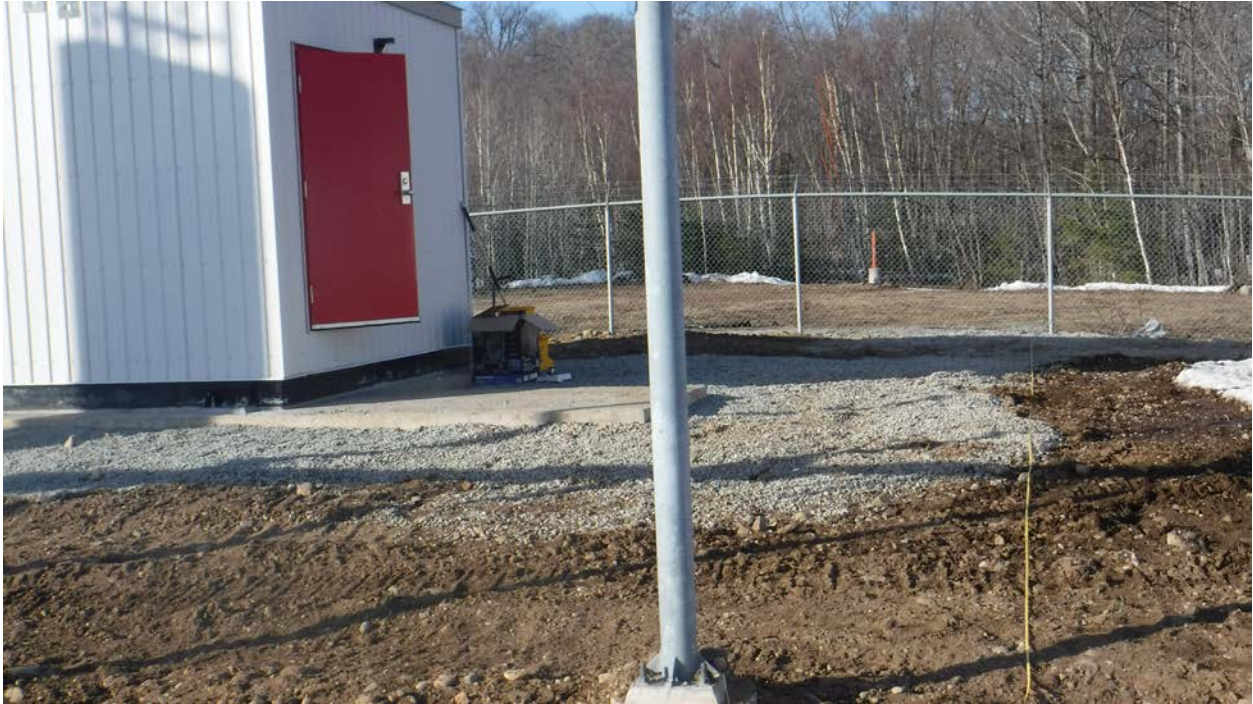
Figure 21: One of two doors of new building. Notice concrete pad extending in front of door.

- .5 The stair systems shall bear on the existing reinforced concrete pads 1.83 m wide x 2.44 m [6' x 8'] long. Refer to existing new foundation drawing in Appendix B3.

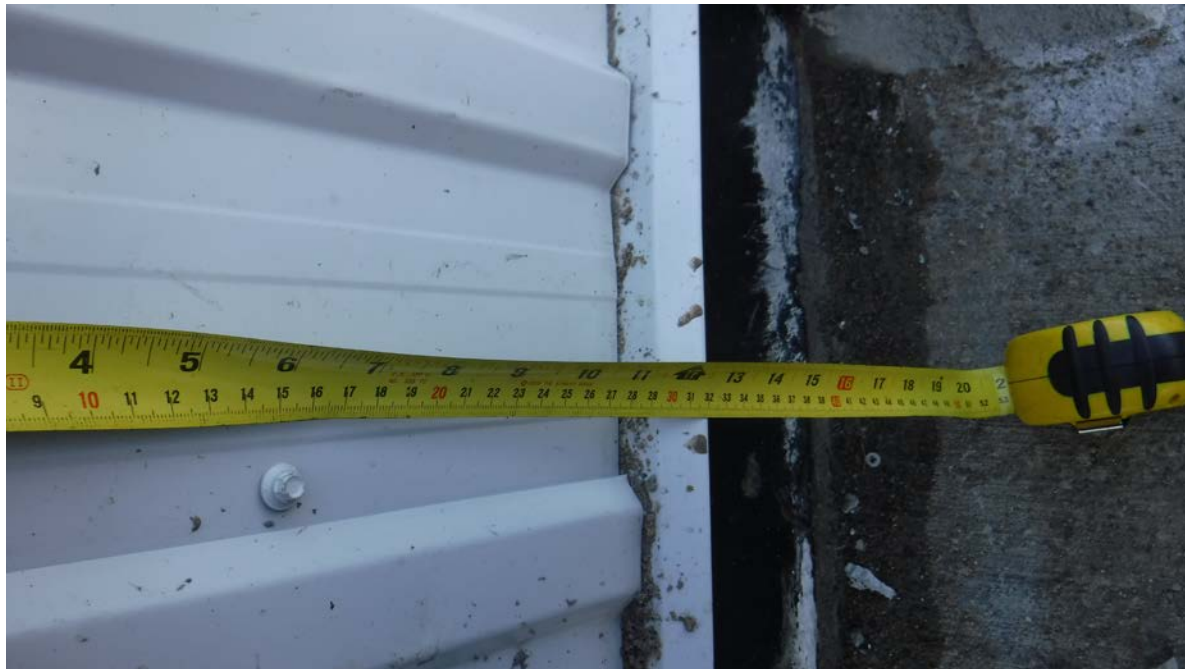
Figure 22: Approximate measurement from concrete pad to floor level in door opening. To be confirmed by contractor.

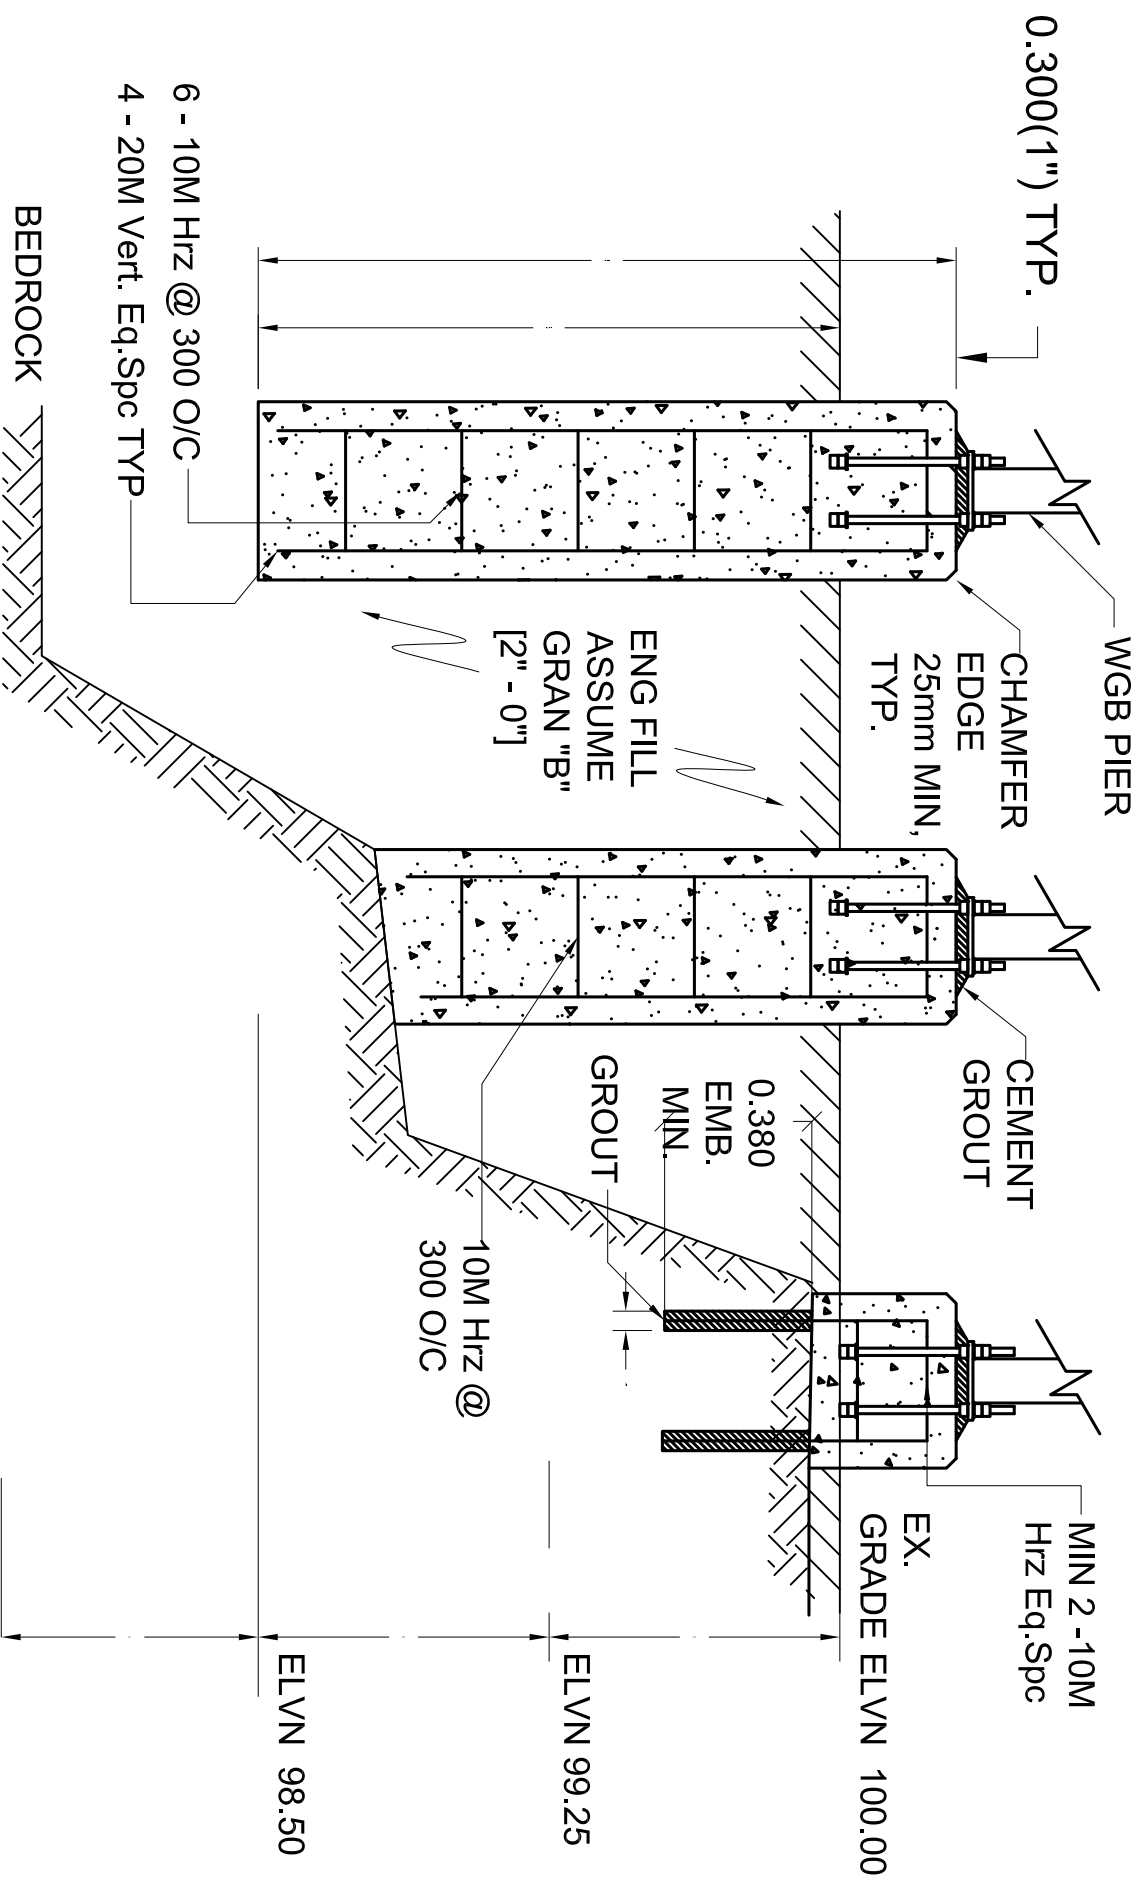
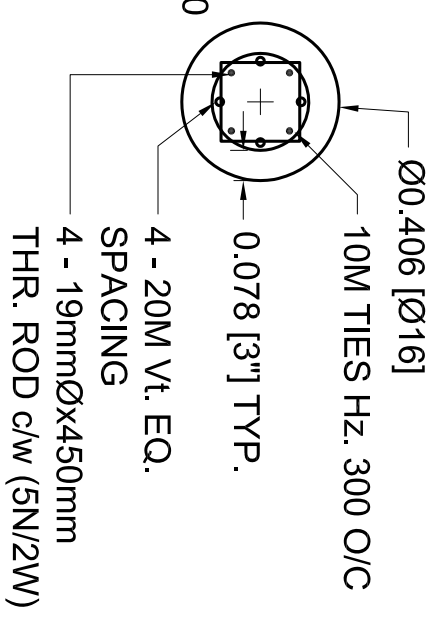
CAPE CROKER TRAILER WAVE GUIDE POST FOUNDATIONS TYPICAL DETAILS TYPES

Piers shall be cast to a depth of 1.5m below ex. grade (Type A). Where bedrock is encountered at an elevation of less than 1.5m the configuration of the pier shall be amended to Type B or C depending upon the depth to bedrock.

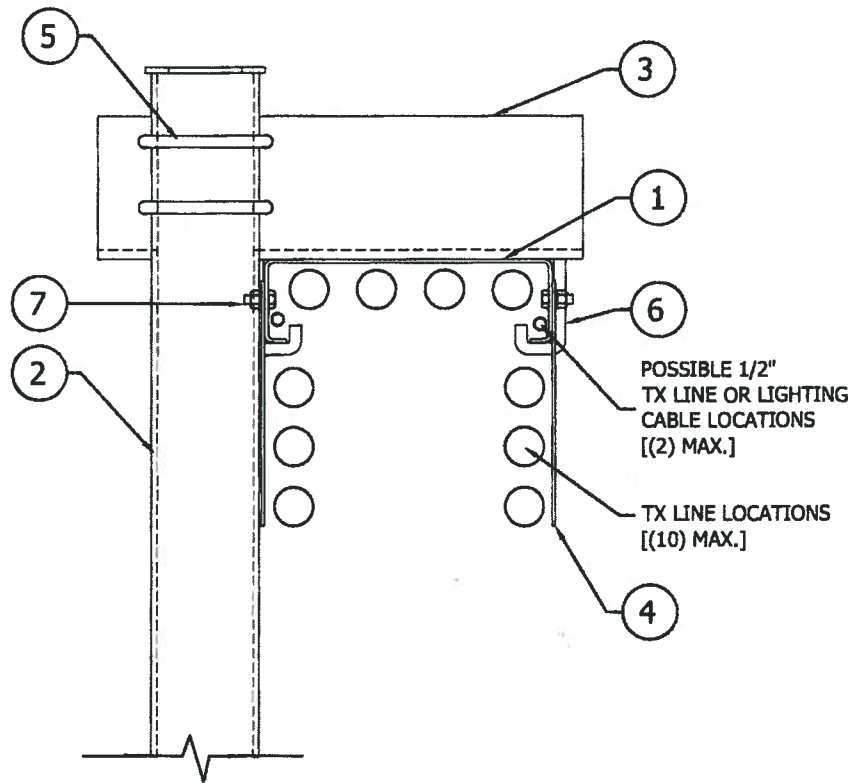
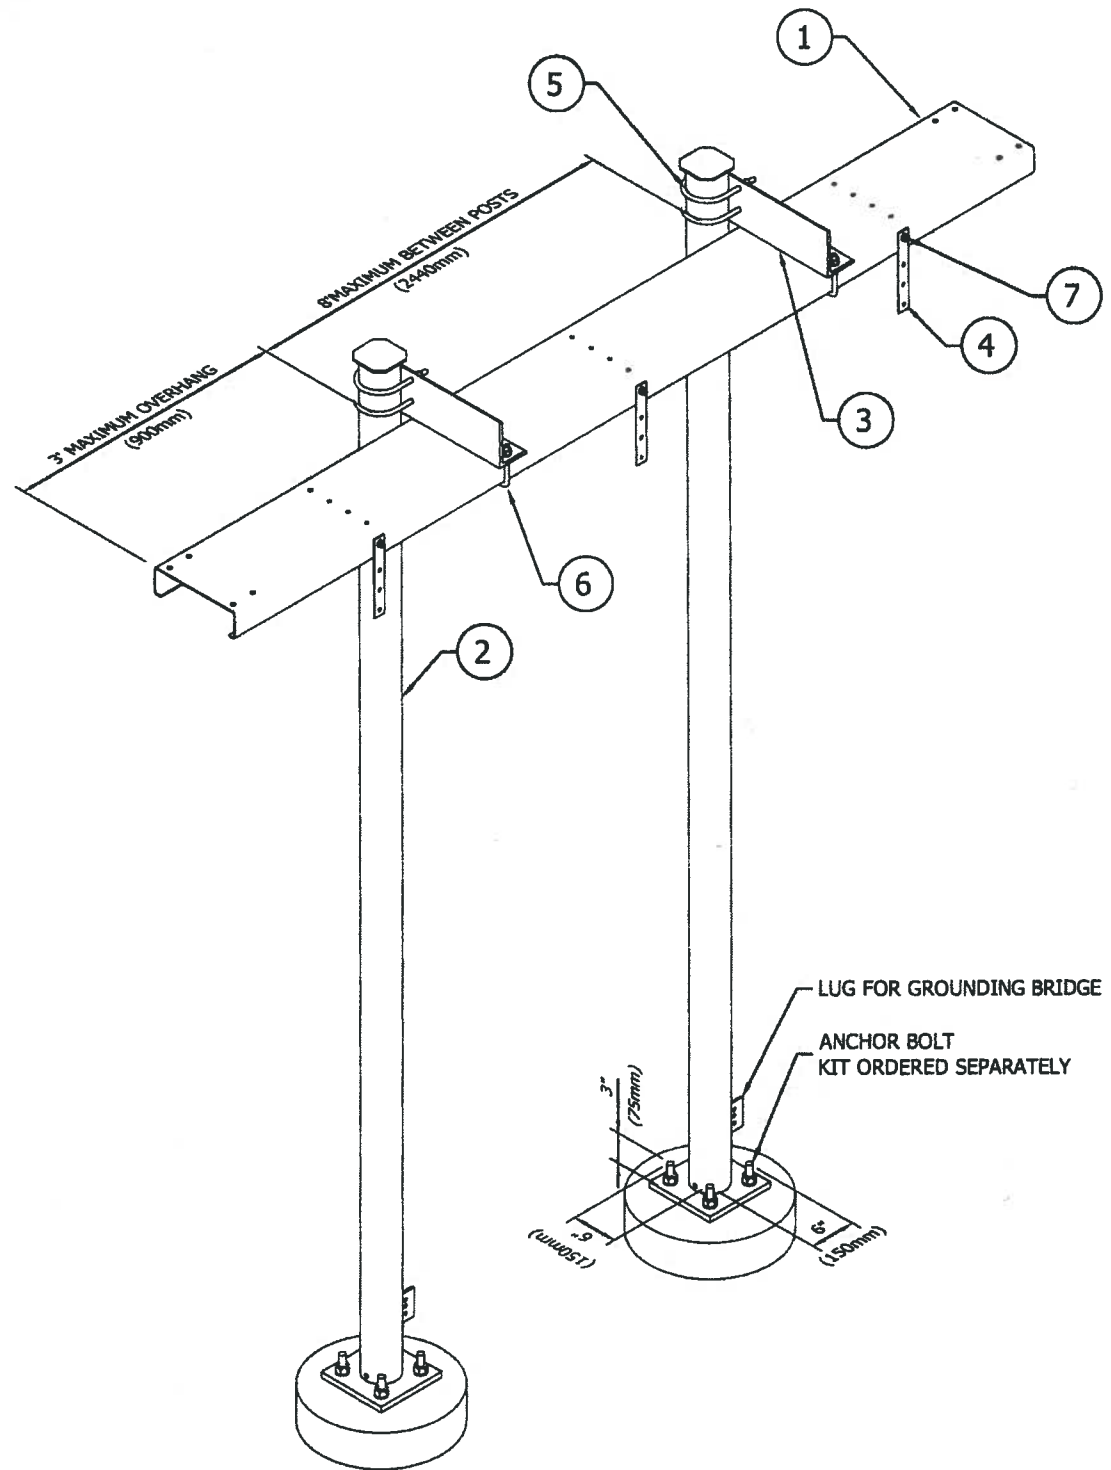
WAVE GUIDE DRAWING TYPICAL DETAILS POST AND WAVE GUIDE TRAY

WHEN DETERMINING END OVERHANG, CONSIDER LOCATION OF EXISTING TOWER AND BUILDING FOUNDATION.
