SOW - MCTS BUILDING DEMOLITION AND SITE REMEDIATION

CCG GROS CAP MCTS

SAULT STE. MARIE, ON

MARITIME AND CIVIL INFRASTRUCTURE

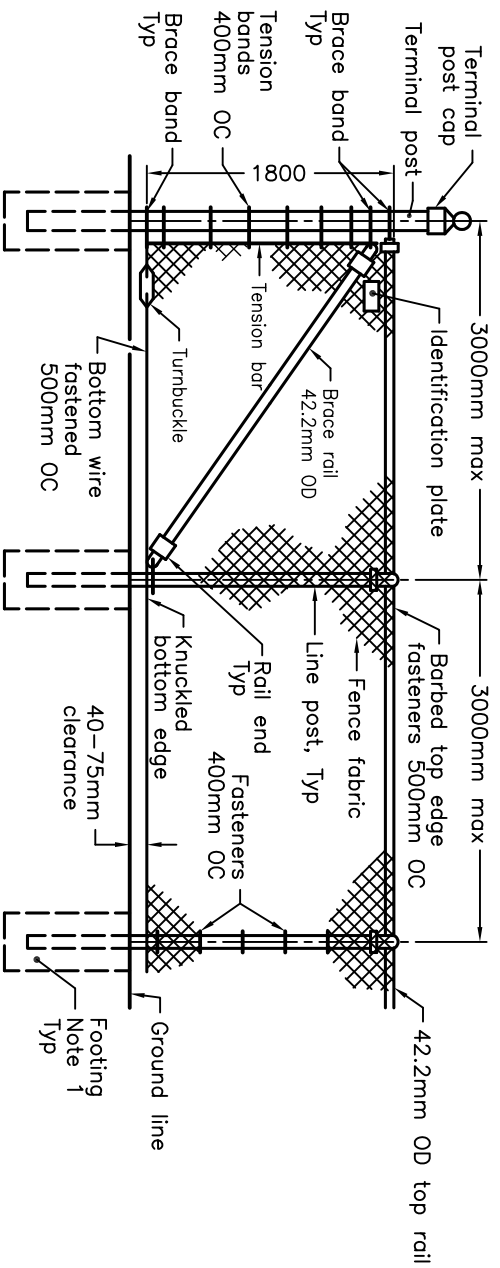
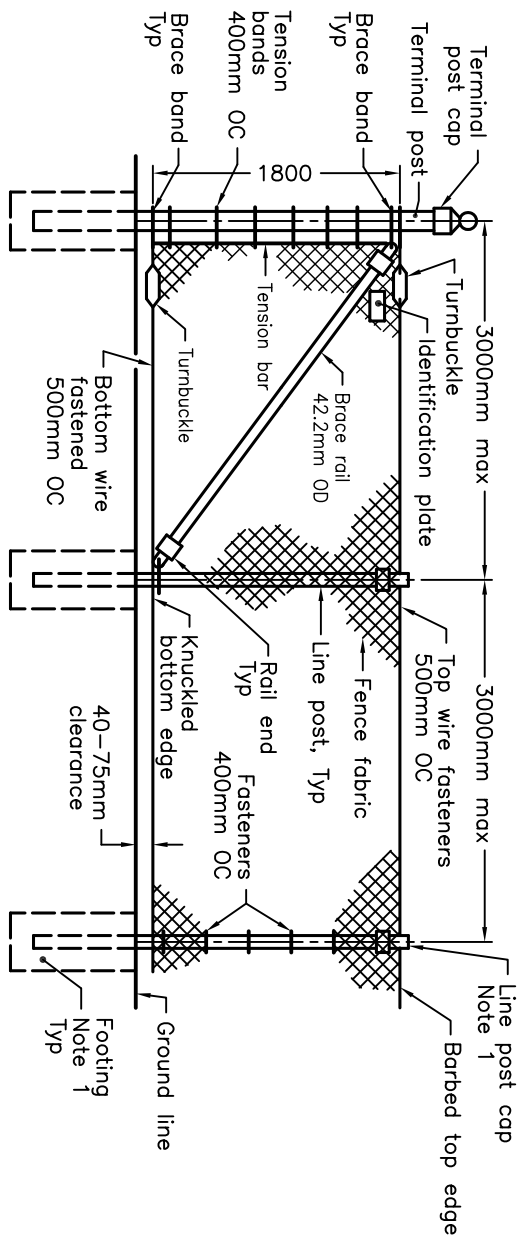
FENCE, CHAIN-LINK INSTALLATION - ROADWAY				
OPSD 972.130

CHAIN-LINK FENCE WITH TOP RAIL

CHAIN-LINK FENCE WITH TOP WIRE (Follow)

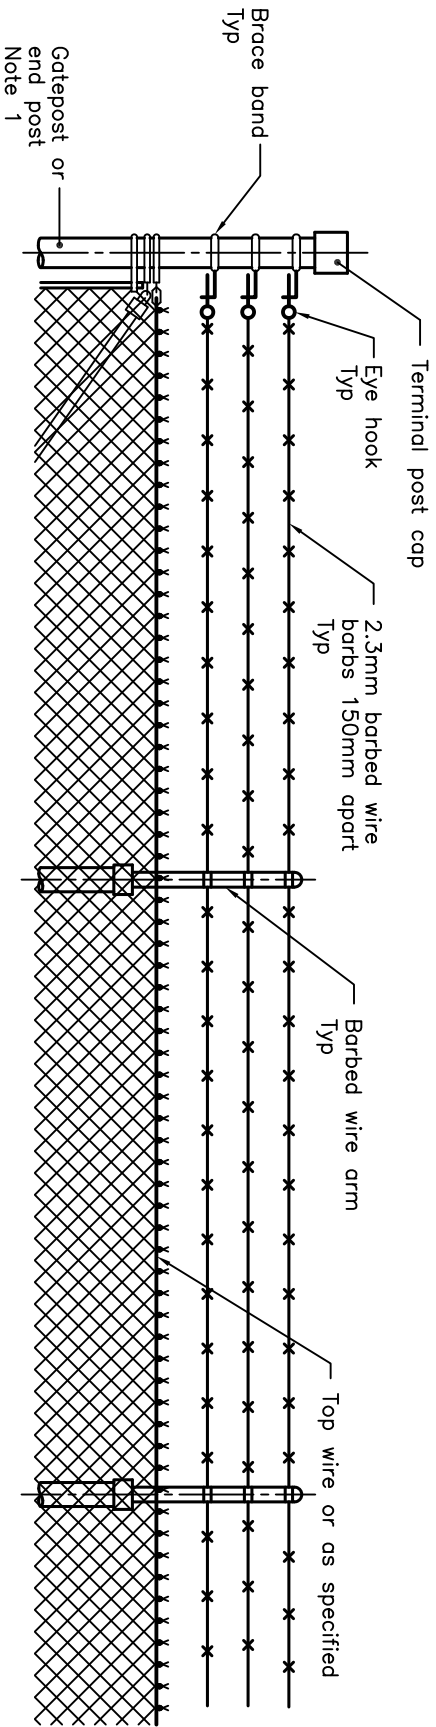
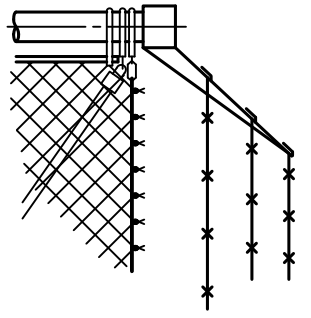
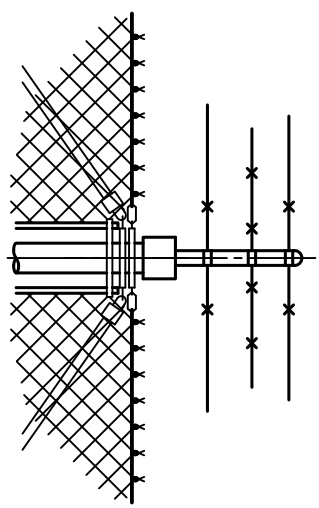
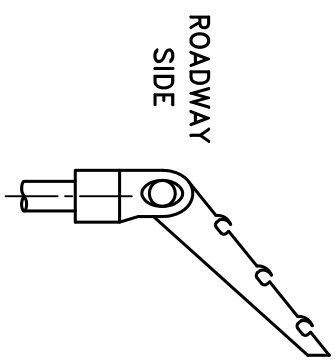
ONTARIO PROVINCIAL STANDARD DRAWING		Nov 2012	Rev 2	
FENCE, CHAIN-LINK COMPONENT - BARBED WIRE				
		OPSD 972.101

CORNER POST WITH BARBED WIRE ARM

STRAINING POST WITH BARBED WIRE ARM

LINE POST WITH BARBED WIRE ARM

- 1 Terminal post shall be lengthened when barbed wire is specified, except when barbed wire arms are used.
- A Installation as viewed from the roadway. Shall be towards roadway and away from inner part of compound.
- B All dimensions are in millimetres unless otherwise shown.

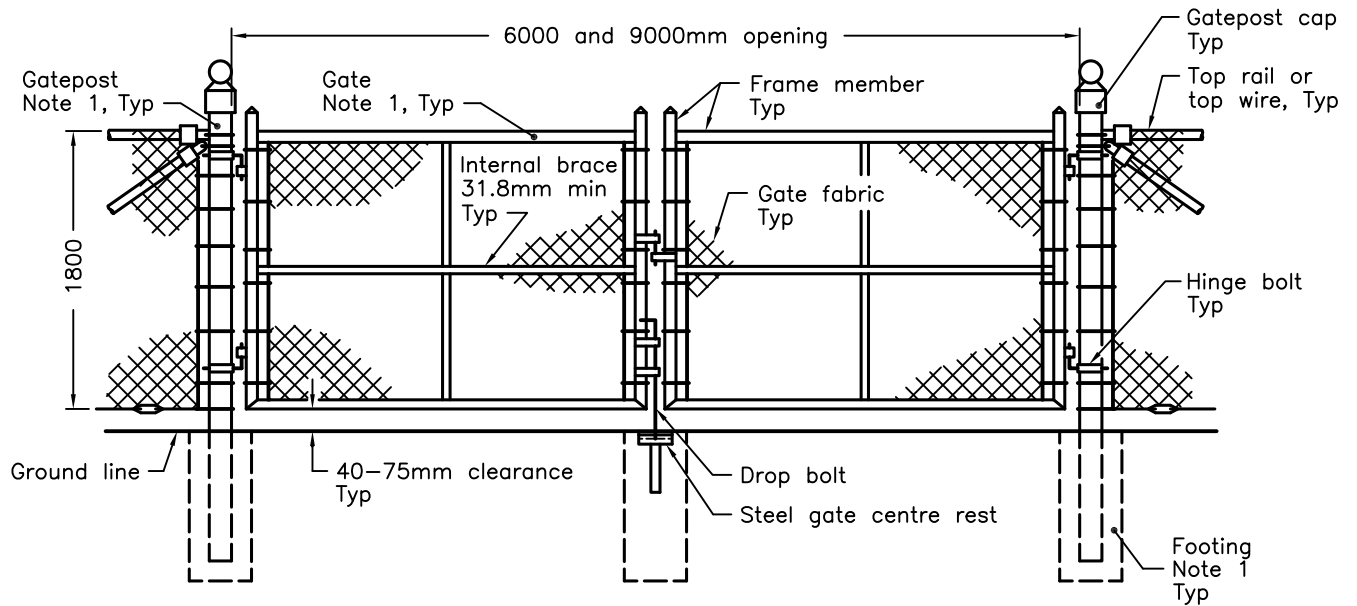
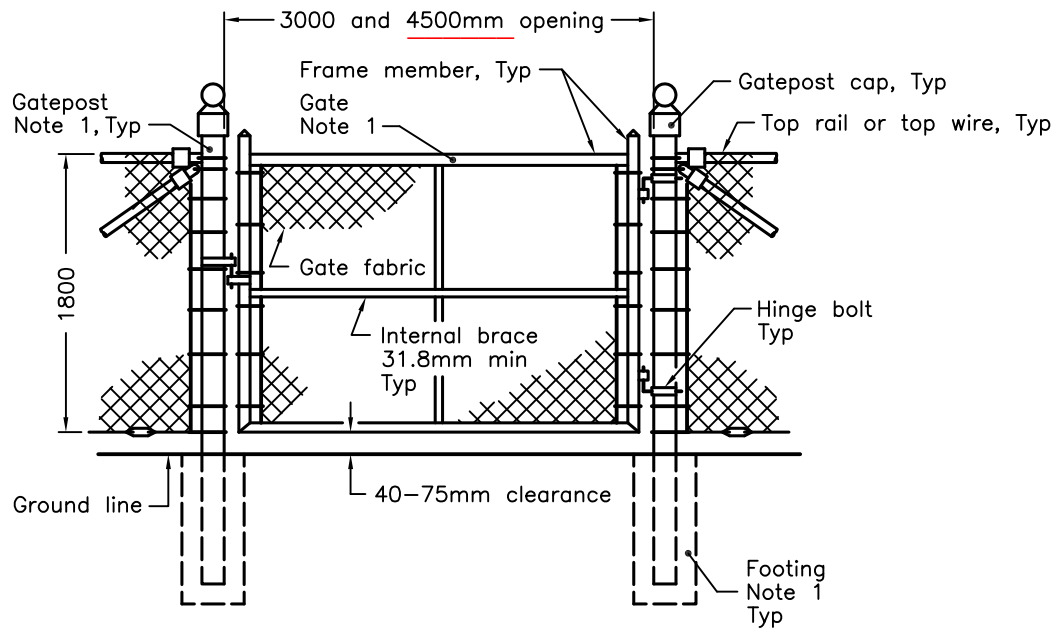
OPSD 972.102

DOUBLE SWING GATE OPENING (Do not follow)

SINGLE SWING GATE OPENING (follow)

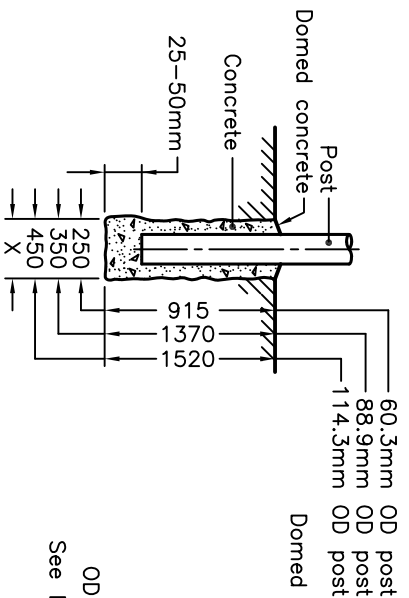
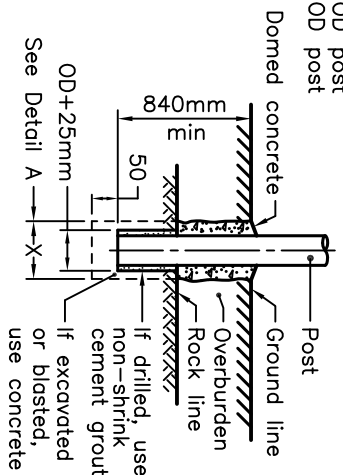
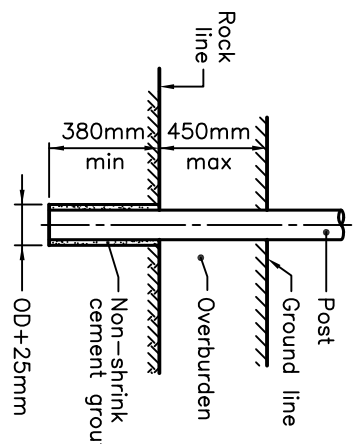
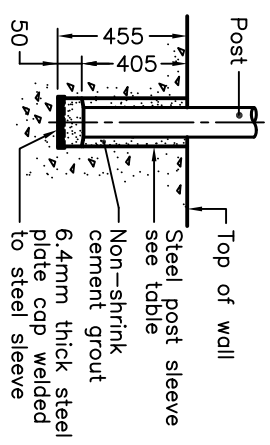
DETAIL A
FOOTING IN EARTH

DETAIL B
FOOTING IN SHALE, LOOSE OR FRIABLE ROCK, OR SOLID ROCK WITH MORE THAN 450mm OVERBURDEN
Do not follow

DETAIL C
FOOTING IN SOLID ROCK LESS THAN 450mm OVERBURDEN
Do not follow

DETAIL D
FOOTING IN RETAINING WALL
Do not follow

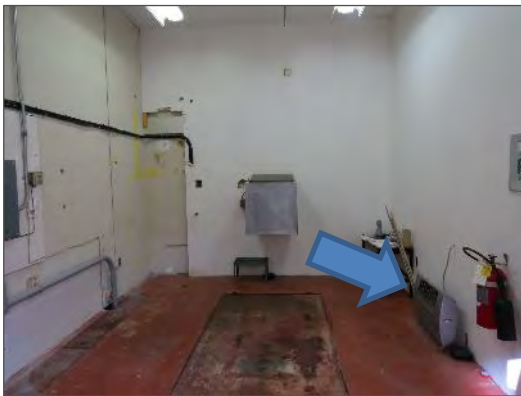
Mechanical equipment is either uninsulated or insulated with non-asbestos fibreglass.

Photo1: Electric baseboard radiators, uninsulated.

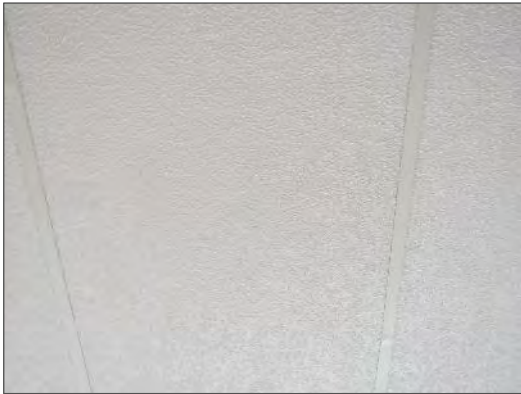
Fibreglass ceiling tiles were present within the assessed area and visually determined to be non-asbestos.

Photo 2: 2' x 4' fibreglass lay-in ceiling tile, does not contain asbestos.

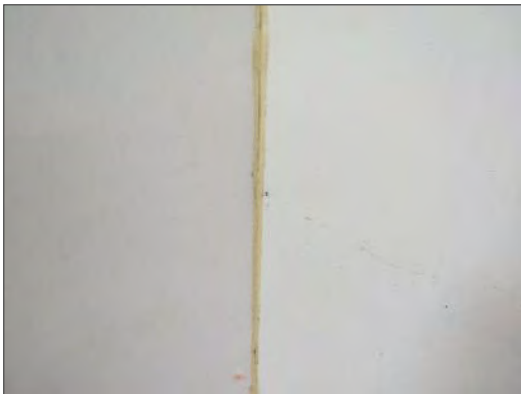
White caulking at corners of plywood wall corners and door frames, contains chrysotile asbestos (samples S0001 A-C). Caulking is non-friable and is in good condition.

Photo 3: White interior caulking, plywood wall corners (S0001 A-C), asbestos-containing.

- .1 A Designated Substance Survey (Hazardous Materials Survey) has been conducted on the building. Non-friable, white interior caulking, containing chrysotile asbestos, at corners of plywood walls were found (see drawing in Appendix B3). It was identified to CCG that some of the doors in the building possess lead-containing paint, see LP-004 and LP-007 on drawing in Appendix B3.
- .2 Notify Coast Guard Representative of friable material discovered during work. Do not disturb such material pending instructions from Coast Guard's representative

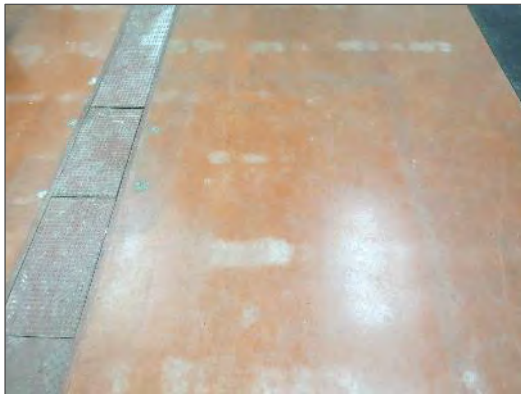
Photo 4: Red paint on concrete floor, insignificant lead concentration.

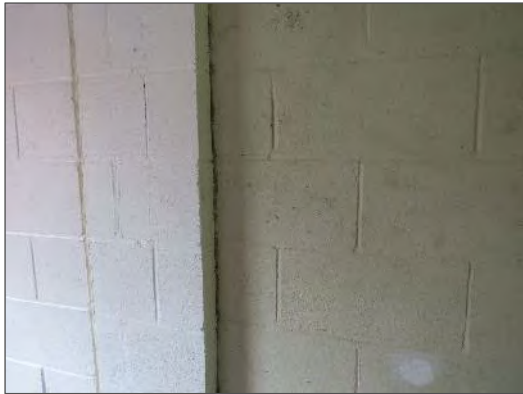
Photo 6: Beige on concrete block, insignificant lead concentration.

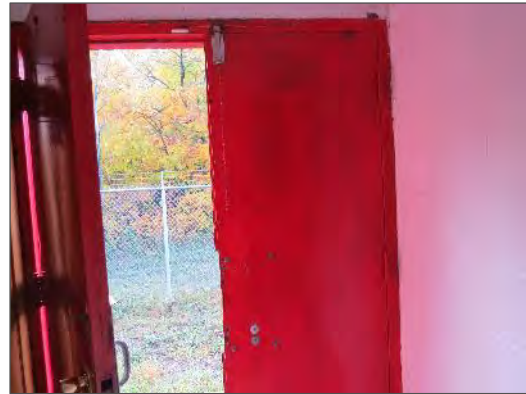
Photo 7: Red paint on metal door, lead-containing.

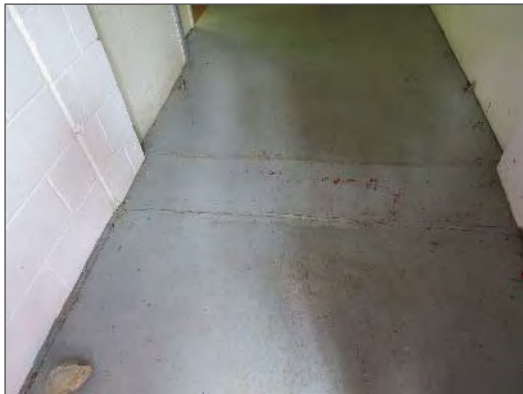
Photo 8: Grey paint on concrete floor, insignificant lead concentration.

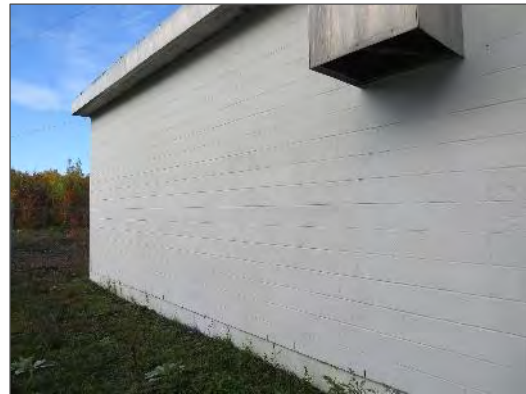
Photo 9: White on concrete block, insignificant lead concentration.

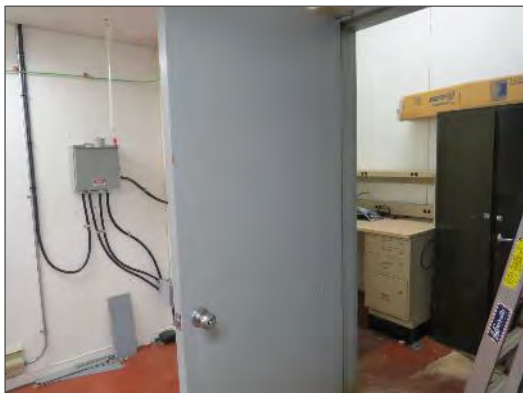
Photo 10: Grey paint on wood door, lead containing.

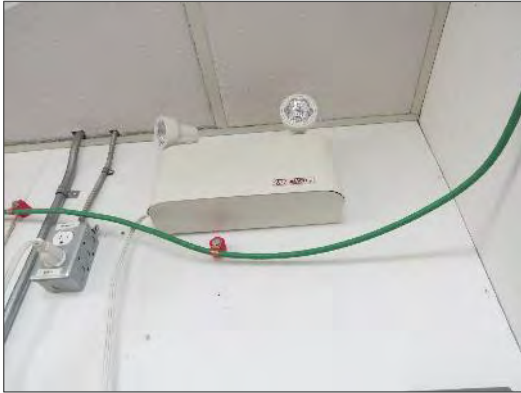
Lead-containing batteries are present in emergency lighting present in the building.

Photo 11: Emergency light, location 1.

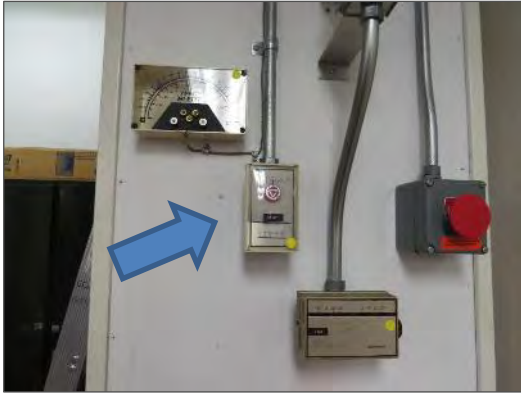
Mercury is present as a liquid in thermostats ampules.

Photo 12: Mercury-containing thermostat.

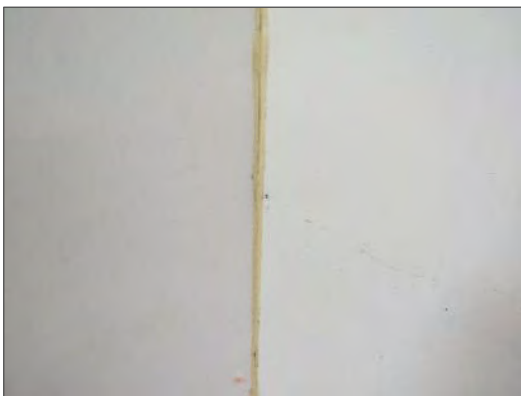
White caulking is present at interior corners on plywood sheeting (sample P-001) and contains <0.5 ppm PCBs. The material is a non-PCB solid based on the threshold given in SOR/2008-273 (50 ppm).

Photo 13: White interior caulking, does not contain PCBs.

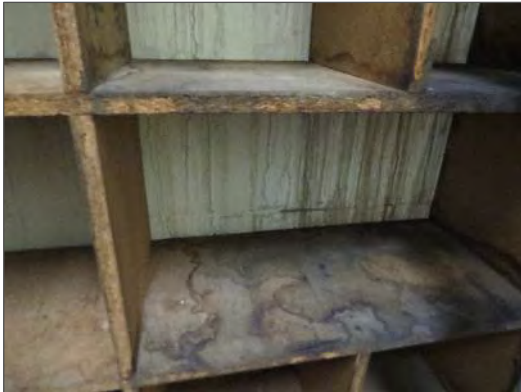
Visible mould growth and water staining was observed on the OSB shelving in Location 3.

Photo 14: Water staining and mould growth on the OSB shelving in Location 3.
