Parks Canada Basic Impact Analysis

Ya Ha Tinda Road Repair

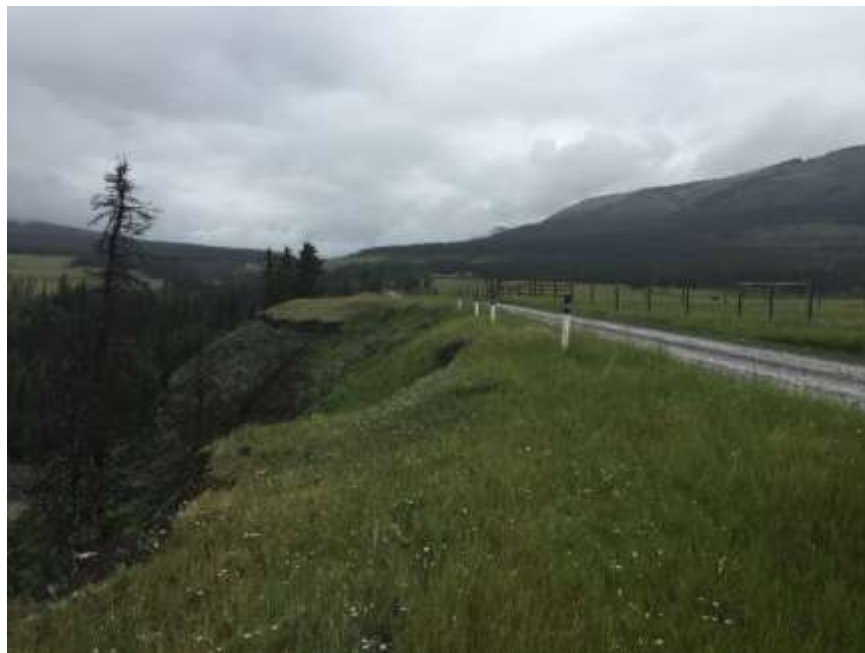
Photo 2 – Look NW at steep, unstable banks between ranch road and Scalp Creek

Flooding in the spring of 2013 caused significant bank erosion and slope failure along Scalp Creek - a tributary of the Red Deer River that a large segment of the highland portion of road parallels. This slope failure has moved to within metres of the road in places and the near-vertical slopes are unstable and dangerous (Photos 2 and 3). The erosion of the banks is progressively encroaching on the road and the significant elevation difference between the creek and road has created a dangerous situation where movement of the bank could take out the road at the top of the bank (Parsons 2014).

Flooding in the spring of 2013 caused significant bank erosion and slope failure along Scalp Creek - a tributary of the Red Deer River that a large segment of the highland portion of road parallels. This slope failure has moved to within meters of the road in places and the near-vertical slopes are unstable and dangerous. The erosion of the banks is progressively encroaching on the road and the significant elevation difference between the creek and road has created a dangerous situation where movement of the bank could take out the road at the top of the bank.

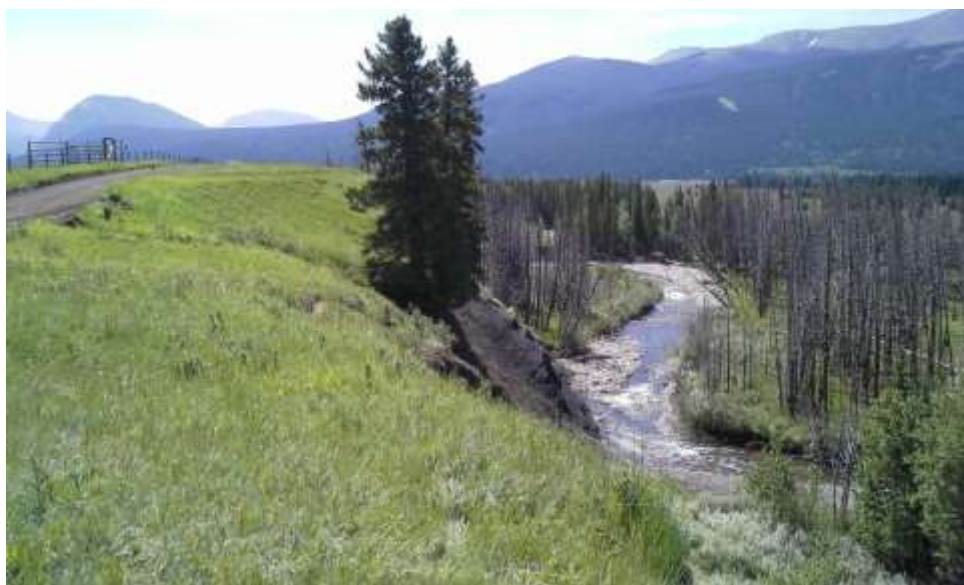
Photo 3 – Looking SE at steep, unstable banks between ranch road and Scalp Creek (Parsons 2014)

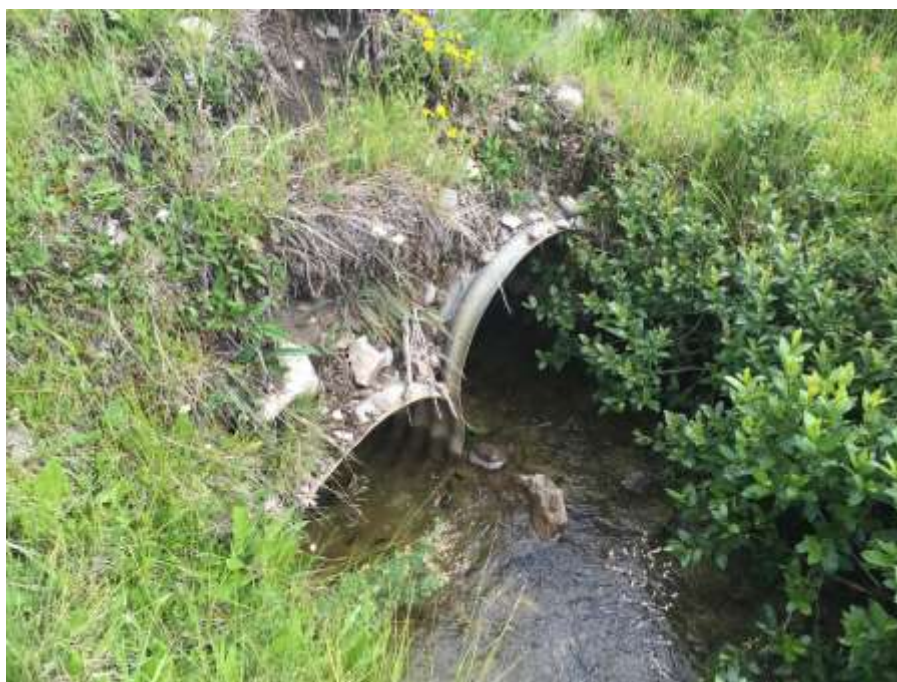
Photo 4 – Double culvert carrying Shelby's Creek under the old road bed/proposed new highland road alignment

The current alignment of the highland road crosses another creek, locally named Shelby’s Creek, approximately 325 m upstream of its confluence with the Red Deer River (Figure 1). Two culverts carry the creek flow under the existing road alignment, but there are frequent problems with the culverts becoming blocked and the creek flooding the road at this location. The proposed new highland road alignment will cross Shelby’s Creek approximately 1 km further upstream. The old road bed at this location also has two culverts to carry the creek flows under the old road bed (Photos 4 and 5). There is no fisheries data for Shelby’s Creek, however the creek appears to have suitable habitat for fish (Photos 6 and 7).

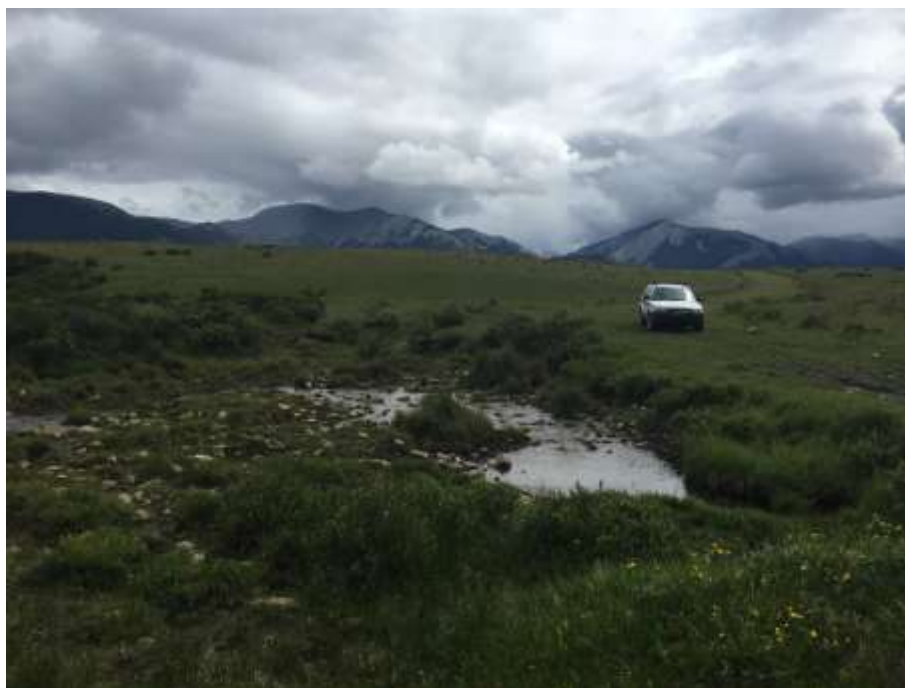
Photo 5 – Looking WSW at old road bed (culvert crossing just out of view at right)

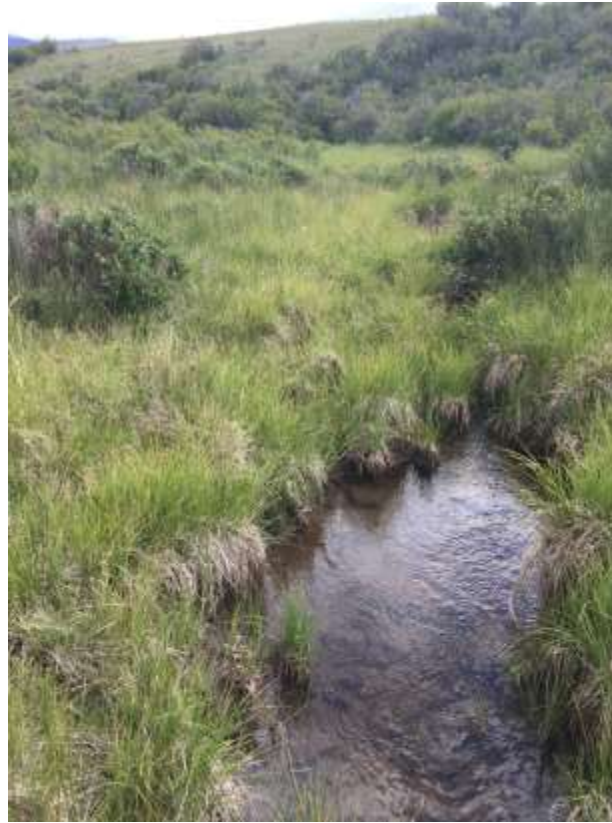
Photo 6 – Shelby's Creek

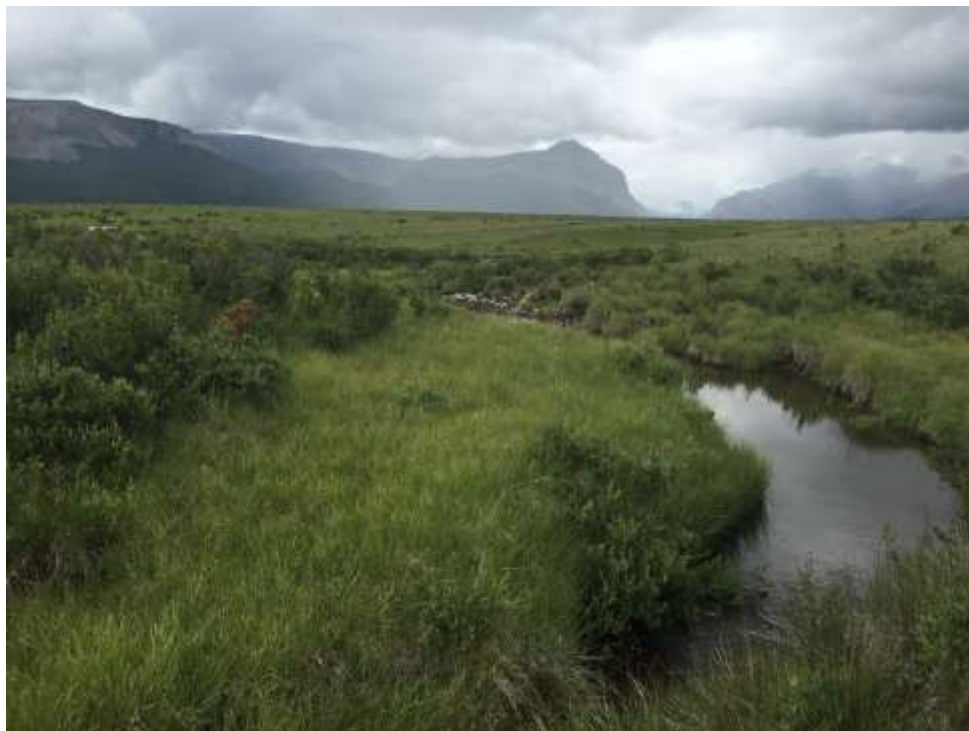
Photo 7 – Shelby's Creek

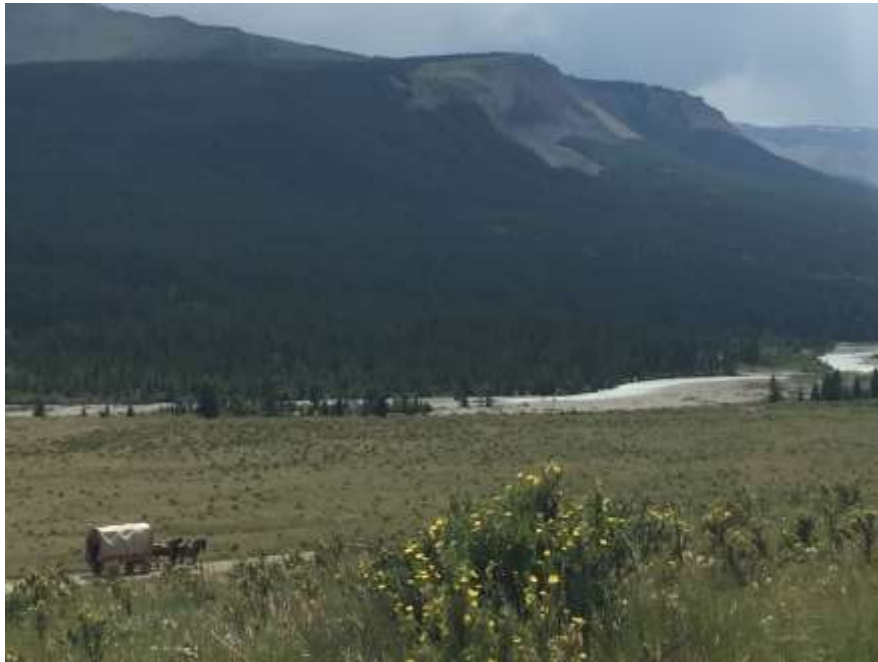
Photo 8 – horse drawn wagon heading for the Scalp Creek crossing

There is also a horse trip outfitter, Outpost at Warden Rock, that accesses their backcountry lodge via the Ya Ha Tinda Ranch, typically departing with horses, wagons and stage coaches from the Bighorn Campground and using the ranch road to access the Scalp Creek crossing (Photo 8).

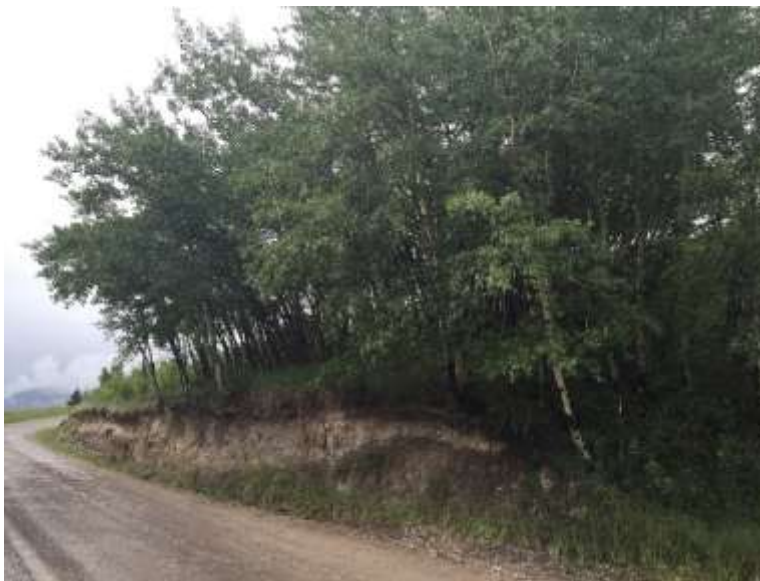
Photo 9 – aspen to be removed

- Tree and shrub removal is limited to a few areas of smaller aspen and shrubs (see Photos 9 and 10).
- The possibility exists for rare plants (soft cinquefoil, Lake Louise arnica and Greenland primrose) to occur within the project disturbance footprint, therefore a pre-construction survey(s) for these species will be undertaken within the anticipated project disturbance footprint, including potential staging areas. Any incidental observations of other rare plants will also be recorded and any additional mitigation measures will be identified as necessary based on the findings of the survey(s) (e.g., salvage/transplant, propagate from seed).

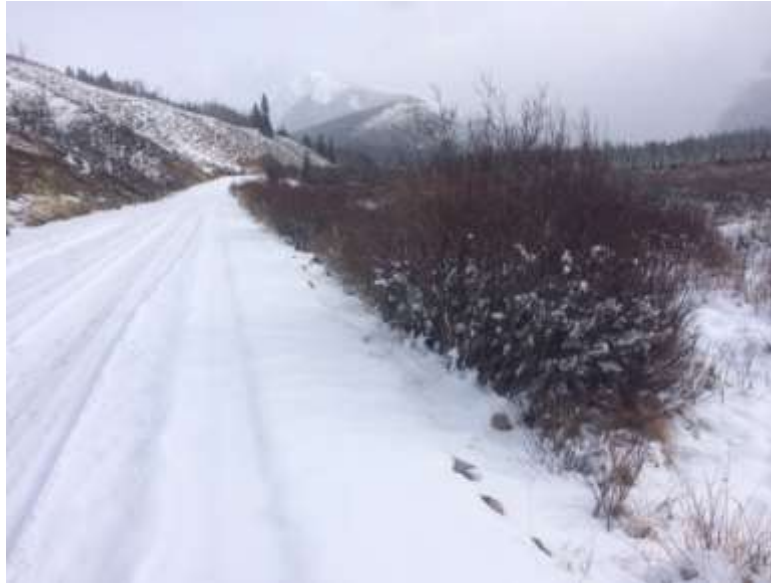
Photo 10 – shrubs to be removed
