# **Historical Review/Phase I ESA and Phase II ESA – Final Report**

**Former Mess Hall and Barracks, Former USN Argentia  
Argentia, NL**

October 24, 2016

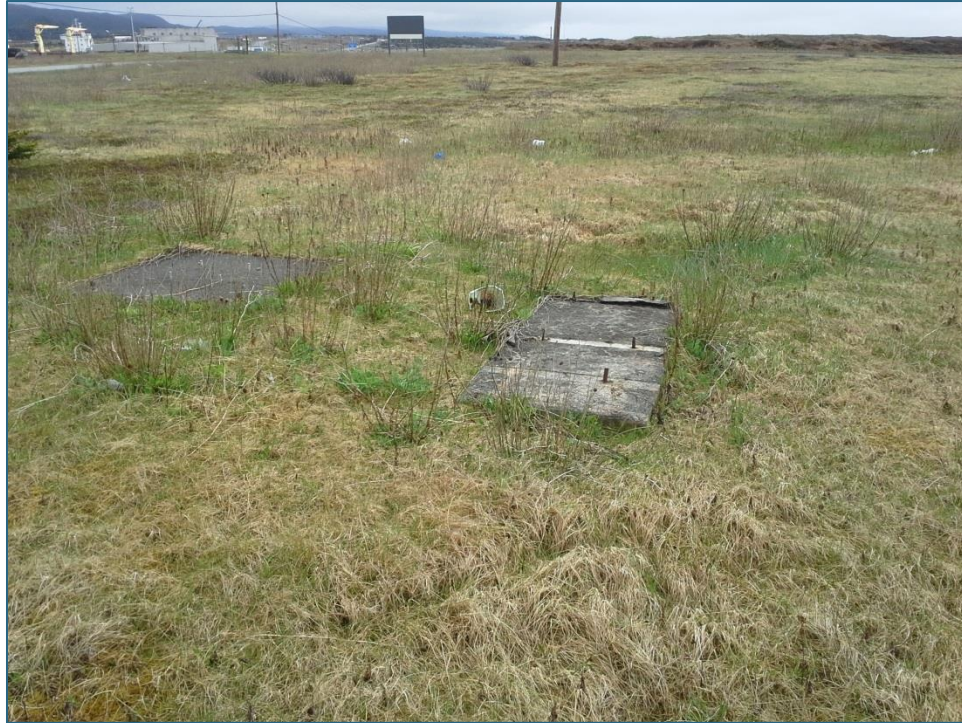
**Photo 5:** Looking south: concrete blocks with rebar in the foreground, MCTC sign in the foreground

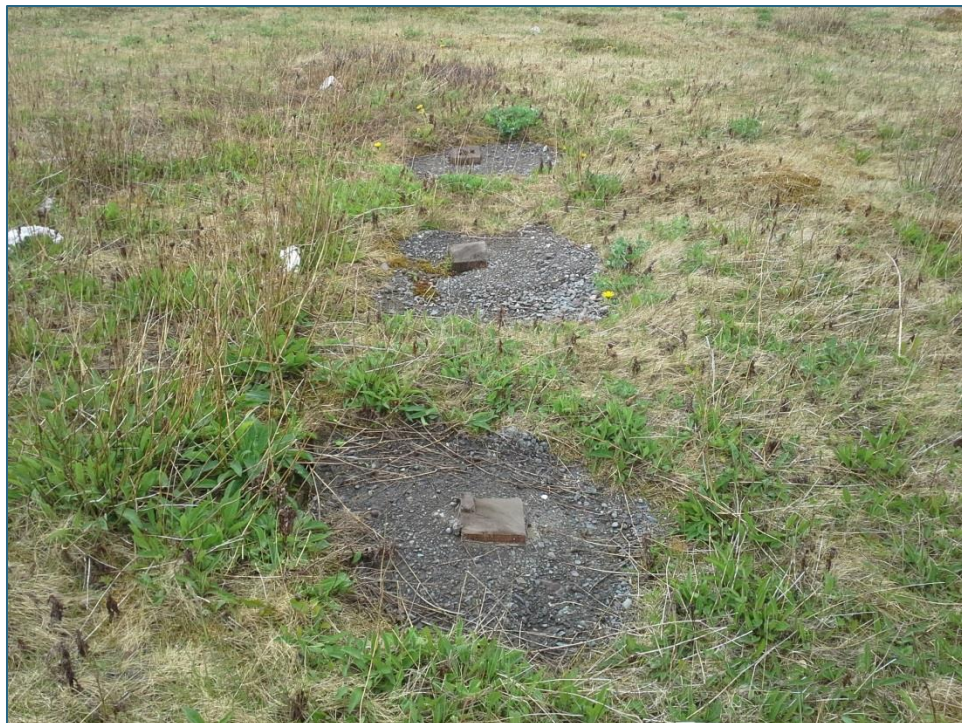
**Photo 6:** Buried Wooden Posts

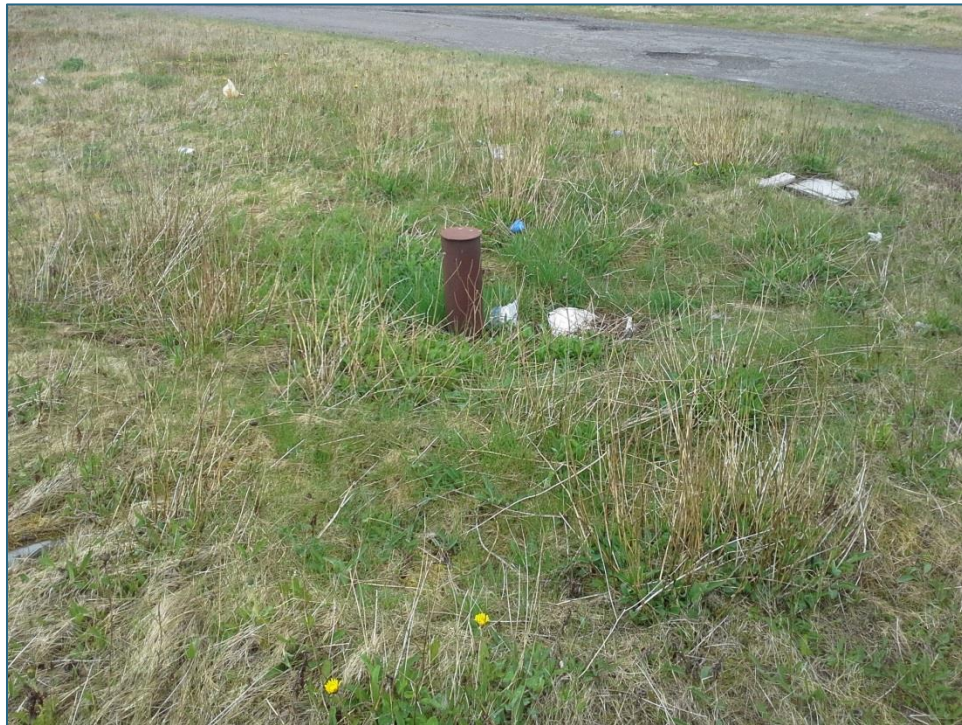
**Photo 8:** Possible monitoring well located on the subject Site

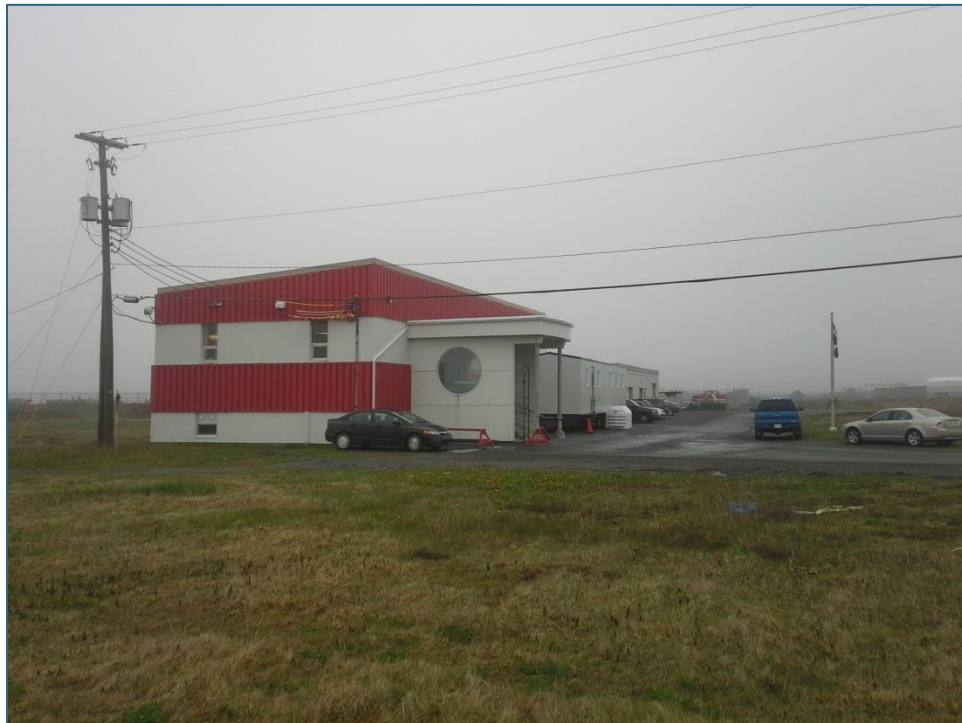
**Photo 12:** Side view of MCTC building showing pole mounted transformers

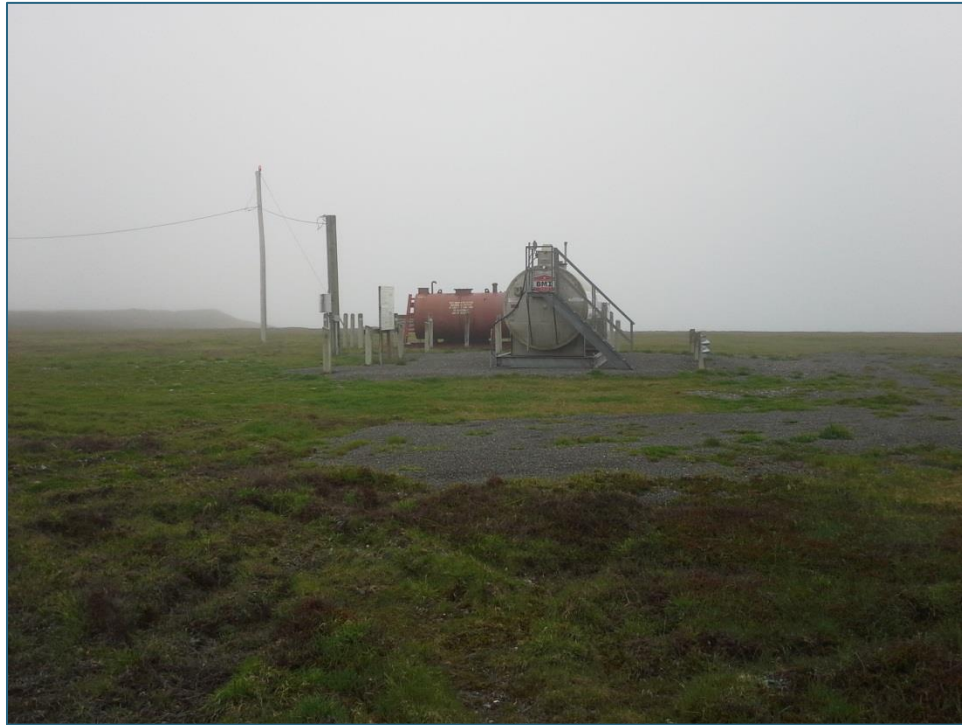
The Coast Guard Helipad is located behind the MCTC Building. It was first developed in 1994 and operates as a refuelling station for helicopters. Historical reports indicate that an above ground storage tank (AST) containing aviation fuel for refuelling helicopters has been onsite since 1994. Prior to that helicopter refueling was conducted using 50 gallon drums. Previous studies conducted on the CCG Helipad found that the 9,090 L tank containing Jet 'A' type fuel was non-compliant with several federal

**Photo 13:** Two 9,090 L above ground storage tanks containing jet fuel located at the CCG helipad behind the MCTC building

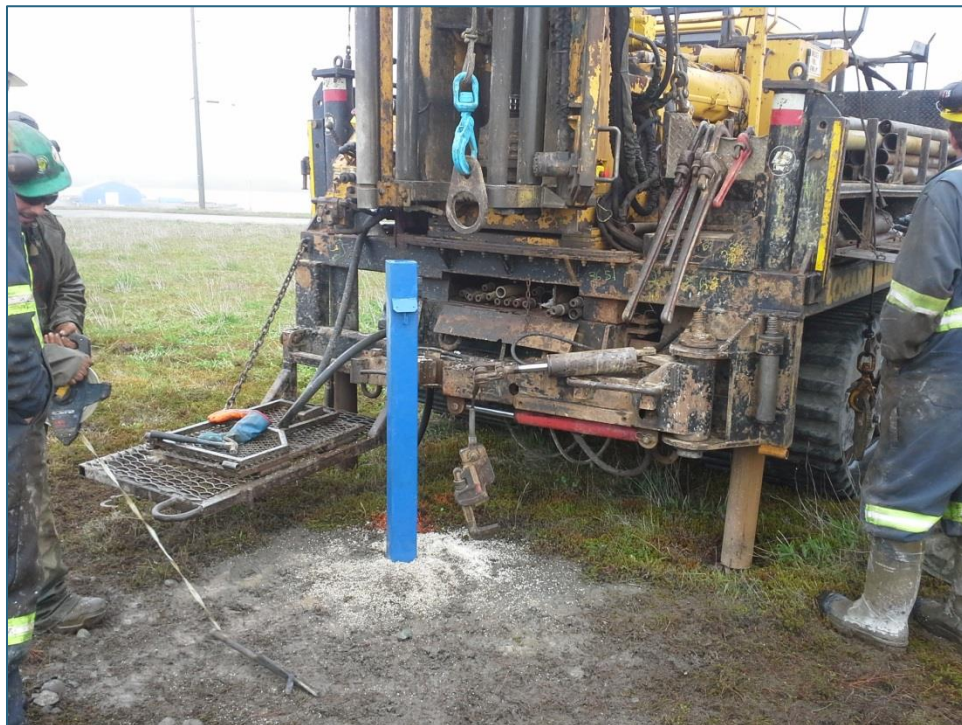
**Photo 18:** Monitor well MW16-2 complete with stick-up, June 16, 2016

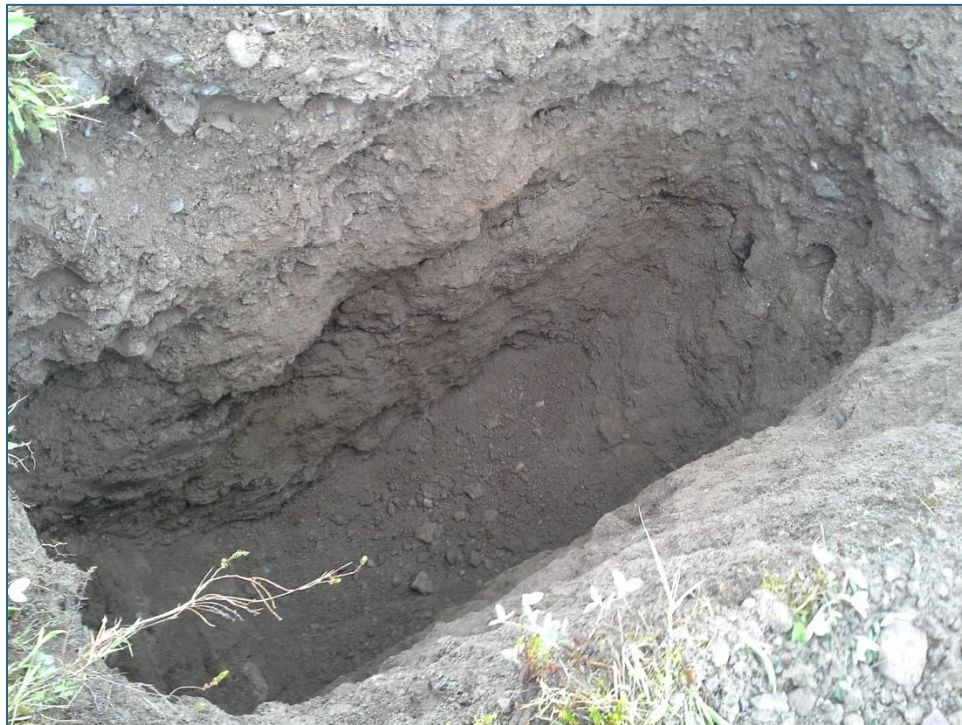
**Photo 20:** Lithology observed in TP16-1 – the surface unit consisting of a brown sand with some gravel, pebbles, and cobbles throughout is visible at the top portion of the photograph

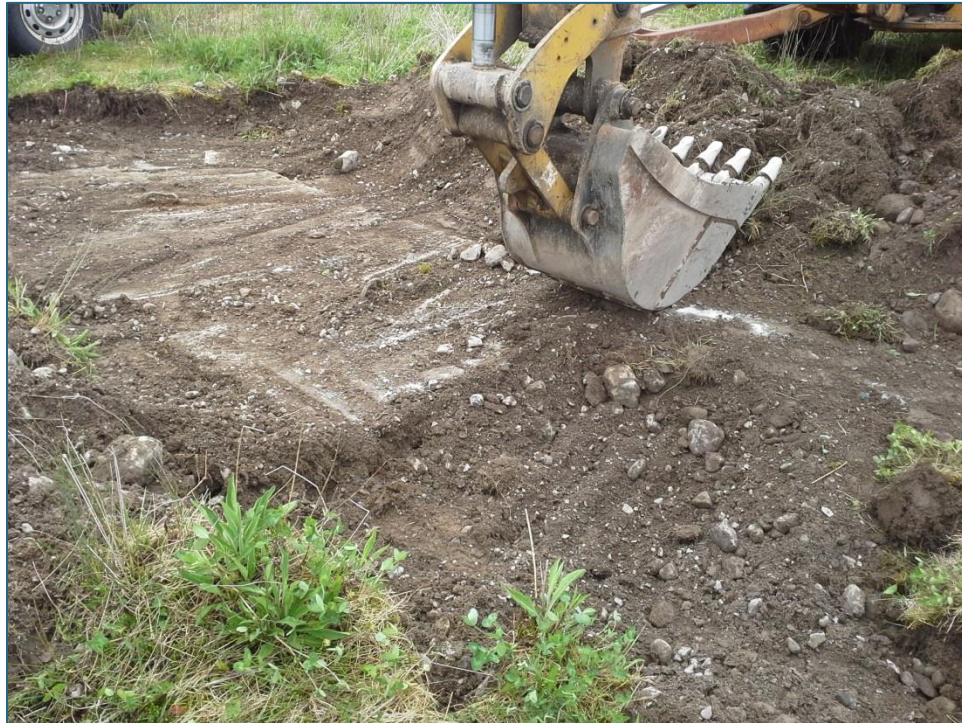
During excavation of the trench adjacent to TP16-2, what appeared to be the concrete casing for the former steam pipeline was observed between the former buildings. The former steam pipeline itself could not be observed due to the presence of the concrete casing. The concrete casing had a height of approximately 1.1 m and a concrete thickness of approximately 0.15 – 0.22 m. The casing appeared to still be connected to the foundations of both former buildings. Concrete debris and rebar was also uncovered in the trench.

**Photo 21:** Top of the concrete steam line casing uncovered between former buildings 301 and 302

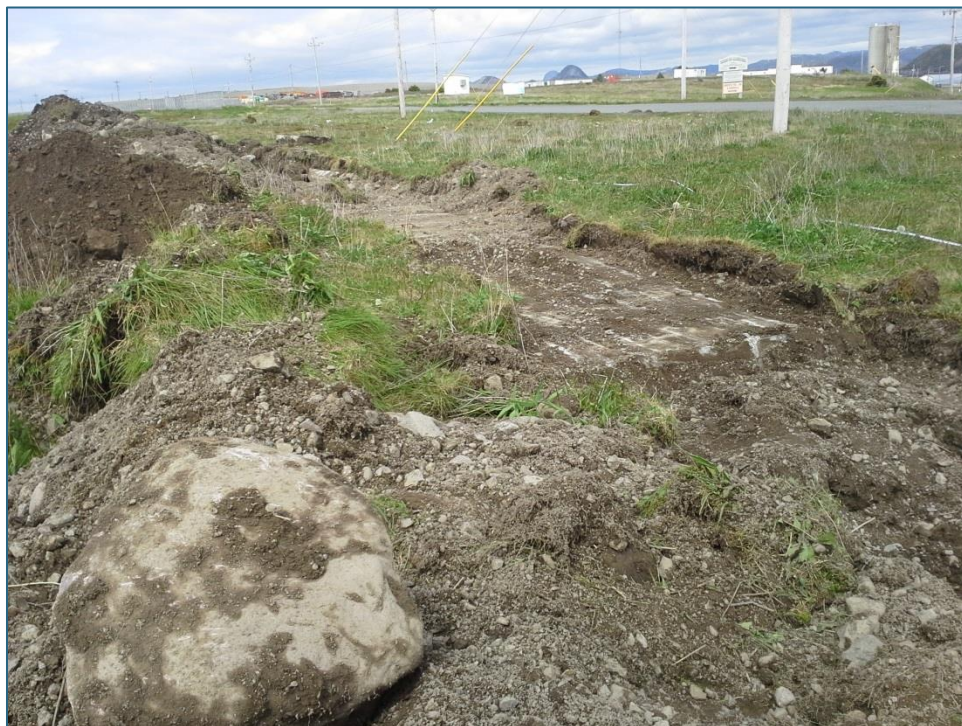
**Photo 22:** Extent of concrete steam line casing located between the former building foundations that was uncovered during test pitting, July 17, 2016

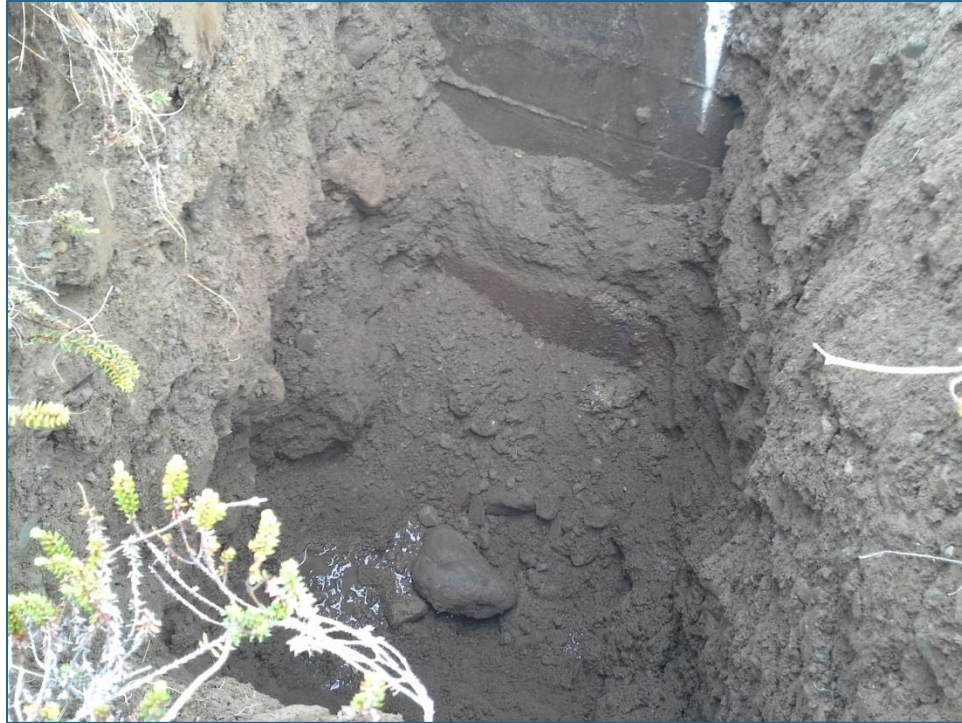
During the excavation of TP16-3, a portion of the foundation of former building 302 was uncovered at a depth of approximately 0.3 mbgs. The concrete wall was approximately 0.22 m thick and 1.85 m high (including a footing of 0.45 m). Water infiltrated the excavation at a depth of 2.13 -2.43 m however this may have been a result of the water introduced to the subsurface during coring activities the previous day.

**Photo 23:** Excavation of TP16-3, adjacent to remains of the former building's foundation
