Title - Sujet Chignecto Multipurpose Bldg, Alma	
Solicitation No. - N° de l'invitation EC015-180661/A	Amendment No. - N° modif. 001
Client Reference No. - N° de référence du client EC015-180661	Date 2017-07-24
GETS Reference No. - N° de référence de SEAG PW-\$PWB-004-4157	
File No. - N° de dossier PWB-7-40042 (004)	CCC No./N° CCC - FMS No./N° VME
Solicitation Closes - L'invitation prend fin at - à 02:00 PM on - le 2017-08-03	
Time Zone Fuseau horaire Atlantic Daylight Saving Time ADT	
F.O.B. - F.A.B. Plant-Usine: <input type="checkbox"/> Destination: <input checked="" type="checkbox"/> Other-Autre: <input type="checkbox"/>	
Address Enquiries to: - Adresser toutes questions à: Doucet, Gisele PWB	Buyer Id - Id de l'acheteur pwb004
Telephone No. - N° de téléphone (506) 636-4541 ()	FAX No. - N° de FAX (506) 636-4376
Destination - of Goods, Services, and Construction: Destination - des biens, services et construction:

Addendum No. 1.

**Geotechnical Investigation Report
Chignecto South Campground**

Prepared for Public Works & Government Services
Canada
Project No. 10456.05

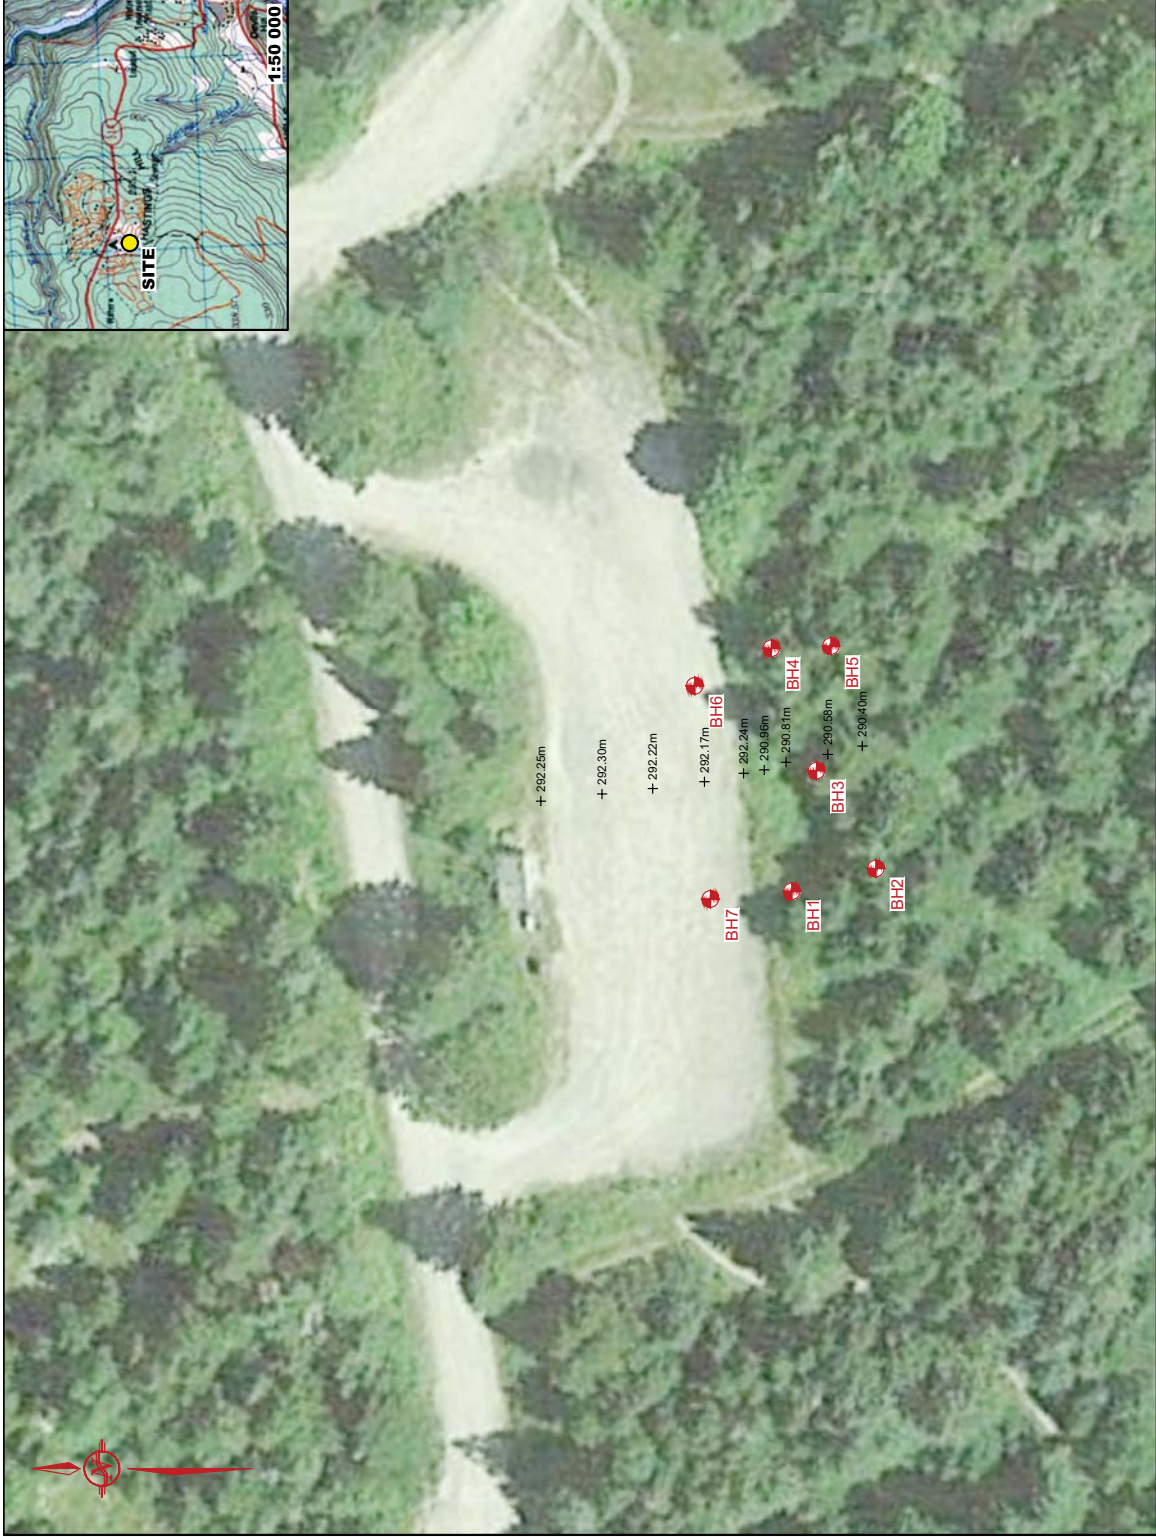
File No.	104560501	Drawing	FIGURE 1
Revision No.		Revision No.	0

SPOT ELEVATION	
+ 290.00			
Note			
1. COORDINATE SYSTEM: NEW BRUNSWICK: STEREOGRAPHIC PROJECTION, NAD83 (CSRS) DATUM.			
2. THIS SURVEY WAS DONE WITH HIGH PRECISION GPS AND REFERENCED LEICA SMARTNET SYSTEM.			
Drawn By	CHG	Checked By	MB
Calculations By		Checked By	
Date	MARCH 2016		
Project	GEOTECHNICAL INVESTIGATION CHIGNECTO SOUTH CAMPGROUND		
Drawing	BOREHOLE LOCATION PLAN		
Scale

The purpose of this geotechnical investigation was to characterize the soil and bedrock conditions in the area of the parking lot and the proposed building and provide geotechnical recommendations for the design and construction of the building's foundation. Five boreholes were advanced in the area of the proposed building; one borehole was advanced near each corner of the proposed building and one borehole near the centre. Two boreholes were advanced in the existing gravel parking lot. See Appendix A for borehole location plan; see Appendix B for descriptive terms and borehole logs.

The site is located in the Chignecto South Campground in Fundy National Park in Alma, New Brunswick. The location of the proposed building is south of the Chignecto South Campground access road, near an existing gravel parking area. The proposed building location is approximately 300 metres from the intersection of Route 114 and the campground access road; see Appendix A for site location and borehole layout on site; see Appendix F for site photos.

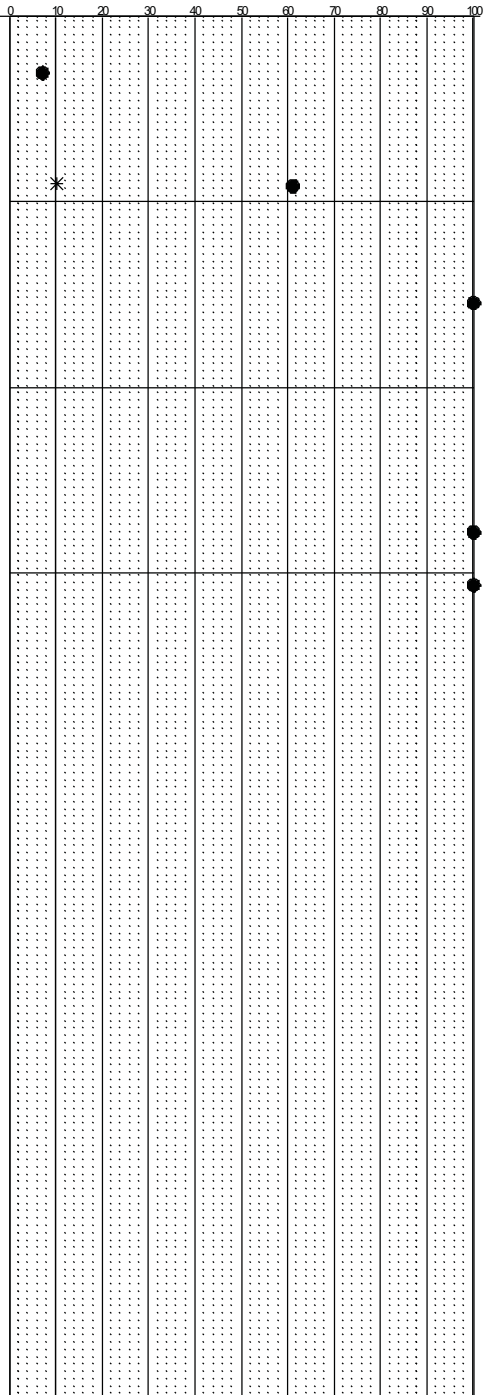
0.09 ROOTMAT 290.10 0.32 Brown Silty SAND and organics 289.87 Brown-grey SAND and GRAVEL, some cobbles

1	2	S	61	430	- Sand and gravel, some silt (AASHTO A-1-a)		
2	3	S	100+	50			
3	4	S	100+	80			
	5	S	100+	10	3.05 Inferred BEDROCK 287.14 3.35 - Auger refusal at 3.35 metres 286.84 End of borehole at 3.35 metres below surface grade Groundwater seepage encountered at 3.05 metres below surface grade

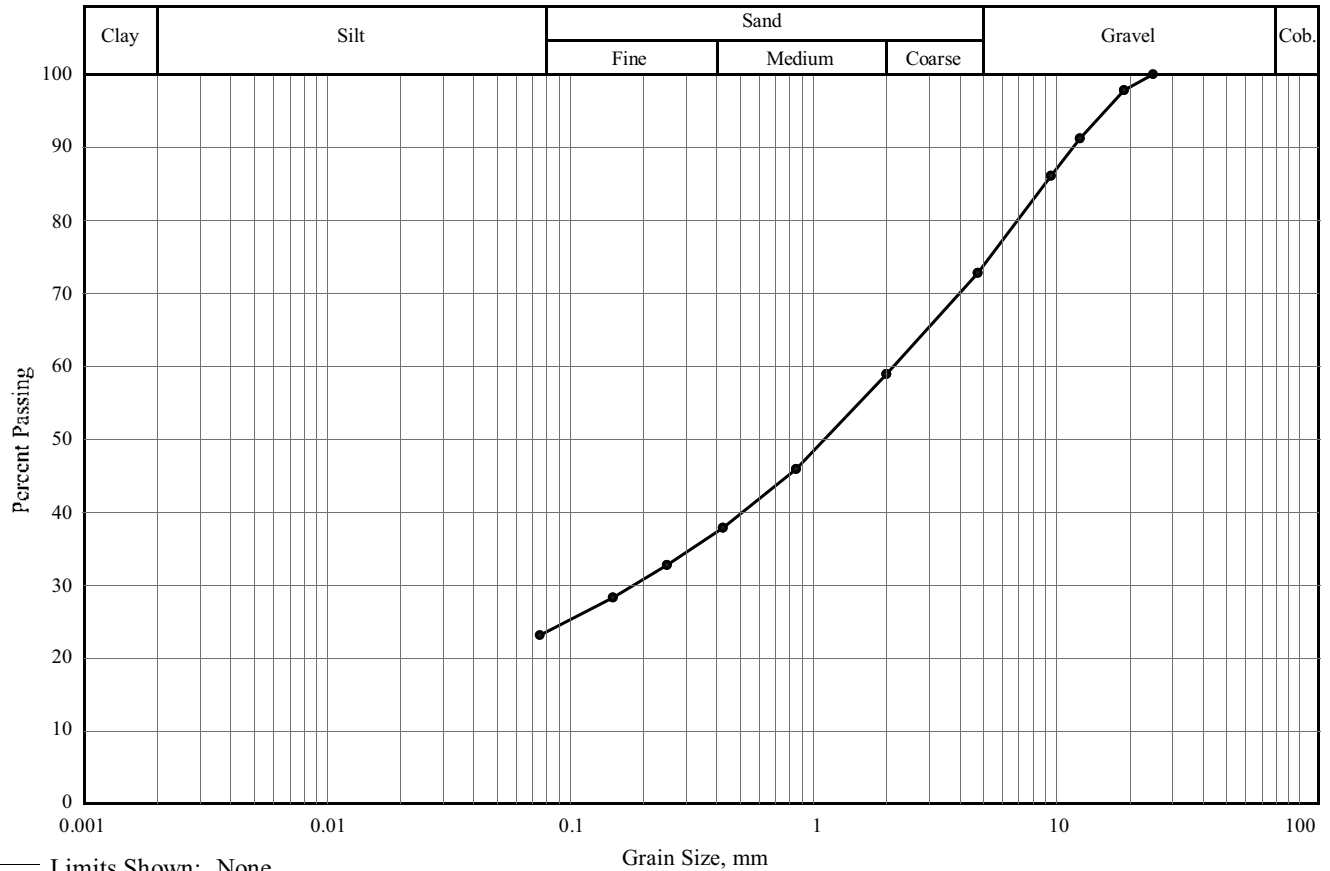
Soils Grading Chart

Line Symbol	Description	Borehole/ Test Pit	Sample Number	Depth	% Cob.+ Gravel	% Sand	% Silt	% Clay	Date Sampled
—●—		6	3		27.2	49.7	23.1		16/03/23

Line Symbol	Sample Description	AASHTO	D ₁₀	D ₁₅	D ₅₀	D ₈₅	% 5-75µm
—●—	Gravelly silty sand	A-1-b	---	---	1.12	8.98	---

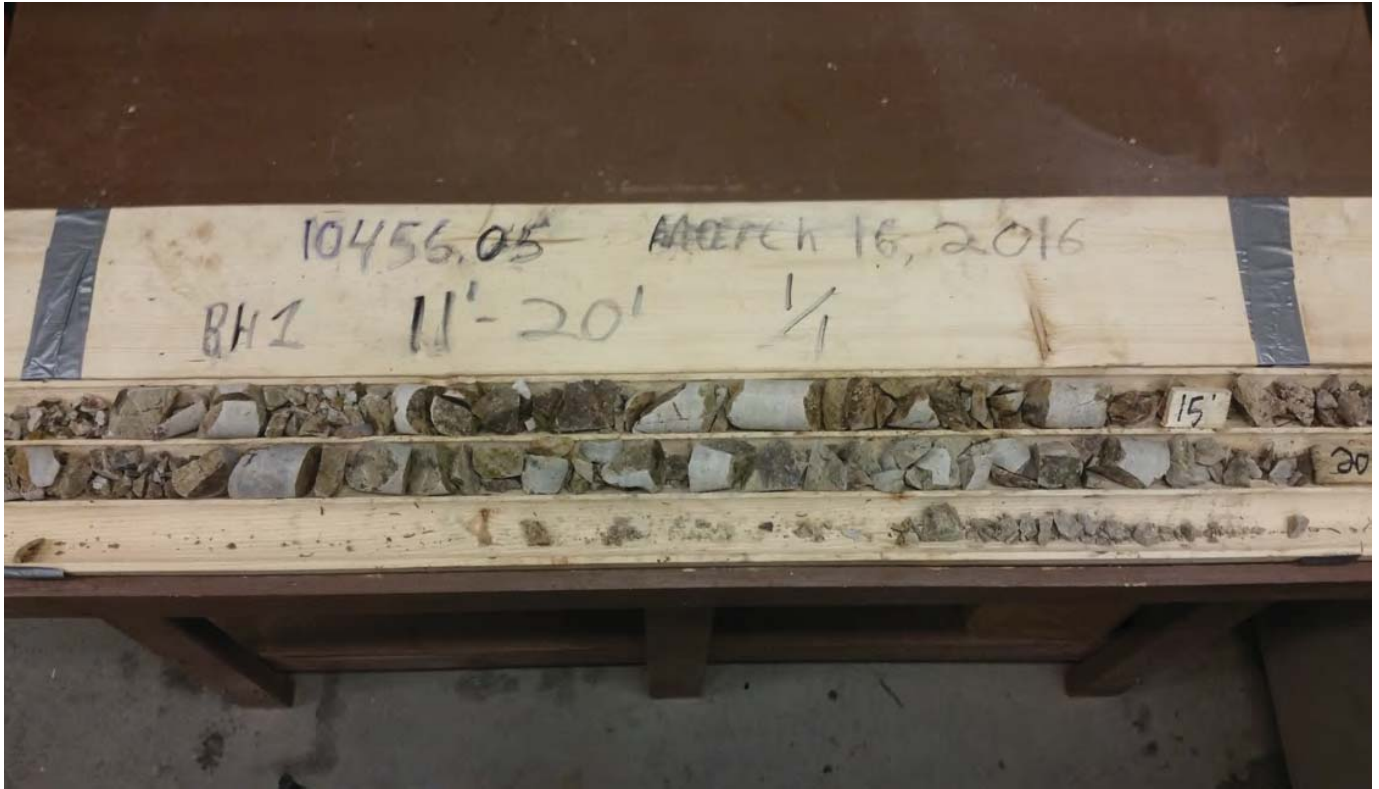
PHOTO 1 - Slate bedrock cores from BH1 (3.3 to 6.06 metres)

Highly fractured bedrock was encountered beneath the silty sand and gravel in boreholes 1, 3, 5, and 7; the other boreholes were terminated upon spoon or auger refusal in probable bedrock. Rock cores measuring 1.7 – 2.7 m were extracted from BH 1, BH 3 and BH 5 (see Appendix E for photos of rock cores). The bedrock is a grey slate bedrock.

The RQD values in the bedrock range from 0 – 22, averaging 6 which indicates that the overall rock quality is very poor. Due to the very close spacing of fractures, none of the bedrock pieces extracted from the boreholes were large enough for compressive strength testing.

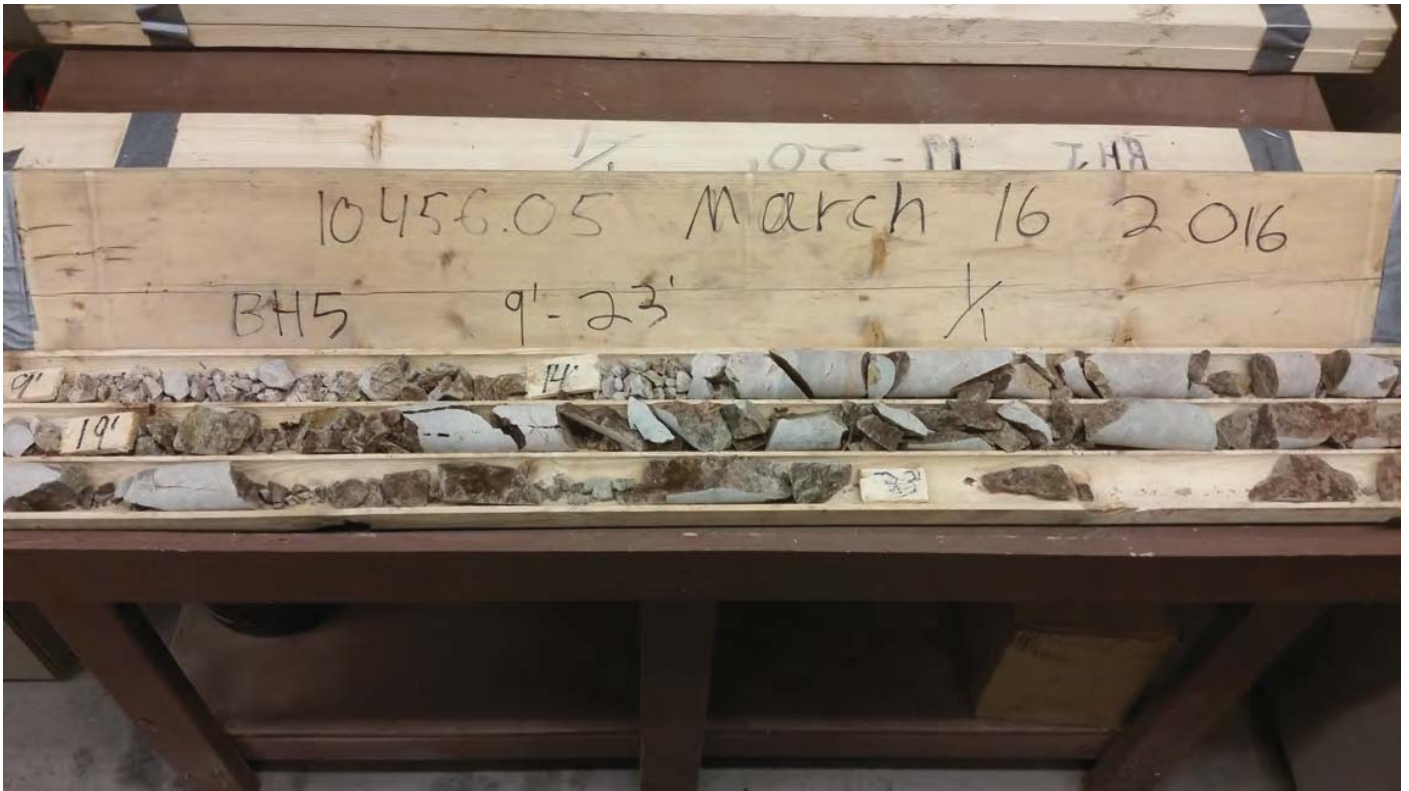
PHOTO 3 - Slate bedrock cores from BH5 (2.74 to 7.0 metres)

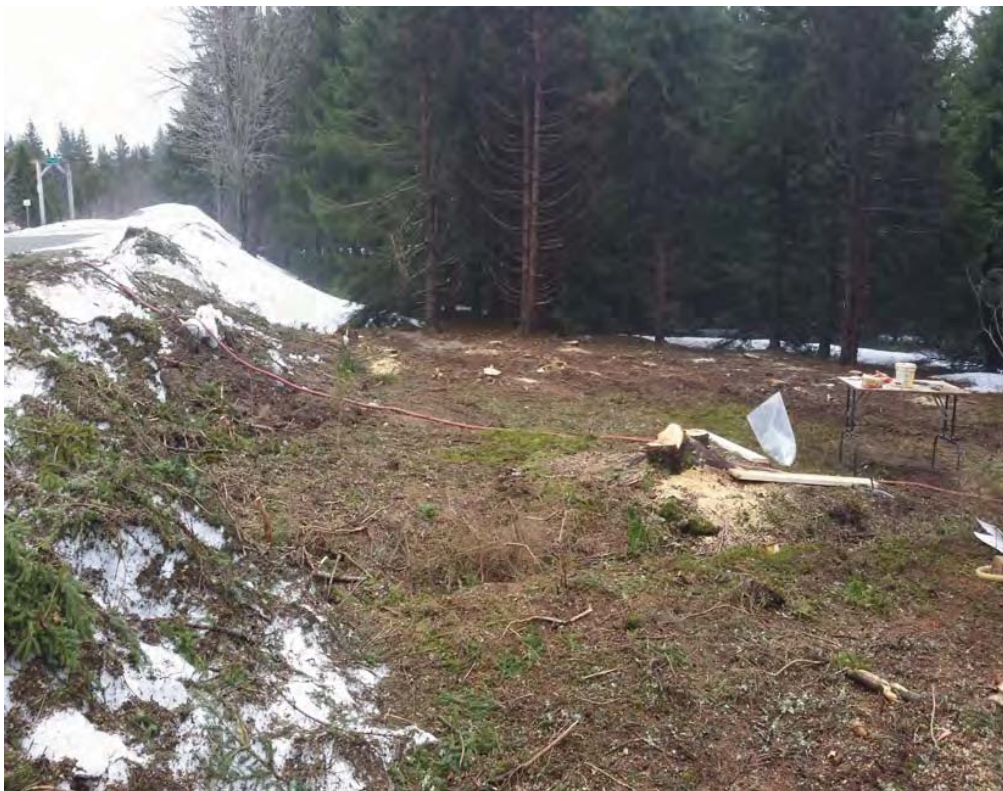
PHOTO 1 - View of Site looking east (near BH1)

Presently, the proposed building location is undeveloped land. Prior to our geotechnical investigation the area was fully treed; see Appendix F. The surrounding property is treed land with some campsite and hiking facilities including a washroom building at the northern side of the gravel parking lot.

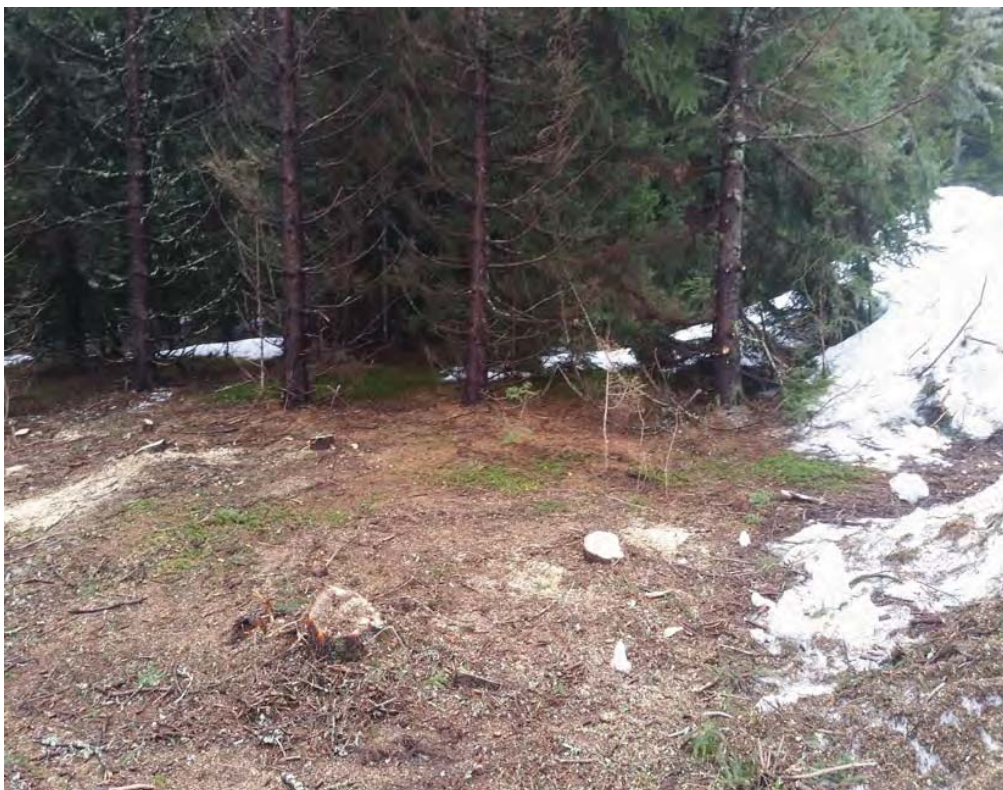
PHOTO 2 - View of Site looking west (near BH3)

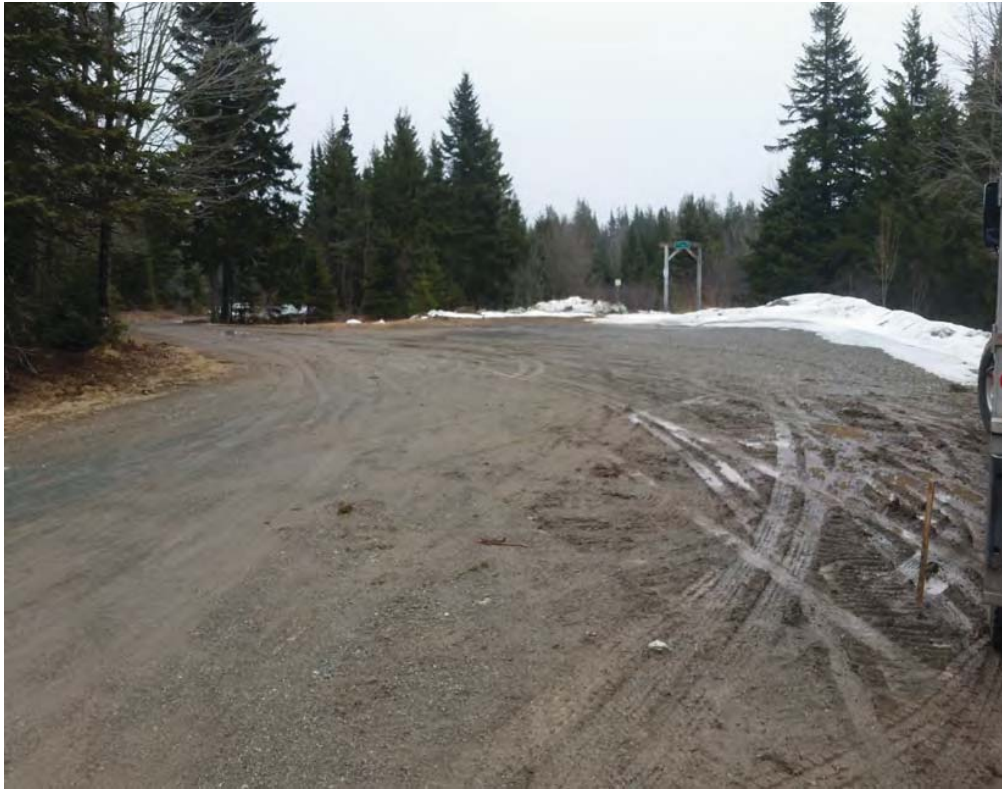
PHOTO 3 - View of gravel parking lot looking east

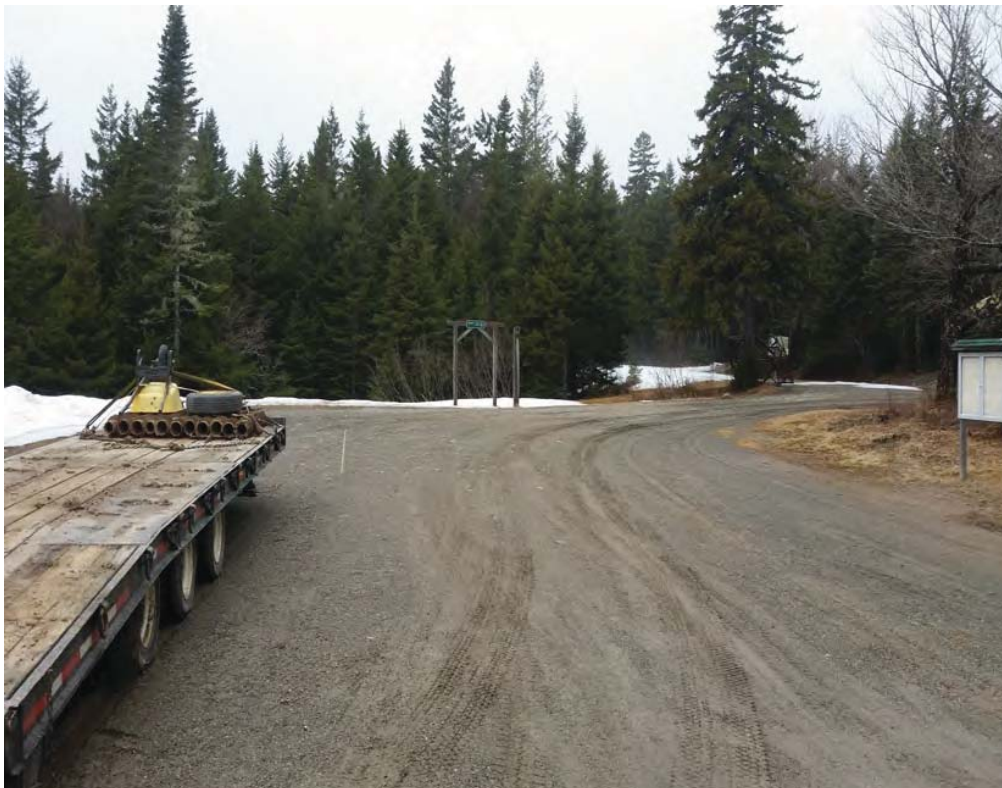
PHOTO 4 - View of gravel parking lot looking west
