DESIGNATED SUBSTANCES ASSESSMENT

Parks Canada: Fort Mississauga – Front Gate and Sally Ports

OESN PROJECT NUMBER: 00090.002

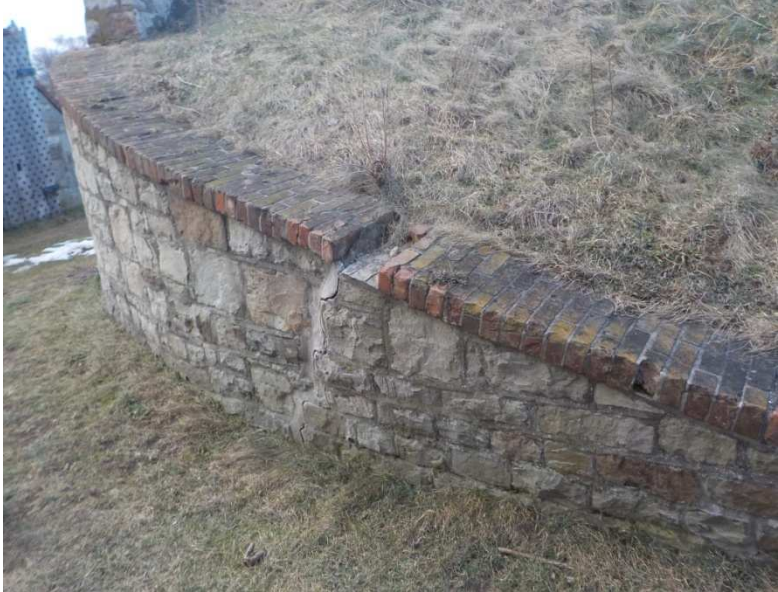
Sample Identification 00090.002-W01 00090.002-W02 00090.002-W03 Sample Code HW-01
	Sample Location of Material Front Gate
	Sample Description Brick Mortar
	Analytical Result None Detected
	Quantity of Material -
	Condition of Material -

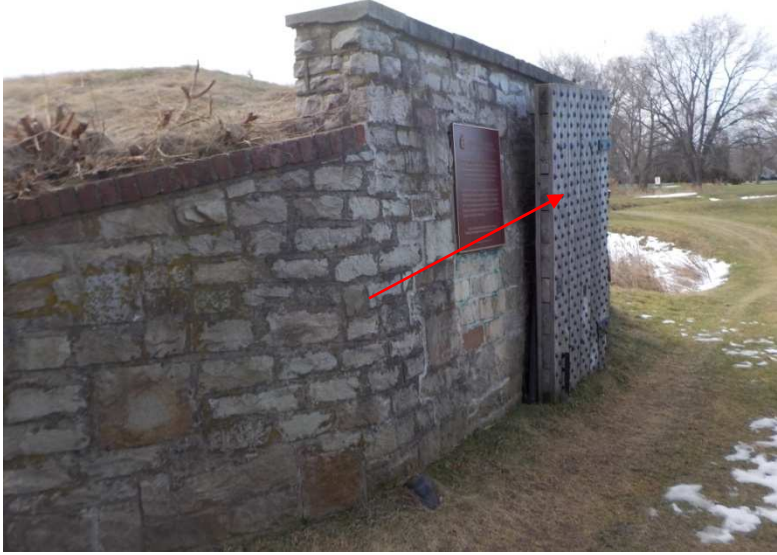
<p>Sample Identification 00090.002-W04 00090.002-W05 00090.002-W06</p> <p>Sample Code HW-02</p>
	<p>Sample Location of Material Front Gate</p>
	<p>Sample Description Stone Mortar</p>
	<p>Analytical Result None Detected</p>
	<p>Quantity of Material -</p>
	<p>Condition of Material -</p>

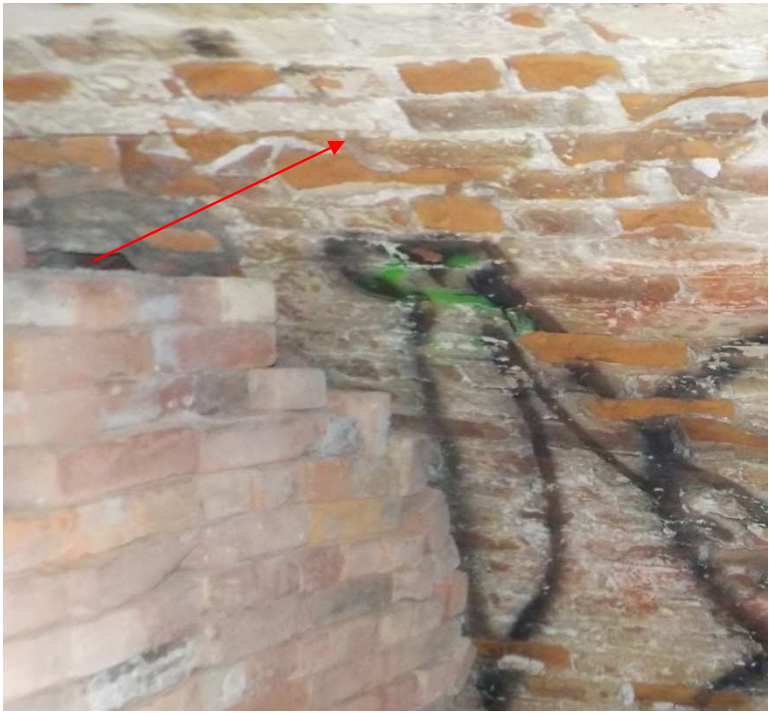
<p>Sample Identification 00090.002-W07 00090.002-W08 00090.002-W09</p> <p>Sample Code HW-03</p>
	<p>Sample Location of Material Sally Ports</p>
	<p>Sample Description Parging inside Sally Ports</p>
	<p>Analytical Result None Detected</p>
	<p>Quantity of Material -</p>
	<p>Condition of Material -</p>

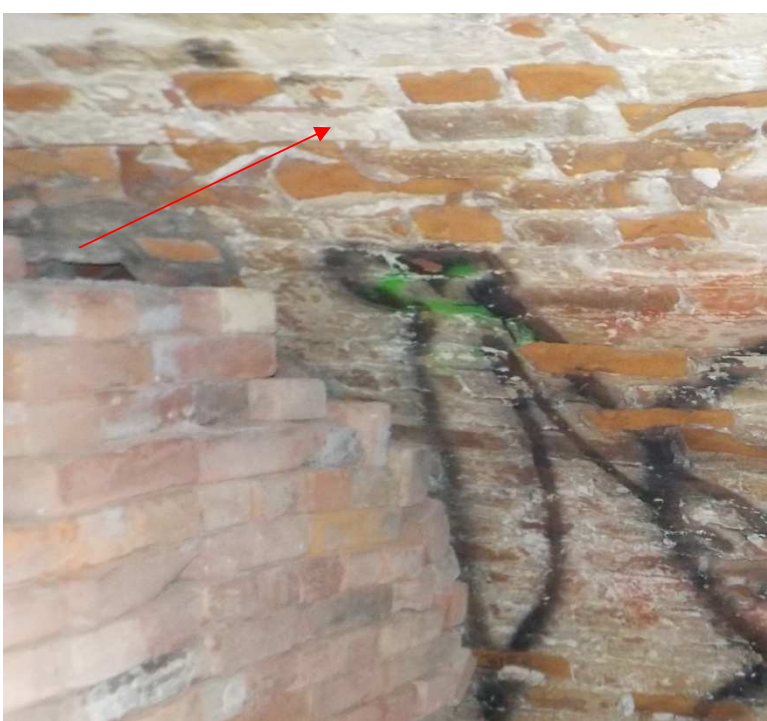
<p>Sample Code L03</p>
	<p>Sample Location of Material Sally Ports</p>
	<p>Sample Description Parging inside Sally Ports</p>
	<p>Analytical Result Above Detection Limit 8.3 ug/g dry</p>

1. The information contained in this report should be provided to all vendors (contractors) prior to conduction of any building maintenance or alteration activities.
2. Contractors performing alteration work to masonry materials should wear an air purifying half-face respirator with a 100-series particulate filter. The respirator must be fitted so that there is an effective seal between the worker's face and the respirator.
