15174A-S03 DRAWING 4 OF 7

WEIR - EDMOND'S LOCK MASONRY REHABILITATION

LOCK (AREA 1) PLAN AND ELEVATIONS

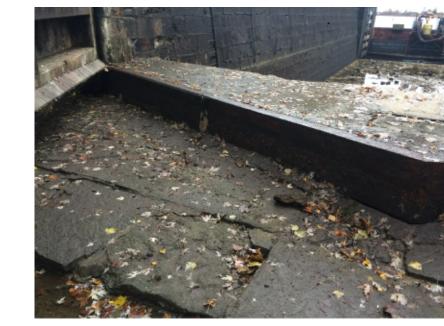
PHOTO SCALE: NTS DAMAGED FLAGSTONES

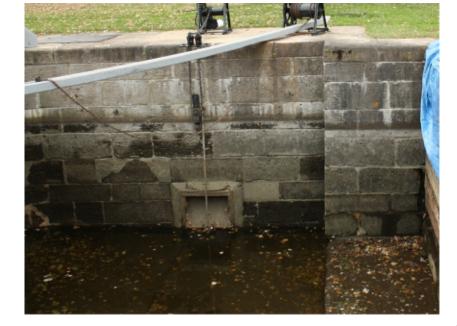
PHOTO SCALE: NTS BADLY DAMAGED EAST WALL AT SLUICE TUNNEL

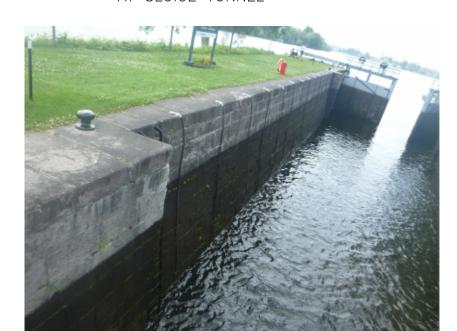
PHOTO

SCALE: NTS LOCK WALL SHOWING. HORIZONTAL JOINTS. AT TOP OF WALL
