## PAVEMENT DESIGN REPORT

# Pavement Investigation and Design for Proposed Reconstruction and Rehabilitation Pukaskwa National Park Heron Bay, Ontario

**Report Number: 1545167**

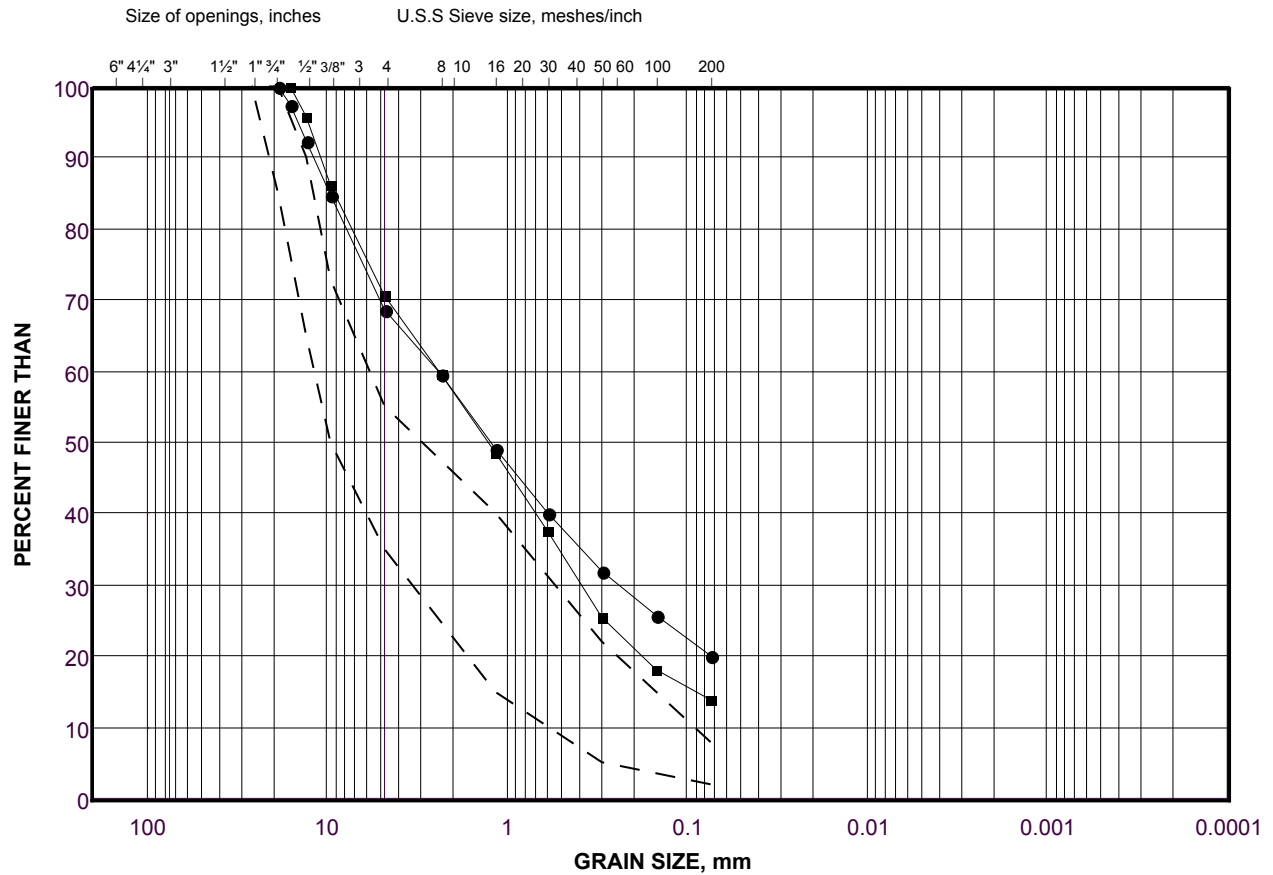
FIGURE 4

The base material generally consists of a brown silty crushed gravelly sand and the subbase material consists of brown fine to coarse sand, trace to some silt, trace cobbles. The results of the gradation testing carried out on two granular base samples indicate that the material generally does not meet the OPSS 1010 specification for Granular A (too fine on multiple sieves and too silty). The gradations of the granular base samples tested are provided on Figure 4.

Granular A

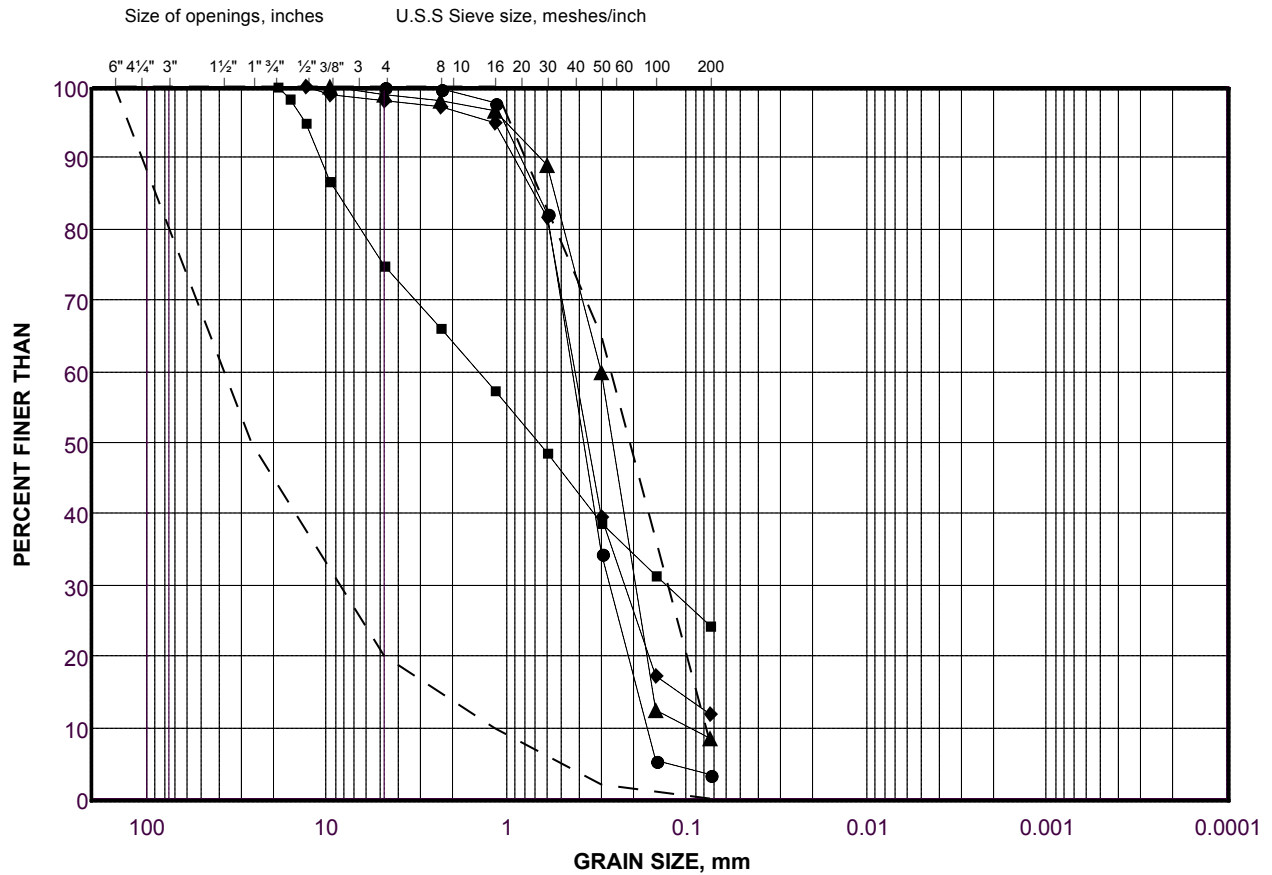
FIGURE 5

Two of the four granular subbase samples tested did not meet the OPSS 1010 specification for Granular B, Type I due to excessive fines. The results of the gradation testing carried out on the granular subbase samples are provided on Figure 5. In many of the boreholes, the subbase material and subgrade material were similar and the layer boundary between the two layers could not be delineated.

Granular B Type 1

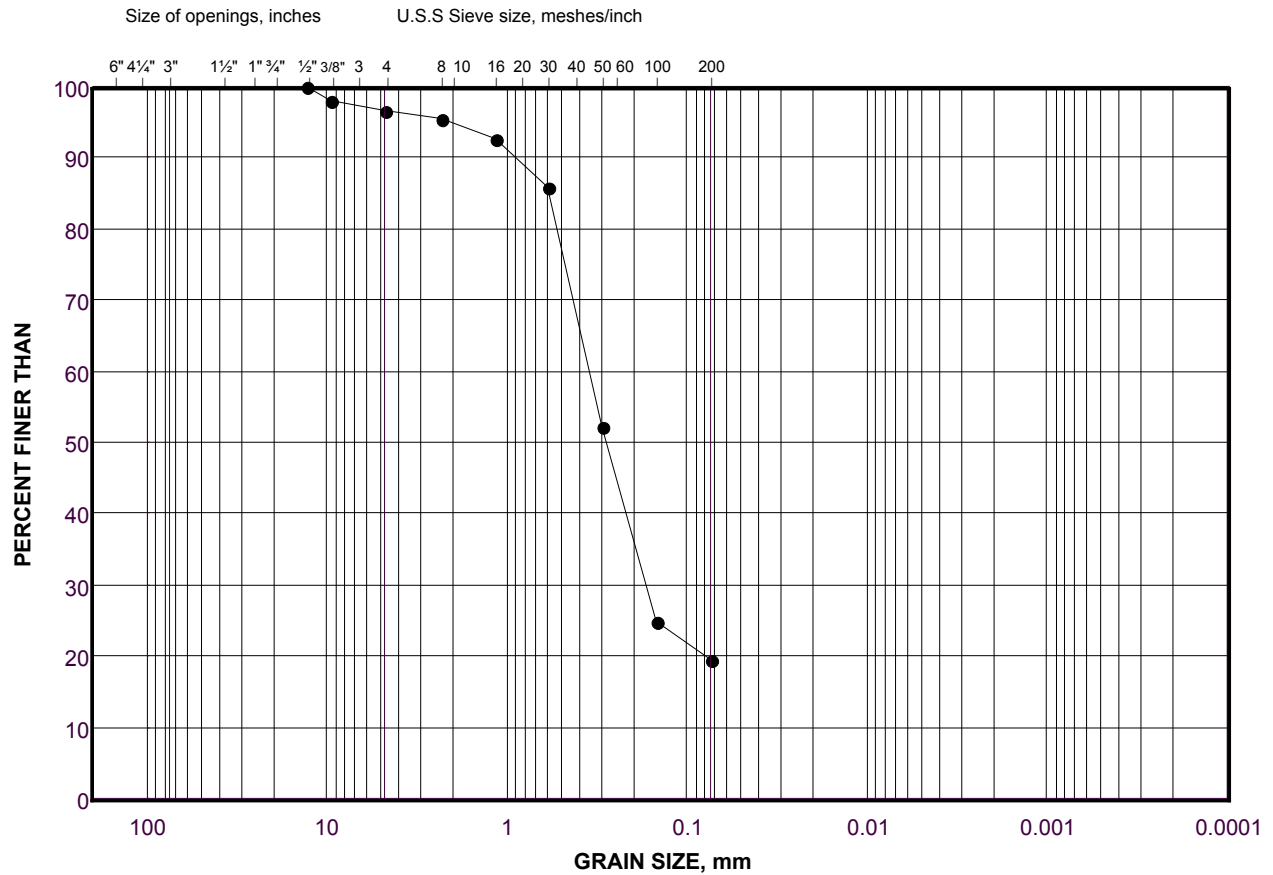
FIGURE 6

The subgrade and subbase materials encountered generally have low frost susceptibility. A localized deposit of highly frost susceptible clayey silt was encountered in Borehole 9 at a depth of 1.9 m; however, based on the pavement condition, it does not appear to be impacting pavement performance. The results of the particle size distribution tests carried out on selected subgrade soil samples are provided on Figures 6 and 7.

Silty Sand

Location	See borehole plan						
BH6	0 - 175 175 - 330 330 - 2.2	Asphalt Brown crushed GRAVELLY SAND Brown SAND trace gravel, trace silt, moist, compact					
Location	See borehole plan						
BH7	0 - 50 50 - 320 320 - 2.2	Asphalt Brown crushed GRAVELLY SAND Brown fine to coarse SAND, trace gravel, trace silt, trace cobbles, moist, free water @ 1.2 m, saturated, compact					
Location	See borehole plan						
BH8	0 - 50 50 - 280 280 - 1.1 - 1.1	Asphalt Brown Crushed GRAVELLY SAND Brown gravelly SILTY SAND, trace cobbles, moist, compact NFP Boulders	300 - 600	LSFH	0.05	5	Figure 5, Unacceptable Granular B Type I, too silty
Location	See borehole plan						
BH9	0 - 50 50 - 300 300 - 690 690 - 1.9 1.9 - 2.2	Asphalt Brown Crushed GRAVELLY SAND Brown SAND, trace gravel, trace silt, trace cobbles, moist, compact Brown SILTY SAND, trace gravel, wet, free water @ 850 mm, saturated, compact Grey CLAYEY SILT, some sand, wet, firm	700 - 1.0 1.9 - 2.2	LSFH HSFH	0.1 0.35	13 23	Figure 6 Figure 7

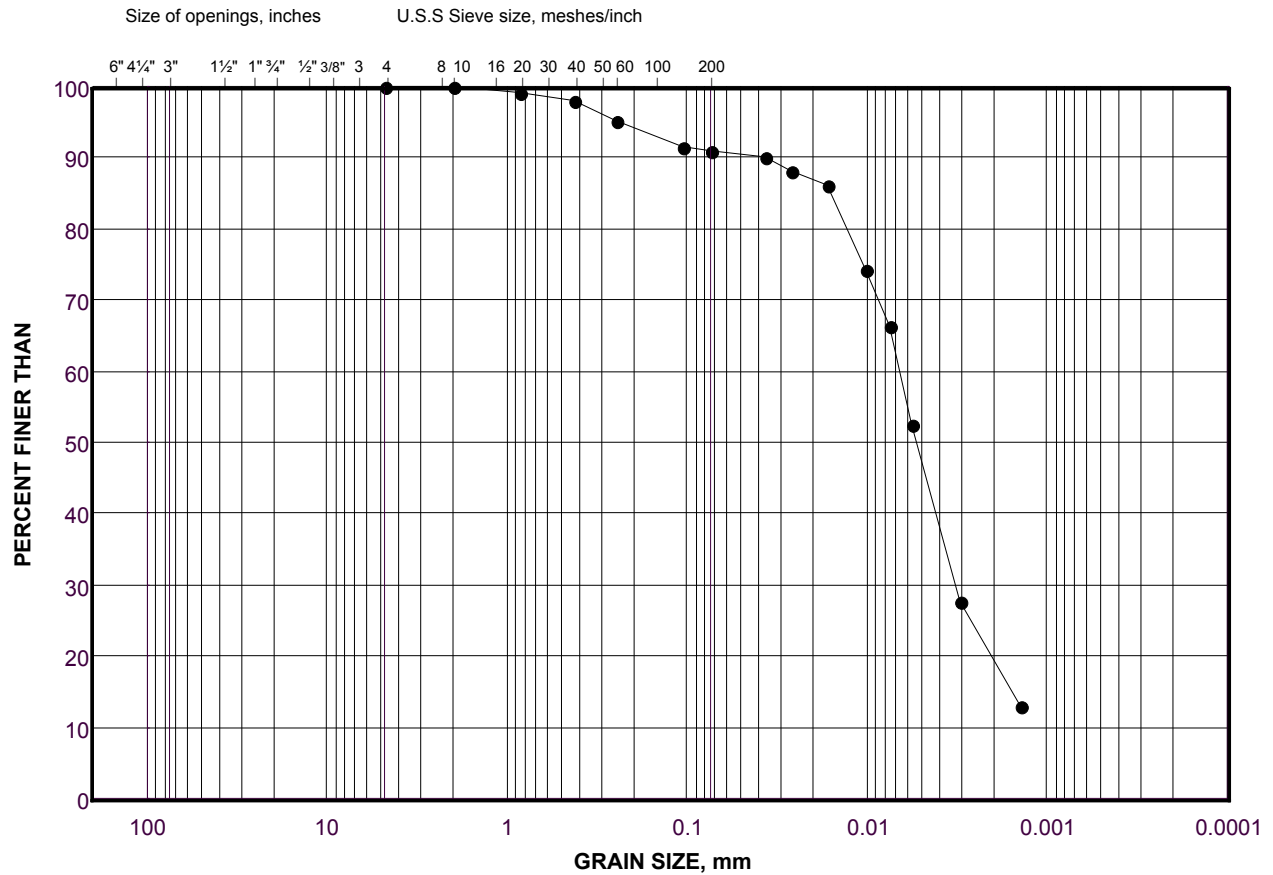
FIGURE 7

Clayey Silt
