REPORT ON

Airside Operations and Maintenance Centre, 2016 Post Remediation Monitoring and LTF Decommissioning, Edmonton International Airport

Report Number: 1657760

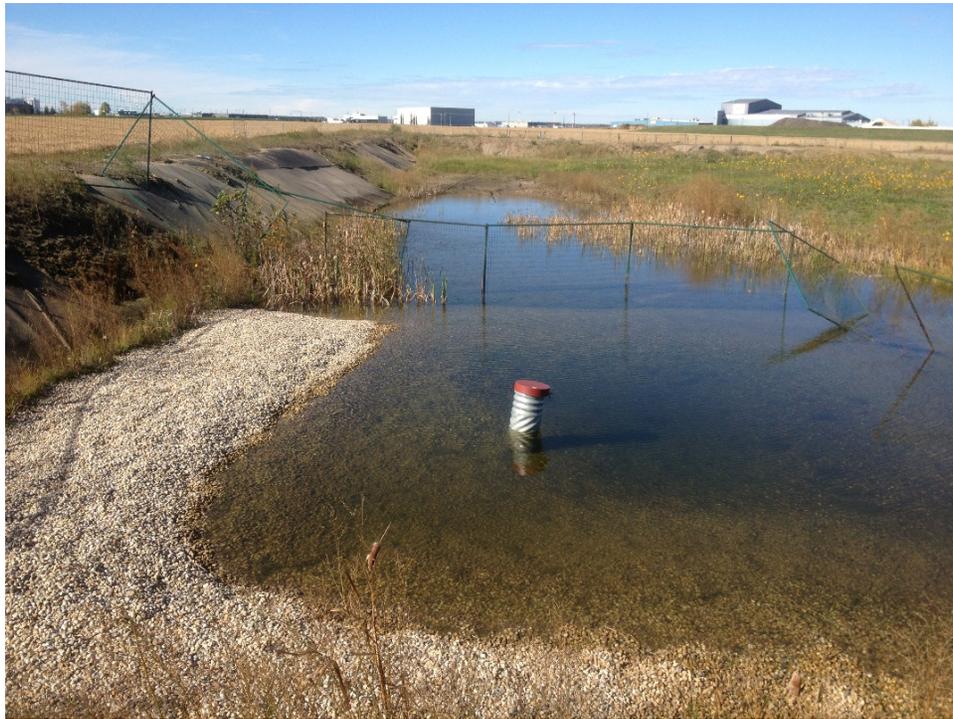
Photograph 1: South sump of the LTF prior to pump and treat activities.

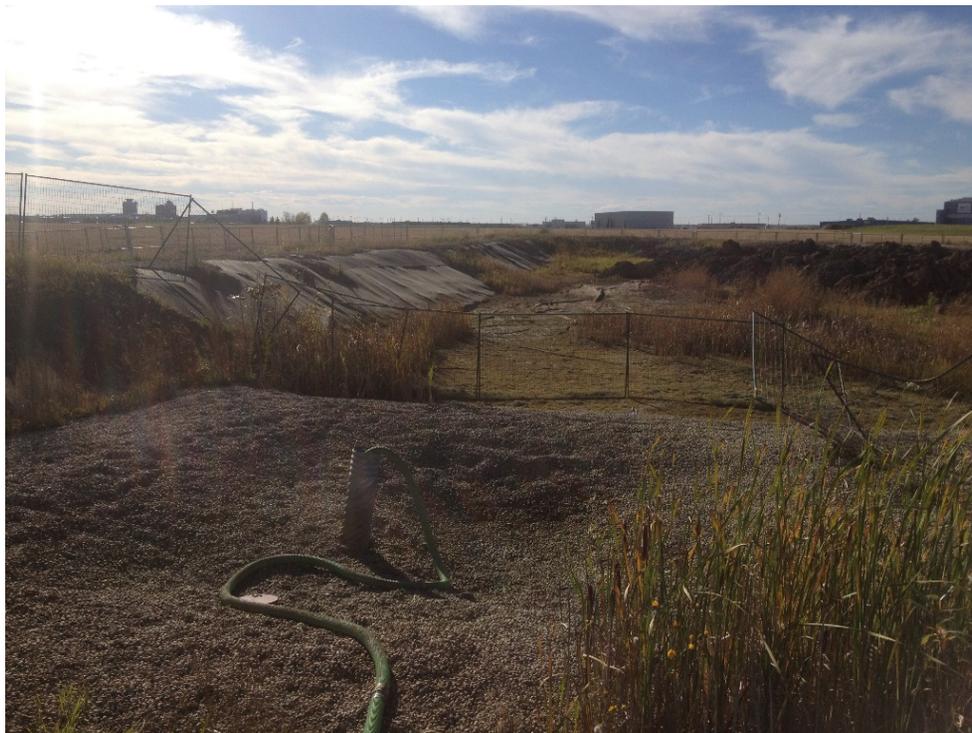
Photograph 2: South sump after pump and treat activities.

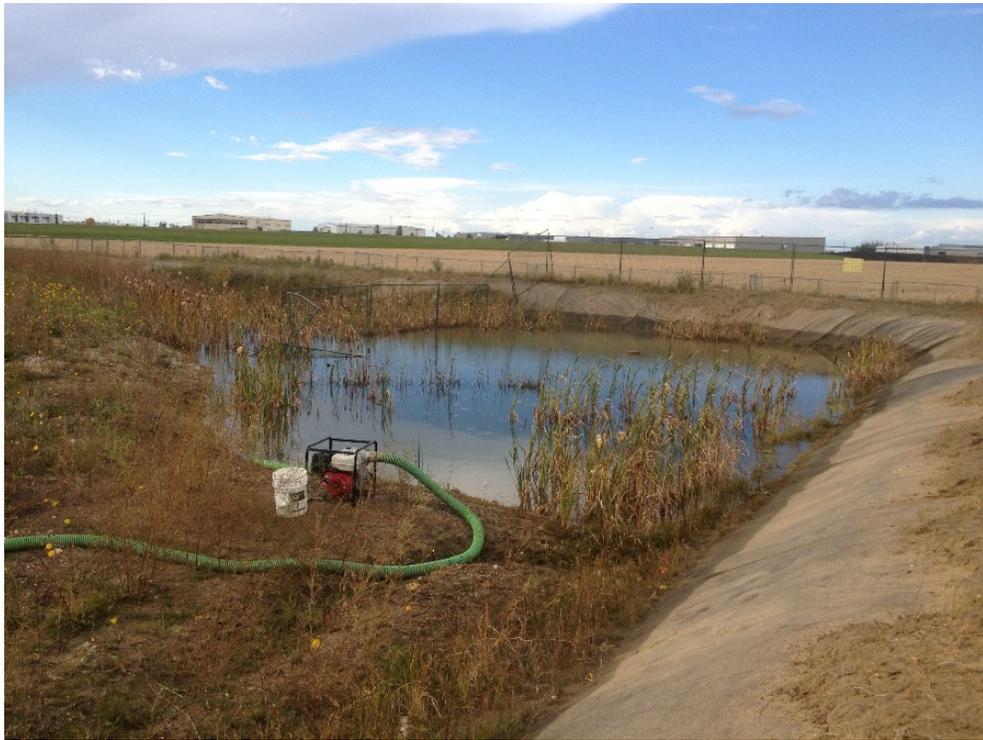
Photograph 3: North sump prior to decommissioning activities.

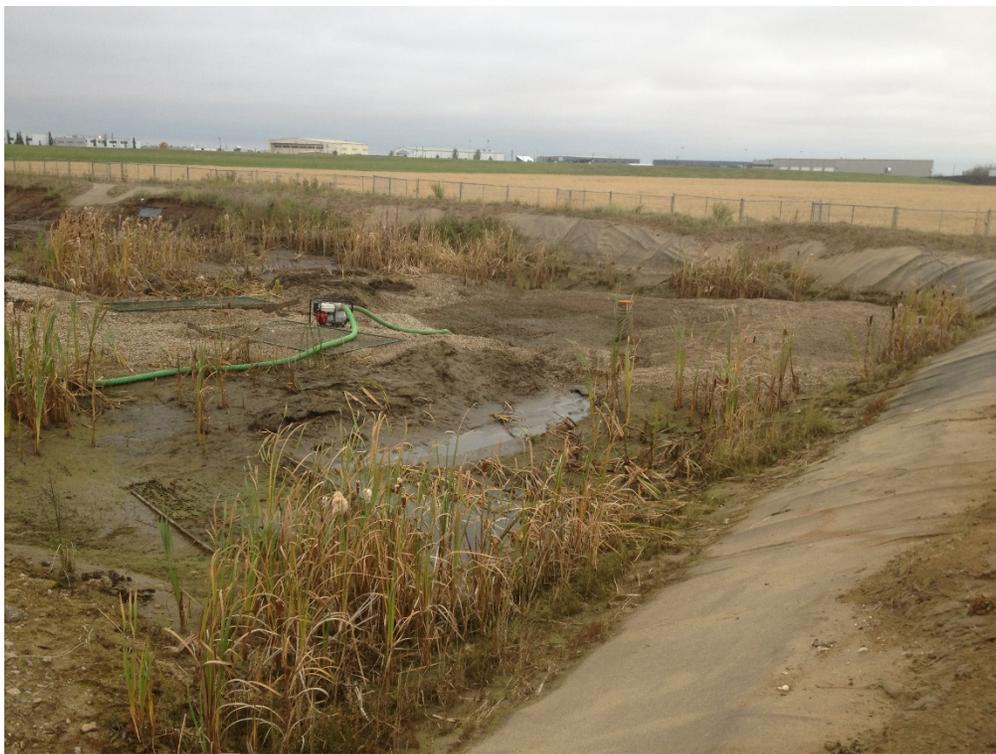
Photograph 4: North sump after pump and treat activities.

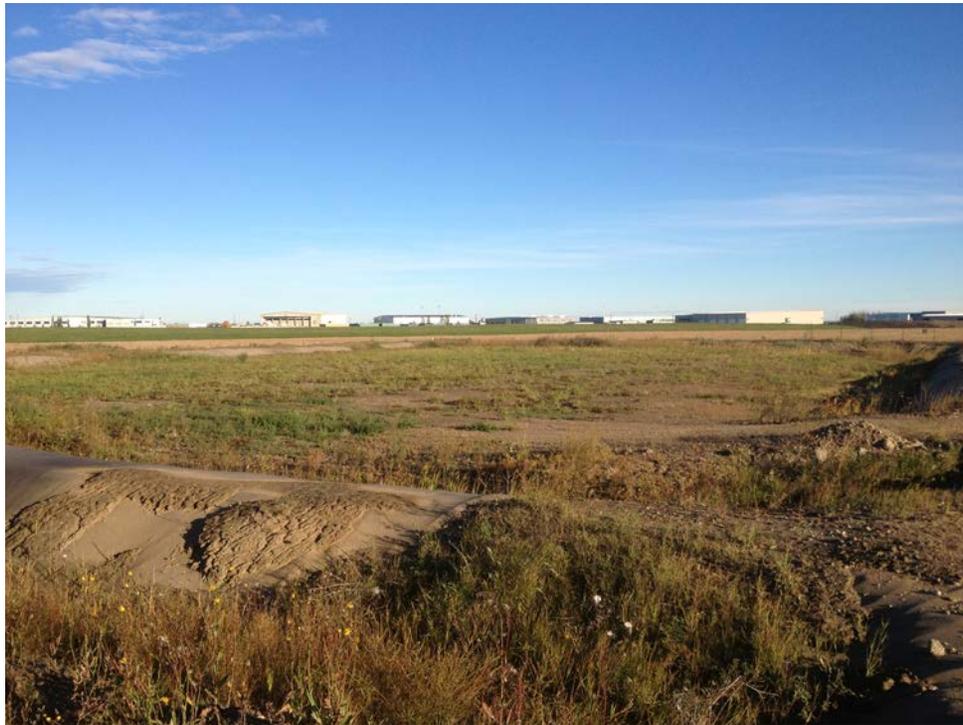
Photograph 5: North cell of the LTF prior to decommissioning activities.

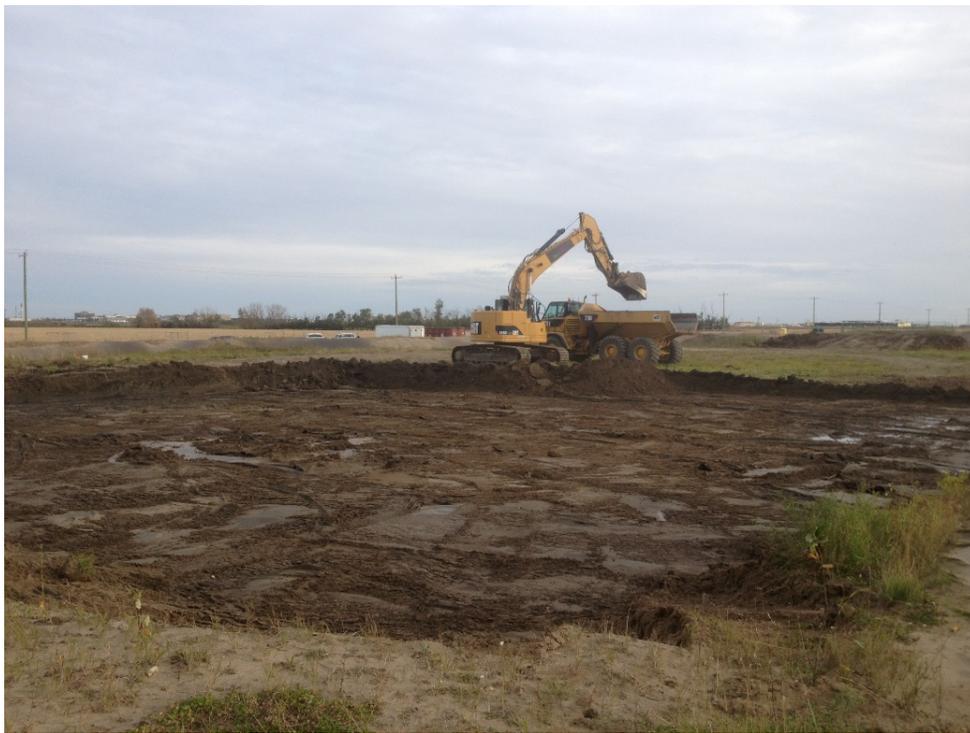
Photograph 6: Removing soil from the north cell.

All liner material was removed and disposed of at the MCL Waste Systems and Environmental Inc. (MCL) Leduc and District Regional Landfill. Each of the three liner layers was removed separately using a CAT 322C excavator to confirm that residual impacted soil was collected and transferred to the south cell. Following the removal of soil and liner material, Golder completed a visual assessment of the footprint of the north cell to identify any areas of staining and/or PHC odours. No areas of staining and/or PHC odours were identified and as a result, the north cell area was backfilled and roughly graded using fill materials from the north cell berms.

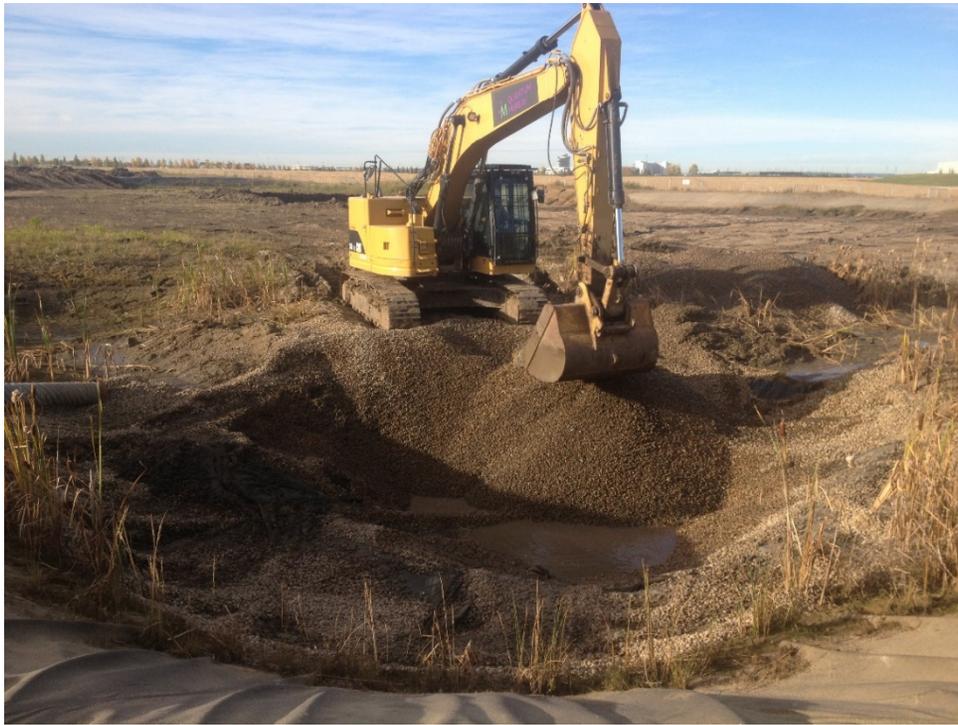
Photograph 7: Removing gravel from the north sump.

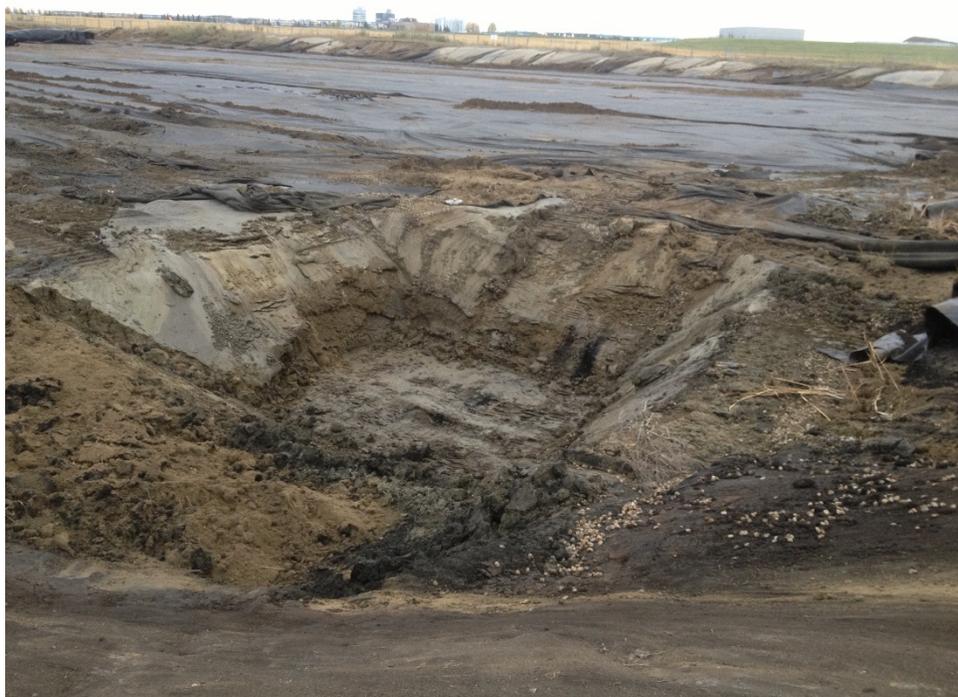
Photograph 8: North sump prior to backfilling.

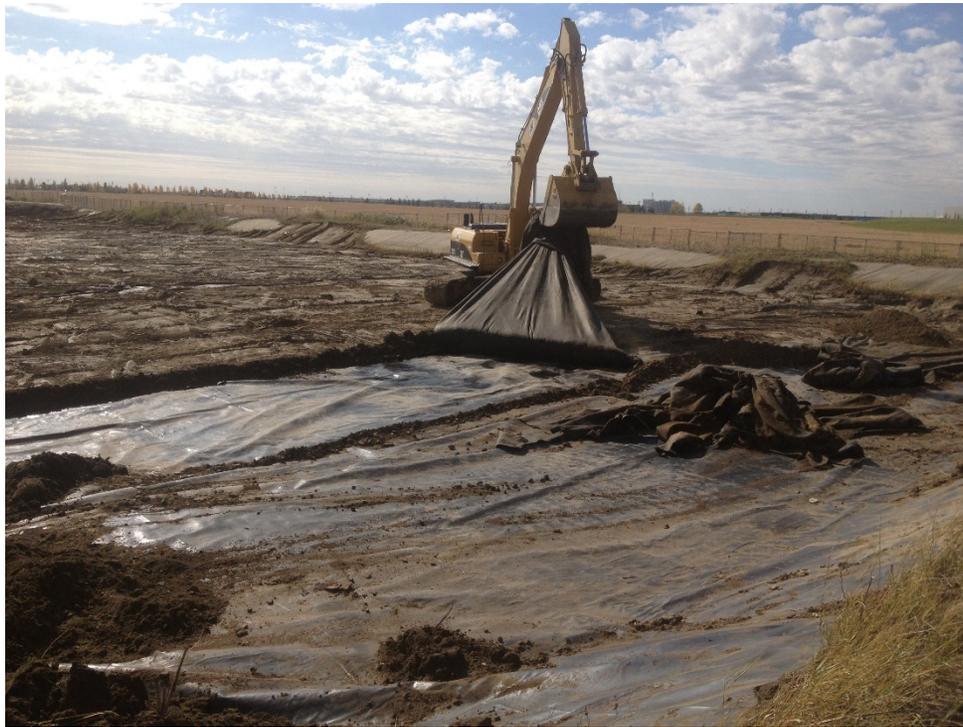
Photograph 9: Removing the top geotextile liner.

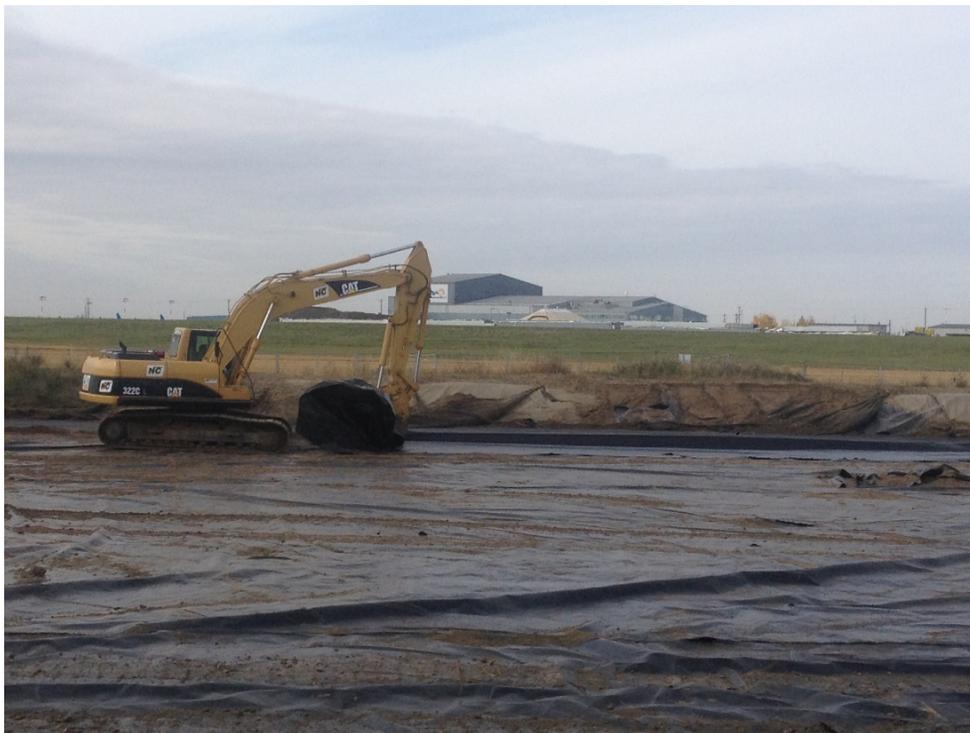
Photograph 10: Removing the second liner.

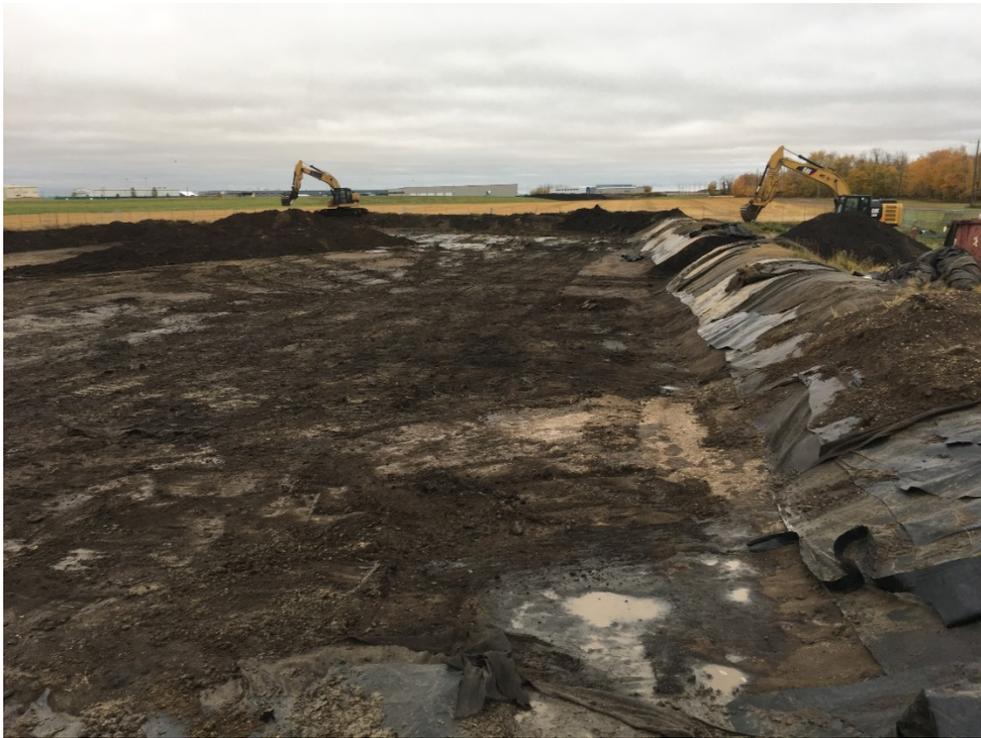
Photograph 11: Removing the liner from the berm and spreading soil in the north cell.

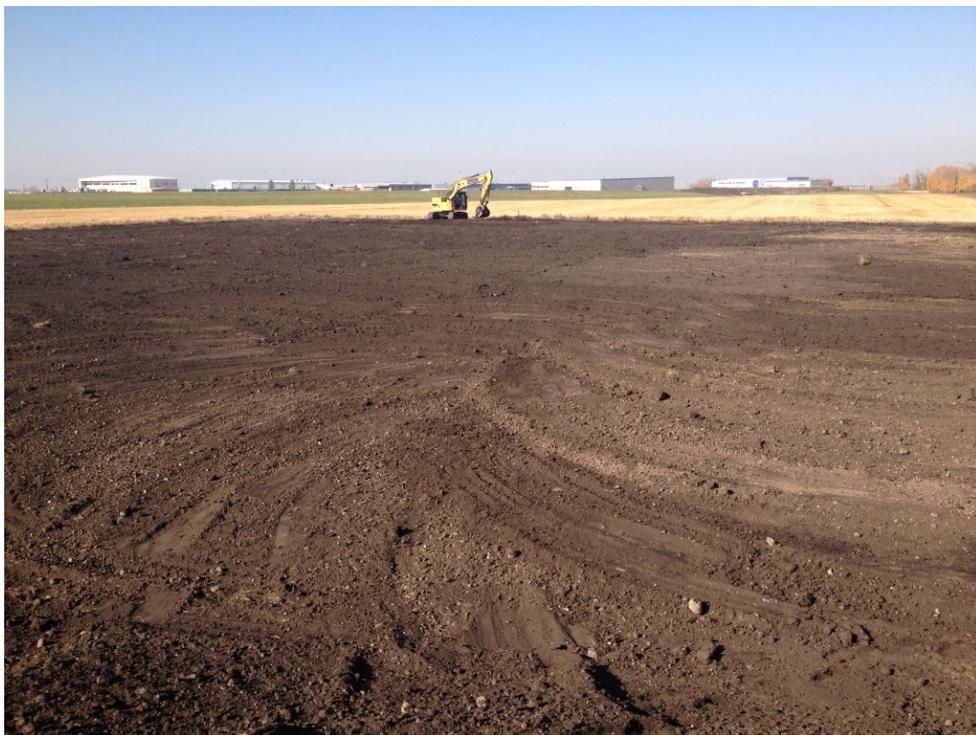
Photograph 12: North cell after decommissioning activities.

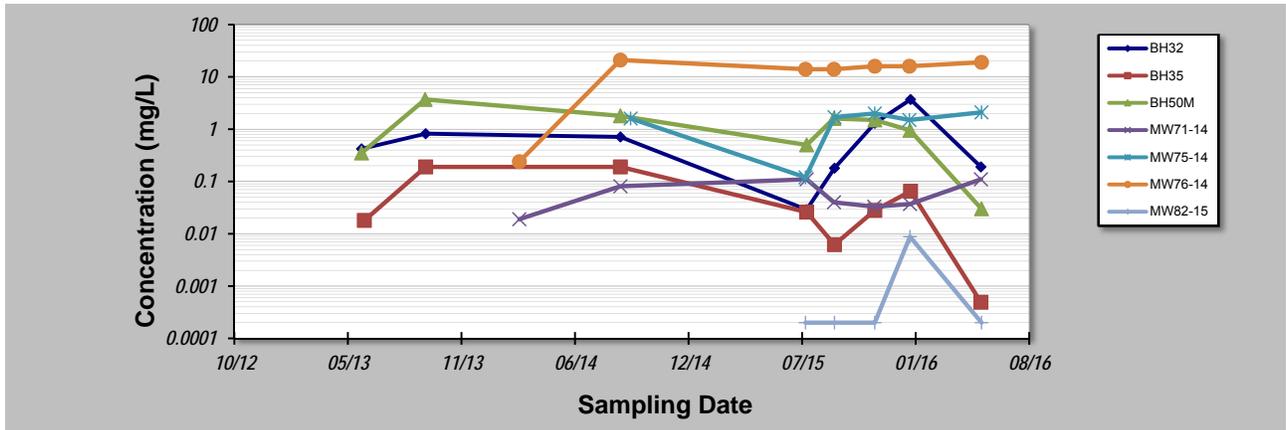
Evaluation Date: 26-Oct-16	Job ID: 1657760
Facility Name: PWGSC - AOMC	Constituent: Benzene
Conducted By: Rebecca Boyce	Concentration Units: mg/L

Sampling Point ID:	BH32	BH35	BH50M	MW71-14	MW75-14	MW76-14	MW82-15
Sampling Event	Sampling Date						
	BENZENE CONCENTRATION (mg/L)						
1	30-May-13	0.42		0.35			
2	4-Jun-13		0.018				
3	19-Sep-13			3.7			
4	20-Sep-13	0.82	0.19				
5	4-Mar-14				0.019		0.24
6	29-Aug-14	0.71	0.19	1.8	0.081		21
7	16-Sep-14					1.6	
8	21-Jul-15				0.12	14	0.0002
9	23-Jul-15	0.029	0.026	0.5	0.11		
10	9-Sep-15			1.6	0.04		14
11	10-Sep-15	0.18	0.0062			1.7	0.0002
12	19-Nov-15				0.033		
13	20-Nov-15	1.3	0.028	1.5		2	16
14	20-Jan-16					1.5	16
15	21-Jan-16			0.95	0.037		0.0088
16	22-Jan-16	3.7	0.065				
17	25-May-16	0.19	0.00049		0.11		
18	26-May-16			0.03		2.1	19
19							0.0002
20							
Coefficient of Variation:	1.30	1.21	0.89	0.62	0.48	0.47	2.00
Mann-Kendall Statistic (S):	4	-7	-10	4	7	9	2
Confidence Factor:	64.0%	76.4%	86.2%	66.7%	86.4%	88.1%	59.2%
Concentration Trend:	No Trend	No Trend	Stable	No Trend	No Trend	No Trend	No Trend

Dissolved-phase PHC trends (BTEX and PHC Fractions F1 and F2) generally indicated either stable or “no-trend” determination based on Mann-Kendall analyses (refer to Appendix E). At monitoring well MW71-14, located immediately downgradient of the historical excavation limit, decreasing trends were noted for toluene. At monitoring well BH50M, located near the southwestern perimeter of the historical excavation limits, decreasing trends were noted for PHC Fraction F2 and at monitoring well BH35, located along the western boundary of the Site, decreasing trends were noted for ethylbenzene.

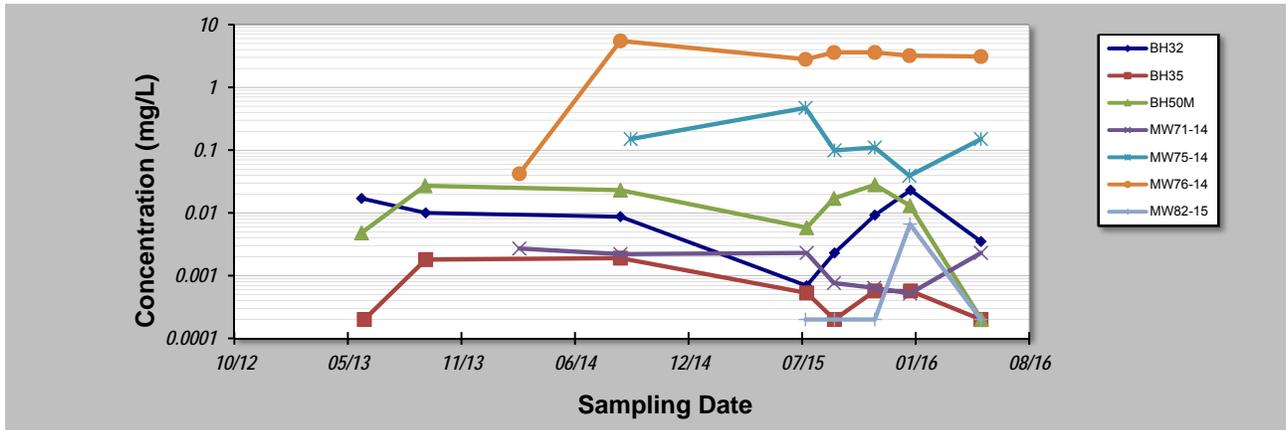
Sampling Event	Sampling Date	TOLUENE CONCENTRATION (mg/L)						
1	30-May-13	0.017		0.0048				
2	4-Jun-13		0.0002					
3	19-Sep-13			0.027				
4	20-Sep-13	0.01	0.0018					
5	4-Mar-14				0.0027		0.042	
6	29-Aug-14	0.0087	0.0019	0.023	0.0022		5.5	
7	16-Sep-14					0.15		
8	21-Jul-15					0.47	2.8	0.0002
9	23-Jul-15	0.00069	0.00053	0.0058	0.0023			
10	9-Sep-15			0.017	0.00076		3.6	
11	10-Sep-15	0.0023	0.0002			0.099		0.0002
12	19-Nov-15				0.00064			
13	20-Nov-15	0.0092	0.00057	0.028		0.11	3.6	0.0002
14	20-Jan-16					0.039	3.2	
15	21-Jan-16			0.013	0.00052			0.0066
16	22-Jan-16	0.023	0.00057					
17	25-May-16	0.0035	0.0002		0.0023	0.15	3.1	0.0002
18	26-May-16			0.0002				
19								
20								
Coefficient of Variation:		0.82	0.94	0.72	0.58	0.90	0.52	1.93
Mann-Kendall Statistic (S):		-4	-4	-4	-10	-4	0	2
Confidence Factor:		64.0%	64.0%	64.0%	90.7%	70.3%	37.9%	59.2%
Concentration Trend:		Stable	Stable	Stable	Prob. Decreasing	Stable	Stable	No Trend

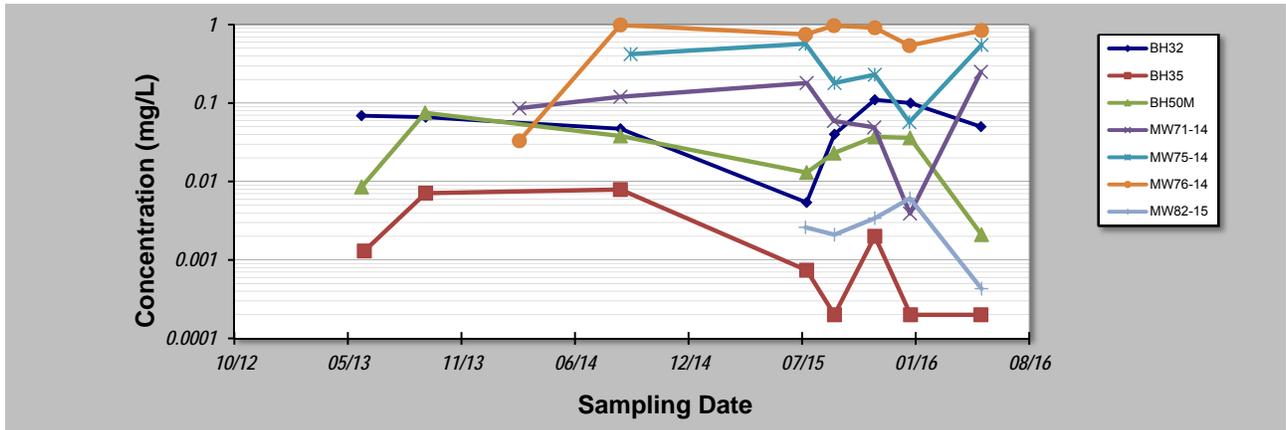
Sampling Event	Sampling Date	ETHYLBENZENE CONCENTRATION (mg/L)						
		BH32	BH35	BH50M	MW71-14	MW75-14	MW76-14	MW82-15
1	30-May-13	0.069		0.0085				
2	4-Jun-13		0.0013					
3	19-Sep-13			0.075				
4	20-Sep-13	0.066	0.0071					
5	4-Mar-14				0.086		0.033	
6	29-Aug-14	0.047	0.0079	0.038	0.12		0.99	
7	16-Sep-14					0.42		
8	21-Jul-15					0.57	0.75	0.0026
9	23-Jul-15	0.0054	0.00074	0.013	0.18			
10	9-Sep-15			0.023	0.059		0.97	
11	10-Sep-15	0.04	0.0002			0.18		0.0021
12	19-Nov-15				0.049			
13	20-Nov-15	0.11	0.002	0.037		0.23	0.91	0.0034
14	20-Jan-16					0.057	0.54	
15	21-Jan-16			0.036	0.0039			0.0061
16	22-Jan-16	0.1	0.0002					
17	25-May-16	0.05	0.0002		0.25			
18	26-May-16			0.0021		0.55	0.84	0.00043
19								
20								
Coefficient of Variation:		0.55	1.30	0.80	0.79	0.63	0.47	0.71
Mann-Kendall Statistic (S):		0	-13	-6	-3	-3	-1	0
Confidence Factor:		45.2%	92.9%	72.6%	61.4%	64.0%	50.0%	40.8%
Concentration Trend:		Stable	Prob. Decreasing	Stable	Stable	Stable	Stable	Stable

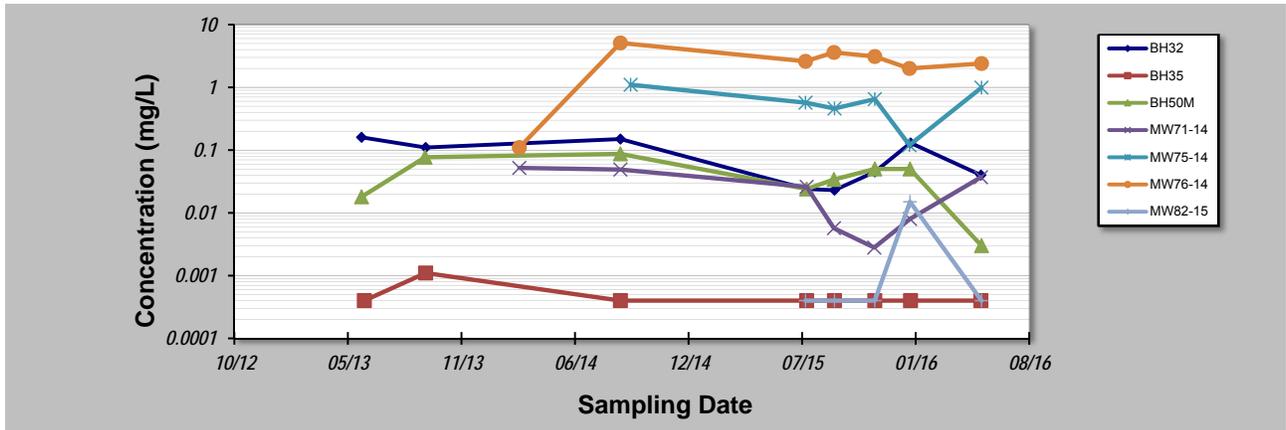
Evaluation Date: 26-Oct-16	Job ID: 1657760
Facility Name: PWGSC - AOMC	Constituent: Xylene
Conducted By: Rebecca Boyce	Concentration Units: mg/L

Sampling Point ID:	BH32	BH35	BH50M	MW71-14	MW75-14	MW76-14	MW82-15
Sampling Event	Sampling Date						
	XYLENE CONCENTRATION (mg/L)						
1	30-May-13	0.16		0.018			
2	4-Jun-13		0.0004				
3	19-Sep-13			0.077			
4	20-Sep-13	0.11	0.0011				
5	4-Mar-14				0.052		0.11
6	29-Aug-14	0.15	0.0004	0.087	0.049		5.1
7	16-Sep-14					1.1	
8	21-Jul-15				0.57	2.6	0.0004
9	23-Jul-15	0.024	0.0004	0.024	0.026		
10	9-Sep-15			0.034	0.0057		3.6
11	10-Sep-15	0.023	0.0004			0.46	0.0004
12	19-Nov-15				0.0028		
13	20-Nov-15	0.045	0.0004	0.05		0.65	3.1
14	20-Jan-16					0.12	2
15	21-Jan-16			0.05	0.008		0.015
16	22-Jan-16	0.13	0.0004				
17	25-May-16	0.04	0.0004		0.037		
18	26-May-16			0.003		0.99	2.4
19							0.0004
20							
Coefficient of Variation:	0.68	0.51	0.67	0.81	0.55	0.57	1.97
Mann-Kendall Statistic (S):	-10	-5	-3	-9	-3	-3	2
Confidence Factor:	86.2%	68.3%	59.4%	88.1%	64.0%	61.4%	59.2%
Concentration Trend:	Stable	Stable	Stable	Stable	Stable	Stable	No Trend

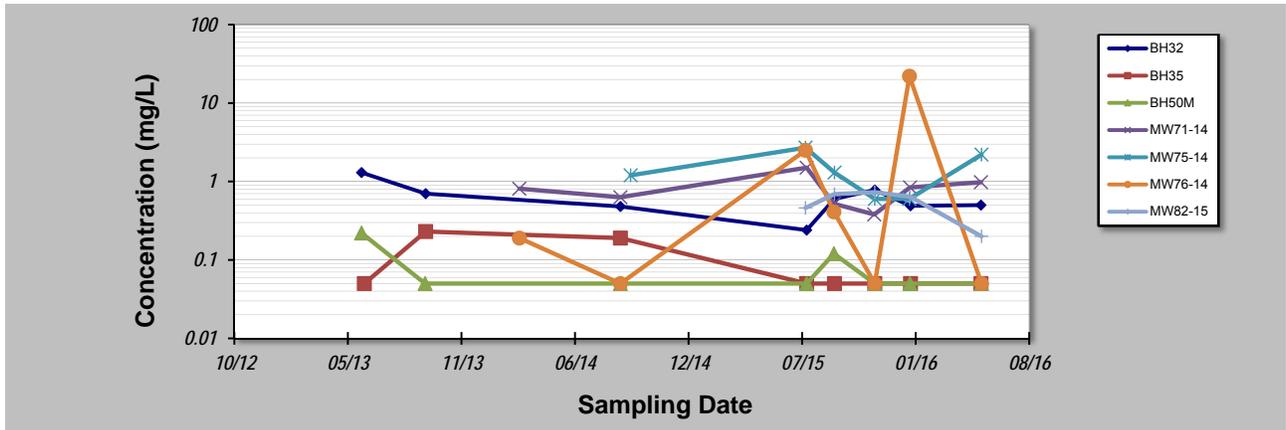
Sampling Event	Sampling Date	PHC F1 CONCENTRATION (mg/L)						
		BH32	BH35	BH50M	MW71-14	MW75-14	MW76-14	MW82-15
1	30-May-13	1.3		0.22				
2	4-Jun-13		0.05					
3	19-Sep-13			0.05				
4	20-Sep-13	0.7	0.23					
5	4-Mar-14				0.81		0.19	
6	29-Aug-14	0.48	0.19	0.05	0.63		0.05	
7	16-Sep-14					1.2		
8	21-Jul-15					2.7	2.5	0.46
9	23-Jul-15	0.24	0.05	0.05	1.5			
10	9-Sep-15			0.12	0.52		0.41	
11	10-Sep-15	0.6	0.05			1.3		0.69
12	19-Nov-15				0.38			
13	20-Nov-15	0.78	0.05	0.05		0.6	0.05	0.73
14	20-Jan-16					0.6	22	
15	21-Jan-16			0.05	0.84			0.64
16	22-Jan-16	0.49	0.05					
17	25-May-16	0.5	0.05		0.98			
18	26-May-16			0.05		2.2	0.05	0.2
19								
20								
Coefficient of Variation:		0.49	0.83	0.77	0.45	0.60	2.26	0.40
Mann-Kendall Statistic (S):		-6	-9	-7	1	-2	0	-2
Confidence Factor:		72.6%	83.2%	76.4%	50.0%	57.0%	37.9%	59.2%
Concentration Trend:		Stable	Stable	Stable	No Trend	Stable	No Trend	Stable

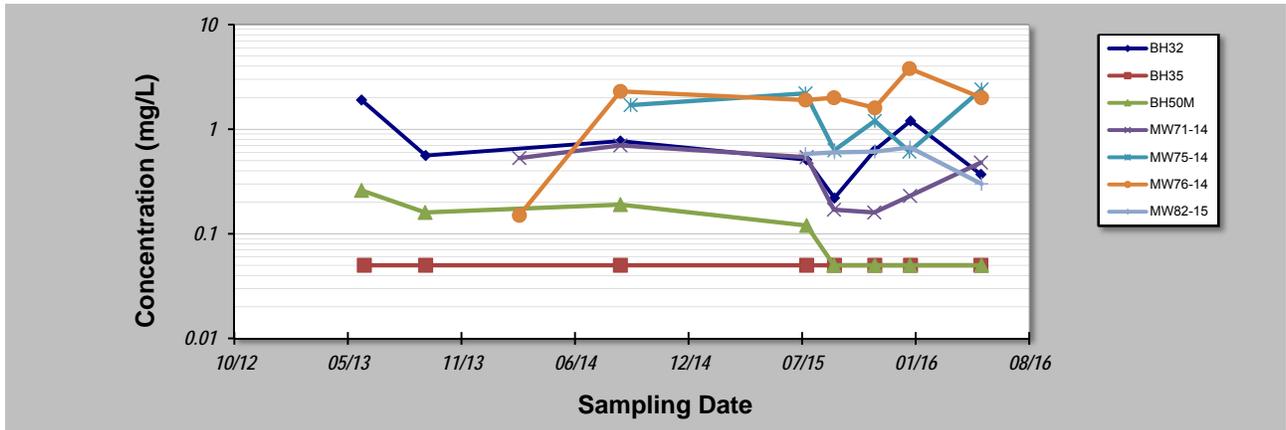
Sampling Event	Sampling Date	PHC F2 CONCENTRATION (mg/L)						
		BH32	BH35	BH50M	MW71-14	MW75-14	MW76-14	MW82-15
1	30-May-13	1.9		0.26				
2	4-Jun-13		0.05					
3	19-Sep-13			0.16				
4	20-Sep-13	0.56	0.05					
5	4-Mar-14				0.53		0.15	
6	29-Aug-14	0.77	0.05	0.19	0.7		2.3	
7	16-Sep-14					1.7		
8	21-Jul-15					2.2	1.9	0.58
9	23-Jul-15	0.51	0.05	0.12	0.54			
10	9-Sep-15			0.05	0.17		2	
11	10-Sep-15	0.22	0.05			0.63		0.6
12	19-Nov-15				0.16			
13	20-Nov-15	0.63	0.05	0.05		1.2	1.6	0.61
14	20-Jan-16					0.61	3.8	
15	21-Jan-16			0.05	0.23			0.67
16	22-Jan-16	1.2	0.05					
17	25-May-16	0.37	0.05		0.48			
18	26-May-16			0.05		2.4	2	0.3
19								
20								
Coefficient of Variation:		0.70	0.00	0.69	0.53	0.53	0.55	0.26
Mann-Kendall Statistic (S):		-8	0	-20	-7	-1	6	2
Confidence Factor:		80.1%	45.2%	99.3%	80.9%	50.0%	76.4%	59.2%
Concentration Trend:		Stable	Stable	Decreasing	Stable	Stable	No Trend	No Trend
