AAFC Pacific Research Centre - Agassiz

Hazardous Building Materials Abatement - Building 28 & 50

Requisition No. EZ899-181581

Project No. R.071945.001
December 2016

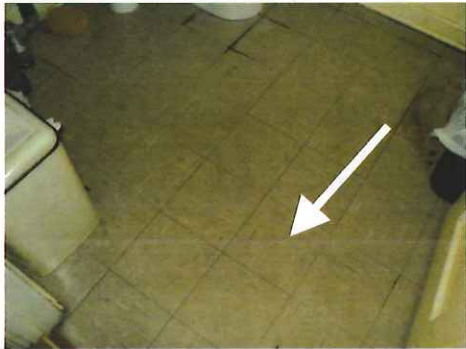
Identified ACM Description and Condition Information		Photo
9"x9" tan floor tile – present in the South office area washroom

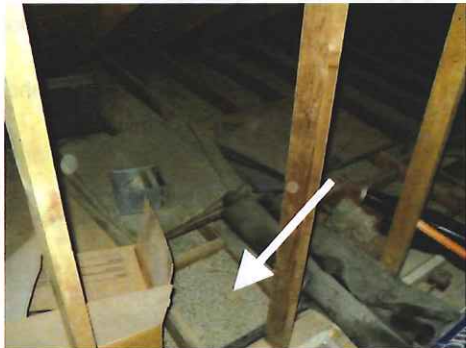
Friability	Non-Friable	
Condition	Good	
Access	A	
Vermiculite insulation – present in the attic space

Friability	Friable	
Condition	Good	
Access	Attic – C

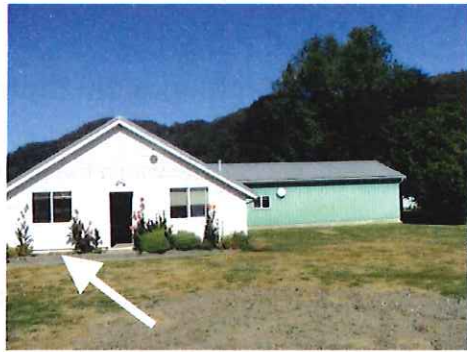
Identified LCP Description	Photo
White paint on exterior walls. This paint was observed to be in good condition (minimal bubbling, flaking or peeling).

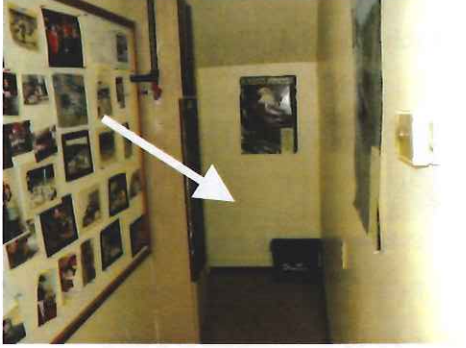
Identified LCP Description	Photo
<p>Beige paint on the walls and ceilings of the South office area. This paint was observed to be in good condition (minimal bubbling, flaking or peeling).</p>

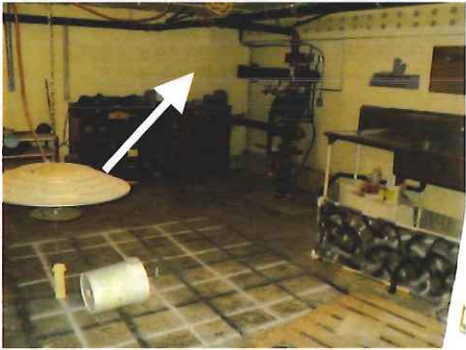
<p>White paint on the walls and ceilings of the barn area. This paint was observed to be in good condition (minimal bubbling, flaking or peeling).</p>

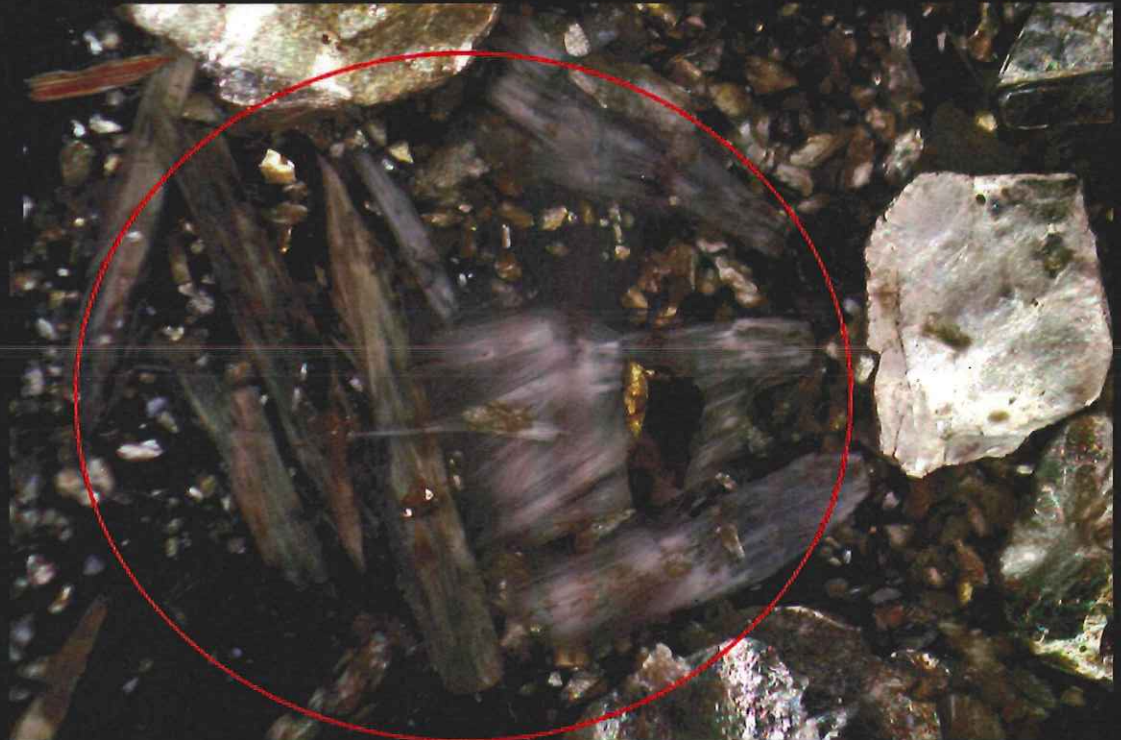
stereo binocular microscopy ~ 15x

washed & sieved

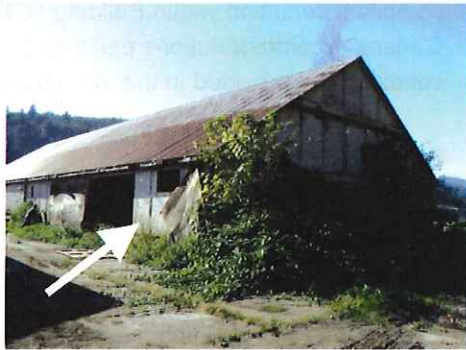
Identified LCP Description	Photo
<p>White paint on exterior walls. This paint was observed to be in good condition (no bubbling, flaking or peeling).</p>

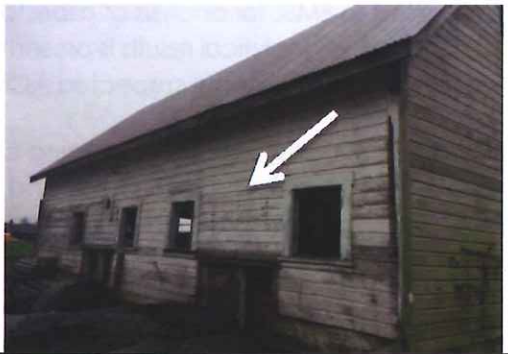
LCP Description		Photo
Paint colour	White

Substrate	Wood	
Location/approx. extent	Exterior walls throughout	
Lead content	89,000 ppm	
Condition	Poor (bubbling, flaking and peeling)	
Paint colour	Green

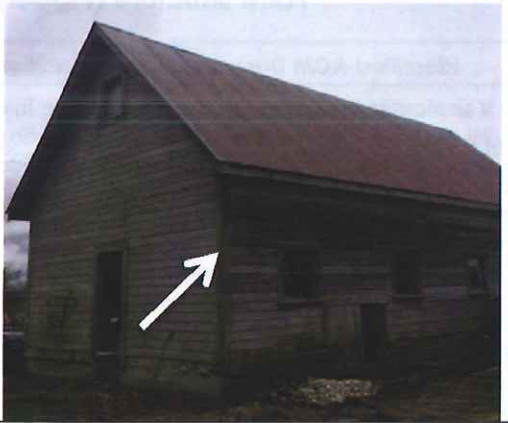
Substrate	Wood	
Location/approx. extent	Exterior trim and window frames	
Lead content	37,000 ppm	
Condition	Poor (bubbling, flaking and peeling)	
Paint colour	Blue

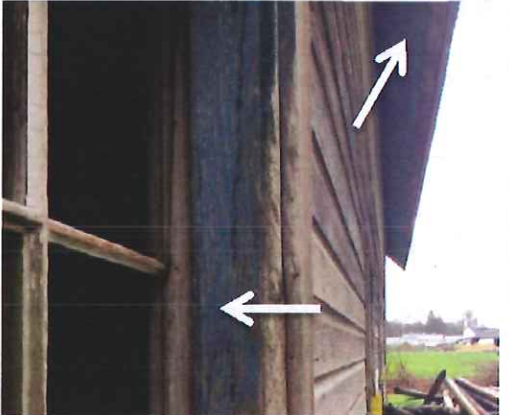
Substrate	Wood	
Location/approx. extent	Exterior trim, window frame and soffits	
Lead content	28,000	
Condition	Poor (bubbling, flaking and peeling)

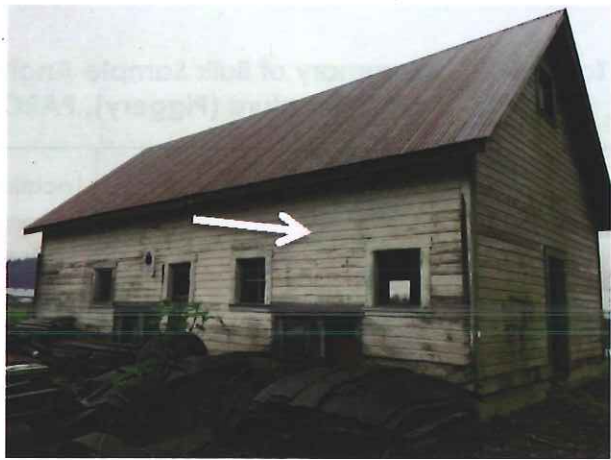
Identified Building Material/Paint with Leachable Lead	Photo
<p>White colour paint on exterior wood paneling</p> <p>Given that the lead concentrations in other exterior paints tested are of a similar magnitude (green trim: 37,000 ppm ; blue trim: 28,000 ppm) and that the substrate is similar to that tested with the white paint (wood), and given that the wood trim materials painted with green and blue paints represent only a small portion of the overall painted wood, it should be assumed all painted exterior wood from the building will contain lead in a dispersible form that its leachate contains greater than 5.0 mg/L.</p>

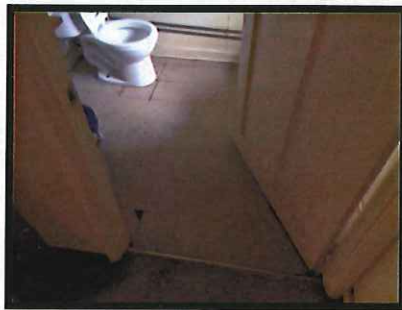
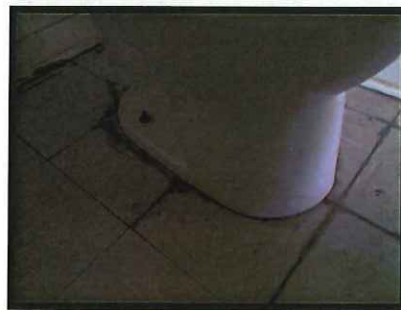
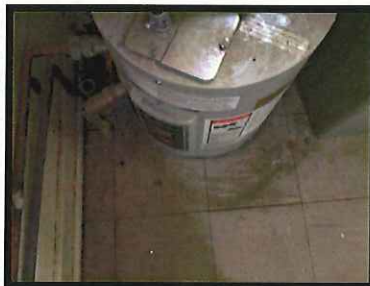
Photo Set 2 Building 28 - Asbestos containing 9"x9" tan vinyl floor tiles within the office area washroom

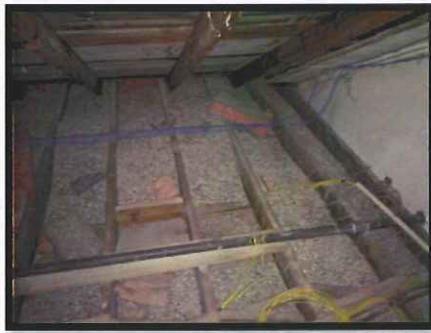
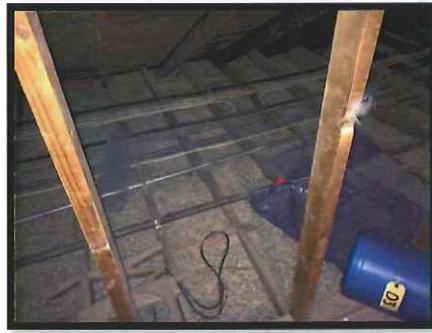
Photo Set 3 Building 28 – Asbestos-containing vermiculite attic insulation

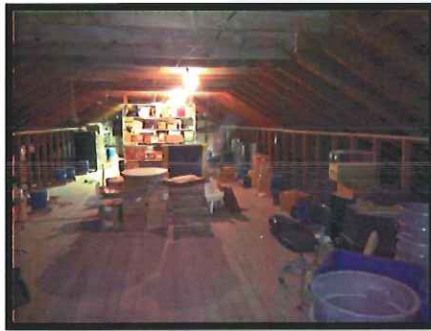
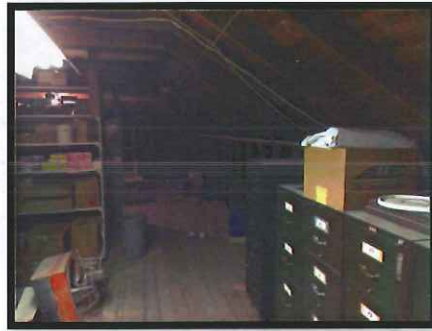
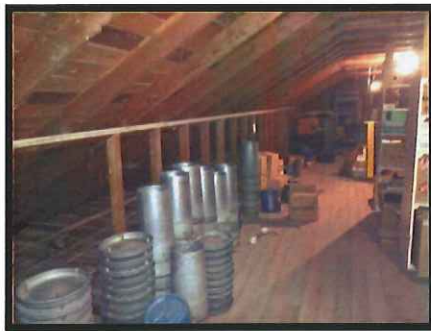
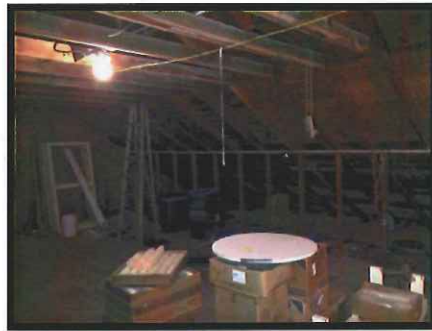
Photo Set 4 Building 28 – View of attic space and contents

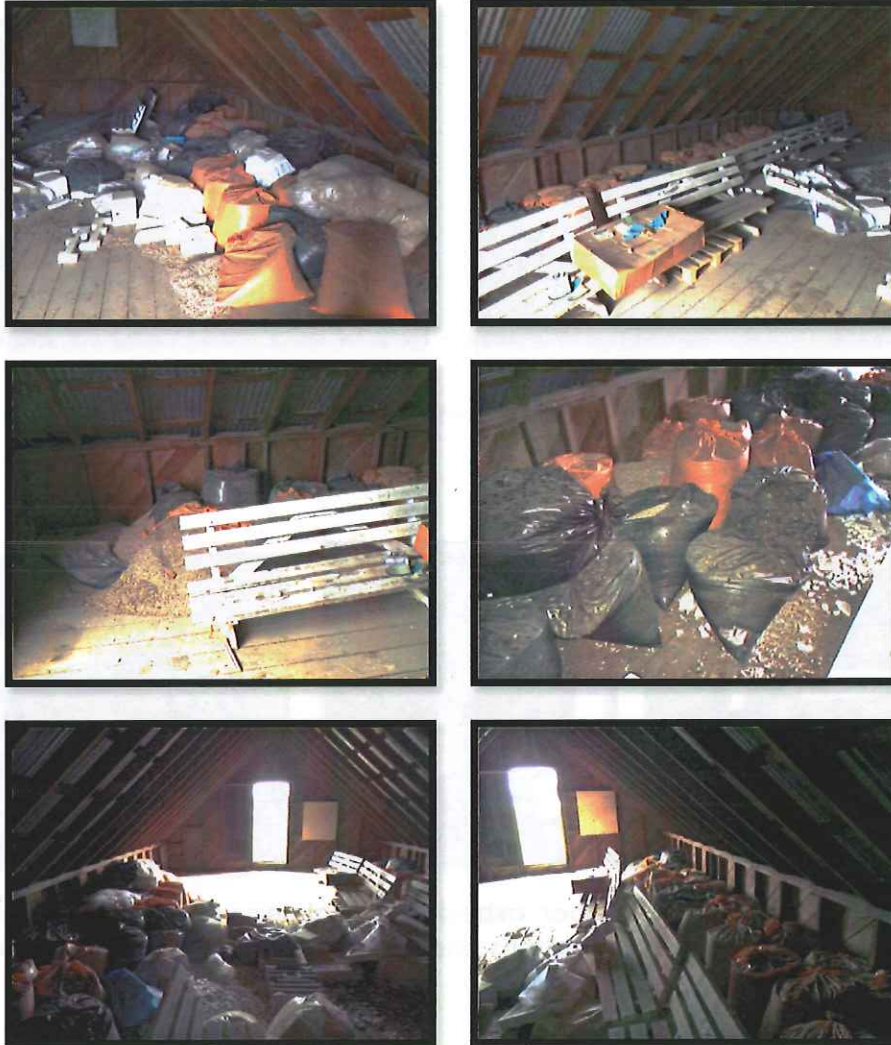
Photo Set 7 Building 50 – Attic space: asbestos-containing vermiculite insulation present in approximately 70 garbage bags as well as scattered throughout the attic – on the floor and on stored items

- .1 Removal and disposal of asbestos-containing vermiculite insulation.
 - .1 Confirmed to be present in 71 large garbage bags, as well as scattered throughout the attic floor as debris, as well as onto various areas on the ground level (through cracks in attic floor).
 - .1 Significant stored items are present within the attic space and on the ground level. All items are to be considered contaminated and included for removal and disposal.
