**PROJECT SPECIFIC DESIGNATED SUBSTANCE SURVEY
A-WING and C-WING RENOVATION PROJECT
BUILDING 201 – 3851 FALLOWFIELD ROAD, OTTAWA, ONTARIO**

GEC PROJECT No. 29008

JANUARY, 2016

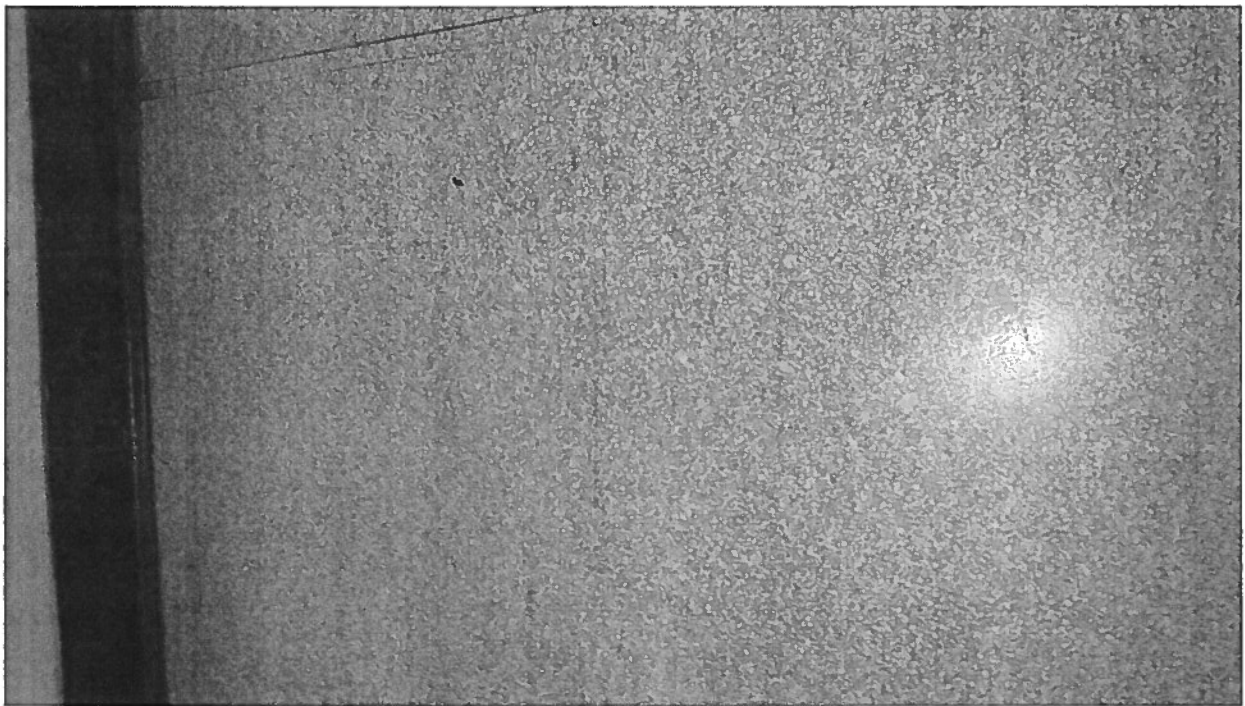
- Three (3) samples (SA-01A/B/C) of a sheet vinyl flooring of a beige sheet vinyl flooring (stone pattern with paper backing) were collected from the 4th Floor A-Wing Corridor for analysis. Based on the laboratory analysis, the vinyl flooring was found to contain **10% Chrysotile asbestos**.
 - This particular style of sheet vinyl flooring was identified as the primary flooring material within A-Wing.
 - Any manipulation of this particular style of sheet vinyl flooring must be completed in accordance with the procedures outlined in O.Reg 278/05.

Photo 1 – ACM Sheet Vinyl Flooring with Stone Pattern and Paper Backing.

- Prior to the planned renovations, all sheet vinyl flooring, drywall joint compound, brown duct sealant, acoustic ceiling tiles and textured ceiling finish that will be or has the potential of being disturbed, must be removed in accordance with the procedures outlined in Ontario Regulation 278/05 as well as the PWGSC Policy regarding Asbestos Management.

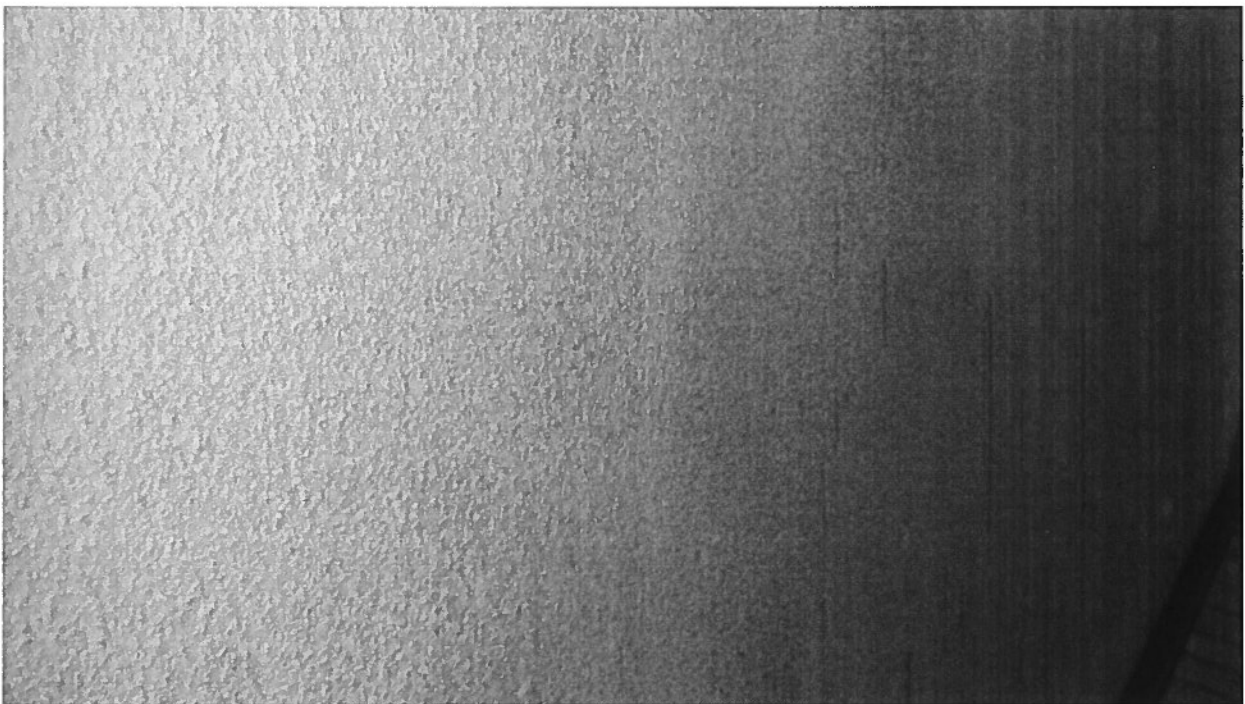
- Three (3) samples (SA-07A/B/C) of a textured ceiling/wall finish were collected from within the C-Wing Lobby area for analysis. Based on the laboratory analysis, SA-07A was found to contain **3% Chrysotile asbestos**.

Photo 2 – ACM Textured Ceiling Finish

- All textured ceiling finish within the project area must be treated as an ACM.
 - Any manipulation of textured wall finish must be completed in accordance with the procedures outlined in O.Reg 278/05.
- Three (3) samples (SA-06A/B/C) of an acoustic ceiling tile (60cm x 120cm with patterned pinholes and pink back) were collected from the 4th floor A-Wing corridor and submitted for laboratory analysis. Based on the laboratory analysis, SA-06A was found to contain **2.32% Chrysotile asbestos** and **0.77 Amosite asbestos**.
 - All visually similar acoustic ceiling tiles within the project area must be treated as an ACM.
 - Any manipulation of the acoustic ceiling tiles must be completed in accordance with the procedures outlined in O.Reg 278/05.

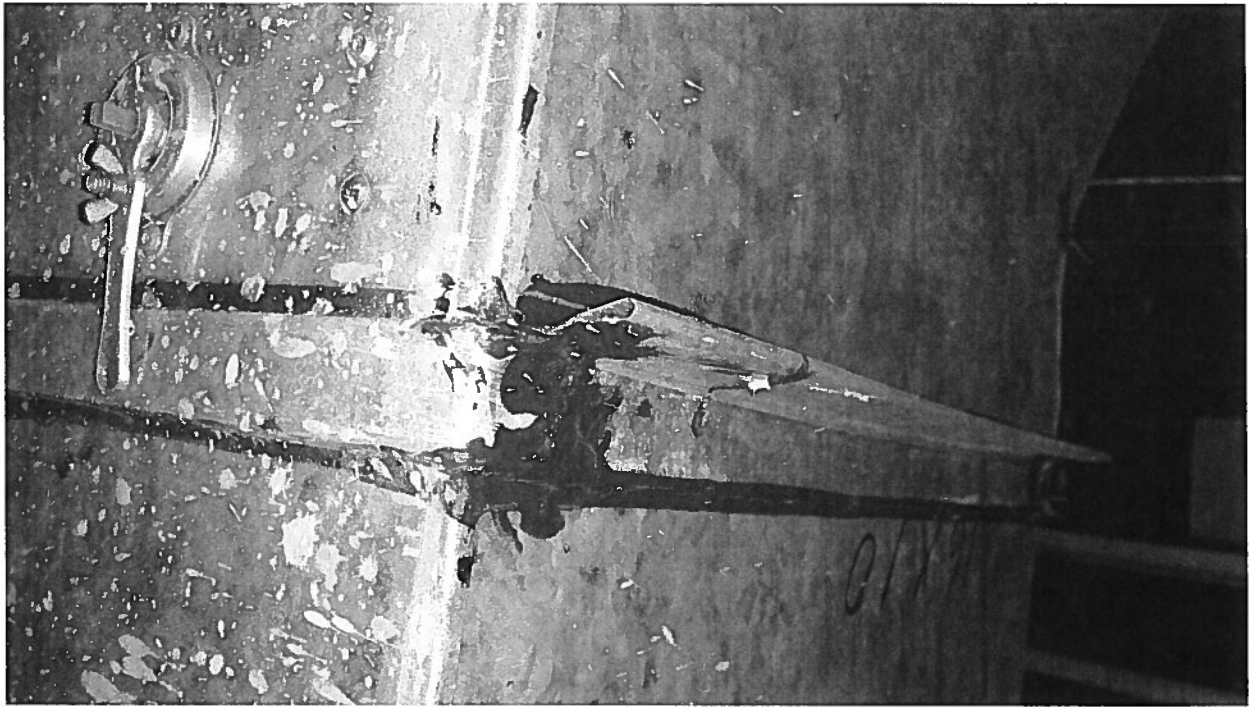
- Three (3) samples (SA-03A/B/C) of a brown duct sealant were collected from the A-Wing ceiling space and submitted for laboratory analysis. Based on the laboratory analysis, SA-03A was found to contain **1.56% Chrysotile asbestos**.
 - All brown duct sealant finish within the project area must be treated as an ACM.

Photo 3 – Asbestos Containing Brown Duct Sealant

- Any manipulation of the brown duct sealant must be completed in accordance with the procedures outlined in O.Reg 278/05.
- Three (3) samples (SA-04A/B/C) of a brown vinyl baseboard and associated adhesive were collected from the 2nd floor A-wing corridor and submitted for laboratory analysis. Based on the laboratory analysis, completed in accordance with the sampling requirements outlined in O.Reg 278/05, no asbestos was identified in the samples analysed.

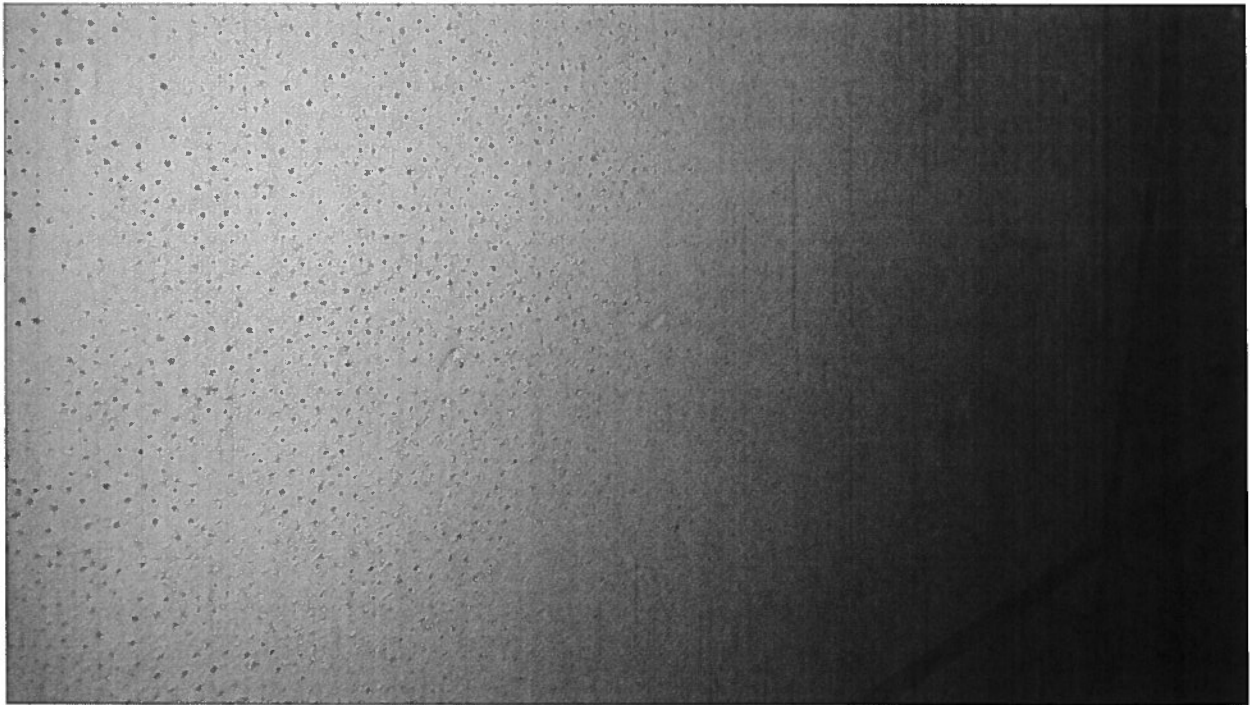
Based on the laboratory data as well as on-site observations, asbestos-containing drywall joint compound, textured ceiling finish, and acoustic ceiling tiles have been identified within the surveyed areas

Photo 4 – Asbestos Containing Pink Back Acoustic Ceiling Tile
