Addendum/Addenda

No./N° 1

Project Description / Description de projet M58 Electrical Vault Upgrade		
Solicitation No./ N° de sollicitation 17-22103	Project No./N° de projet 5160	W.O. No./N° d'ordre de travail A1-011392-01
Departmental Representative / Représentant Ministériel Richard Maurice	Date Dec 4,2017	
Notice: This addendum shall form part of the tender documents and all conditions shall apply and be read in conjunction with the original plans and specifications.		Nota: Cet addenda fait partie intégrale des dossiers d'appel d'offres; toutes les conditions énoncées doivent être lues et appliquées en conjonction avec les plans et les devis originaux.

RE: Summary Report – Project-Specific Designated Substances Survey
Building M-58, Electrical Room WG-05
National Research Council Campus, 1200 Montreal Road, Ottawa, ON

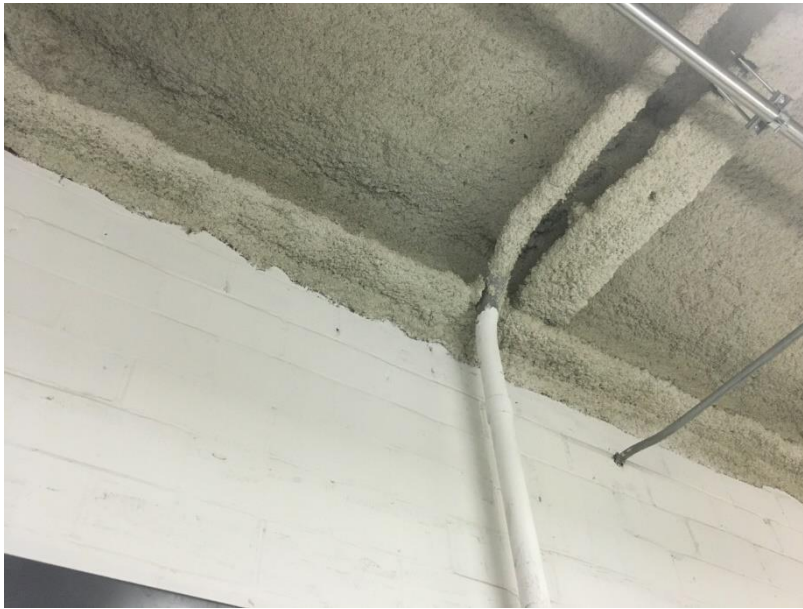
- Non-friable mortar associated with terracotta block, containing 1% Amosite asbestos, observed on walls throughout the project area (DST samples M58-01-A-C).
- 1.5 square metres (total) of non-friable assumed asbestos-containing Transite panels, located inside wall-mounted fuse boxes.

Photo 1: Non-friable asbestos-containing mortar associated with terracotta block throughout the project area. The sprayed fireproofing was confirmed to be non-ACM.

The removal or disturbance of non-friable asbestos-containing material (terracotta block mortar on walls throughout the project area) can be completed using Type 1 asbestos precautionary measures, provided the material is wetted and only non-powered hand-held tools are used. If these conditions cannot be met, then more stringent (Type 2 or Type 3) procedures are required.

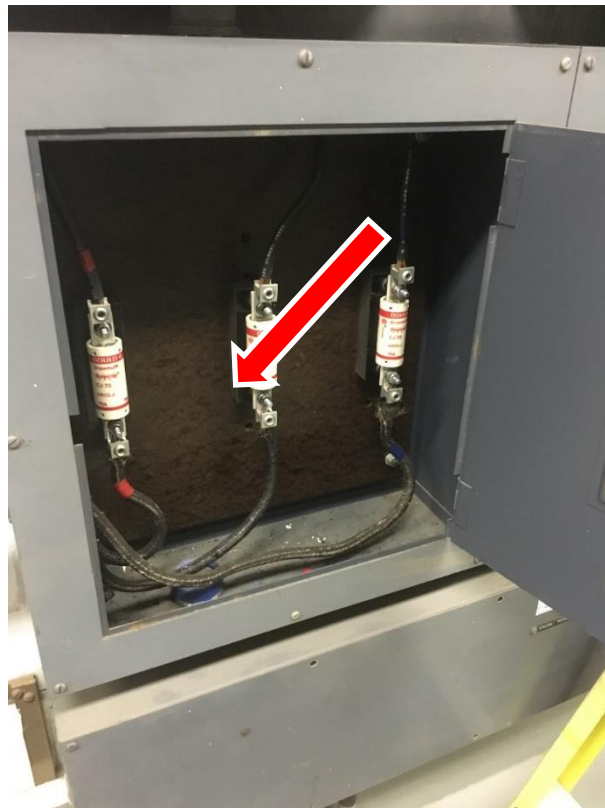
Photo 2: Assumed asbestos-containing Transite panels, located behind wall-mounted fuse boxes in the project area.

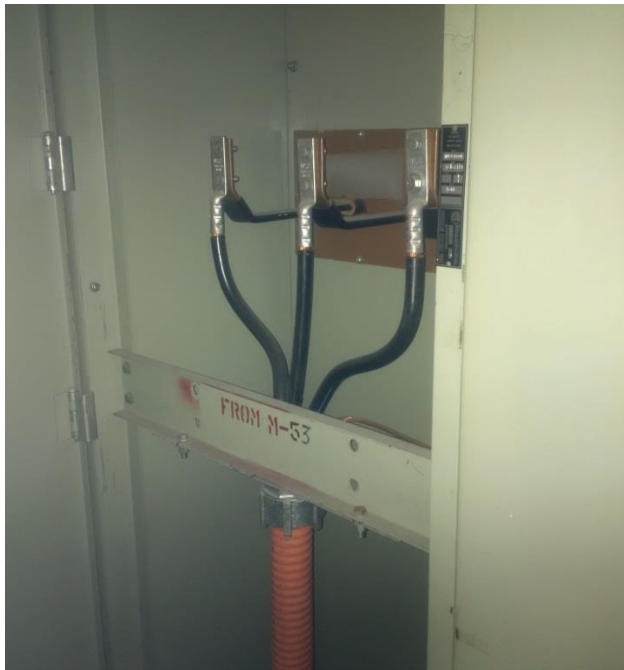
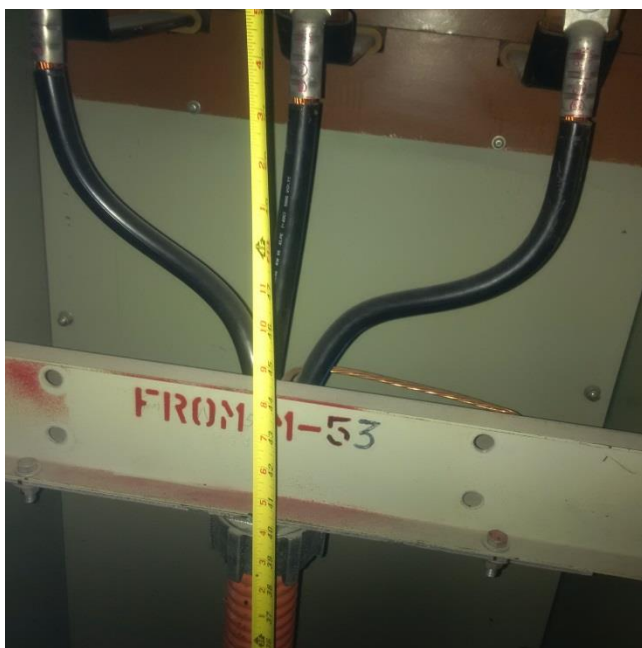
5. Picture of existing cable connection of M58LS2

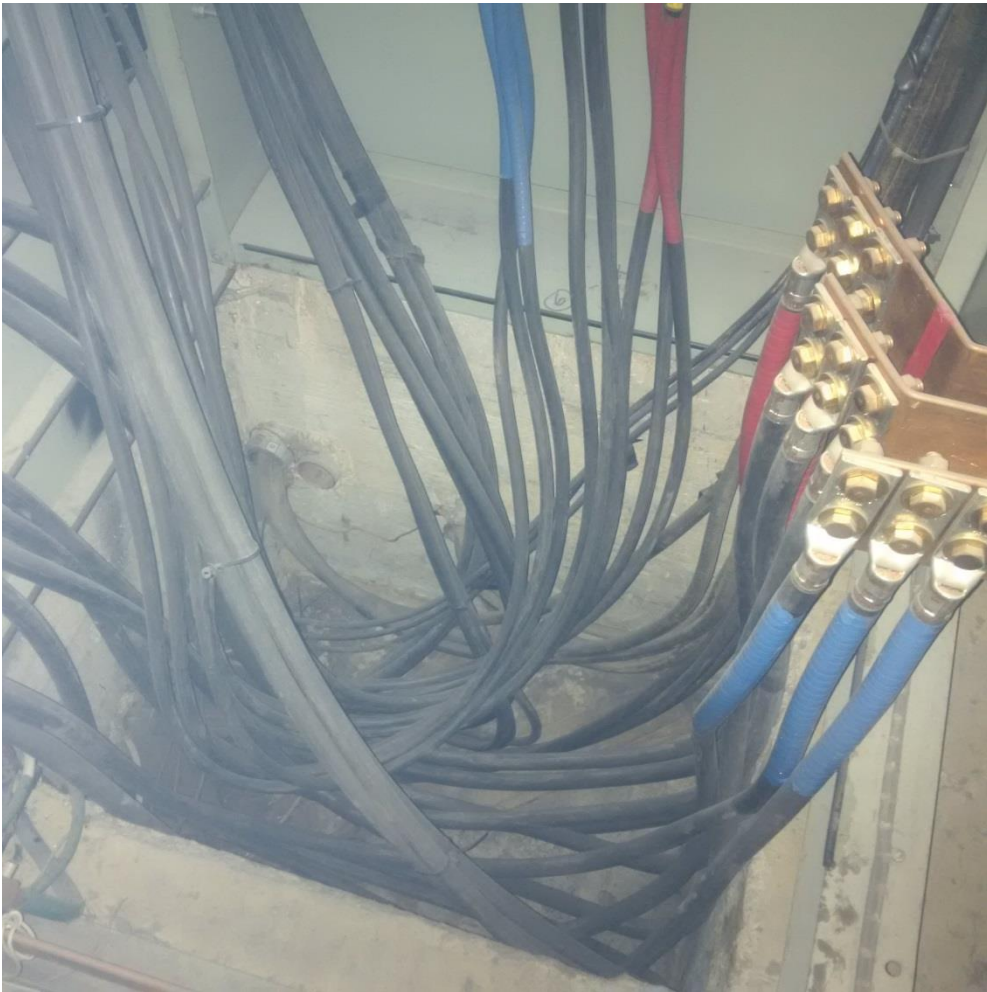
1. E03, delete scope of note 5.
2. Understab conduit from exiting pit below panel PD1 to junction box at room CB04 is estimated to be 25m length.
3. Contractor is responsible for repair of any damages to any exsiting building component caused by construction activities.
4. Designated substance report for electrical room WG25 is attached.

6. Picture of pit below existing panel PD1, underslab conduits at left side leave for room CB04.
