**Public Works and
Government Services Canada**

DRAWINGS & SPECIFICATIONS
for
Asbestos Abatement for the OSD area at IOS

ABATEMENT OF SUSPENDED CEILING AND PLENUM

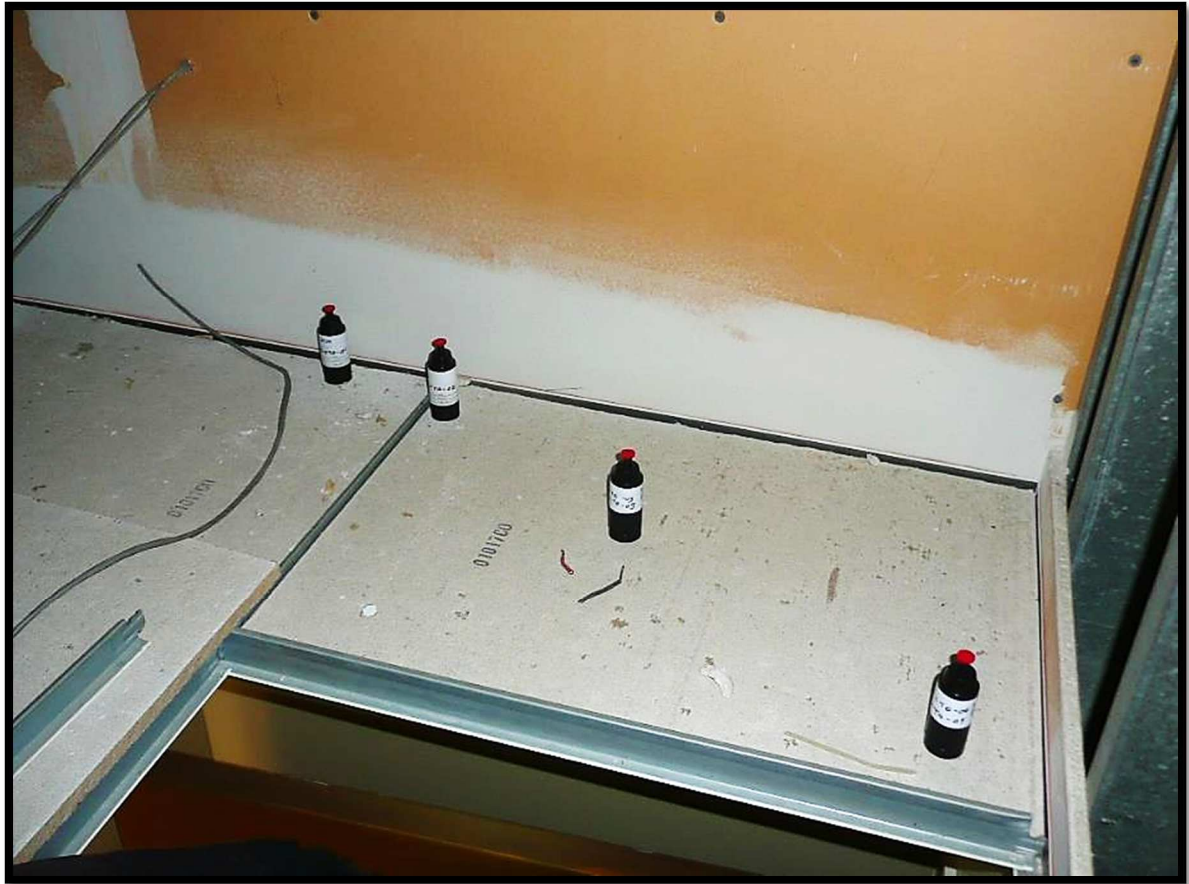
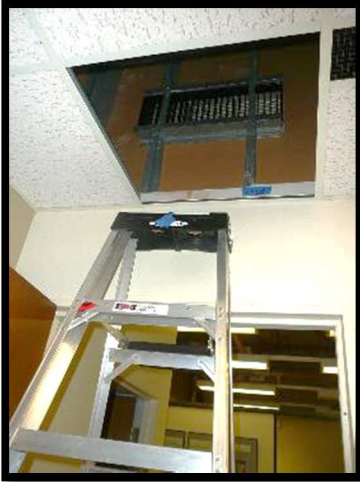
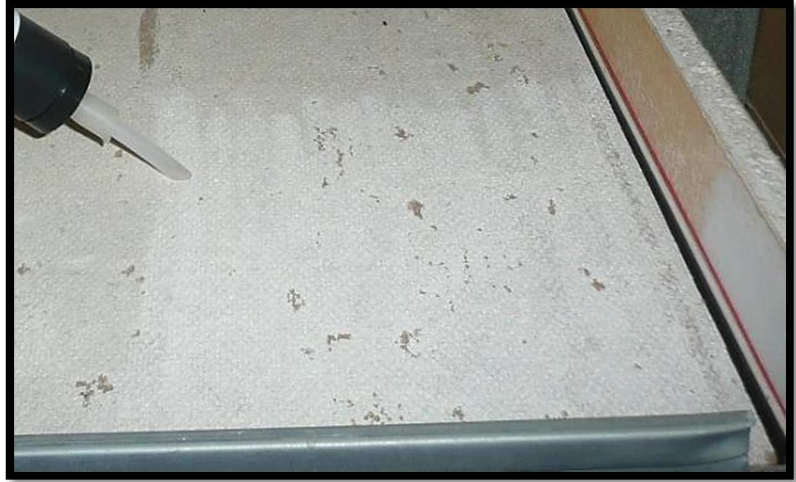
Site sampling location → Room 1217, northwest corner, from on top of the suspended ceiling tile.

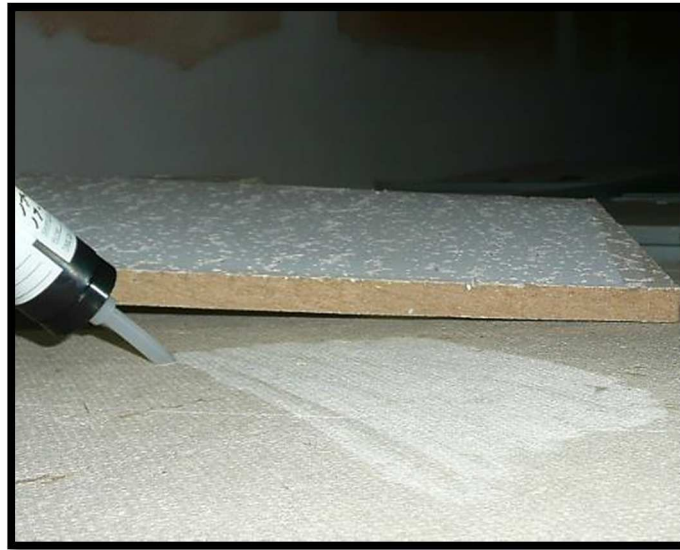
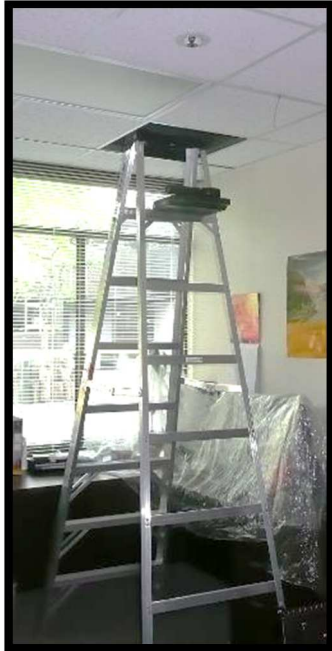
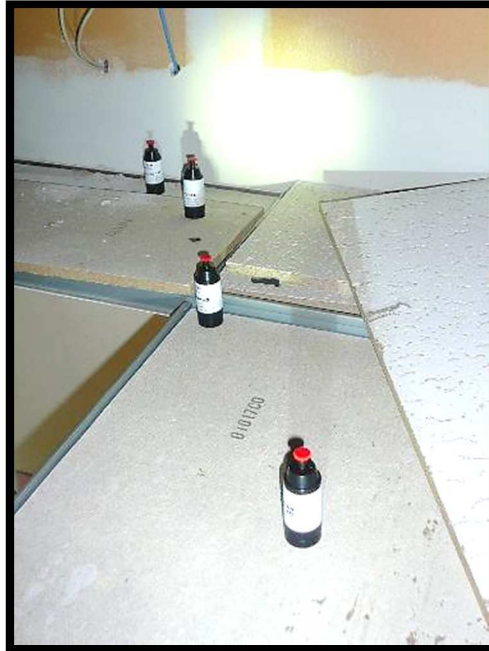
Site sampling location → Room 1220, southwest corner, from on top of the suspended ceiling tile.

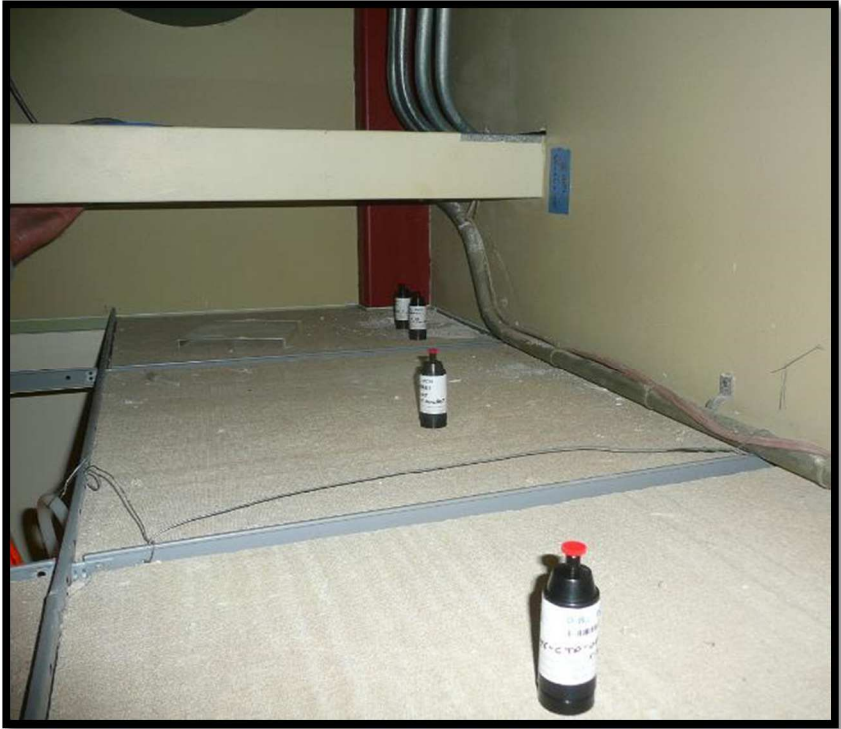
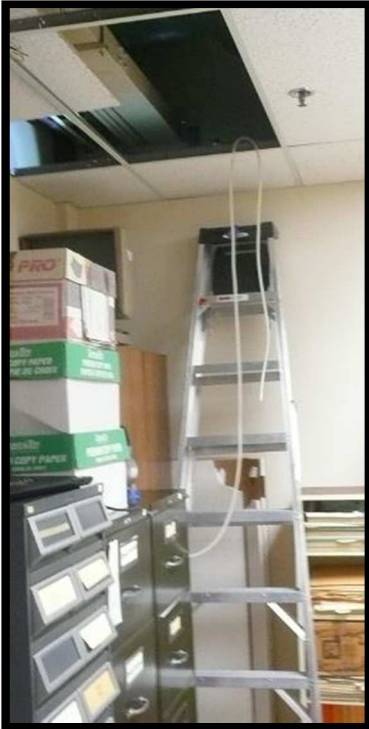
Site sampling location → Room 1246, northwest corner, from on top of the suspended ceiling tile.
