Wreck of General Cargo Vessel “MANOLIS L”

STATEMENT OF WORK

(Oil Removal Solicitation)

10 March 2017

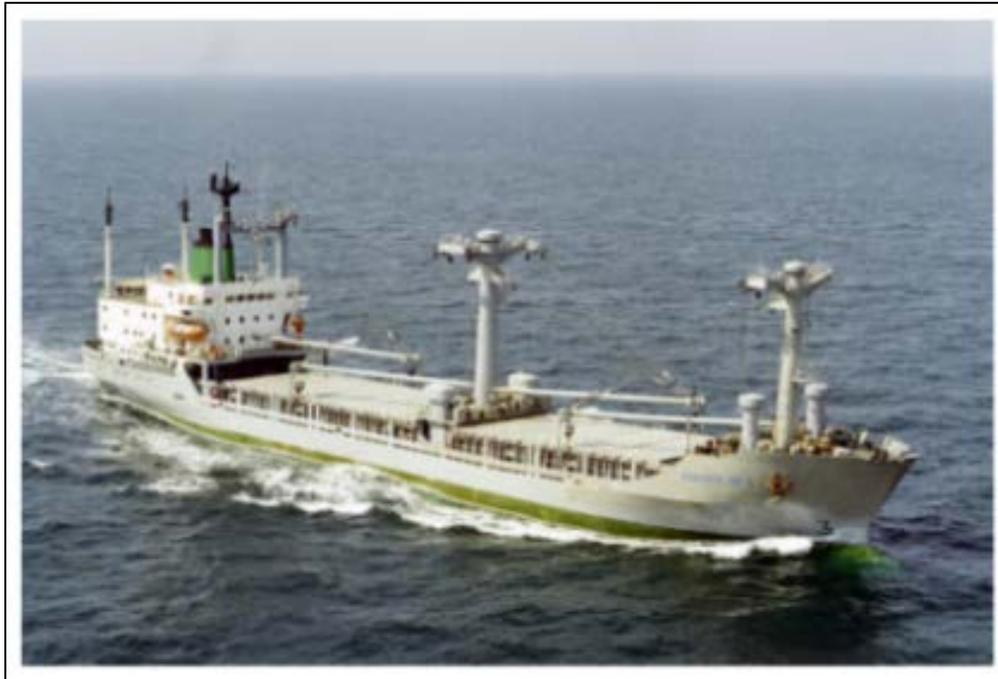
Figure 1 - "MANOLIS L"

"MANOLIS L" was a general cargo vessel built in 1980, owned by Dunnet Bay Shipping. She flew the Liberian flag and was classed with DNV.

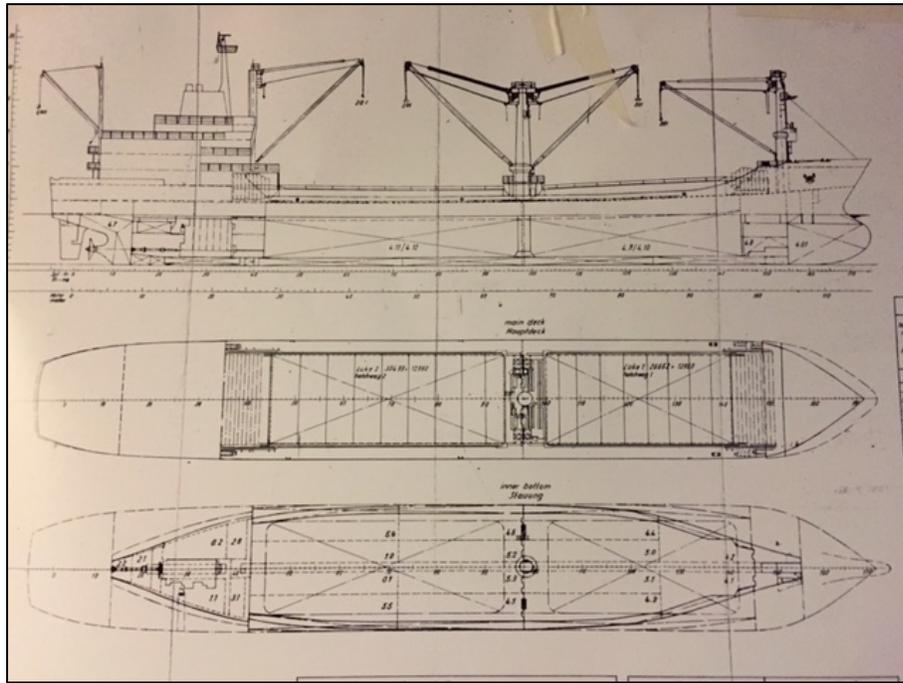
The vessel had two holds forward of the engine room, secured by hatch pontoons and served by two derricks per hold. Beneath the cargo hold were sets of double bottom tanks for bunkers and ballast with bunkers stored in the inner tanks and ballast in the outer tanks. The hull was a welded construction strengthened for heavy cargoes.

Figure 2 - "MANOLIS L" – Side & Plan Elevation

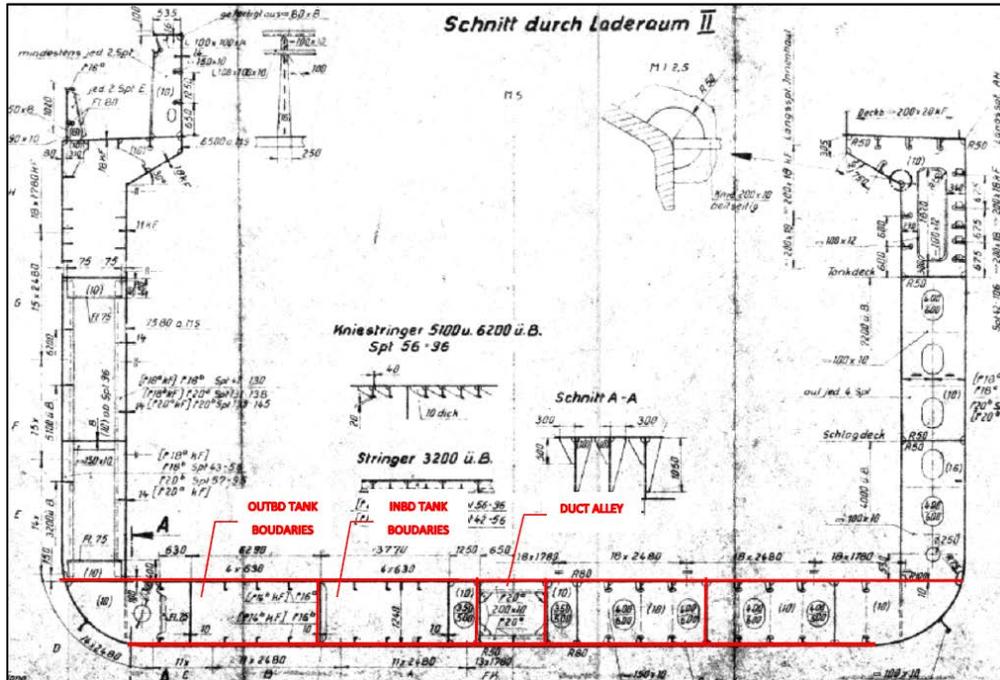
Figure 3 – “MANOLIS L” – Midship Section

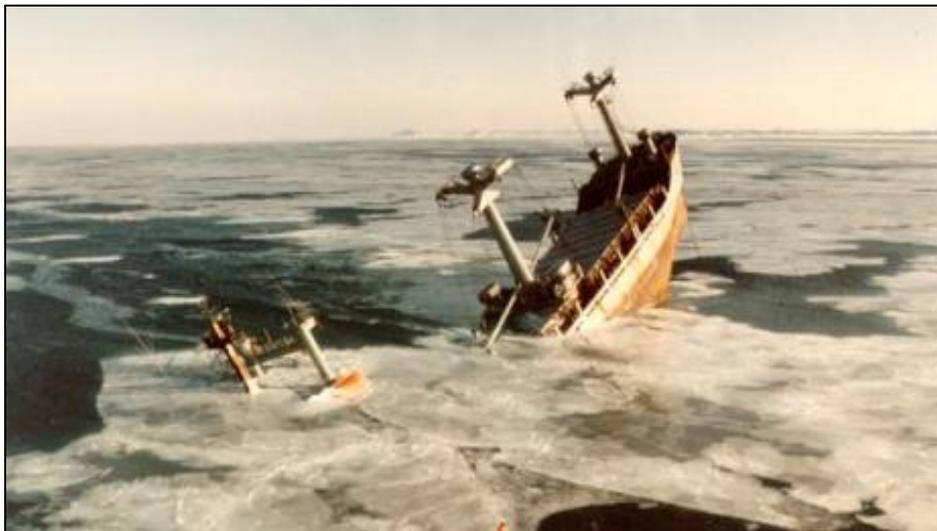
Figure 4 - “MANOLIS L” – Sinking

“MANOLIS L” sank in the position now confirmed as 49°40' 47.224"N, 054°31.15.147"W (midships centre line) off Blowhard Rocks in Notre Dame Bay. The vessel went down by the stern and settled on the seabed in an inverted position. The heading is 034° True. The water depth to the hull has been confirmed as 49.7m on the high (west/starboard) side,

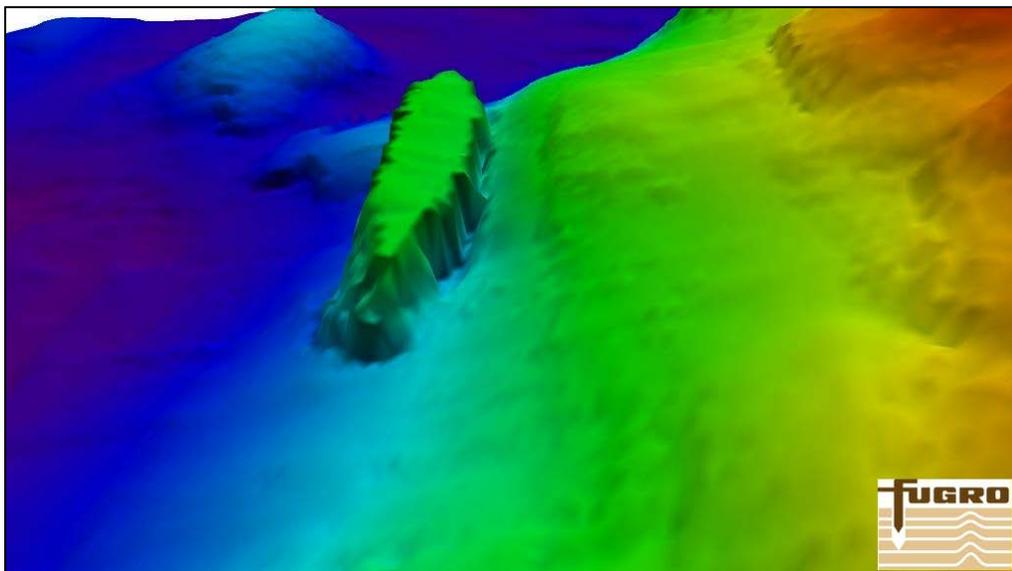
The hull of the wreck lies firmly on a gentle sloping seabed to the west (or starboard side) and virtually against a steep slope to the east (port side) as shown in the multi-beam screenshot below.

Figure 6 - Screen shot from multi-beam survey showing wreck hull on seabed (source – FUGRO)

50.5m amidships and 51.2m on the low (east/port) side. The depth along the starboard side is about 70-72m and the port side, 62-65m. The seabed composition is mainly bedrock, sand and stone.

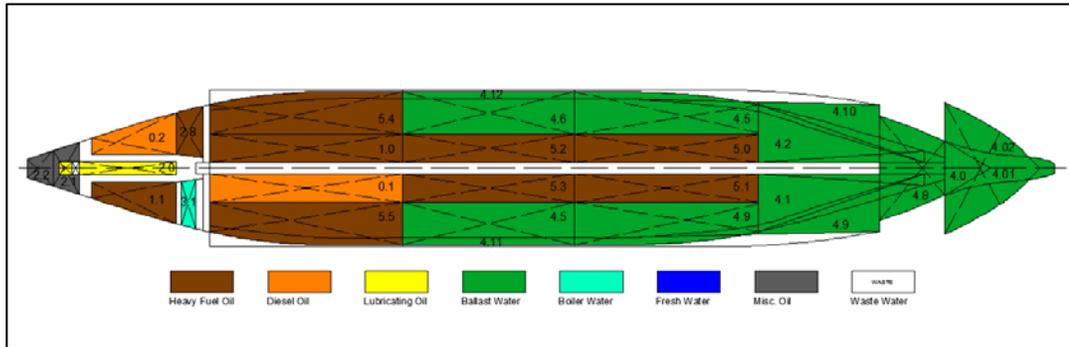
Figure 7 - Colour Coded Tank Plan

Tank No	Description	Capacity (cu.m)
5.0	Port Inner Double Bottom	72.7
5.1	Starboard Inner Double Bottom	72.7
5.2	Port Inner Double Bottom	67.5
5.3	Starboard Inner Double Bottom	67.5
1.0	Port inner Double Bottom	80.5
5.4	Port Outer Double Bottom	96.8
5.5	Starboard Outer Double Bottom	96.8

Tank No	Description	Capacity (cu.m)
1.1	Overflow Tank Engine Room	32.3
1.2	Daily Service Port	21.0
1.3	Daily Service Starboard	21.0
1.4	Settling Tank Port	28.4
1.5	Settling Tank Starboard	28.4

Tank No	Description	Capacity (cu.m)
0.1	Starboard Inner Double	58.0
0.2	Overflow Tank ER	27.5
0.3	Daily Service/ Settling Tank ER	4.8
0.5	Daily Service/ Settling Tank ER	4.3
0.7	Storage Tank ER	2.6
0.8	Storage Tank ER	0.9
	Total	98.1

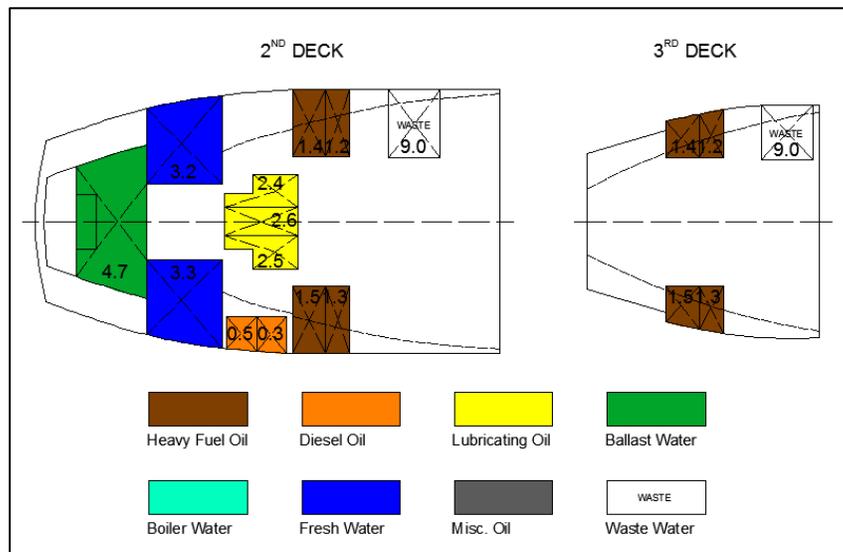
Figure 8 - Extract from Tank Plan Showing Daily Service & Settling Tanks

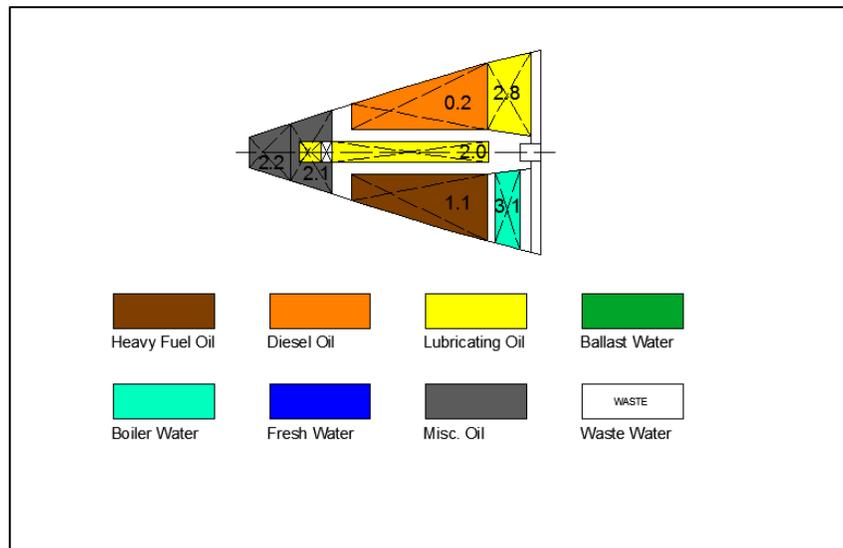
Figure 9 - HFO & DO Overflow Tanks

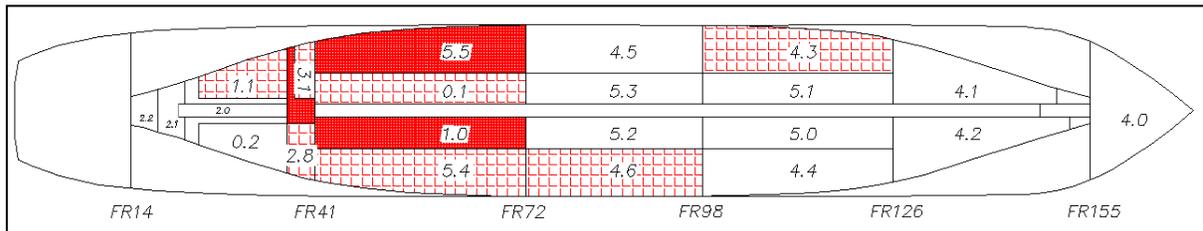
Figure 11 - Oil Location Diagram – (Source – Resolve Report Figure 3-4)

Tank Name	Oil Presence
DO 0.1S	<i>Traces found, negligible volume</i>
DO 0.2P	<i>N/A</i>
DO 0.3S	<i>Bulk oil found</i>
DO 0.5S	<i>Bulk oil found</i>
HFO 1.0P	<i>Bulk oil found</i>
HFO 1.1S	<i>Traces found, negligible volume</i>
HFO 1.2P	<i>No oil found</i>
HFO 1.3S	<i>No oil found</i>
HFO 1.4P	<i>Traces found, negligible volume</i>
HFO 1.5S	<i>Bulk oil found</i>
HFO 5.0P	<i>No oil found</i>
HFO 5.1S	<i>No oil found</i>
HFO 5.2P	<i>No oil found</i>
HFO 5.3S	<i>No oil found</i>
HFO 5.4P	<i>Traces found, negligible volume</i>
HFO 5.5S	<i>Bulk oil found</i>
LO 2.0C	<i>No oil found</i>
LO 2.1C	<i>N/A open to the sea</i>
LO 2.2C	<i>N/A open to the sea</i>
LO 2.8P	<i>Traces found, negligible volume</i>
BWT 4.0C	<i>N/A open to the sea</i>
BWT 4.1S	<i>N/A open to the sea</i>
BWT 4.2P	<i>N/A open to the sea</i>
BWT 4.3S	<i>Traces found, negligible volume</i>
BWT 4.4P	<i>No oil found</i>
BWT 4.5S	<i>No oil found</i>
BWT 4.6P	<i>Traces found, negligible volume</i>

- i. Remove the bulk oil from DB tanks 1.0; 5.5; ER space; ER tanks 0.3, 0.5, 1.5.
- ii. Flush DB DO tank 0.1S, DB HFO tank 5.4p, DB BWT 4.3S, DB BWT 4.6P, ER tank, 1.1S, ER tank 1.4P, LO tank space 2.8P FWT 3.1S.
