Geotechnical Investigation-Preliminary Design Stage Relocation/Reconstruction Bolingbroke Dam

Crow Lake Road, Maberly, Ontario

CIMA + c/o Parks Canada

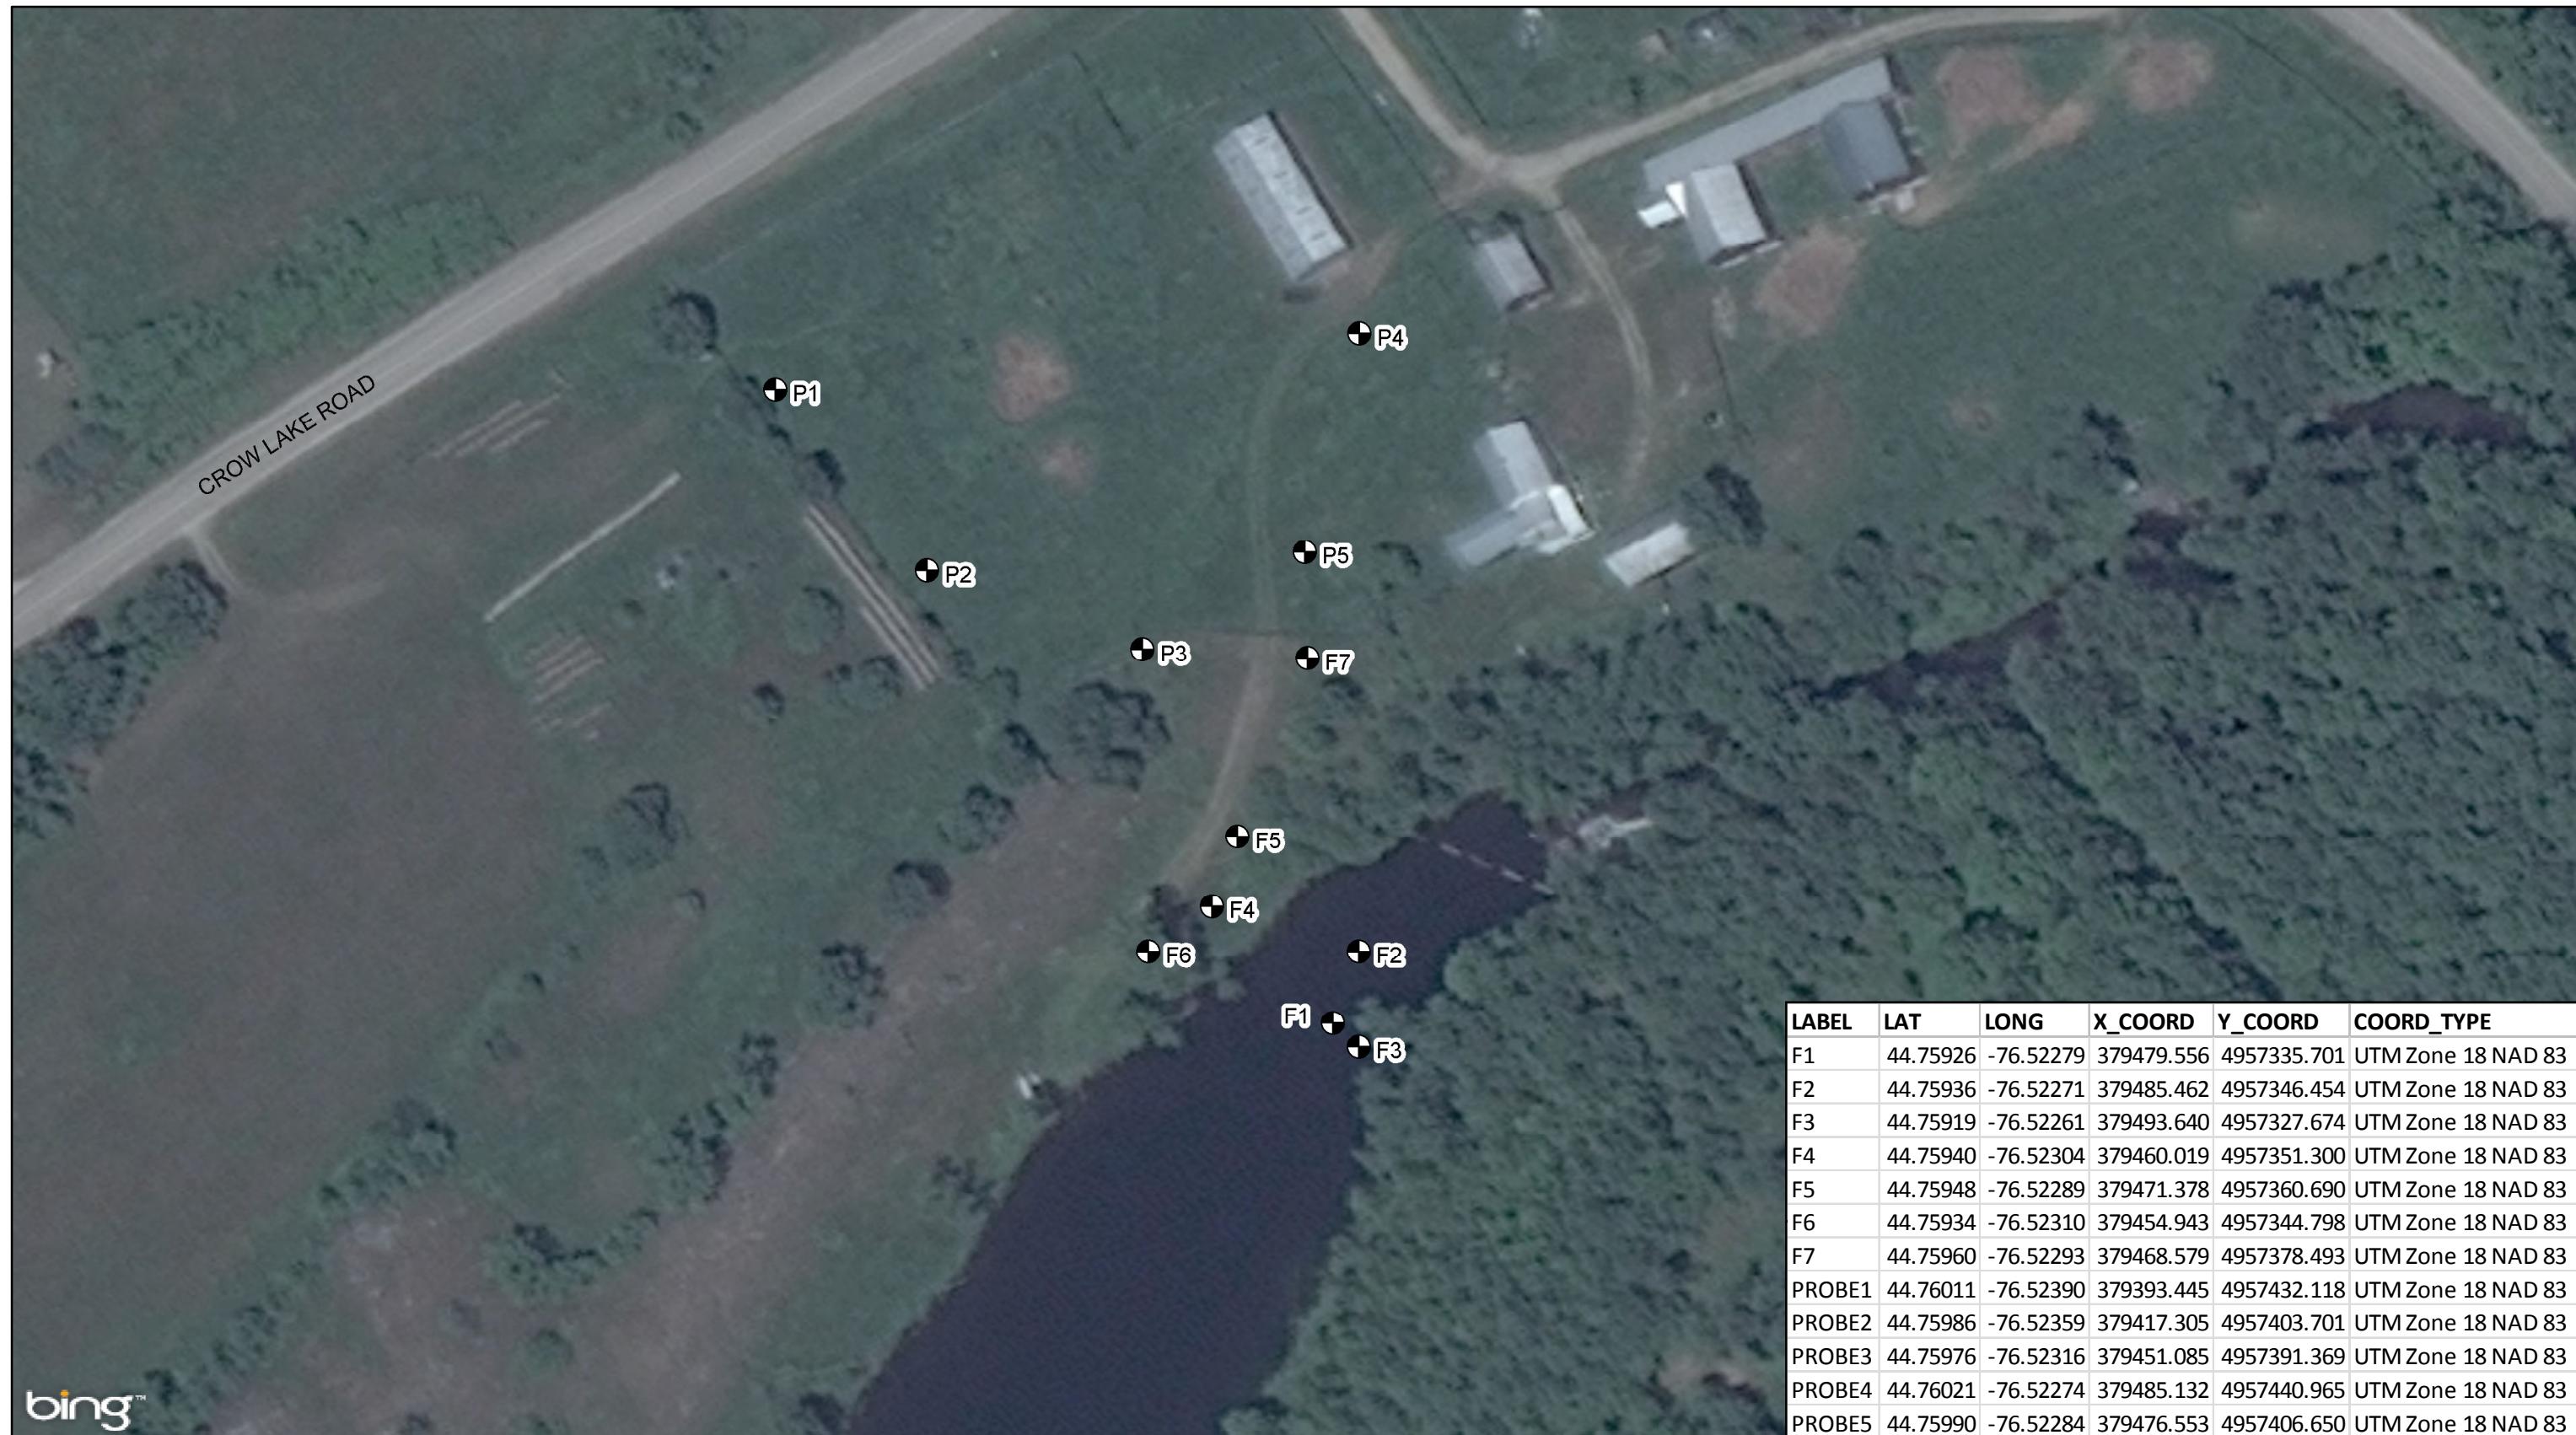
- Figure 1 Site Location Plan
Figure 2 Borehole Location Plan

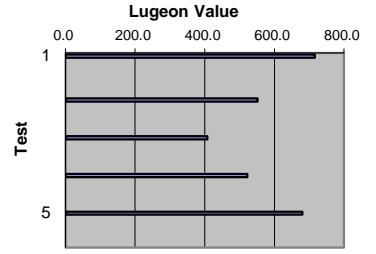
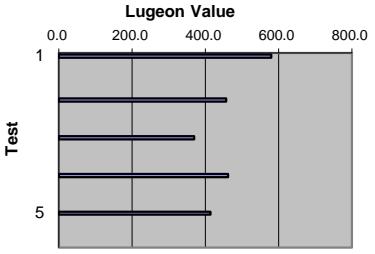
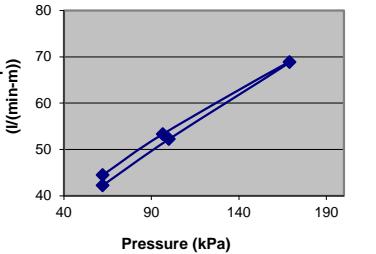
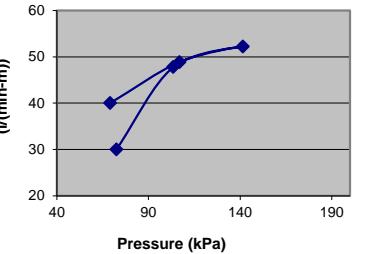
ROCK PERMEABILITY TEST RESULTS LUGEON (PACKER) TEST METHOD

Borehole NO.: F1	Borehole NO.: F1
Project NO.: 11103700-A1	Project NO.: 11103700-A1
Test NO.: 1	Test NO.: 2
Test Depth: $Z \text{ (H)} = 7.4 \text{ m (Top)}$ $Z = 8.7 \text{ m (Bottom)}$	Test Depth: $Z \text{ (H)} = 5.8 \text{ m (Top)}$ $Z = 7.0 \text{ m (Bottom)}$
Figures	Figures

Equation $k = q / (2 \times \pi \times L \times h) \times \log_e (L / r)$	Equation $k = q / (2 \times \pi \times L \times h) \times \log_e (L / r)$
$k = 3.342E-03 \text{ cm/s}$	$k = 3.028E-03 \text{ cm/s}$

Lugeon Test (or Packer Test) results carried out in boreholes F1 to F6 show a hydraulic conductivity of between 2×10^{-3} to 3.7×10^{-3} cm/s in the fractured zones and 1.2×10^{-1} to 7.2×10^{-4} cm/s in fair to good quality bedrock zones. Generally the results show a turbulent flow within the bedrock with wash out or void filling in some of the test locations. It should be noted that the rock closer to these surface may have higher permeability.

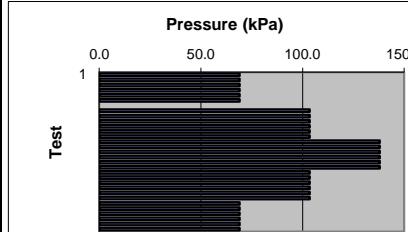
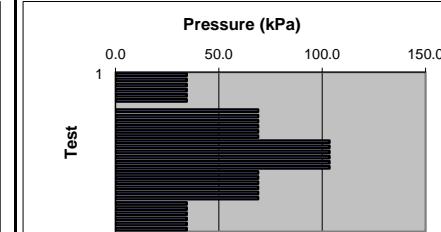
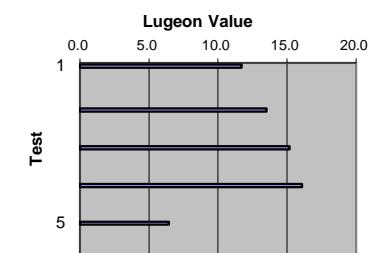
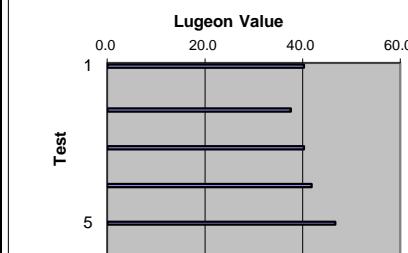
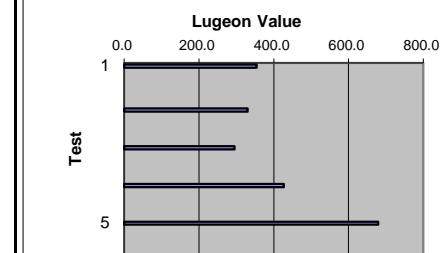
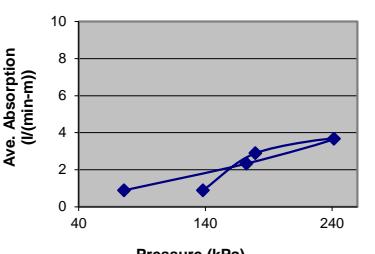
ROCK PERMEABILITY TEST RESULTS LUGEON (PACKER) TEST METHOD

Borehole NO.: F5	Borehole NO.: F5	Borehole NO.: F5
Project NO.: 11103700-A1	Project NO.: 11103700-A1	Project NO.: 11103700-A1
Test NO.: 1	Test NO.: 2	Test NO.: 3
Test Depth: $Z (H) = 14.1$ m (Top) $Z = 15.5$ m (Bottom)	Test Depth: $Z (H) = 11.1$ m (Top) $Z = 12.3$ m (Bottom)	Test Depth: $Z (H) = 8.0$ m (Top) $Z = 4.2$ m (Bottom)
Figures	Figures	Figures

Lugeon Value $L_u = 15.2$	Lugeon Value $L_u = 40.3$	Lugeon Value $L_u = 295.2$
Corresponding Pressure 241.5	Corresponding Pressure 138.0	Corresponding Pressure 103.5
Equivalent Permeability Coefficient	Equivalent Permeability Coefficient	Equivalent Permeability Coefficient
<i>Equation</i> $k = q / (2 \times \pi \times L \times h) \times \log_e(L/r)$	<i>Equation</i> $k = q / (2 \times \pi \times L \times h) \times \log_e(L/r)$	<i>Equation</i> $k = q / (2 \times \pi \times L \times h) \times \log_e(L/r)$
$k = 1.245E-04 \text{ cm/s}$	$k = 3.301E-04 \text{ cm/s}$	$k = 2.421E-03 \text{ cm/s}$

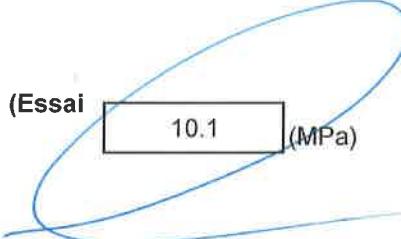
Résistance en tension
(Brésilien)

Diamètre (D):	47.3	47.3	(mm)
Longueur (L):	24.1	23.9	(mm)
Ratio L/D	0.51	Entre 0.20 et 0.75	
Condition d'humidité:	Dry		
Taux de chargement:	15187.2	(N/min)	
Type de fracture:	Shear		
Durée de l'essai	1min 7sec	Entre 1 et 10 minutes

Greenish white medium grained quartzitic marble

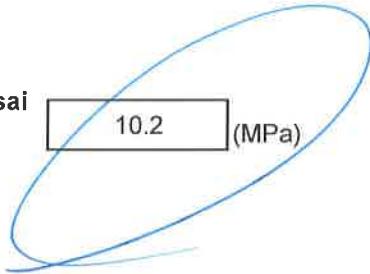
Diamètre (D):	47.3	47.3	(mm)
Longueur (L):	22.4	22.8	(mm)
Ratio L/D	0.48	Entre 0.20 et 0.75	
Condition d'humidité:	Dry		
Taux de chargement:	-		
Type de fracture:	Shear		
Durée de l'essai	1min 2sec	Entre 1 et 10 minutes

10.2 (MPa)
