Detailed Impact Analysis

Bobs Lake Dam Reconstruction
Bolingbroke, Ontario

Prepared for: Parks Canada Agency
Prepared by: Parsons

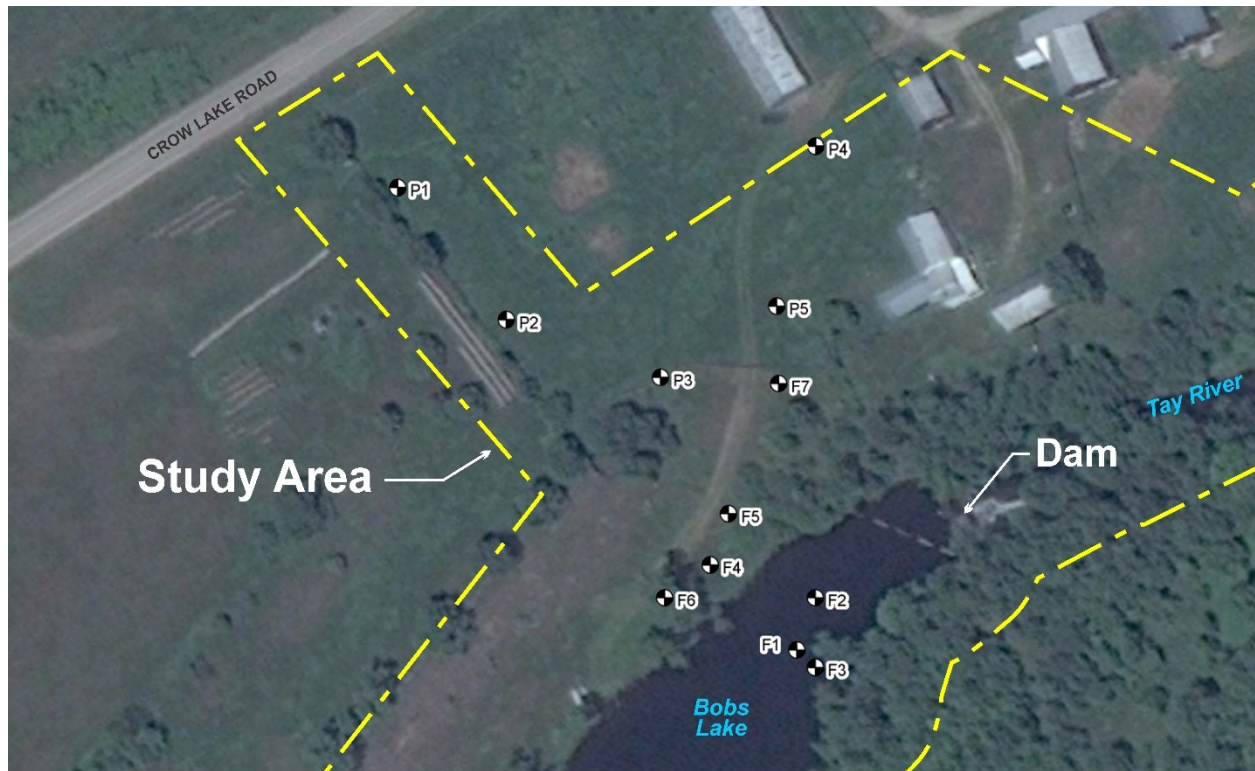
Figure 5 – Borehole and Rock Probe Locations (Source: Modified from GHD, 2015)

During investigations, highly weathered and intensely fractured coarse grained calcite marble was encountered at the borehole locations. The colour of the marble was found to be white to pale grey becoming grey with depth. Gneiss beddings were observed in borehole F2. The Rock Quality Designation (RQD) values indicated the quality of this rock to be very poor to fair in the upper portion of the bedrock. The rock quality was found to become good to excellent at depth in F4 and F6

locations. Although the rock quality was found to be very poor to fair, the recovery values suggest low probability of cavities within the rock mass (GHD, 2015).

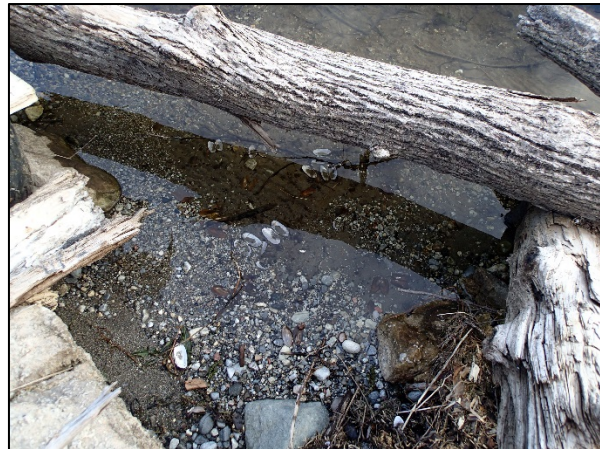
Photo 14 (right): Substrate at Photo 13 location, showing freshwater mussel shells.

The north bank littoral zone of the Tay River downstream of the existing dam was also searched for evidence of mussels. One severely worn Eastern Elliptio valve was discovered amidst the rocks on the north bank approximately 110 m downstream of the dam.

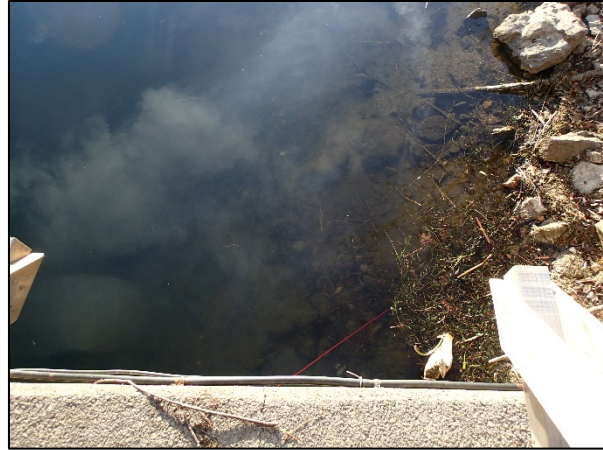
Photo 18 (right): Sediment in Bobs Lake immediately upstream of the dam (north bank).

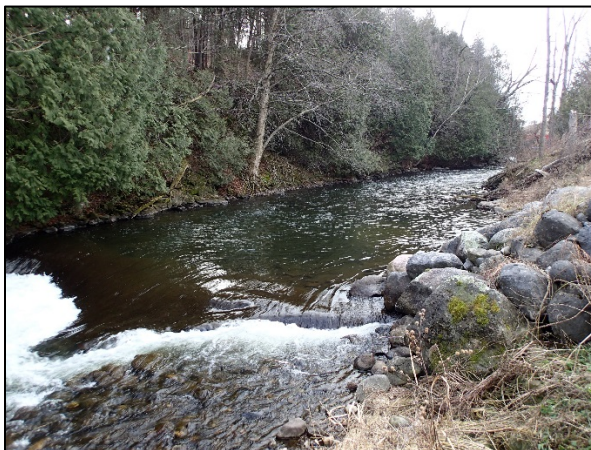
Photo 21 (left): Tay River at the rock/concrete weir near the small outbuilding monitoring station, looking upstream towards the dam (approx. 100 m).
