Parks Canada Basic Impact Analysis Template

Hopedale Mission National Historic Site (NHS) Provision Warehouse Recapitalization
Hopedale, Labrador

RPA 1131.02 Hopedale Mission NHS Provision House Recap
HMNHS-2018-001

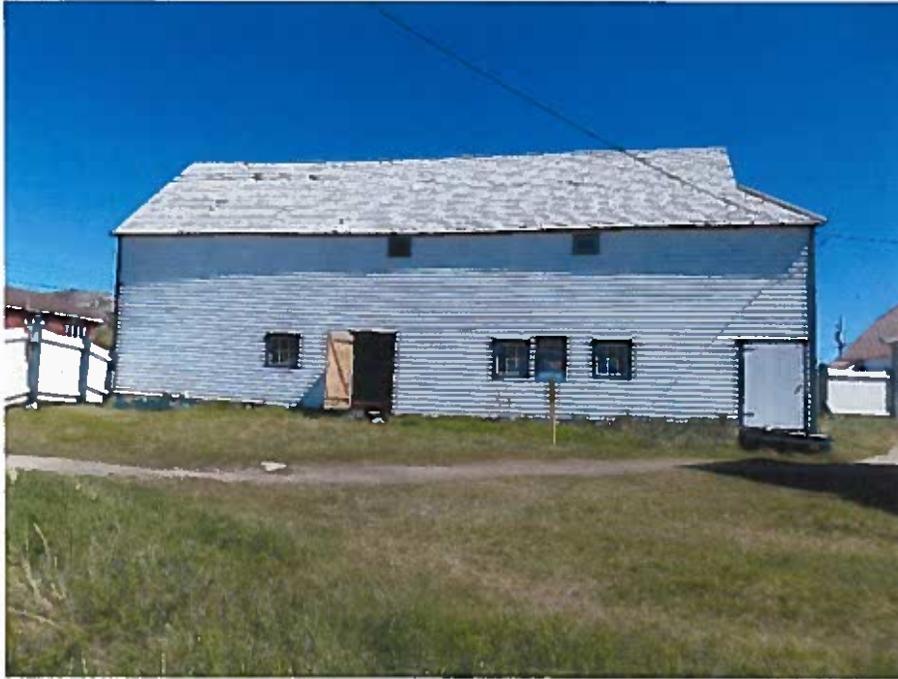
Photo 2: Bedrock and vegetation on north side of Provisions Warehouse, illustrating the east-west slope of the bedrock.

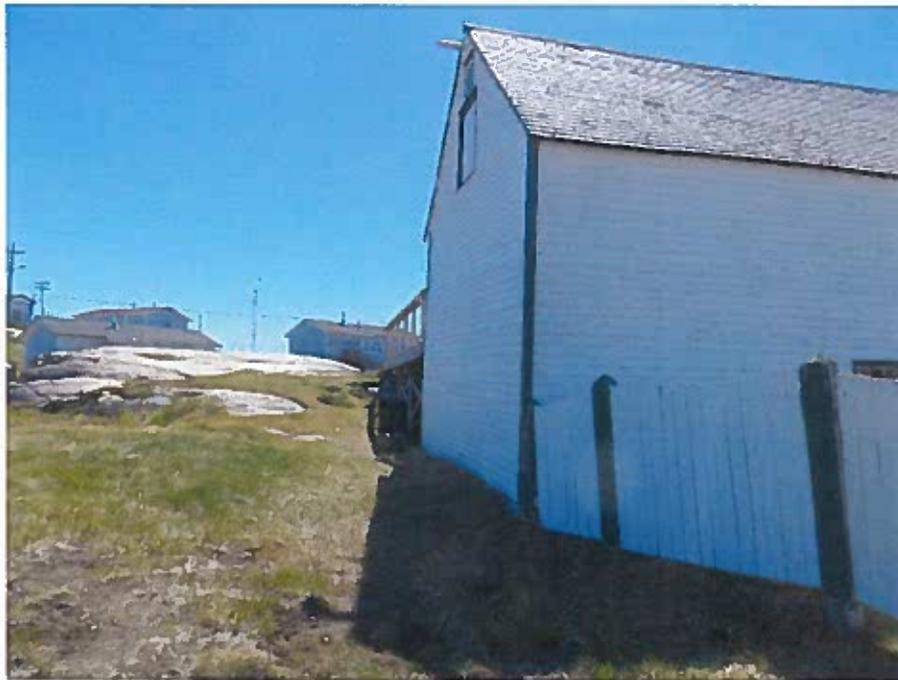
Photo 3: Vegetation and uneven ground to south of Provisions Warehouse

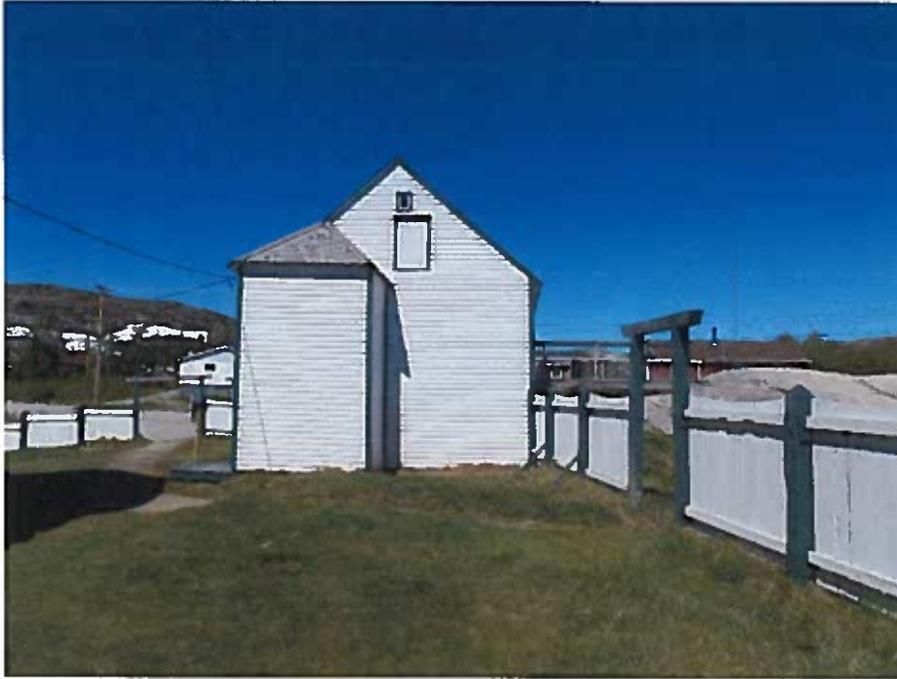
Photo 4: Bedrock on east side of Provisions Warehouse
