Basic Impact Analysis (BIA)

Highway 10 Pavement Rehabilitation

Riding Mountain National Park

April 2016

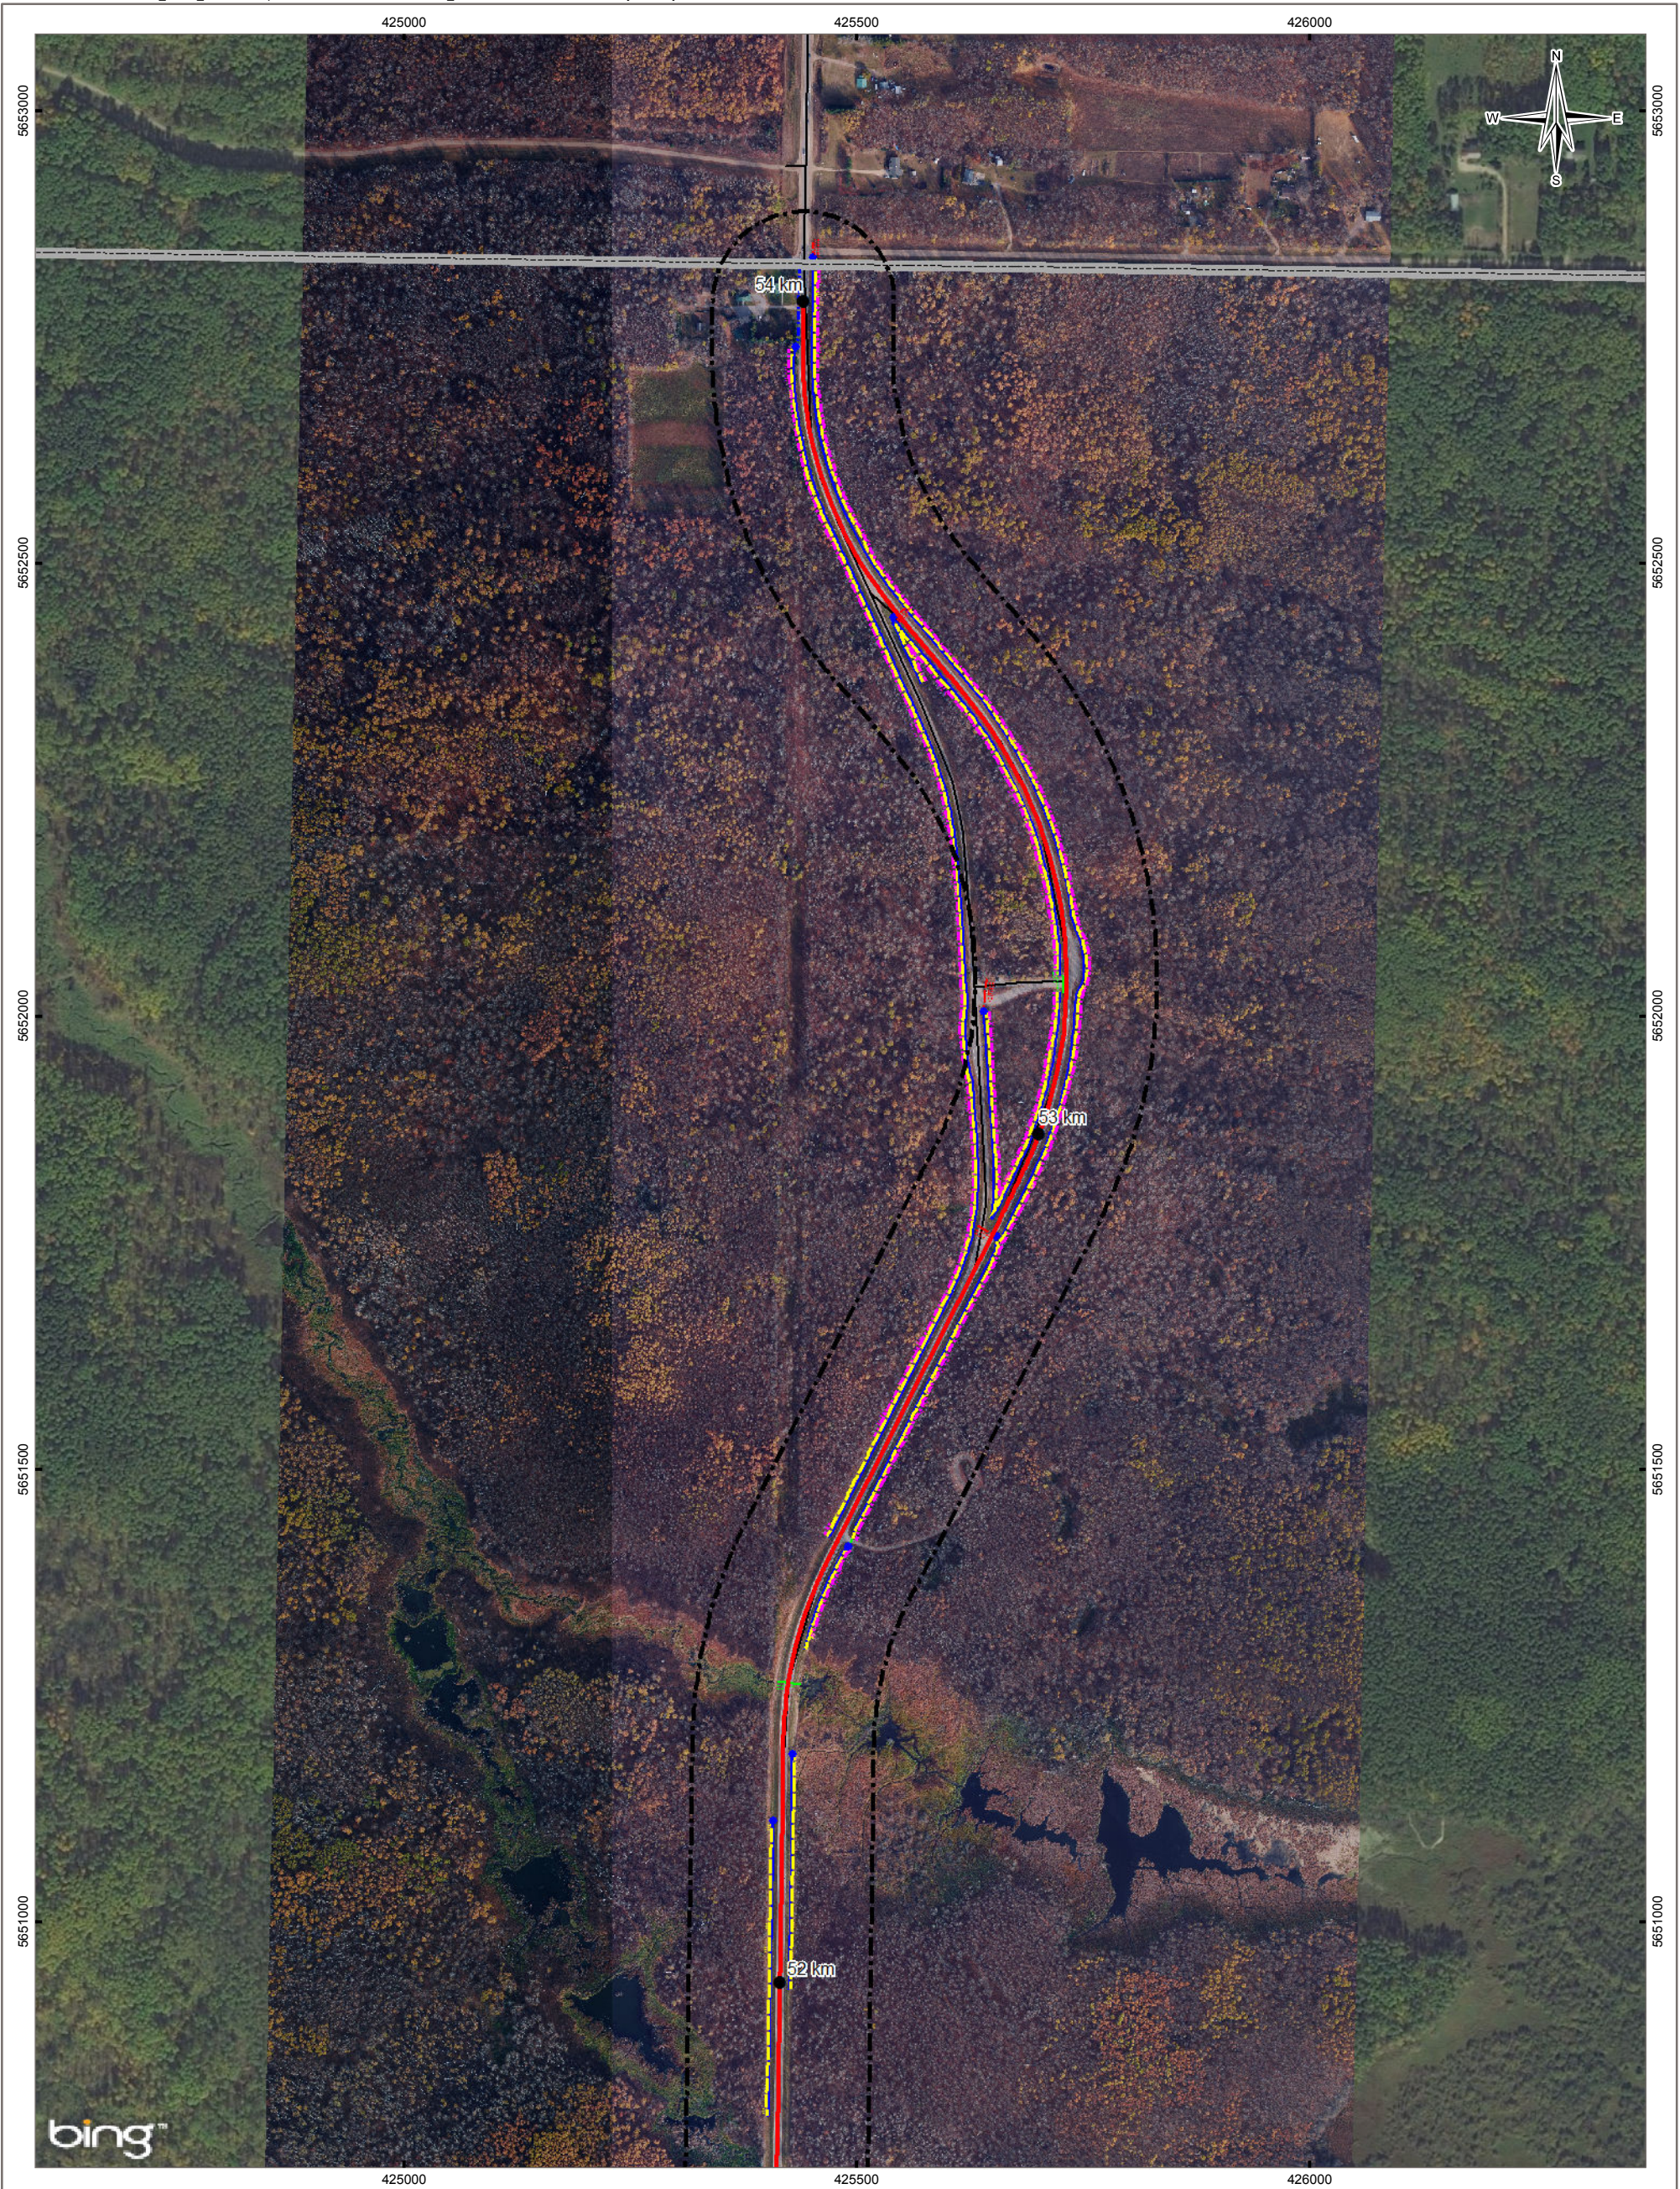
Metres					
FILE NO. ENVIND03979_FIG2.mxd					
PROJECT NO. ENVIND03979-01	DWN BB	CKD MS	APVD TC	REV 0	Figure 2a
OFFICE Tt EBA-CAL	DATE March 17, 2016

- KM Marker
- Highway 10 (within Park Limits)
- Road
- Riding Mountain National Park Boundary
- 100m Buffer
- Construction Plans**
 - Bottom of Ditch
 - Top of Ditch
 - Clearing and Grubbing

For the purpose of the effects assessment, a 100 m buffer was applied to both sides of the highway surface (herein referred to as the Project Area; Figure 2). Evaluation of existing conditions, effects, and mitigation include the 100 m buffer.

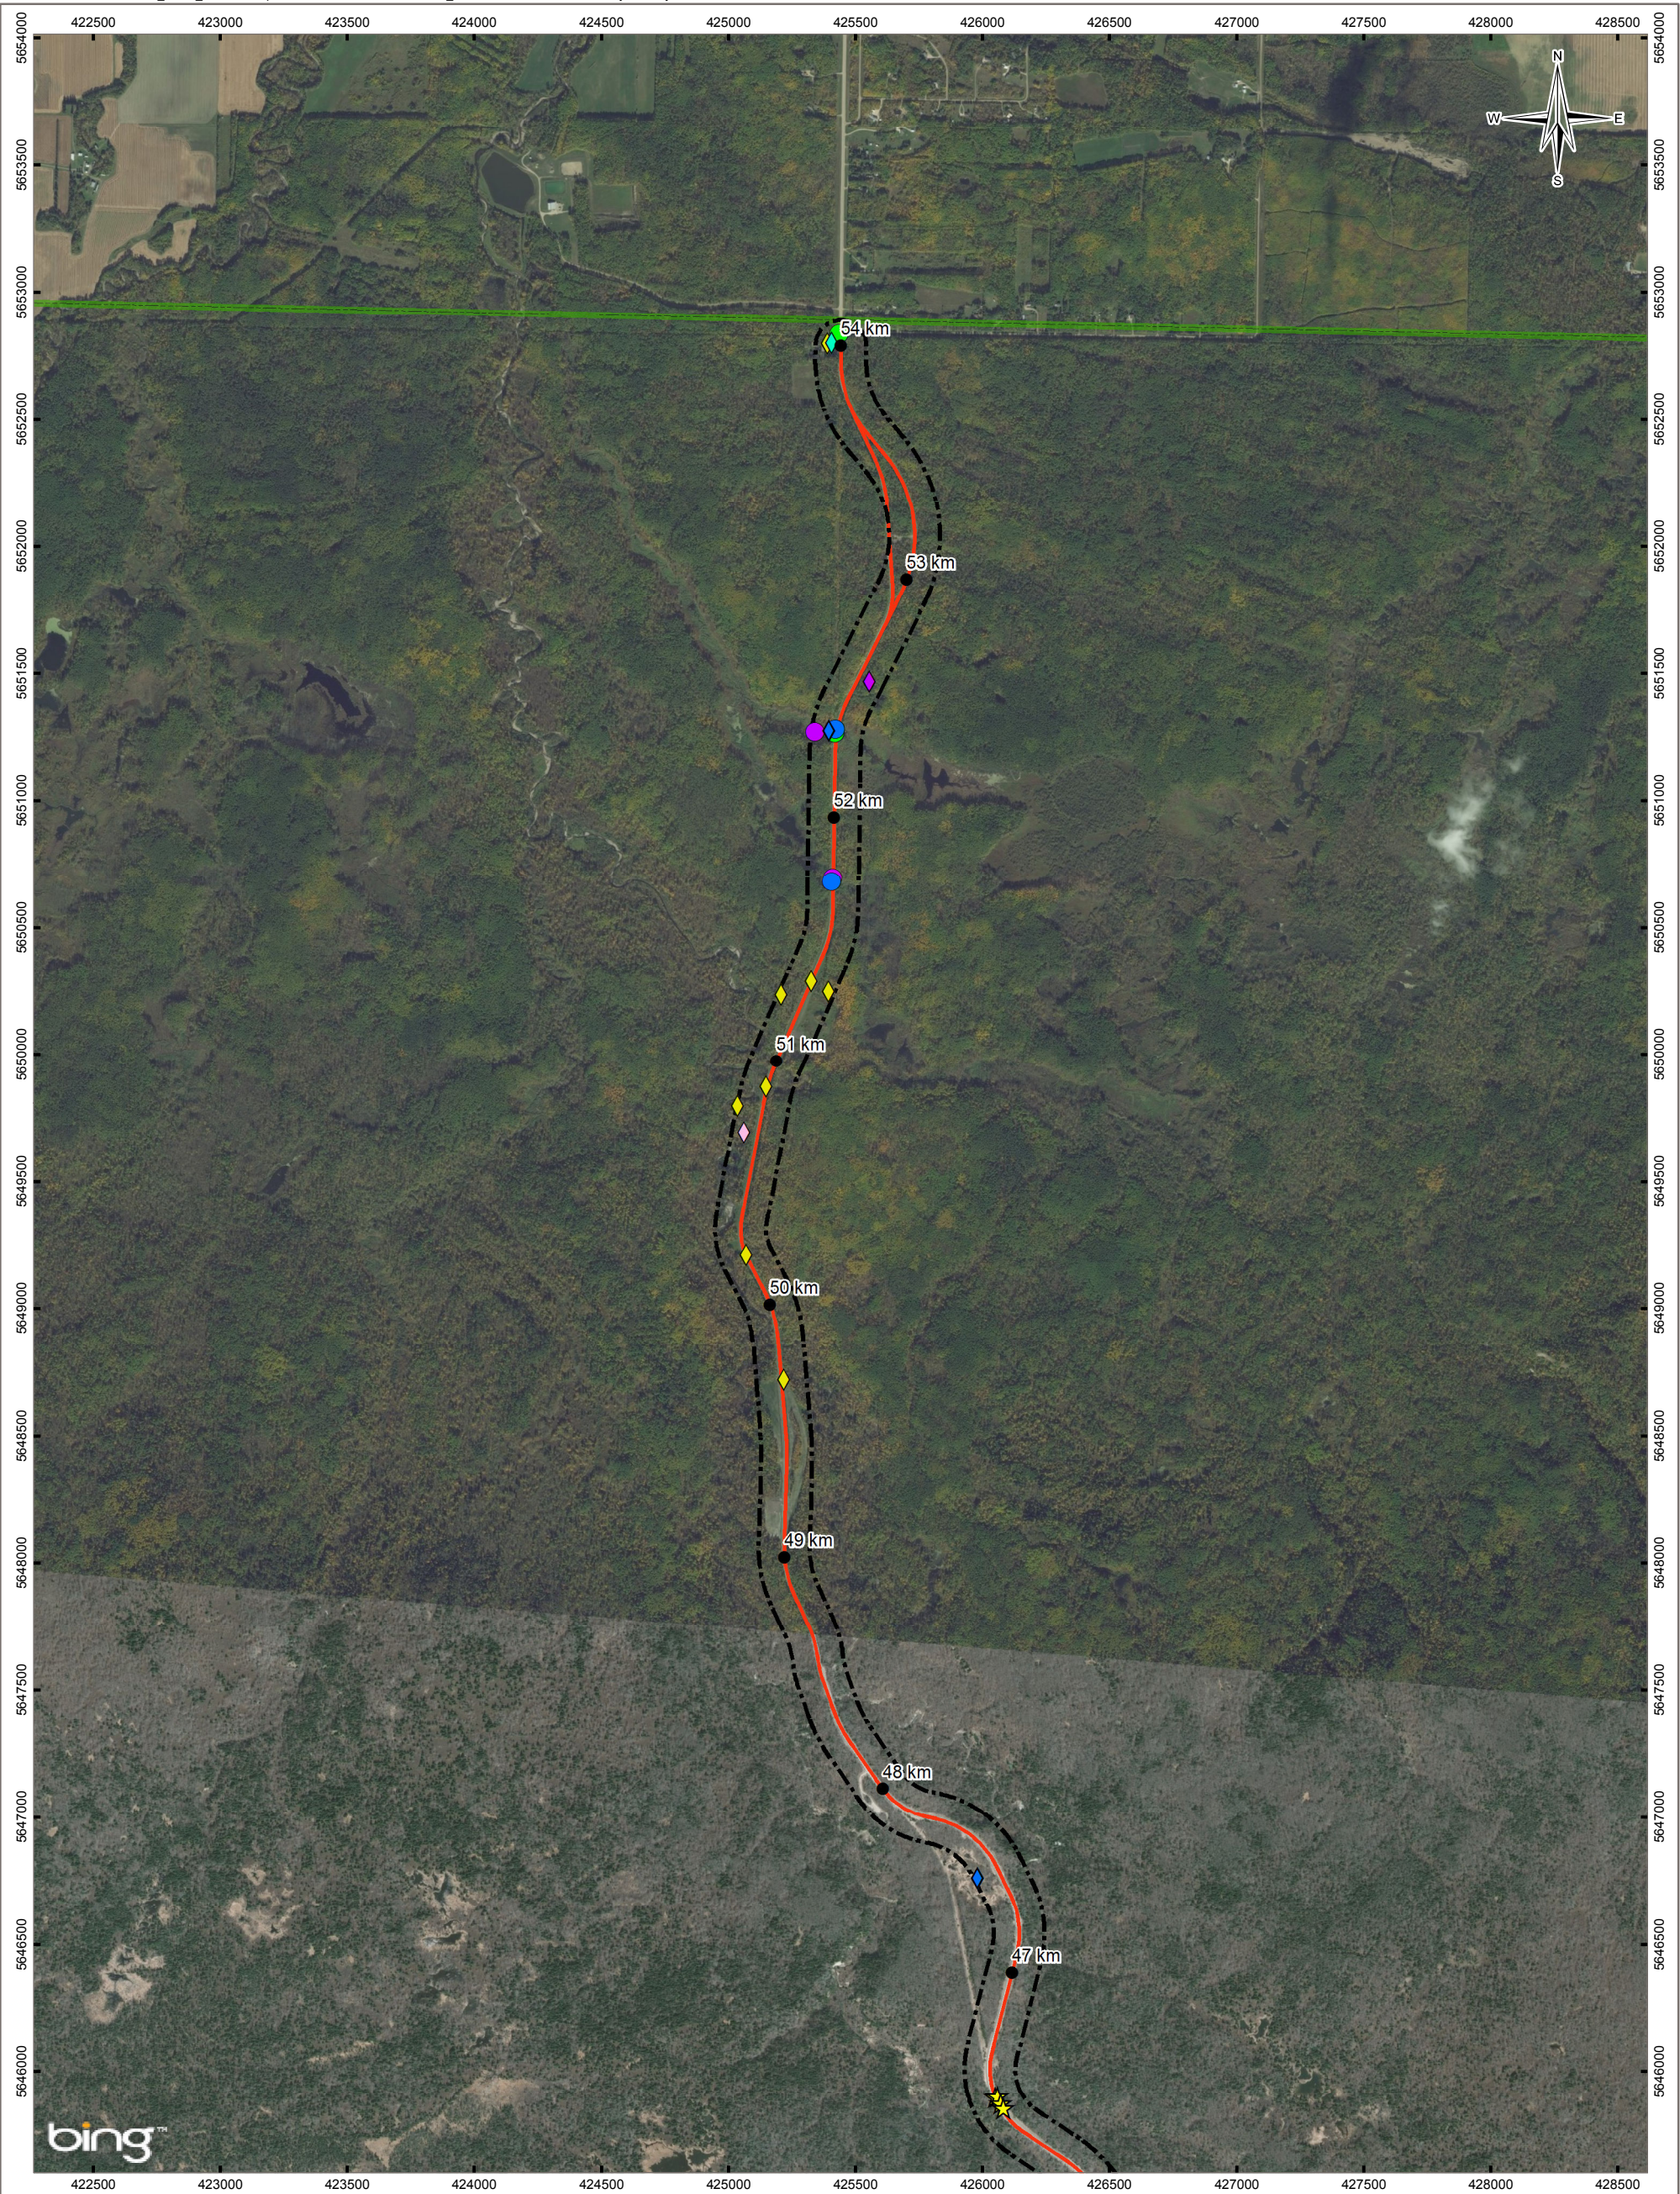
Metres					
FILE NO. ENVIND03979_FIG4.mxd					
PROJECT NO. ENVIND03979-01		DWN BB	CKD MS	APVD TC	REV 0
OFFICE Tl EBA-CAL		DATE April 8, 2016			Figure 4a

- KM Marker
- Highway 10 (within Park limits)
- - - Project Area (100m Buffer)
- ▭ Riding Mountain National Park Boundary
- June 2015 Observations**
- ▲ Barn Swallow Nest
- Barn Swallow Observation
- Canada Warbler Observation
- Golden-winged Warbler Observation
- Northern Leopard Frog Observation

During the June 2015 field visit, Tetra Tech EBA detected 89 bird species within the Project Area, three of which are considered SOMC: **Barn Swallow**, **Canada Warbler** (*Cardellina canadensis*), and **Golden-winged Warbler** (*Vermivora chrysoptera*). Barn Swallows were observed at km 0.5, 5.5, 6, 30.5, 34.5, 42.5, 52.5, and 54, and specifically using culverts for nesting within the Project Area at approximately km 0.5, as well as two additional sites between km 12.5-19.5 (Figure 4). Canada Warbler and Golden-winged Warbler were detected at km 25 and 52.5, respectively (Figure 4). Three amphibian species were detected, including one species of management concern, Northern Leopard Frog (*Lithobates pipiens*), which was detected near km 35 and 52 (Figure 4). These species are all SARA-listed species (Table 1), and all have historical records of occurrence within the Project Area (Figure 4).
