TRANSCANADA HIGHWAY IMPROVEMENT PROJECT, GLACIER NATIONAL PARK

Fish Habitat Assessment, DFO Self-Assessment and Detailed Mitigations Summary

Report Number: 1654325_RP0002_Rev B

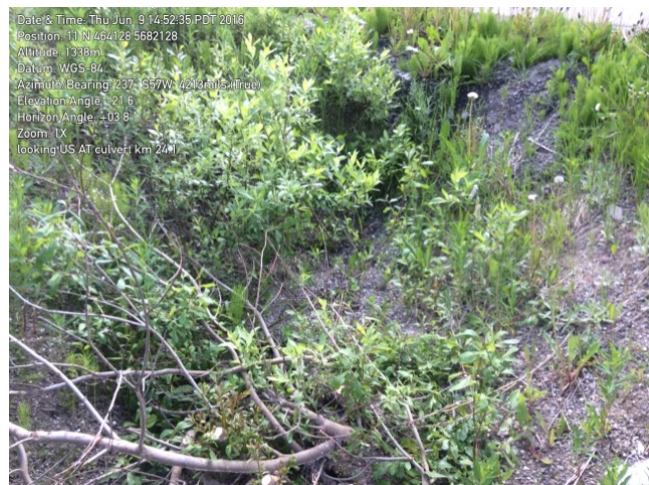
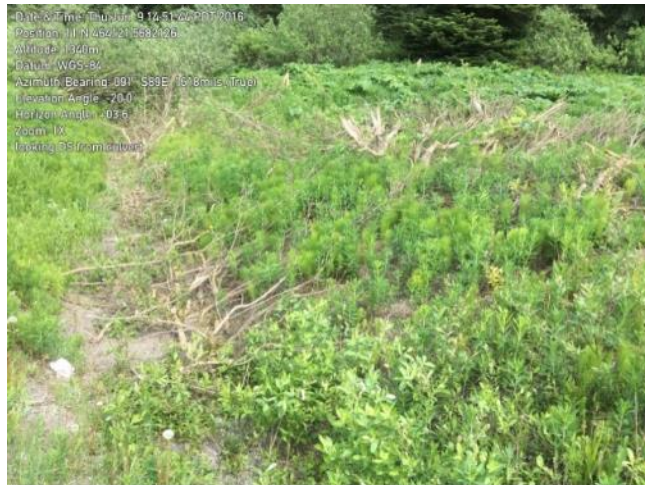
Culvert Condition: Good condition, based on the June 2016 field survey. No information for this culvert was provided in Taylor and Helms (2007).

Fish Habitat and Connectivity Comments: Unnamed drainage that flows into an unnamed tributary of the Illecillewaet River. The drainage consisted of a ditch on the upstream, westbound side of the TCH with no defined bed or banks and no fish habitat present. A dry and undefined drainage with terrestrial vegetation was present on the downstream, eastbound side of the TCH, indicating potential flows during snowmelt periods, also with no fish habitat (Figure 7). No hydrological connectivity issues were found.

Figure 7: TCH km 24.15 (TCHGlacier_19.6) – Crossing on upstream, westbound side (left) and downstream below the culvert outlet on the eastbound side (right)

Timing of Work Window: No fish and fish habitat timing restrictions apply. If water is flowing within this drainage at the time of construction, all construction works within the flow path of this drainage will be isolated to prevent suspended sediment transport downstream to the unnamed tributary of the Illecillewaet River.

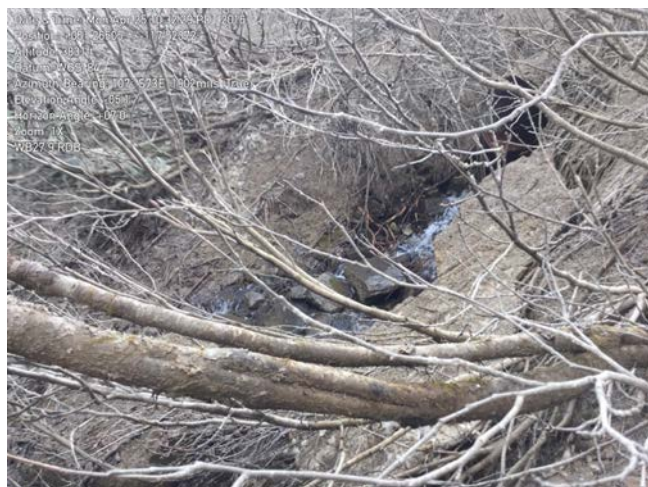
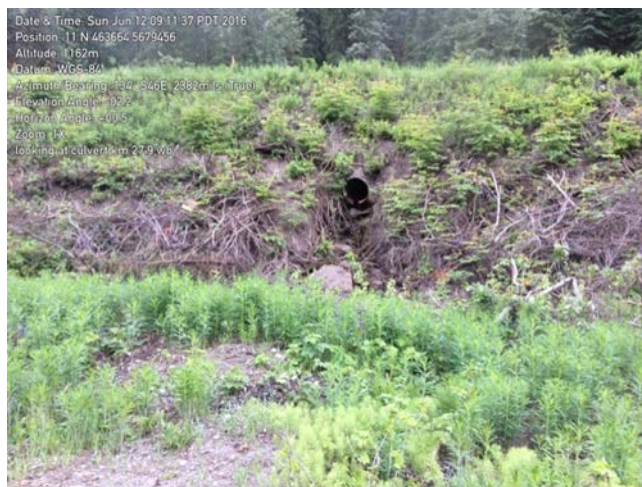
Culvert Condition: Culvert was identified as damaged and hanging (perched) on the downstream, westbound side of the TCH, during the June 2016 field survey. No information for this culvert was provided in Taylor and Helms (2007).

Figure 8: TCH km 27.9 (TCHGlacier_15.8) – Crossing on downstream, westbound side taken in April 2016 (left) and at the same location in June 2016 (right)

Timing of Work Window: No fish and fish habitat timing restrictions apply. If water is flowing within this drainage at the time of construction, all construction works within the flow path of this drainage will be isolated to prevent suspended sediment transport downstream to the unnamed tributary of the Illecillewaet River.

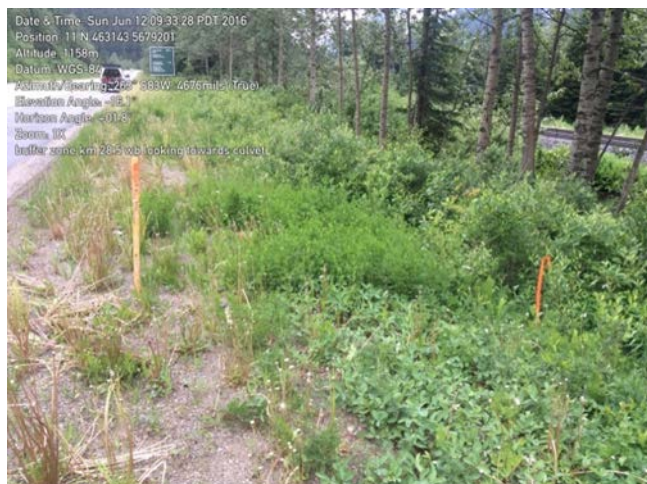
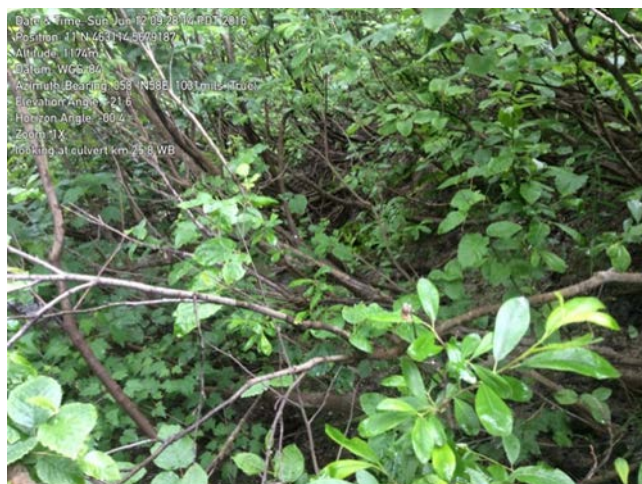
Culvert Condition: Good condition, based on the June 2016 field survey. Taylor and Helms (2007) indicated that this culvert was not hanging (perched) and that no barriers exist.

Fish Habitat and Connectivity Comments: Unnamed drainage that flows into the Illecillewaet River. The drainage consisted of a ditch on the upstream, eastbound side of the TCH with no defined bed or banks and no fish habitat present. A dry and undefined drainage with terrestrial vegetation was present on the downstream, eastbound side of the TCH, indicating potential flows during snowmelt periods, but with no fish habitat (Figure 9). Taylor and Helms (2007) also indicated that there was no likelihood of fish at this location. No connectivity issues were found.

Figure 9: TCH km 28.5 (TCHGlacier_15.1) – Ditchline on upstream, eastbound side of TCH (left) and downstream below the culvert outlet on the westbound side (right)

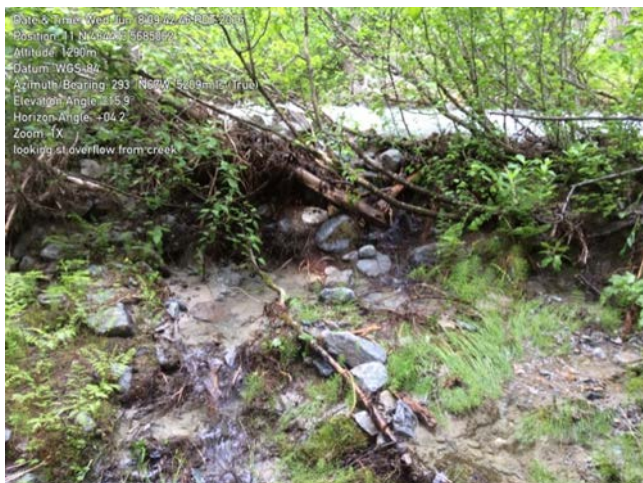
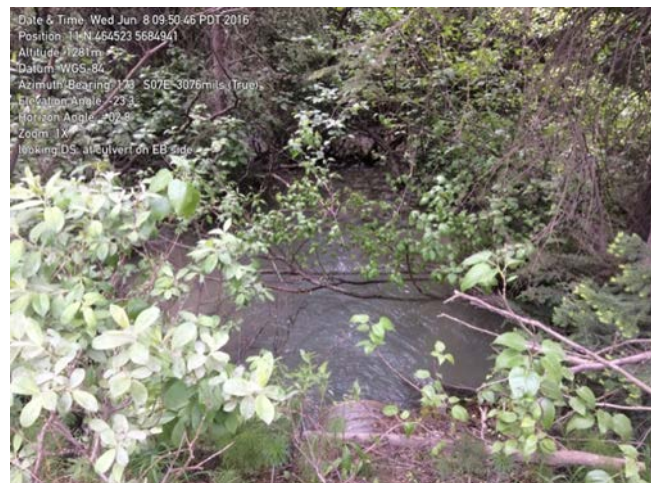
Culvert Condition: Good condition; no hanging issues identified. No information for this culvert was provided in Taylor and Helms (2007).

Fish Habitat and Connectivity Comments: Unnamed watercourse that flows into Connaught Creek. On the upstream, westbound side of the TCH, the watercourse consisted of multiple, poorly-defined and seasonal channels with steep slopes, cascading water, and no potential for fish to move upstream or downstream and is likely non-fish bearing. Additional dry channels were also noted in the area, indicating higher flows during snowmelt periods. Water depth in the channels was measured at less than 0.1 m. On the downstream, eastbound side of the TCH, the watercourse consists of a pool below the culvert, which flows into multiple, poorly-defined and seasonal channels with steep slopes. Water depths in these channels were less than 0.1 m, with the presence of abundant terrestrial vegetation and debris. Directly below the culvert, the watercourse is non-fish bearing (Figure 10) due to the channel gradient and cascades present towards Connaught Creek. No connectivity issues were found. Flows through this culvert are predominantly from snowmelt, as well as freshet overflow from nearby Hermit Creek (TCH km 21.06). Hermit Creek had overtopped its banks during the June 2016 field program and inundated the entire area.

Figure 10: TCH km 20.94 (TCHGlacier_22.8) – Watercourse on upstream, westbound side (left) and downstream below the culvert outlet on the eastbound side (right)

Timing of Work Window: No fish have previously been documented at this location (PCA 2016b) and due to lack of fish habitat, fish presence is unlikely. No fish and fish habitat timing restrictions apply. If water is flowing within this watercourse at the time of construction, all construction works within the flow path will be isolated to prevent suspended sediment transport downstream to Connaught Creek.

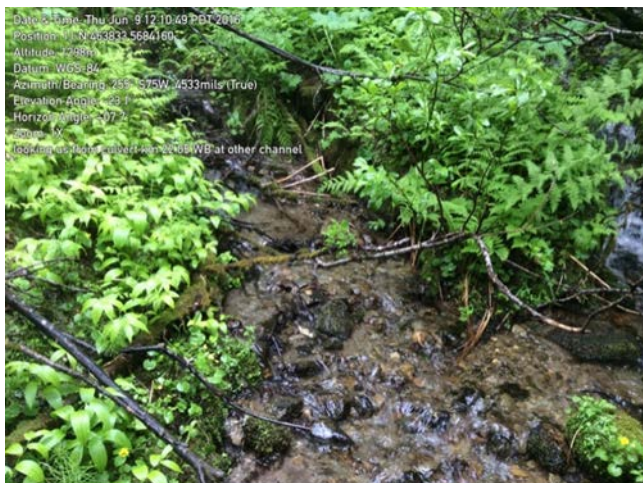
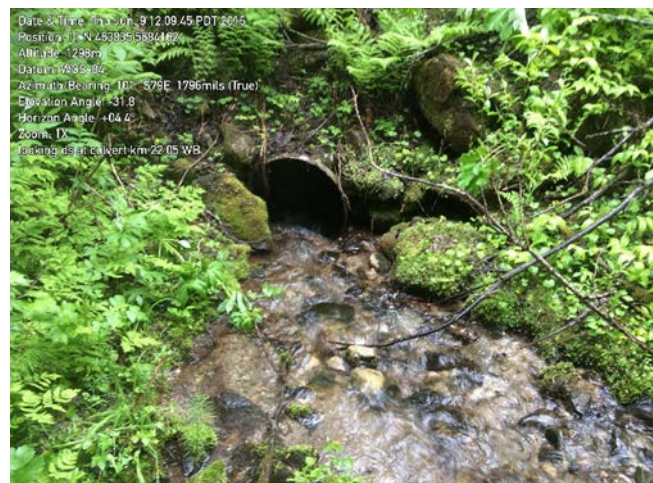
Culvert Condition: Culvert was identified as hanging (perched) on the downstream, eastbound side of the TCH. No information for this culvert was provided in Taylor and Helms (2007).

Figure 11: TCH km 22.05 (No named culvert/stream) – Watercourse on upstream, westbound side looking upstream at the two channels (left) and looking downstream where these two channels meet and go through the culvert inlet (right)

Timing of Work Window: No fish have previously been documented at this location (PCA 2016b) and due to lack of fish habitat, fish presence is unlikely. No fish and fish habitat timing restrictions apply. If water is flowing within this watercourse at the time of construction, all construction works within the flow path will be isolated to prevent suspended sediment transport downstream to Connaught Creek.

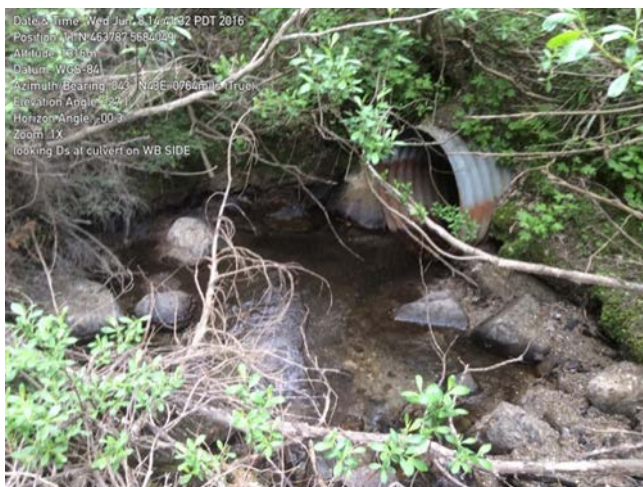
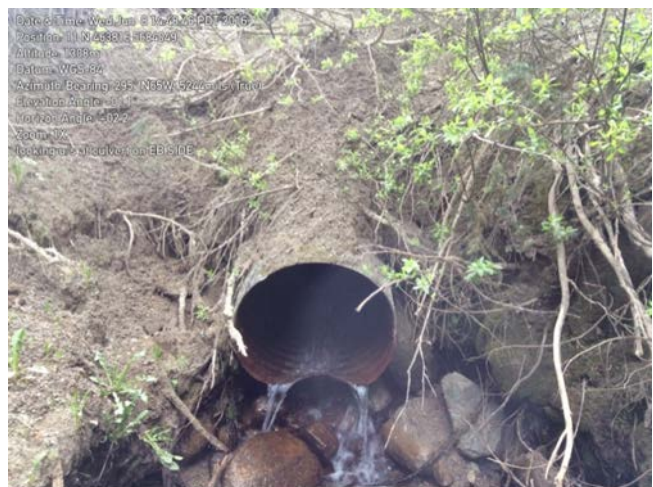
Culvert Condition: Culvert was identified as hanging (perched), with a very steep gradient (greater than 10%) on the downstream, eastbound side of the TCH. Taylor and Helms (2007) indicated that there was a 1.2 m drop on the culvert outlet.

Figure 12: TCH km 22.15 (TCHGlacier_21.6) – Watercourse on upstream, westbound side (left) and downstream below the culvert outlet on the eastbound side (right)

Proposed Construction Activity: Twinning of TCH at this location, proposed culvert replacement/extension (Culvert #4) of an 800 mm culvert that will be extended by 3 m on the inlet side with an additional 2.3 m³ of rip rap added for support and stabilization (Armstrong-Bayliss 2016b; McElhanney 2016b).

Timing of Work Window: No fish have previously been documented at this location (PCA 2016b) and due to lack of fish habitat, fish presence is unlikely. No fish and fish habitat timing restrictions apply. If water is flowing within this watercourse at the time of construction, all construction works within the flow path will be isolated to prevent suspended sediment transport downstream to Connaught Creek.

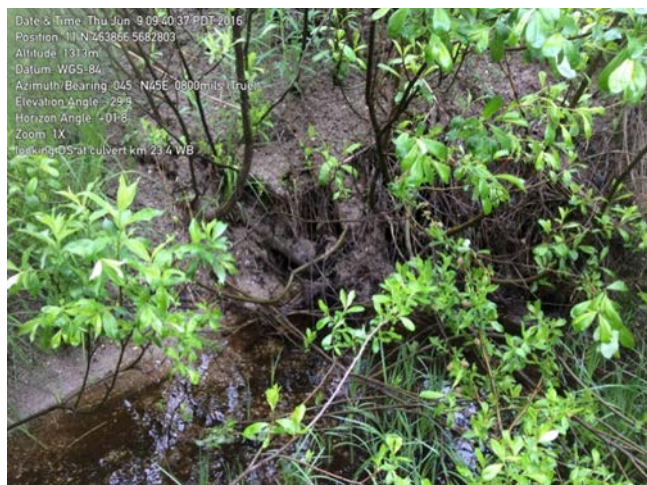
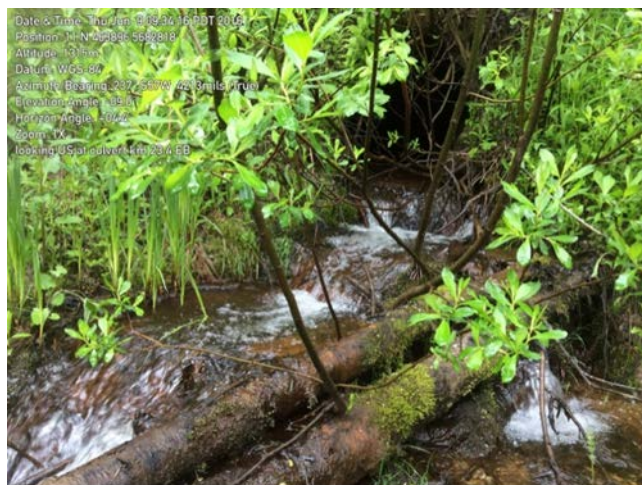
Culvert Condition: Culvert was identified as plugged with debris and hanging (perched), with a very steep gradient (greater than 10%) on the downstream, eastbound side of the TCH. Taylor and Helms (2007) indicated that there was a 1.2 m drop on the culvert outlet.

Figure 13: TCH km 23.4 (TCHGlacier_20.7) – Watercourse on upstream, westbound side (left) and downstream below the culvert outlet on the eastbound side (right)

Proposed Construction Activity: Twinning of TCH at this location, proposed culvert replacement/extension (Culvert #7), based on the Phase 2 IFT drawing package (McElhanney 2016b), which includes an extension of the inlet by 1.3 m with an additional 10.9 m³ of rip rap added for support and stabilization (Armstrong-Bayliss 2016b).

Timing of Work Window: No fish have previously been documented at this location (PCA 2016b) and fish presence is unlikely. No fish and fish habitat timing restrictions apply. If water is flowing within this watercourse at the time of construction, all construction works within the flow path will be isolated to prevent suspended sediment transport downstream to Rogers Creek.

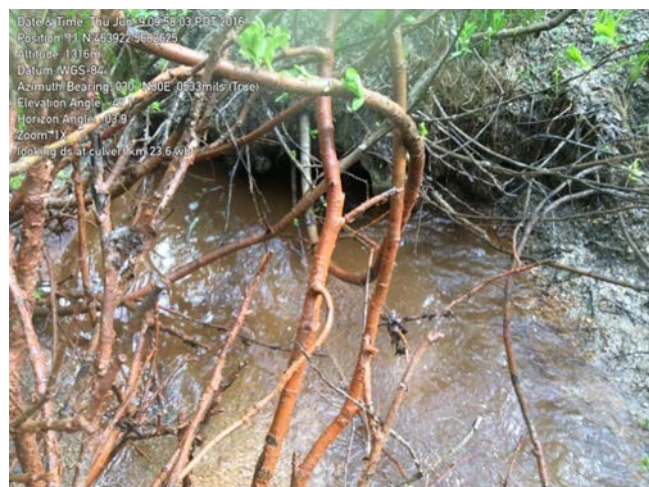
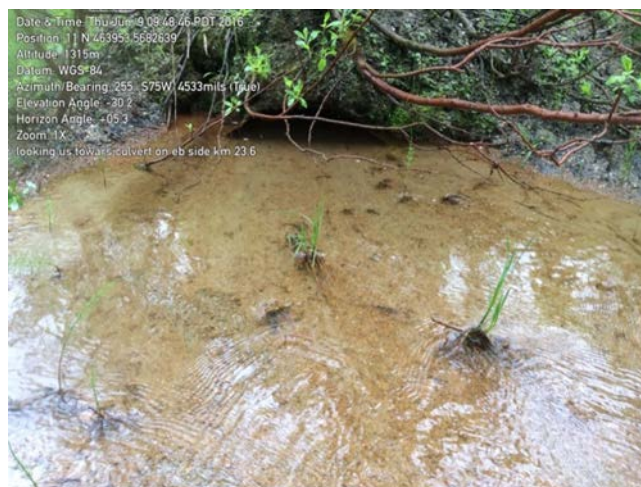
Culvert Condition: Culvert was identified as plugged with debris. Taylor and Helms (2007) indicated that the culvert was not hanging.

Figure 14: TCH km 23.6 (TCHGlacier_20.2) – Watercourse on upstream, westbound side (left) and downstream below the culvert outlet on the eastbound side (right)

Proposed Construction Activity: Twinning of TCH at this location, proposed culvert replacement/extension (Culvert #8) based on the Phase 2 IFT drawing package (McElhanney 2016b), which includes an extension of the outlet by 4.5 m with an additional 6.1 m³ of rip rap added for support and stabilization (Armstrong-Bayliss 2016b).

Timing of Work Window: No fish have previously been documented at this location (PCA 2016b) and fish presence is unlikely. No fish and fish habitat timing restrictions apply. If water is flowing within this watercourse at the time of construction, all construction works within the flow path will be isolated to prevent suspended sediment transport downstream to Rogers Creek.

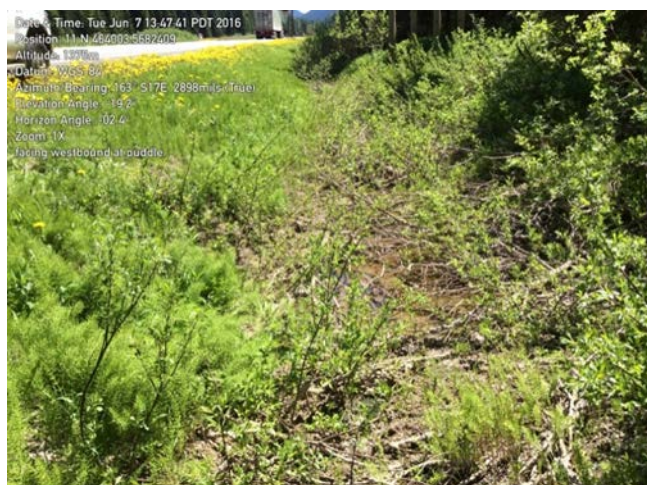
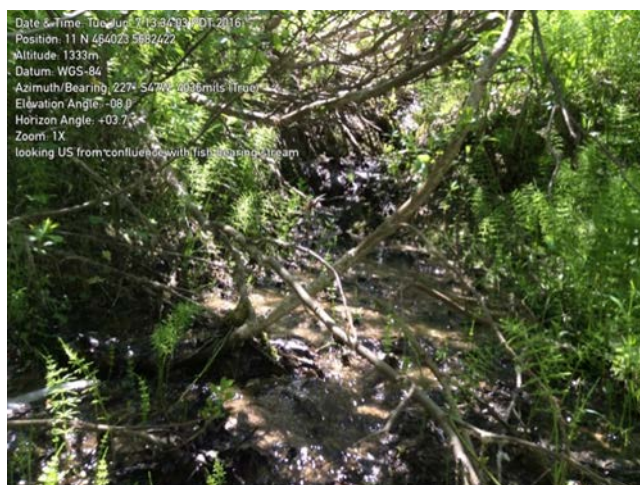
Culvert Condition: Culvert was identified as partially plugged with debris. Taylor and Helms (2007) indicated that the culvert was not hanging.

Figure 15: TCH km 23.84 (TCHGlacier_19.9) – Poorly-defined watercourse on upstream, westbound side (left) and defined watercourse downstream below the culvert outlet on the eastbound side (right)

Proposed Construction Activity: Twinning of TCH at this location, proposed culvert replacement/extension (Culvert #9) based on the Phase 2 IFT drawing package (McElhanney 2016b), which includes an extension of the outlet by 9.7 m with an additional 6.1 m³ of rip rap added for support and stabilization (Armstrong-Bayliss 2016b).

Timing of Work Window: No fish have previously been documented at this location (PCA 2016b) and fish presence is unlikely. No fish and fish habitat timing restrictions apply. If water is flowing within this watercourse at the time of construction, all construction works within the flow path will be isolated to prevent suspended sediment transport downstream to Rogers Creek.

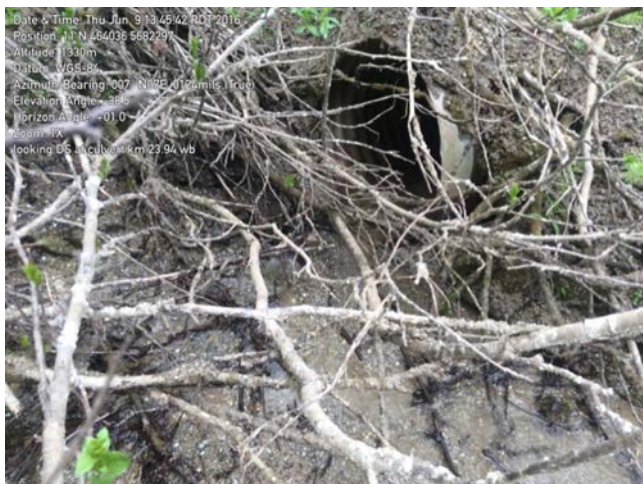
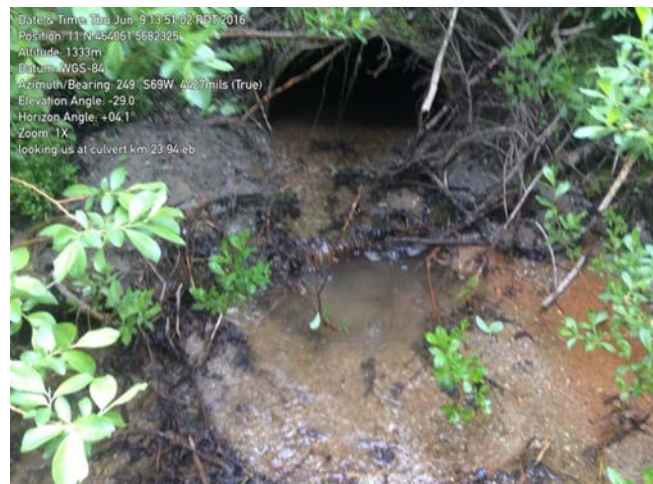
Culvert Condition: Culvert was identified as plugged with debris. Taylor and Helms (2007) indicated that the culvert was not hanging.

Figure 16: TCH km 23.94 (TCHGlacier_19.8) – Watercourse on upstream, westbound side (left) and downstream below the culvert outlet on the eastbound side (right)

Timing of Work Window: No fish have previously been documented at this location (PCA 2016b) and fish presence is unlikely. No fish and fish habitat timing restrictions apply. If water is flowing within this watercourse at the time of construction, all construction works within the flow path will be isolated to prevent suspended sediment transport downstream to the unnamed tributary of Rogers Creek.

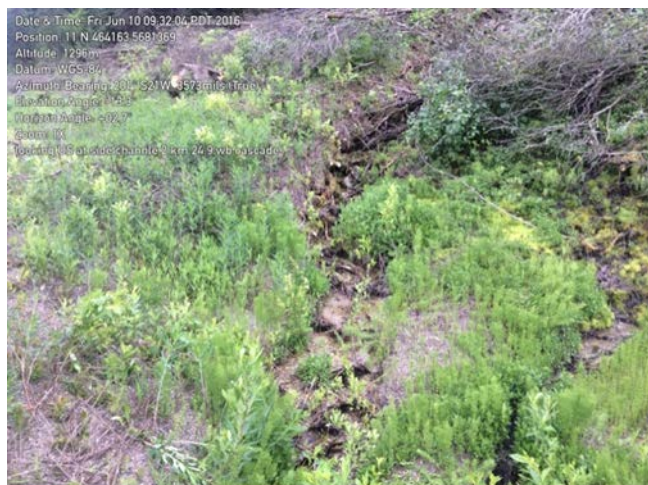
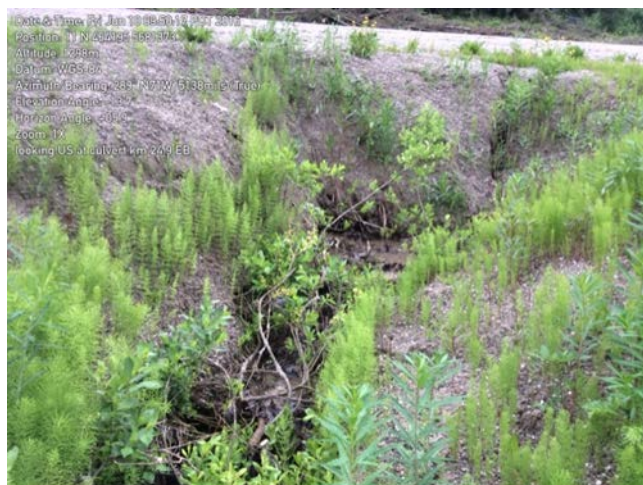
Culvert Condition: Good condition. No information for this culvert (TCHGlacier_18.8 at km 24.9) was provided in Taylor and Helms (2007). No culvert was found at TCH km 25.0.

Figure 17: TCH km 24.9 (TCHGlacier_18.8) – Watercourse on upstream, westbound side (left) and downstream below the culvert outlet on the eastbound side (right)

Timing of Work Window: This watercourse flows into a known fish-bearing tributary of the Illecillewaet River; however, due to the lack of fish habitat within this watercourse, fish use is unlikely. If water is flowing within this watercourse at the time of construction, all construction works within the flow path will be isolated to prevent suspended sediment transport downstream to the unnamed tributary of the Illecillewaet River.

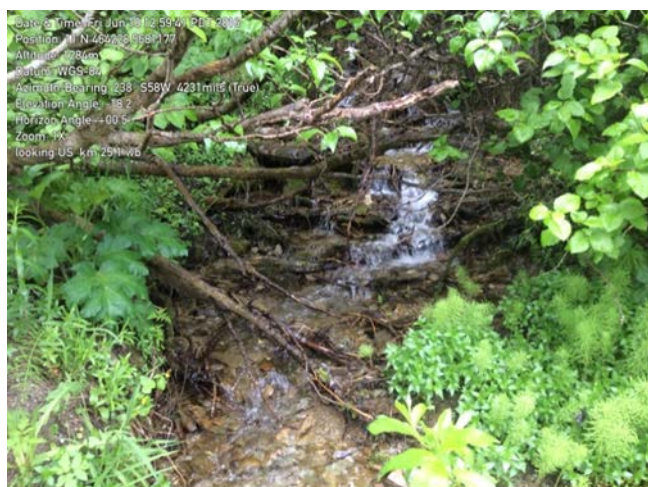
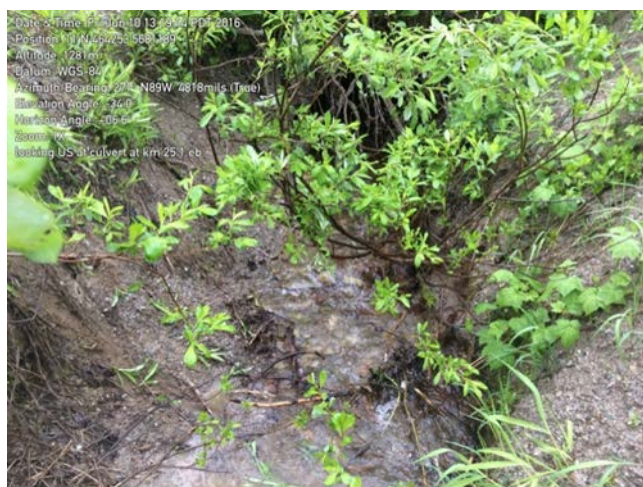
Figure 18: TCH km 25.1 (TCHGlacier_18.6) – Watercourse on upstream, westbound side (left) and downstream below the culvert outlet on the eastbound side (right)

Timing of Work Window: This watercourse flows into a known fish-bearing tributary of the Illecillewaet River; however, due to the lack of fish habitat within this watercourse, fish use is unlikely. If water is flowing within this watercourse at the time of construction, all construction works within the flow path will be isolated to prevent suspended sediment transport downstream to the unnamed tributary of the Illecillewaet River.

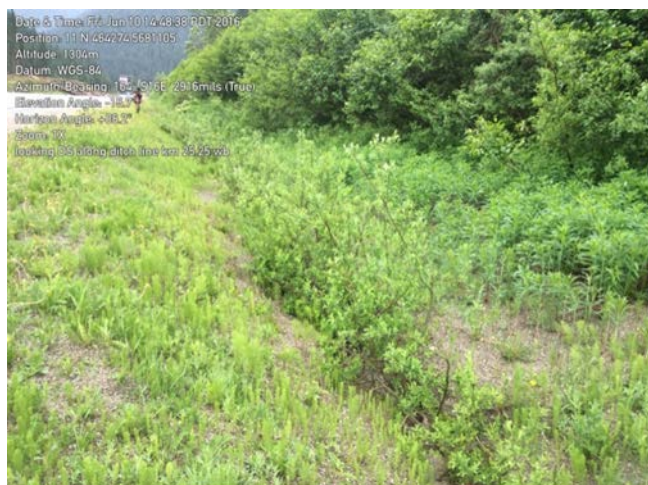
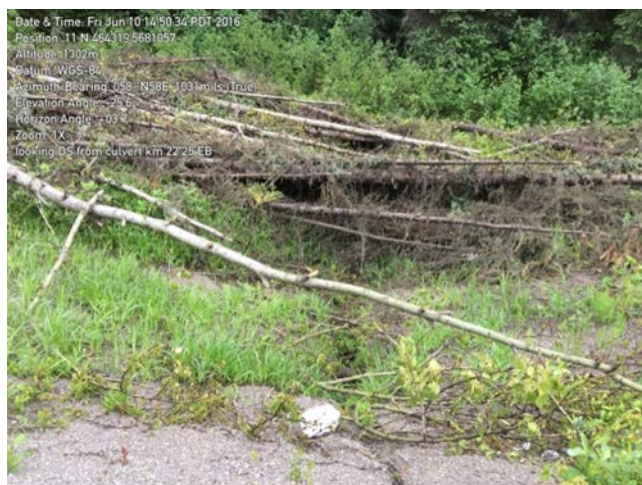
Figure 19: TCH km 25.25 (TCHGlacier_18.5) – Watercourse on upstream, westbound side (left) and downstream below the culvert outlet on the eastbound side (right)

Timing of Work Window: This watercourse flows into a fish-bearing tributary of the Illecillewaet River; however, due to the lack of fish habitat within this watercourse, fish use is unlikely. If water is flowing within this watercourse at the time of construction, all construction works within the flow path will be isolated to prevent suspended sediment transport downstream to the unnamed tributary of the Illecillewaet River.

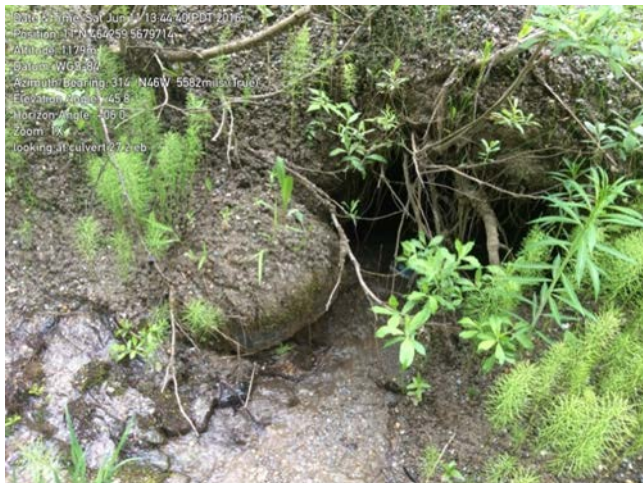
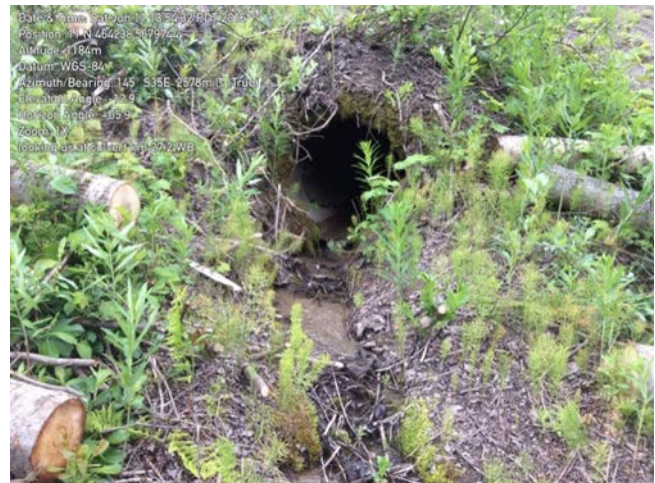
Figure 20: TCH km 27.25 (TCHGlacier_16.4) – Watercourse on upstream, eastbound side (left) and downstream below the culvert outlet on the westbound side (right)

Timing of Work Window: This watercourse flows into a known fish-bearing watercourse (Illecillewaet River); however, due to the lack of fish habitat within this watercourse, fish use is unlikely. If water is flowing within this watercourse at the time of construction, all construction works within the flow path will be isolated to prevent suspended sediment transport downstream to the Illecillewaet River.

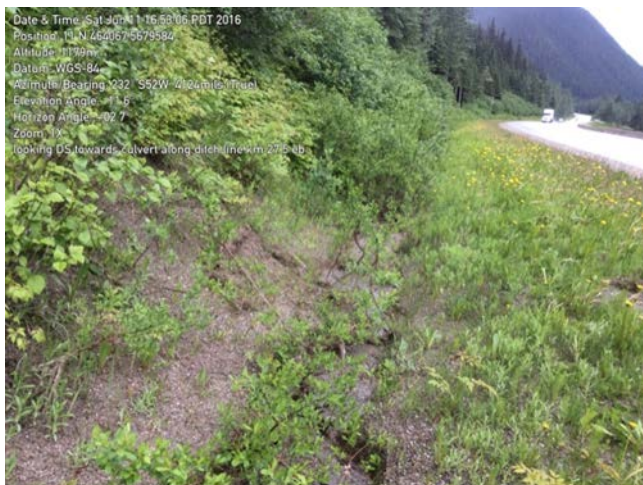
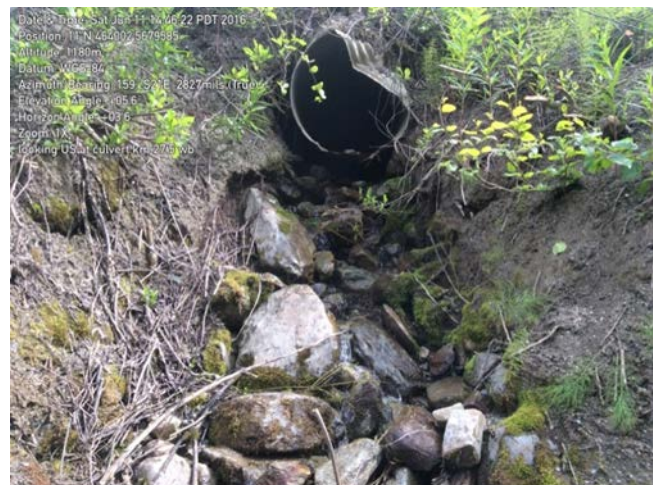
Figure 21: TCH km 27.5 (TCHGlacier_16.2) – Watercourse on upstream, eastbound side (left) and armoured section downstream below the culvert outlet on the westbound side (right)

Timing of Work Window: This watercourse flows into a known fish-bearing watercourse (Illecillewaet River); however, due to the lack of fish habitat within this watercourse, fish use is unlikely. If water is flowing within this watercourse at the time of construction, all construction works within the flow path will be isolated to prevent suspended sediment transport downstream to the Illecillewaet River.

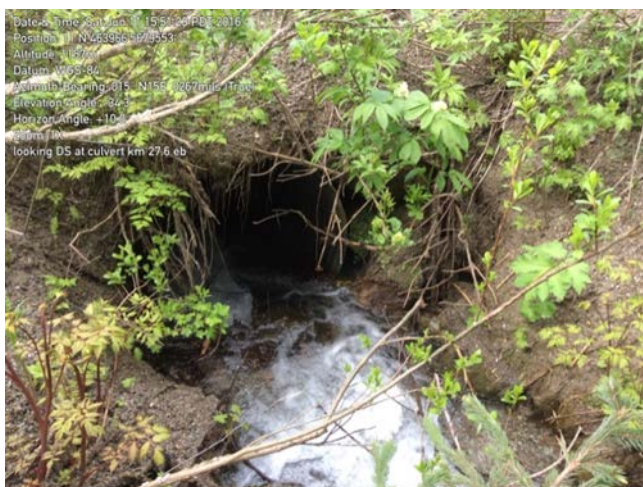
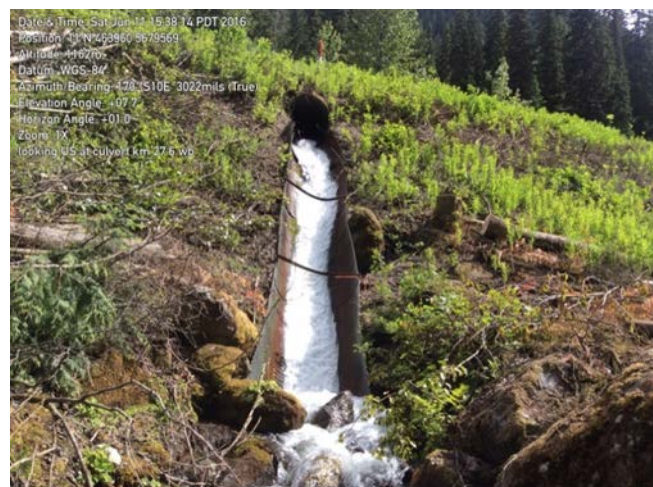
Figure 22: TCH km 27.6 (TCHGlacier_16.1) – Watercourse on upstream, eastbound side (left) and downstream below the culvert outlet on the westbound side (right)

Timing of Work Window: This watercourse flows into a known fish-bearing watercourse (Illecillewaet River); however, due to the lack of fish habitat within this watercourse, fish use is unlikely. If water is flowing within this watercourse at the time of construction, all construction works within the flow path will be isolated to prevent suspended sediment transport downstream to the Illecillewaet River.

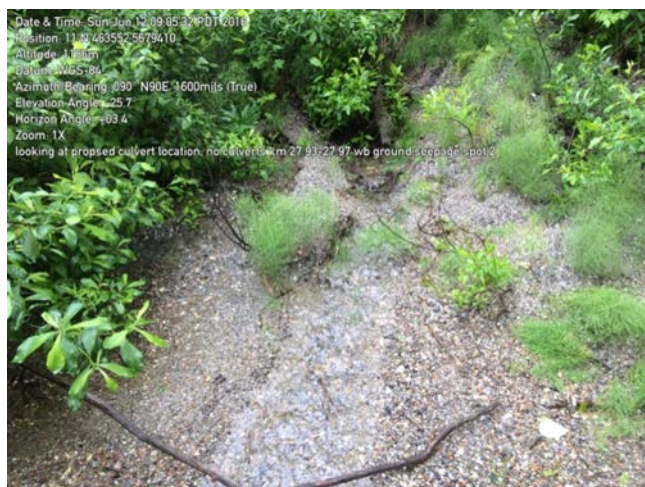
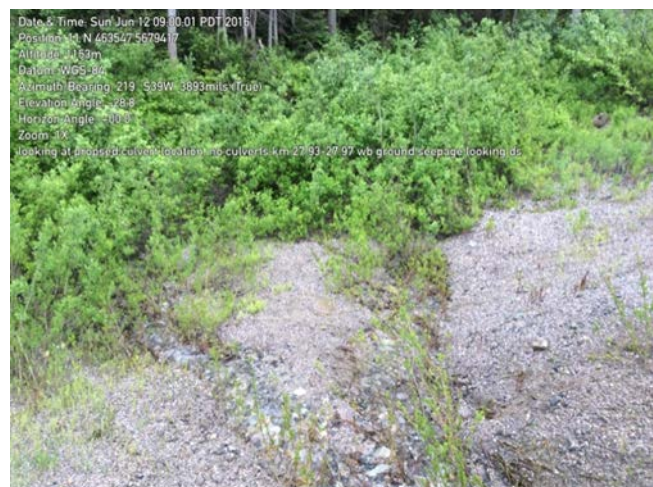
Figure 23: TCH km 28.0 (No named culvert/stream) – Overland flow channels on downstream, westbound side of the TransCanada Highway looking upstream towards the highway (right) and downstream towards the Illecillewaet River (left).

Timing of Work Window: This watercourse flows into a known fish-bearing watercourse (Illecillewaet River); however, due to the lack of fish habitat within this watercourse, fish use is unlikely. If water is flowing within this watercourse at the time of construction, all construction works within the flow path will be isolated to prevent suspended sediment transport downstream to the Illecillewaet River.

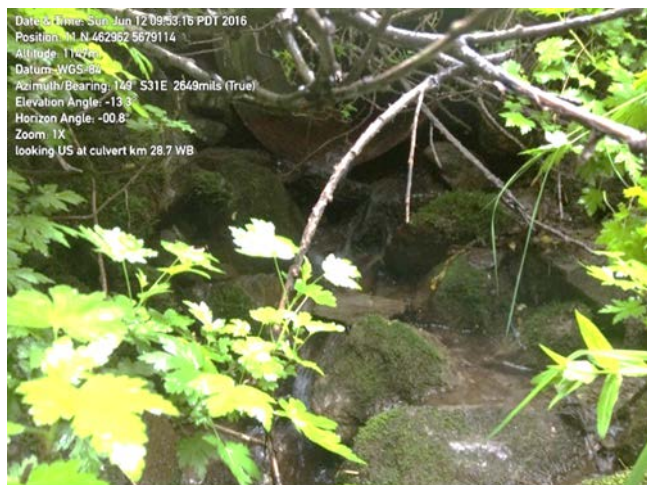
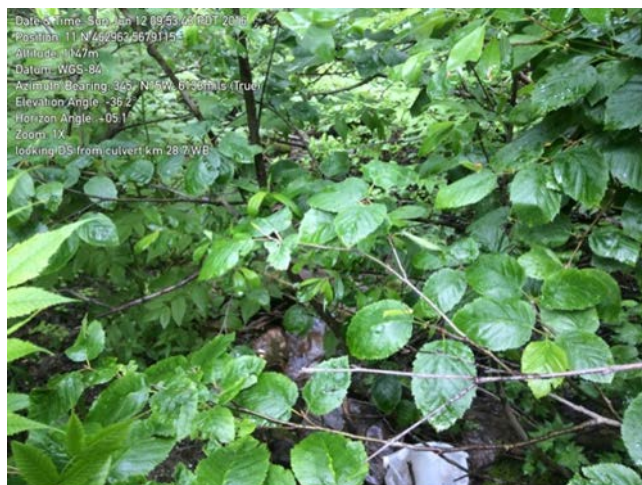
Figure 24: TCH km 28.7 (TCHGlacier_15.0) – Hanging culvert on downstream, westbound side of TCH (left) and watercourse downstream below the culvert outlet on the westbound side (right)

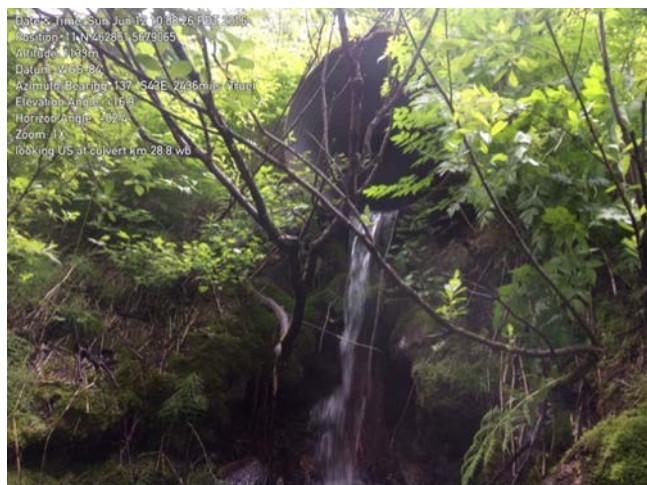
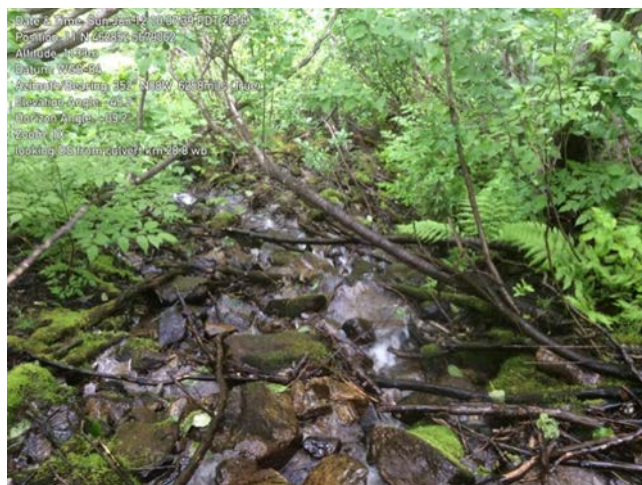
Figure 25: TCH km 28.8 (TCHGlacier_14.8) – Hanging culvert on downstream, westbound side of TCH (left) and watercourse downstream below the culvert outlet on the westbound side (right)

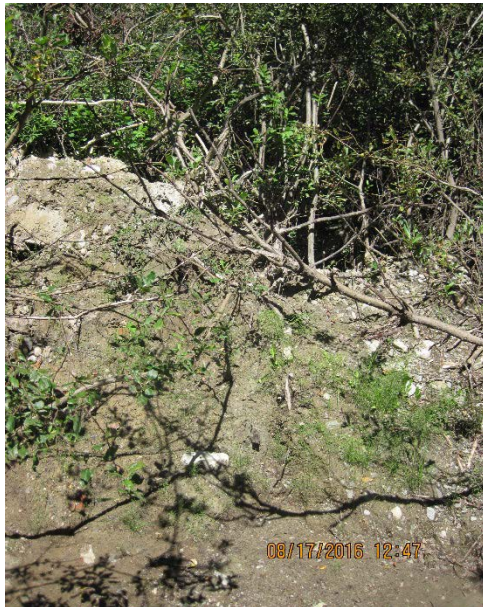
Figure 26: TCH km 21.0 (TCHGlacier_23.0) – Watercourse on upstream, westbound side of the TransCanada Highway (left) and on the downstream side, below the culvert outlet on the eastbound side of the highway (right)

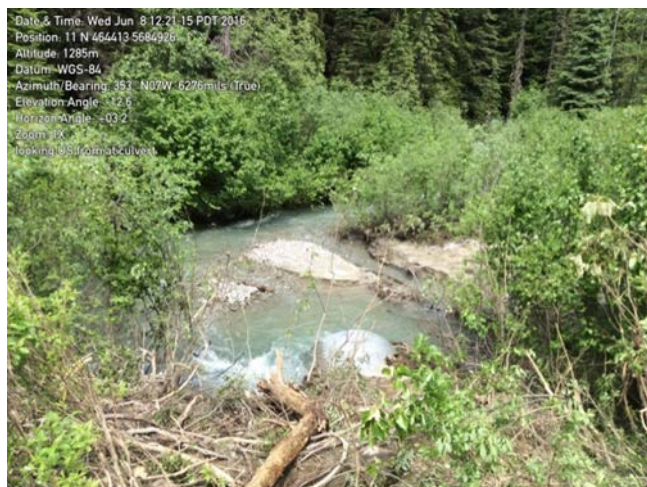
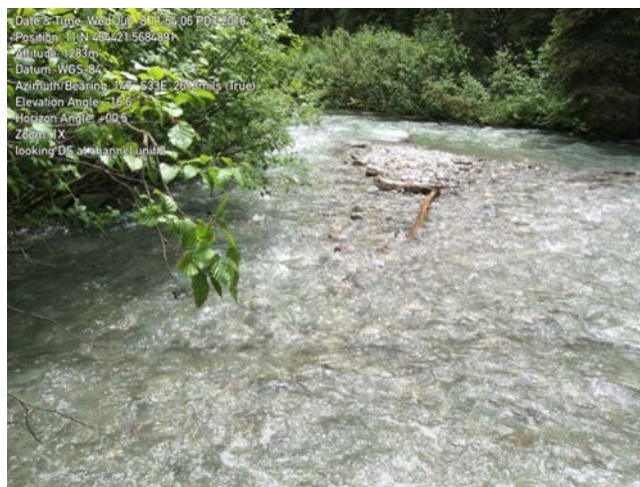
Figure 27: TCH km 21.08 (Hermit Creek) – Aquatic habitats on upstream, westbound side (left) and downstream below the culvert outlet on the eastbound side (right)

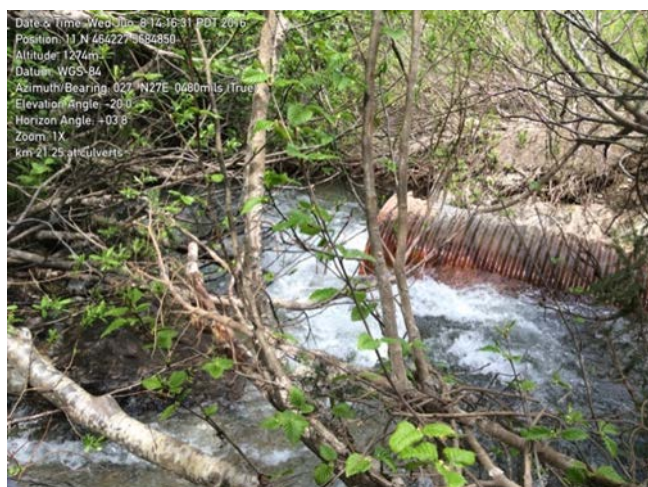
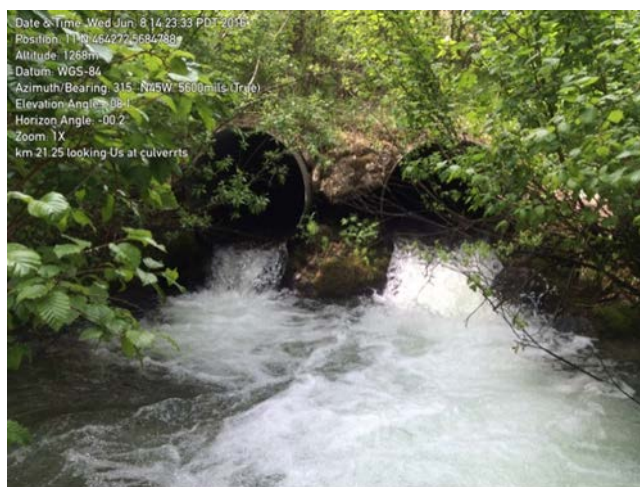
Figure 28: TCH km 21.25 (TCHGlacier_22.5) – Aquatic habitats on upstream, westbound side (left) and downstream below the culvert outlet on the eastbound side (right)

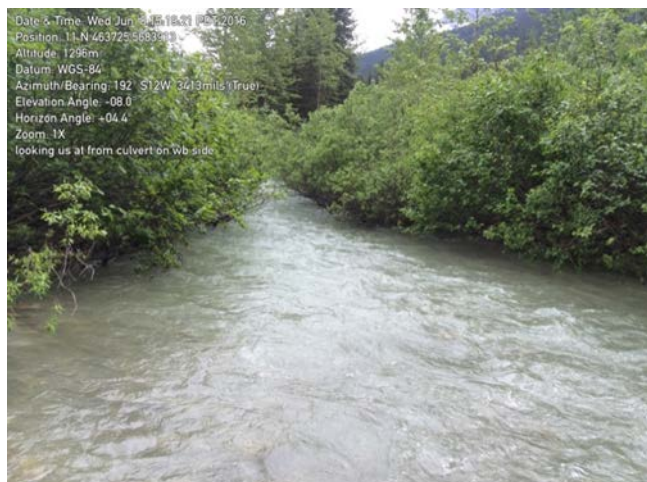
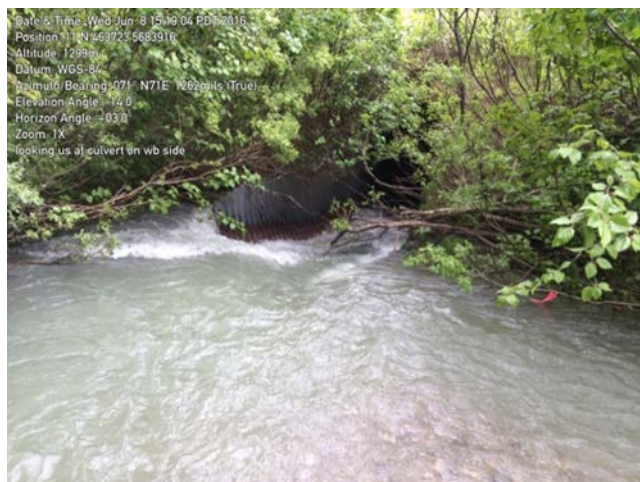
Figure 29: TCH km 22.3 (Connaught Creek, TCH/Glacier_21.5) – Aquatic habitats of Connaught Creek on upstream, westbound side, looking upstream above the culvert inlet (left) and downstream towards the culvert inlet (right)

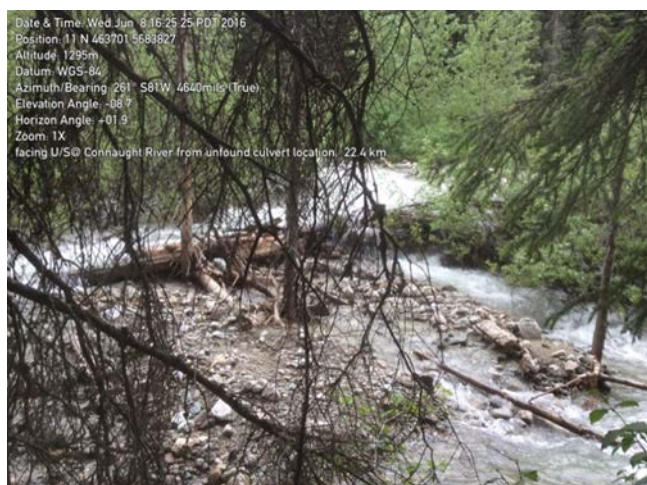
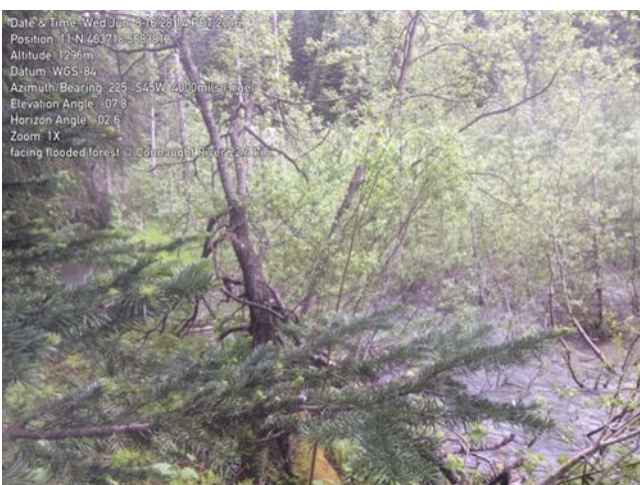
Figure 30: TCH km 22.4 to 22.5 – Aquatic habitats and inundated forest of channels flowing into Connaught Creek on upstream, westbound side, looking west at TCH km 22.4 (left) and southwest towards TCH km 22.5 (right)

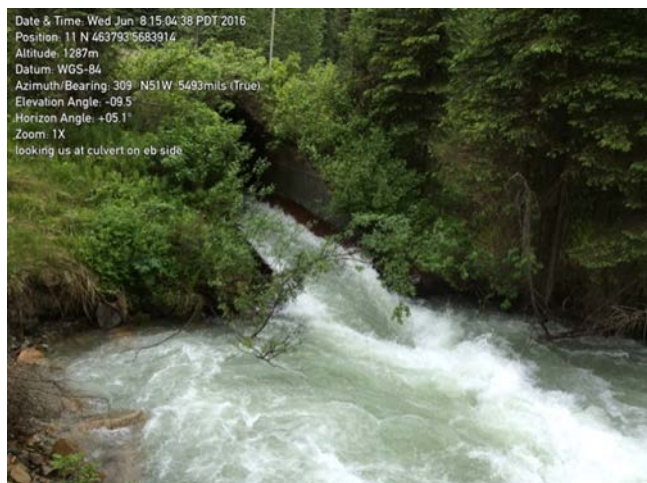
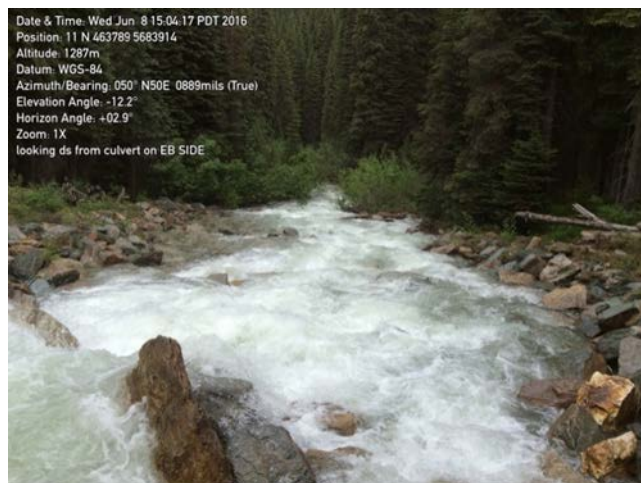
Figure 31: TCH km 22.3 (Connaught Creek, TCHGlacier_21.5) – Aquatic habitats of Connaught Creek on downstream, eastbound side, looking upstream towards the culvert outlet (left), and downstream, below the culvert outlet (right)

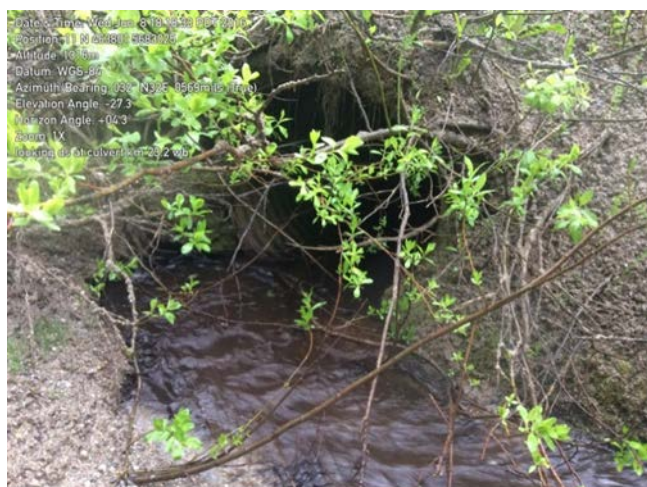
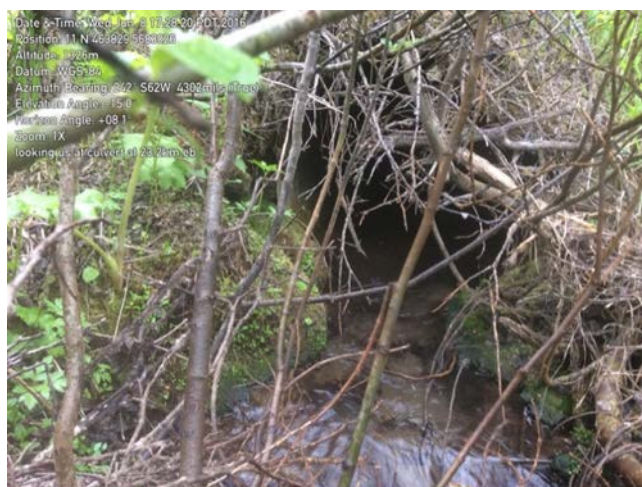
Figure 32: TCH km 23.2 (TCHGlacier_20.6) – Aquatic habitats on upstream, westbound side (left) and downstream below the culvert outlet on the eastbound side (right)

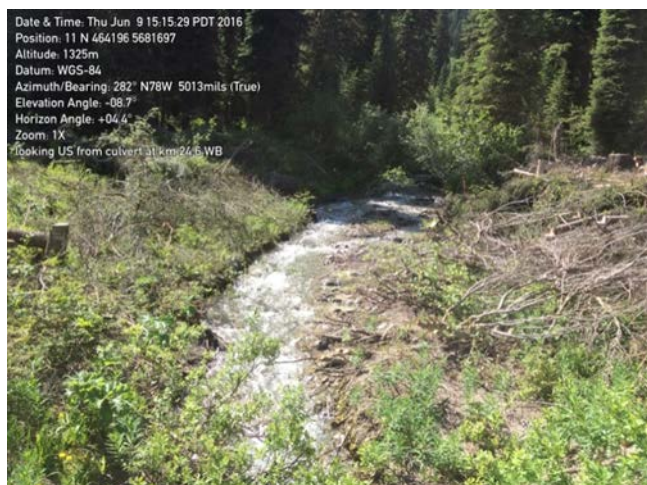
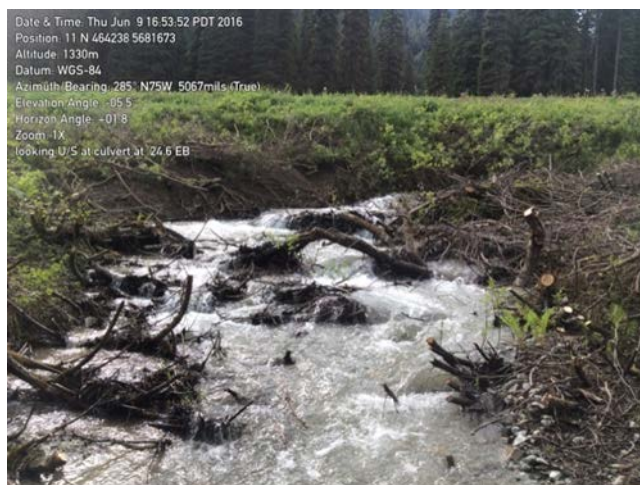
Figure 33: TCH km 24.6 (TCHGlacier_19.2) – Aquatic habitats on upstream, westbound side (left) and downstream below the culvert outlet on the eastbound side (right)

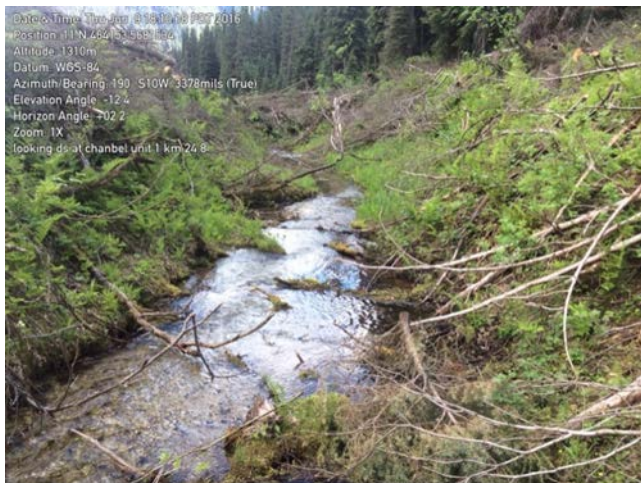
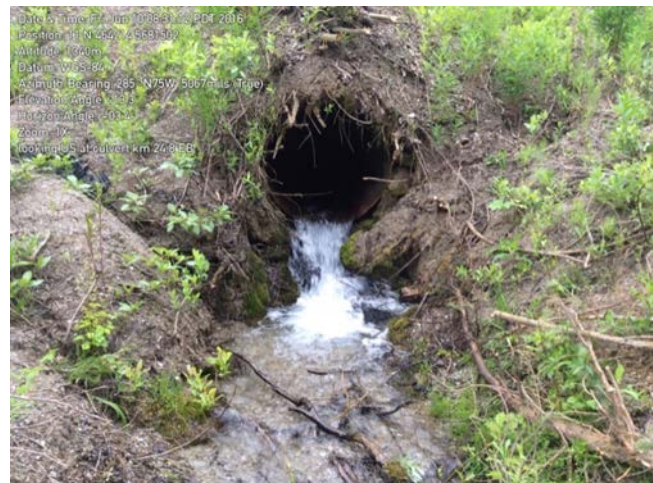
Figure 34: TCH km 24.6 (TCHGlacier_19.0) – Aquatic habitats on upstream, westbound side (left) and downstream below the culvert outlet on the eastbound side (right)

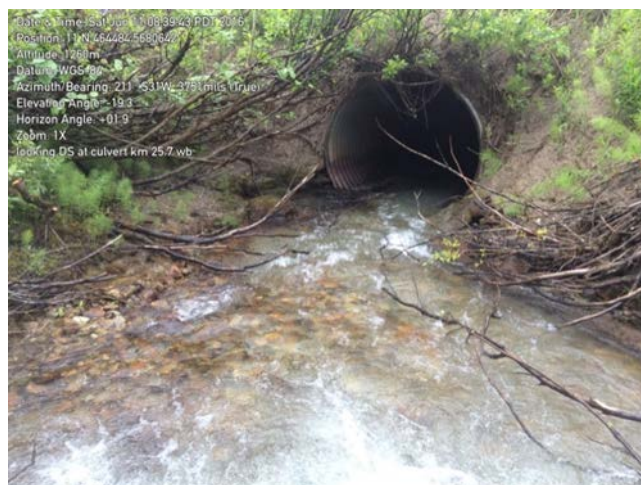
Figure 35: TCH km 25.7 (TCHGlacier_18.0) – Aquatic habitats of the unnamed creek on upstream, eastbound side, looking upstream above the culvert inlet (left) and downstream towards the culvert inlet (right)
