TRANSCANADA HIGHWAY IMPROVEMENT PROJECT, GLACIER NATIONAL PARK

Fish Habitat Assessment, DFO Self-Assessment and Detailed Mitigations Summary

Report Number: 1654325_RP0002_Rev B

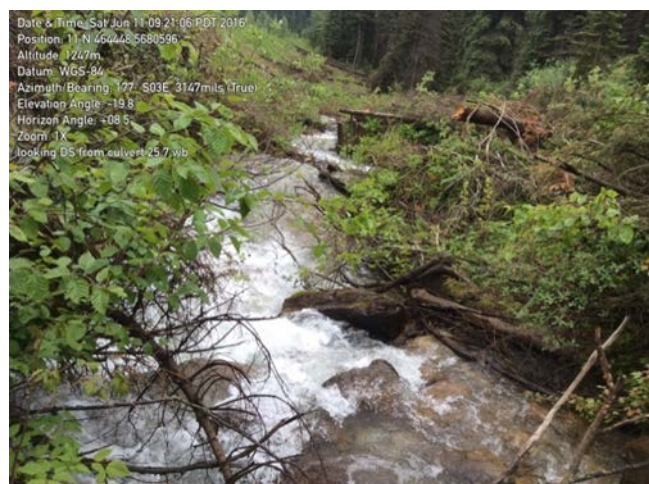
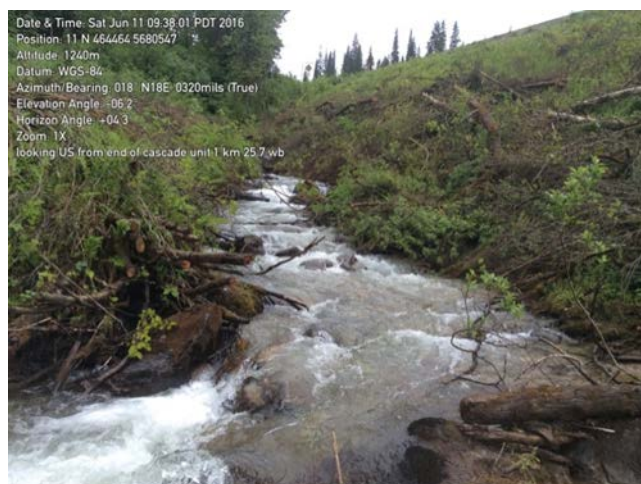
Figure 36: TCH km 25.7 (TCHGlacier_18.0) – Aquatic habitats of the unnamed creek on downstream, westbound side, looking downstream, below the culvert outlet (left), and upstream towards the culvert outlet (right)

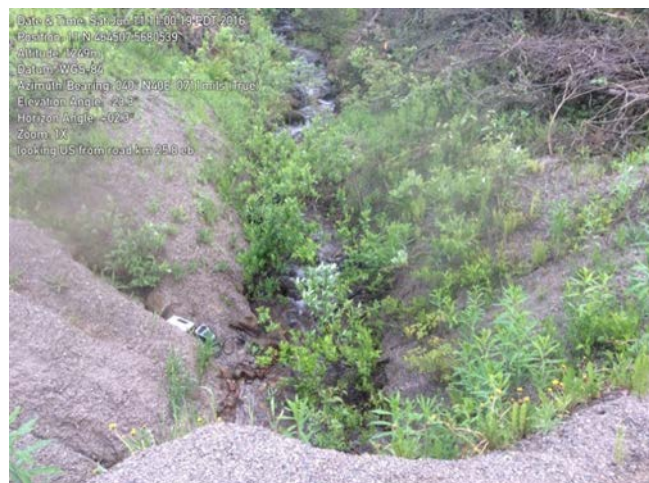
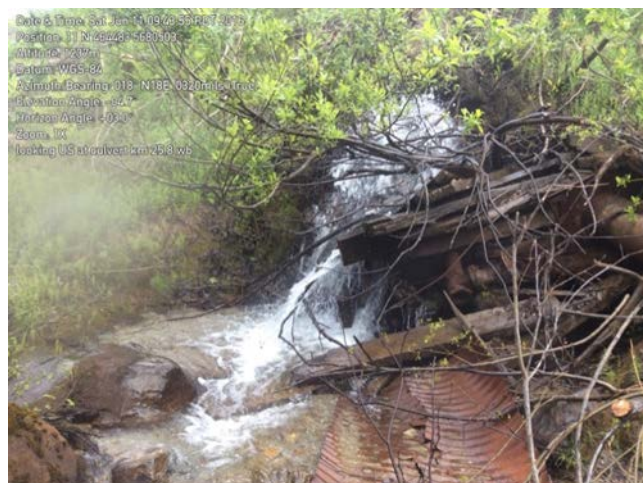
Figure 37: TCH km 25.8 (TCHGlacier_17.9) – Aquatic habitats on upstream, eastbound side (left) and downstream below the culvert outlet on the westbound side (right)

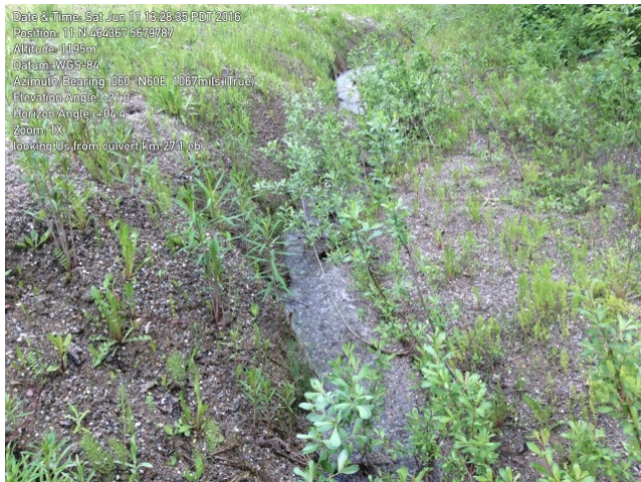
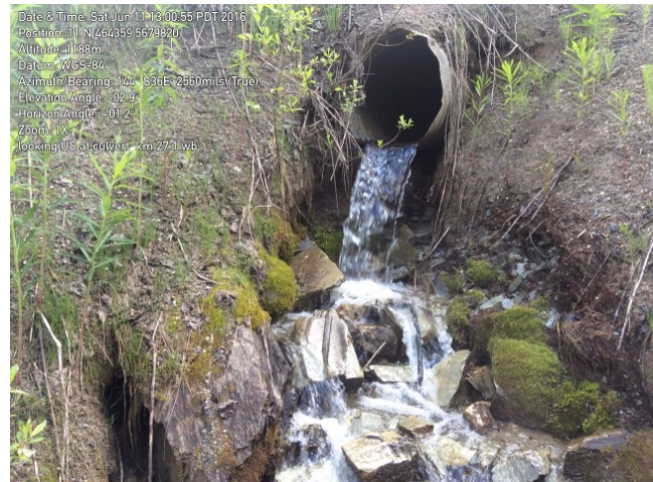
Figure 38: TCH km 27.1 (TCHGlacier_16.6) – Aquatic habitats on upstream, eastbound side (left) and downstream below the culvert outlet on the westbound side (right).
