GLACIER NATIONAL PARK AVALANCHE MITIGATION PHASES 1A, 1B AND 2

Geotechnical Investigation and Stability Assessment, East Gate Landslide Deflection Berm

Report Number: 1654746_RP0004_Rev 0

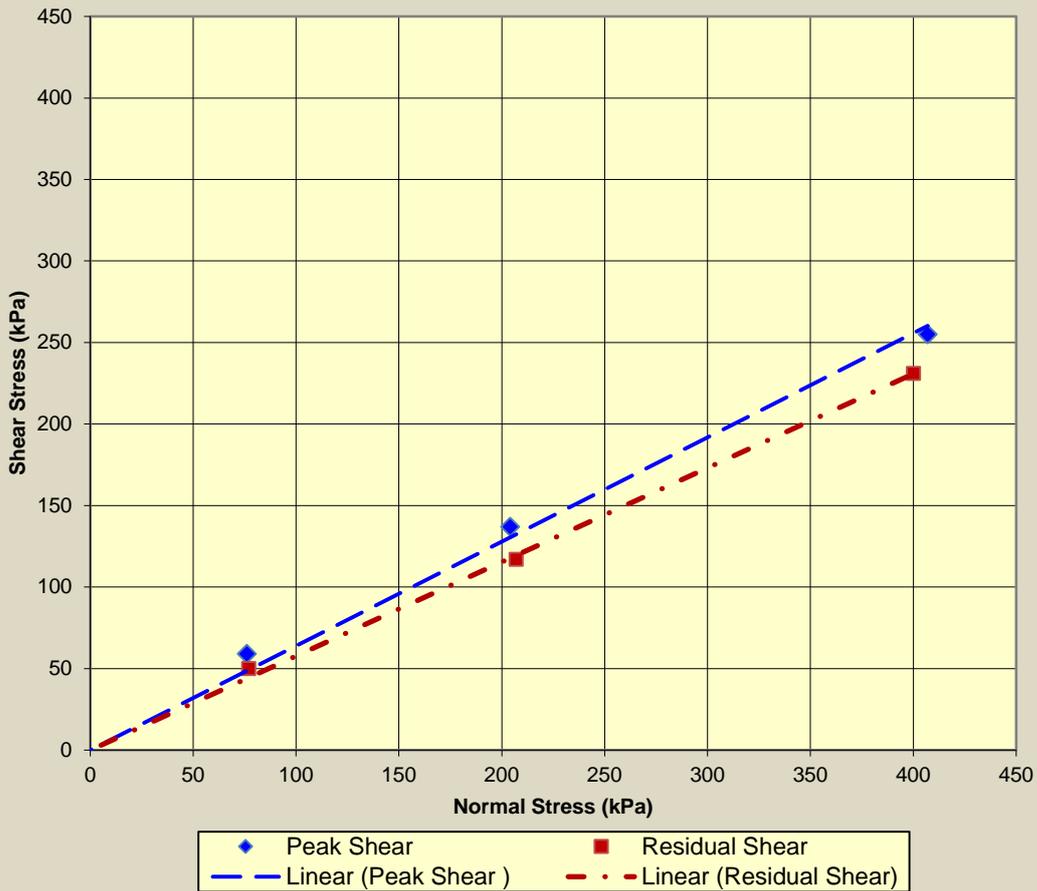
Shear Stress vs. Normal Stress

Test No.	Peak			Residual		
	1	2	3	1	2	3
Normal Stress, kPa	76	204	407	77	207	400
Shear Stress, kPa	59	137	255	50	117	231

Peak	Residual
Friction Angle, Degrees	33	30
Cohesion, kPa	0	0

Large direct shear tests were completed on an aggregate soil specimen comprising grab samples that were obtained during the site reconnaissance and selected SPT samples. These soil samples were combined into a single aggregate sample for the direct shear tests. The aggregate sample is considered representative of the encountered berm soil based on available information and in consideration of the disturbance and fracturing of coarse-grained soils that occurs during ODEX drilling and sampling. Test results for the aggregate sample (Appendix B) indicate this sample comprised silty, sandy gravel with a Standard Proctor Maximum Dry Density of 2010 kg/m³ and Optimum Water Content of about 11%. Particles larger than 15 mm were removed from the aggregate sample prior to commencing the direct shear tests to maintain compliance with ASTM requirements for maximum particle size for the shear box dimensions. The sheared samples comprised gravelly silty sand.
