February 22, 2011

Ref. No.: 09-202-11C

Attn: Ms. Allison Myatt**RE: Limited Groundwater and Soil Remediation Project, Richmond Landing, Ottawa, Ontario, NCC Property Asset 96189.**

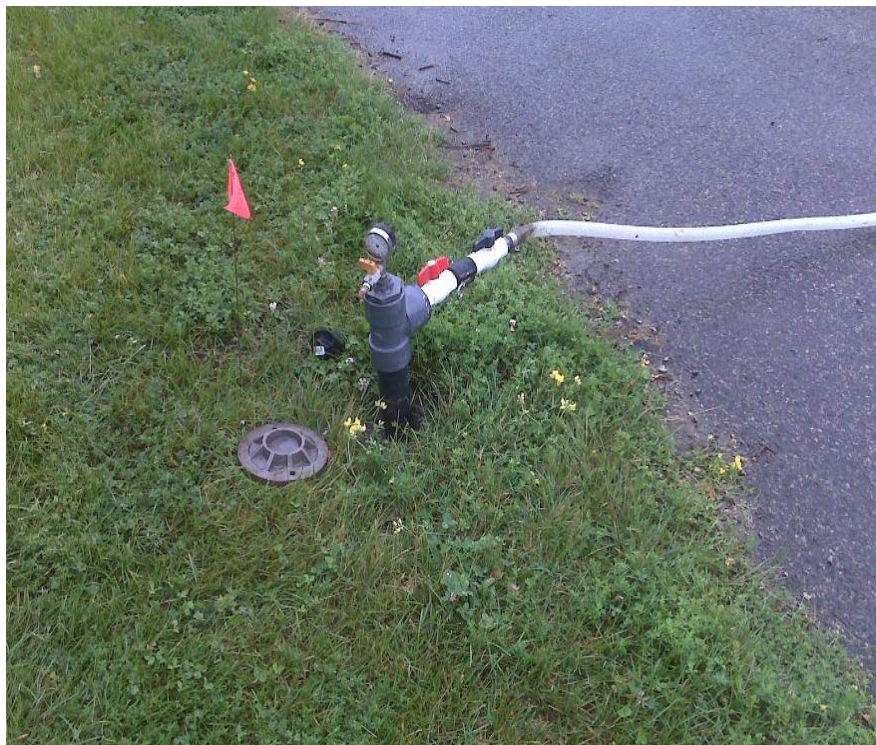
Picture 1: Attachment injection fixture at monitoring wells

The injection fixture was outfitted with a pressure gage and fittings for hoses as shown in picture one, Attachment A. The fixture was placed over top of the riser at each well location while the hoses led to a trailer where the solution was mixed and then pressurized into the well. The solution was injected at a rate of 10 to 15 Liters per minute (L/min) and at a pressure of less than 20 pounds per square inch (psi).

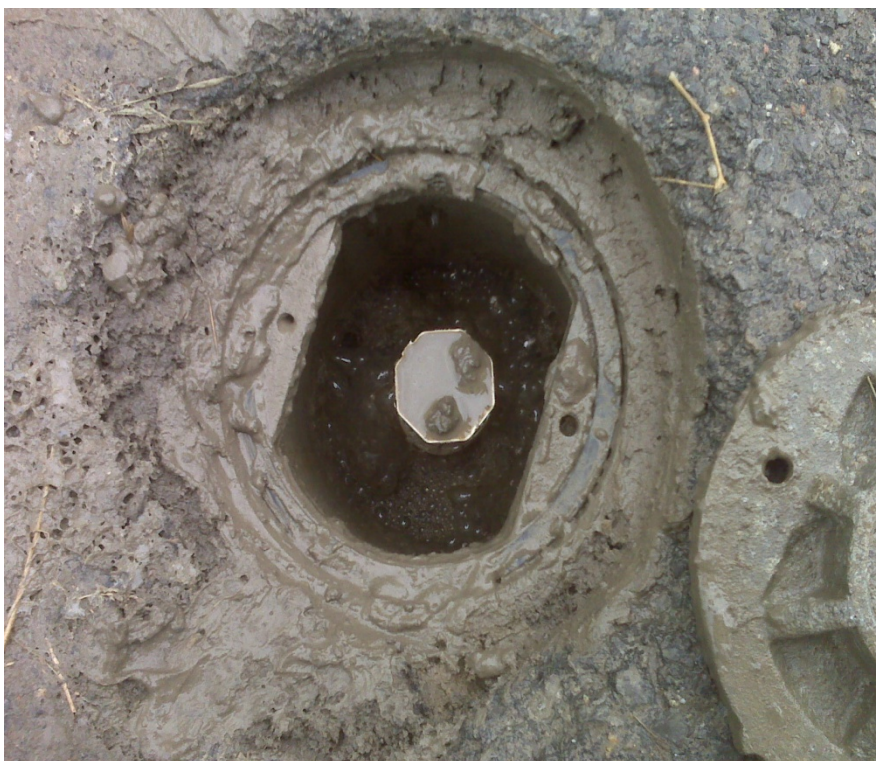
Picture 2: Post cleanup at MW09-18

While injecting MW09-18 on June 9, 2010 some oxidant came to surface through the exterior of the flushmount casing. Upon observation of the solution at surface, the injection into MW09-18 ceased immediately and absorbent socks were placed to contain the oxidant, which was diluted with water and neutralized with application of sodium thiosulphate (a reductant), as shown in picture two, Attachment A. MW09-18 was monitored for a period of 4 hours to ensure that no further oxidant came to surface. MW09-18 finished injection at 0 psi (gravity feed) on June 10, 2010. Injection into MW09-3 showed signs of the oxidant coming to surface around the casing also, thus VERTEX ceased the injection and on June 10, 2010 finished by gravity feeding the oxidant into the well. As a precaution, MW09-19 and MW09-2 were also gravity fed as they were similar in construction to MW09-18 and MW09-3. Further details are provided in the VERTEX Memorandum, Attachment B (VERTEX, 2010b).

On June 9, 2010 after injecting 70 L into MW09-18, some oxidant solution short circuited to ground surface ("day lighted") from the exterior of the flush mount casing. Upon observation of the solution, injection at MW09-18 immediately ceased, the oxidant was neutralized and MW09-18 was monitored for a period of 4 hours to ensure no additional oxidant day lighted. To avoid oxidant at ground surface at MW09-18 continued injection at MW09-18 was completed at 0 psi pressure (gravity feeding). No day lighting was observed at any other injection location.
