## Bow Lake and Peyto Lake Traffic and Parking Activity

PRESENTED TO  
**Parks Canada**

FEBRUARY 1, 2018  
ISSUED FOR REVIEW  
FILE: TRN.VHWY03045-01

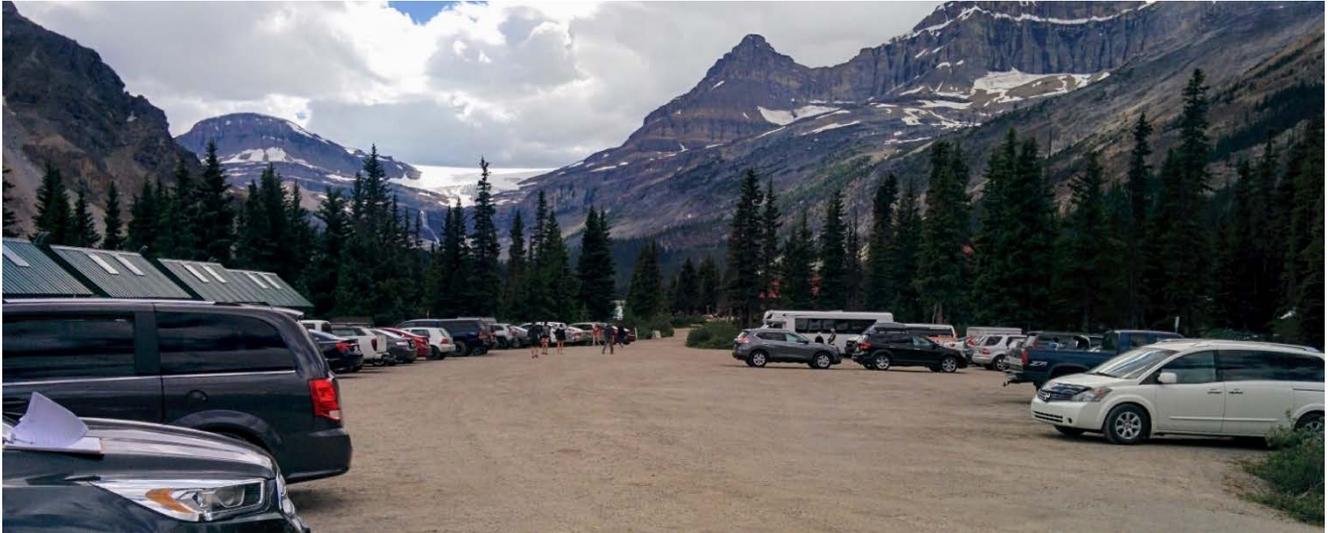
Photo 1: Bow Lake Day Use Lot

- **Bow Lake Day Use Lot (Photo 1):** This lot is primarily used by day use visitors for hiking, taking up-close photos by the water and for washroom and coffee breaks. It is also a popular stop for tour buses. The lot is unpaved with no markings for parking stalls. The lot provides access to the Hotel Hum-Ti-Jah lodge and is accessed via an internal roadway that connects to the Upper Lot and Highway 93. A total of thirteen washroom are provided. Currently four washroom buildings with 14 washroom stalls (4 male, 8 female, 1 unisex) are provided.

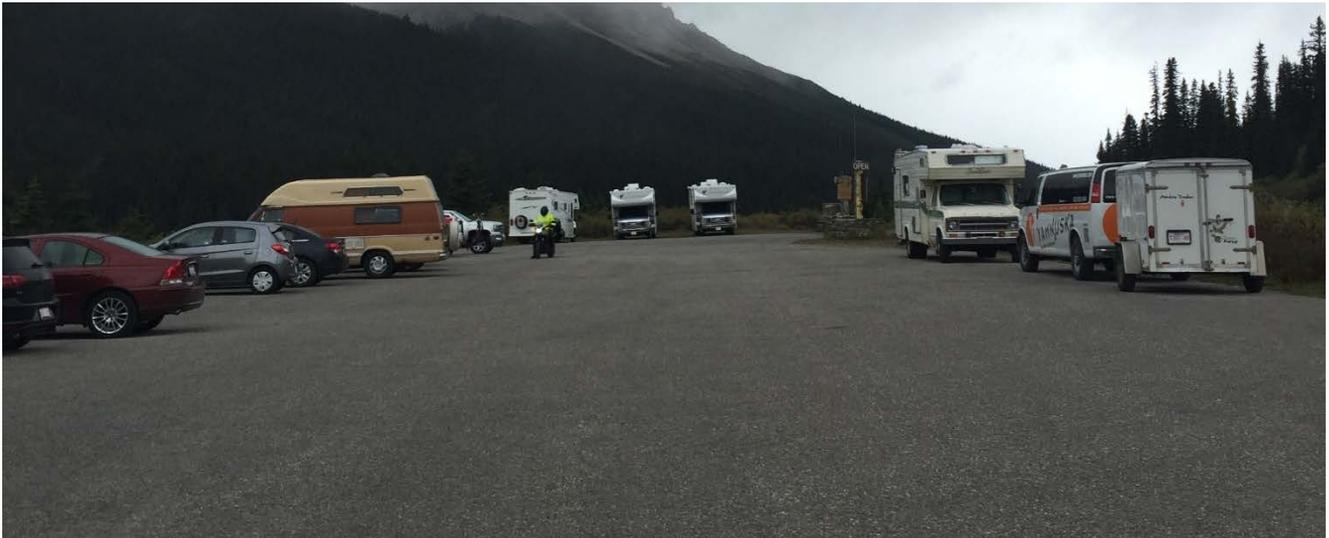
Photo 2: Bow Lake Upper Lot

- **Bow Lake Upper Lot (Photo 2):** This parking area is located right off the highway. Based on observations, it is primarily used for short stops for quick photos or when the day use lots are at capacity. No washrooms are provided.

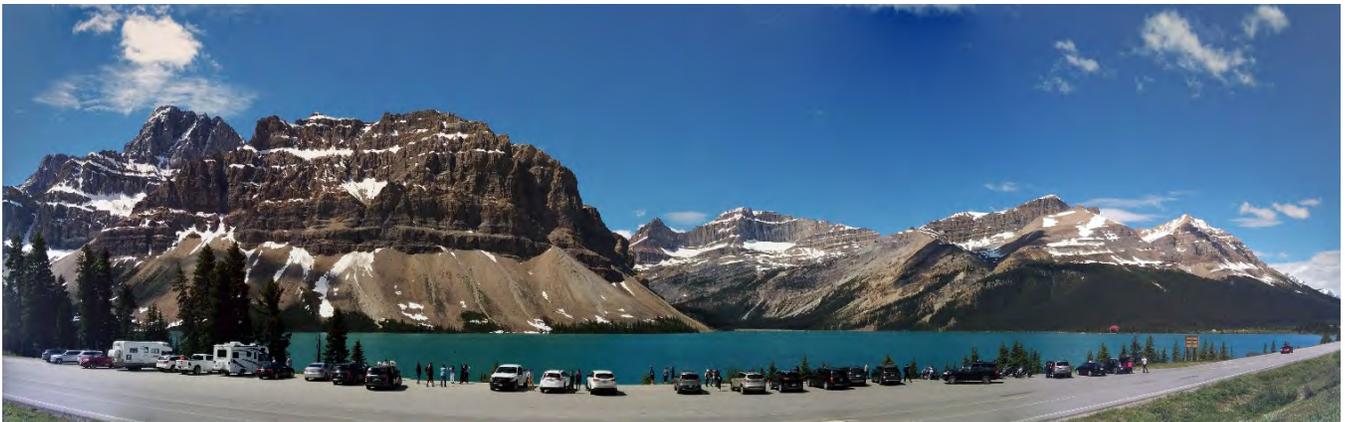
Photo 3: Bow Lake Viewpoint

- **Bow Lake Viewpoint (Photo 3):** This viewpoint is accessed via an uncontrolled pull-out 2.0 km southeast of the Bow Lake access. This is another popular spot for tourist buses. No washrooms are provided.

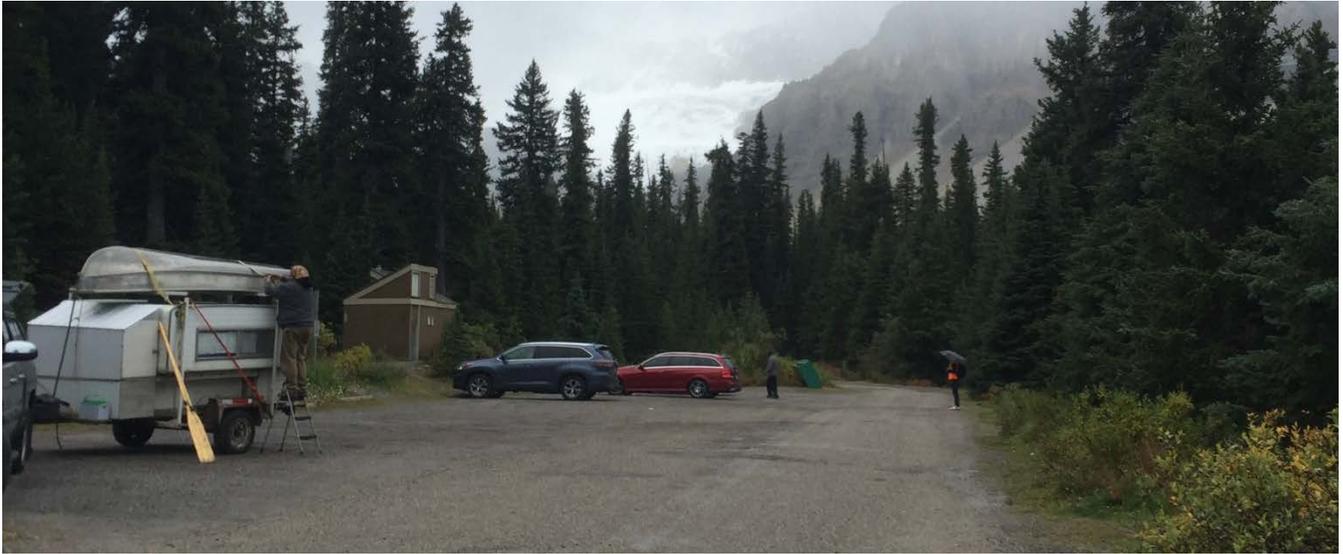
Photo 4: Bow Lake Picnic Area

- **Bow Lake Picnic Area (Photo 4):** With limited exposure and signage, this area is rarely utilized. It is accessed via a paved road from the Bow Lake Viewpoint. Several picnic tables are provided by the water. One washroom with four stalls (two male, two female) are also provided by the parking area.

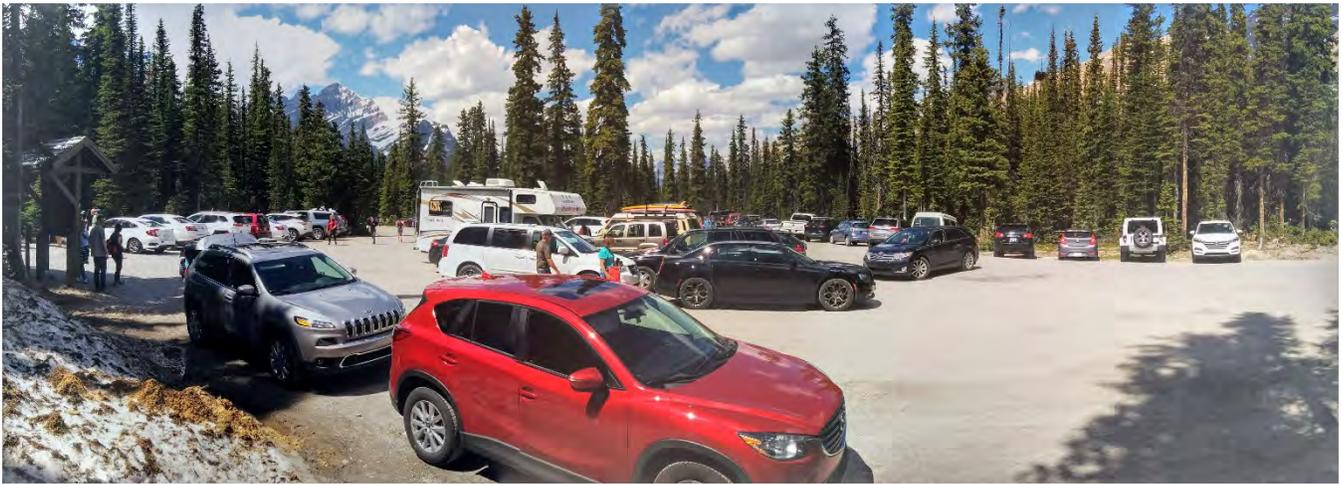
Photo 5: Peyto Lake Day Use Lot

- **Peyto Day Use Lot (Photo 5):** This parking area is used by day use visitors to Peyto Lake. A short 15-20 minutes (min) hike is required to access the Peyto Lake lookout. A separate area is provided for disabled and bus parking at Bow Summit. One washroom building with two stalls, both unisex, are provided.

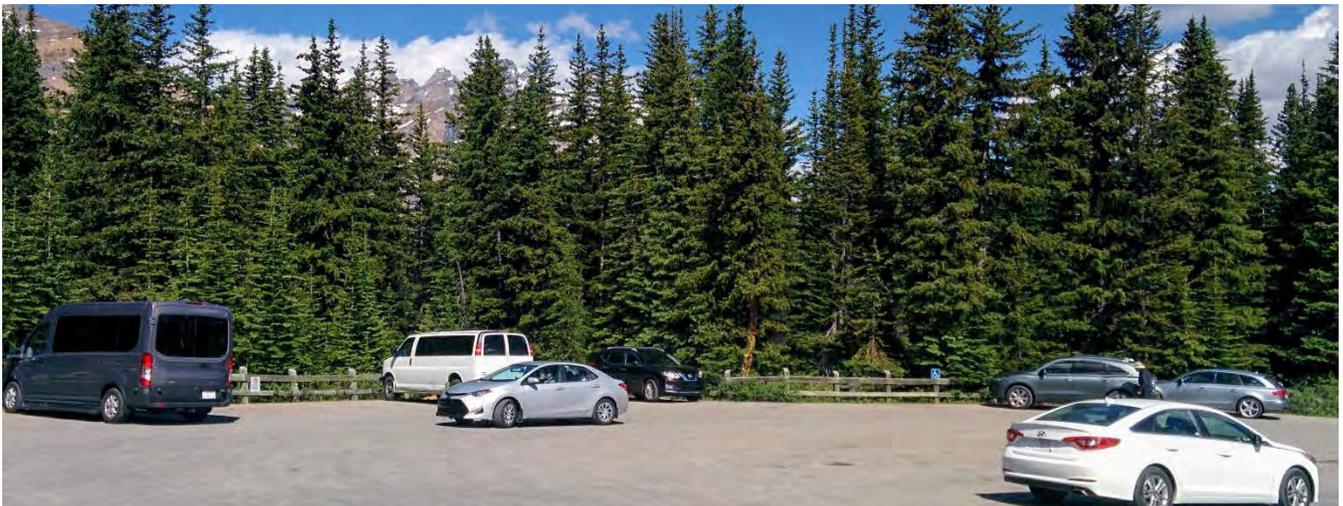
Photo 6: Bow Summit

- **Bow Summit (Photo 6):** This is the designated area for bus and disabled parking. Only a short 2-3 minutes walk is required to access the lookout. No washrooms are provided.

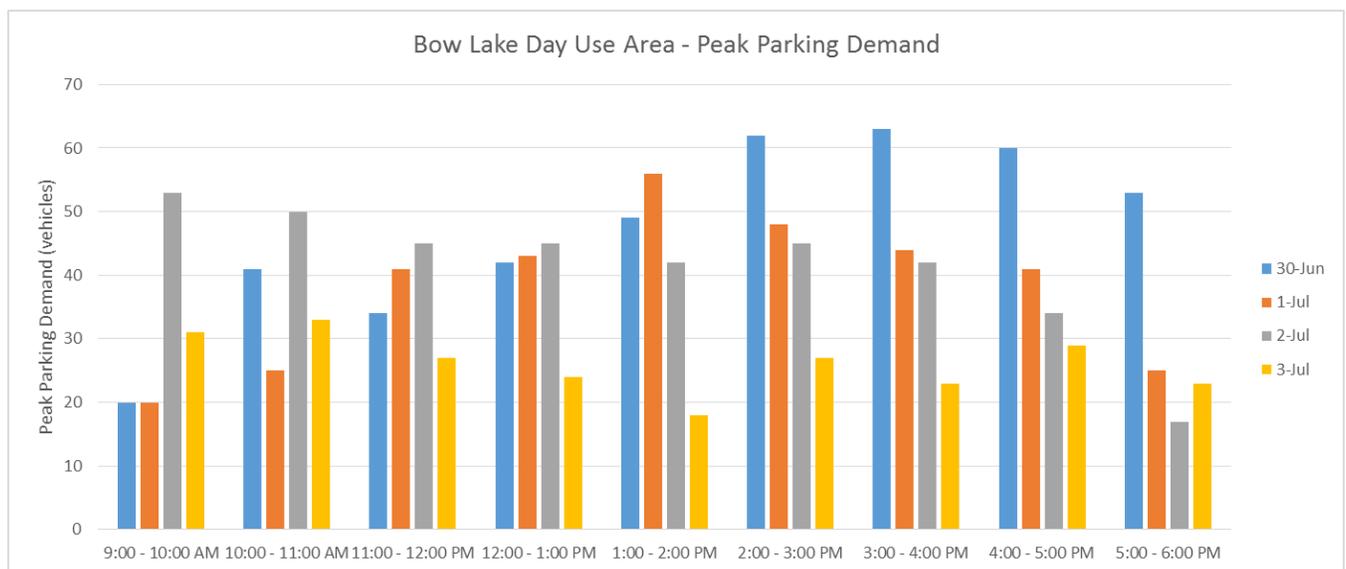
- Parking demand at this location peaked at different times on all surveyed dates. It was observed that the parking lots were full during these peak times indicating that the approximate parking capacity was 55 to 70 vehicles.
- When the parking lot became full, visitors either parked along the shoulder of the internal roadway or left altogether.
- Bus only parking signs were ignored during the peak periods. This negatively impacted the maneuverability of buses exiting the parking area.
- Approximately 20 vehicles left the parking lot due to the lot being full during the peak period.
- On July 3, the survey data indicates that there were only 33 vehicles parked during the peak period even though the lots were observed to be full. This may have been due to vehicles parking in a non-optimal configuration or there may have been a higher proportion of large vehicles occupying the stalls.

**Chart 1: Bow Lake Day Use Area Parking Demand**

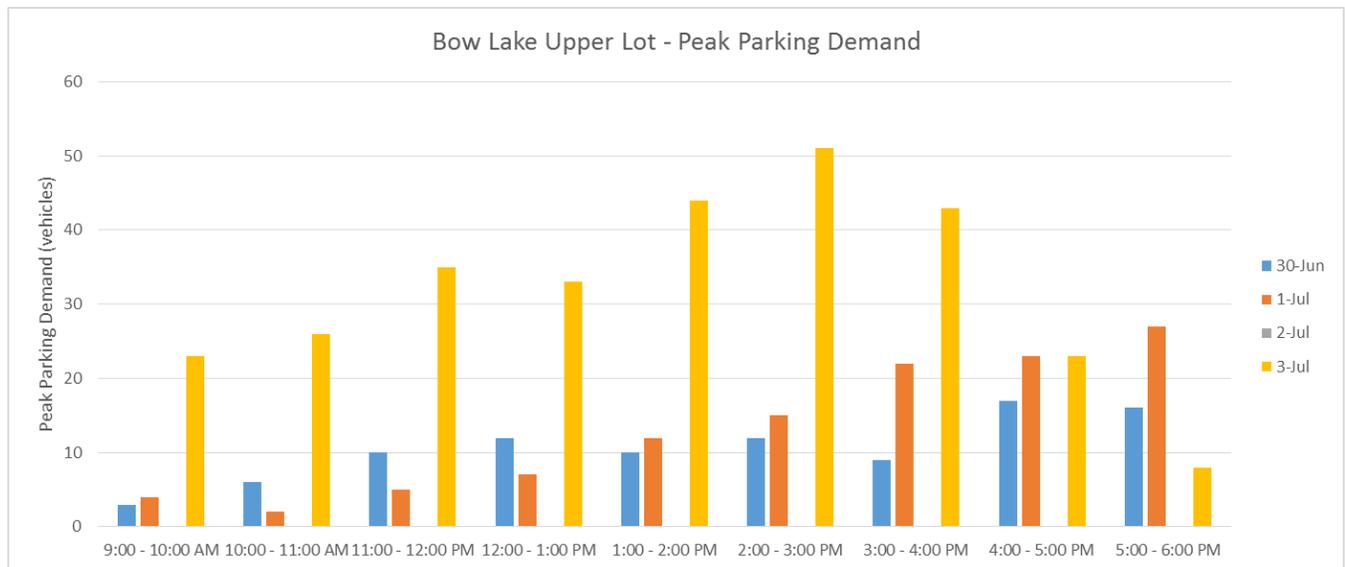
- The parking demand peaked at 51 vehicles on Monday, July 3.
- The peak parking demand at the Upper Lot was much higher on July 3 compared to the other surveyed dates. This is likely due to the lack of capacity at the day use lot, where it was observed that only 33 vehicles were only able to park in the lot compared to a maximum capacity of 40 to 50 vehicles on typical days.

**Chart 2: Bow Lake Upper Lot Parking Demand**

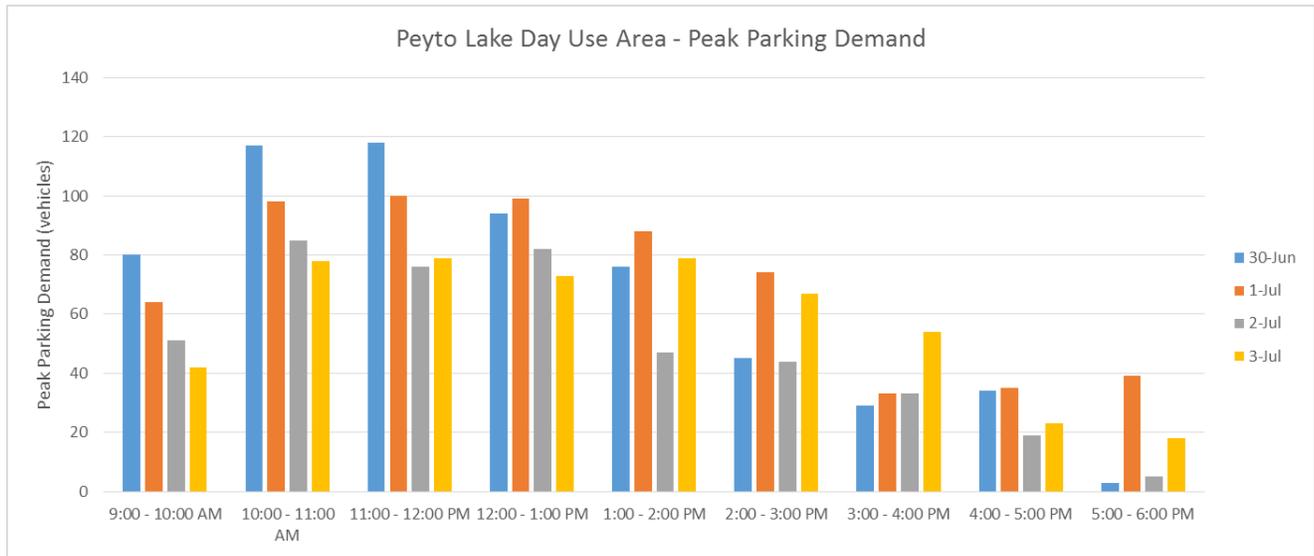
- The peak parking demand occurred between 10 a.m. and 12 p.m. on all four days.
- It was noted that on all four days, the parking lot reached capacity. The differences in the peak parking demand can be attributed to the different parking configurations and differences in vehicle mix (i.e., large vehicles such as RVs or buses occupying more spaces).
- When the parking lots became full, visitors parked along the shoulders of the internal roadway or at the upper lot.

Chart 3: Peyto Lake Day Use Area Parking Demand

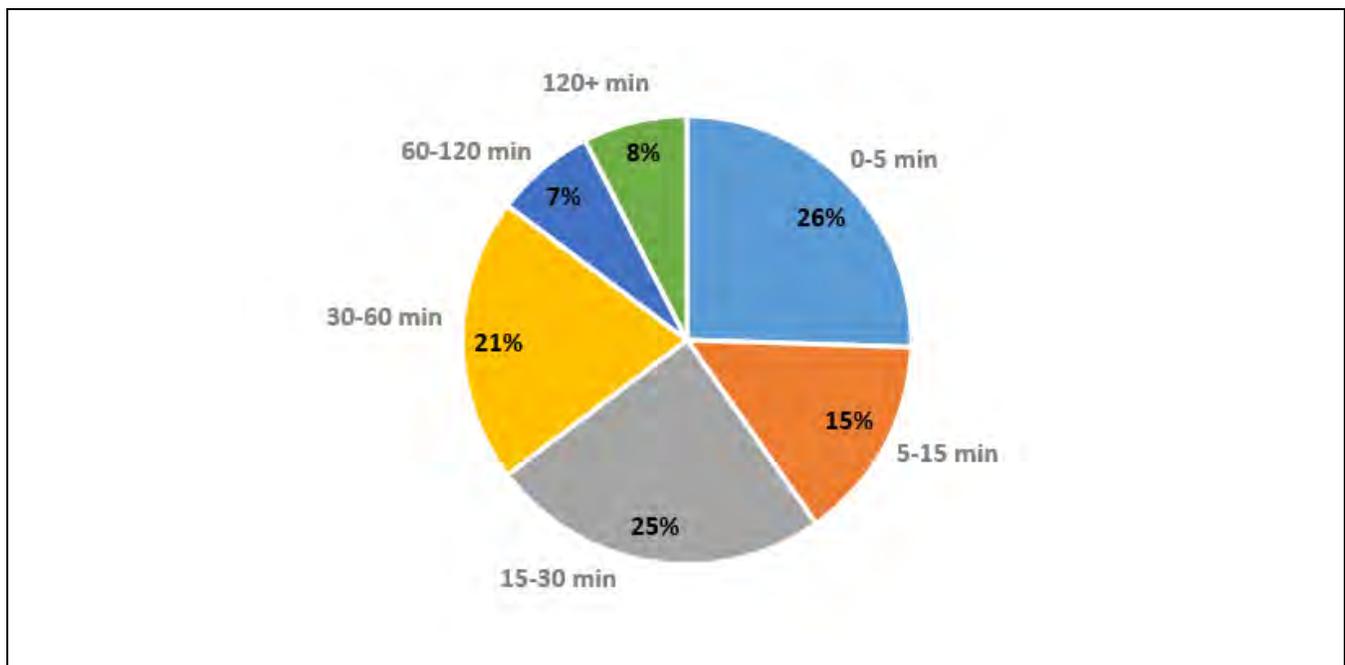
- **Bow Lake Day Use Area:** More than 60% of all visitors stayed in excess of 15 minutes and approximately 25% of all visitors departed in less than 5 minutes suggesting that they either stopped for a quick washroom break, or the parking area was too full to park. This is consistent with the parking duration observed in the 2016 surveys.
- **Bow Lake Day Upper Lot:** Approximately 70% of all visitors stayed for less than 5 min. This suggests that most stops were for short breaks.
- **Bow Lake Viewpoint:** The data suggests that more than 50% of the visitors stayed no longer than 15 minutes. This suggests that most stops are for short photo stops.
- **Peyto Lake:** As observed in the 2016 surveys, most visitors (73%) parked in excess of 30 minutes. As the hike to the Peyto Lake observation deck is 30-40 minutes roundtrip, this was to be expected.

**Chart 4: Bow Lake Day Use Area Parking Duration (4-day Average)**

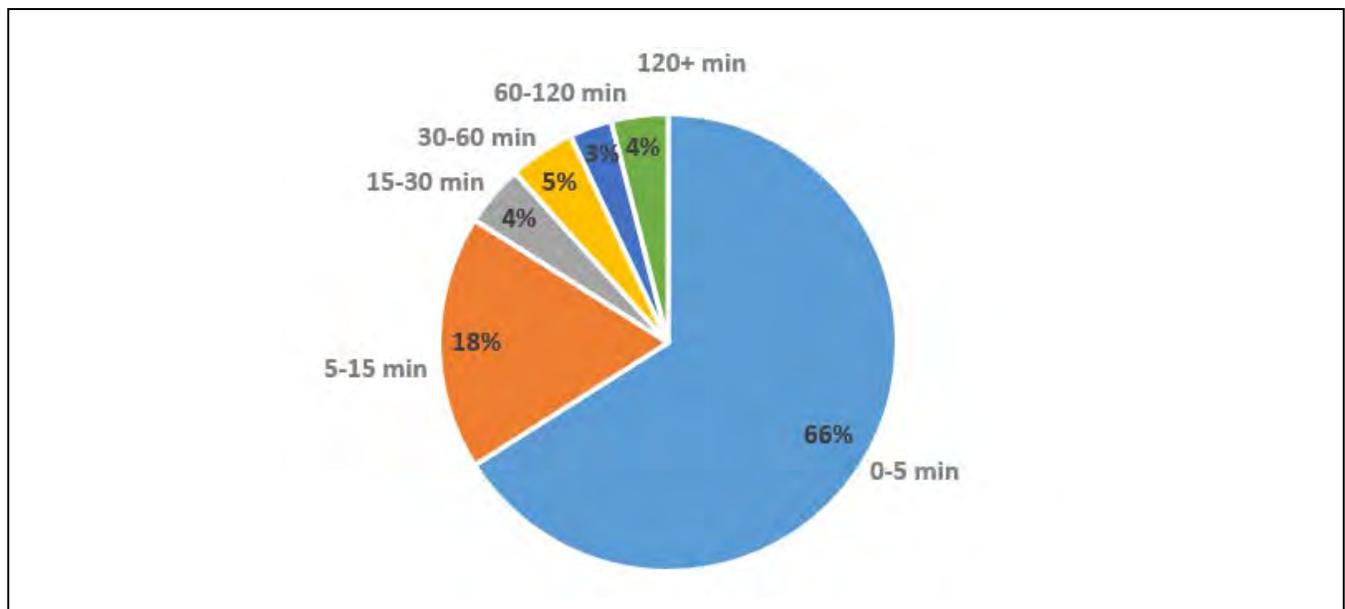
**Chart 5: Bow Lake Upper Lot Parking Duration (4-day Average)**

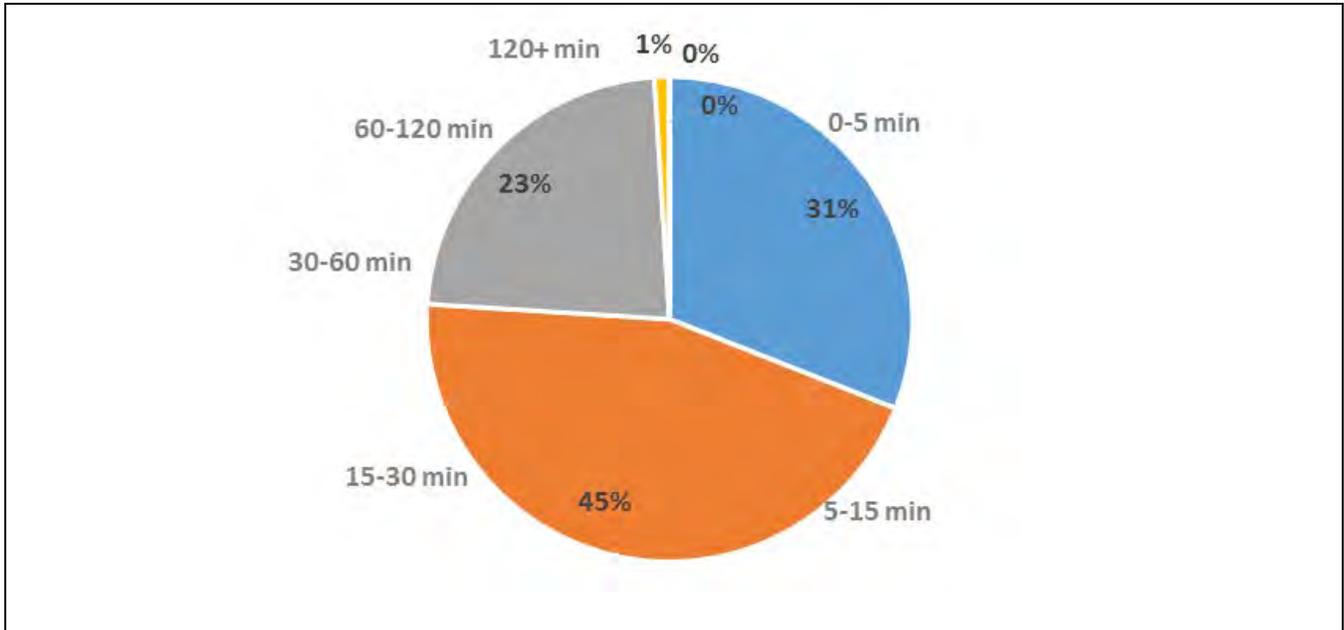
Chart 6: Bow Lake Viewpoint Parking Duration (3-day Average)

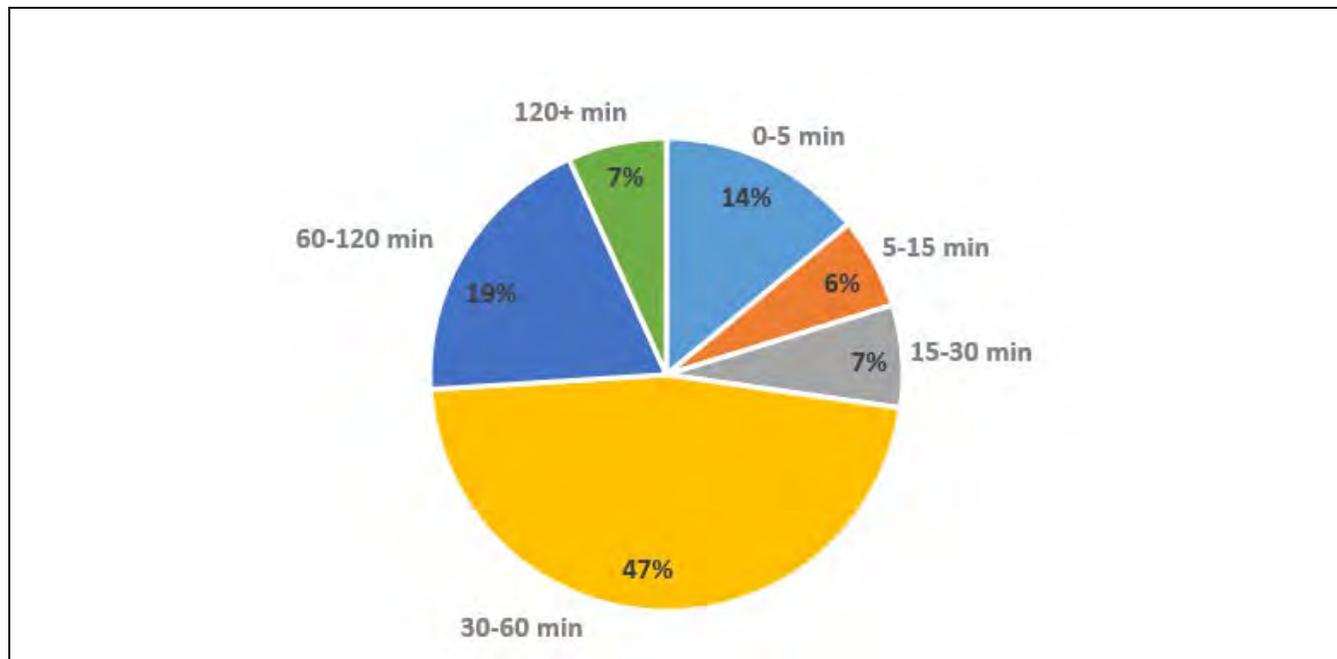
**Chart 7: Peyto Lake Day Use Area Parking Duration (4-day Average)**

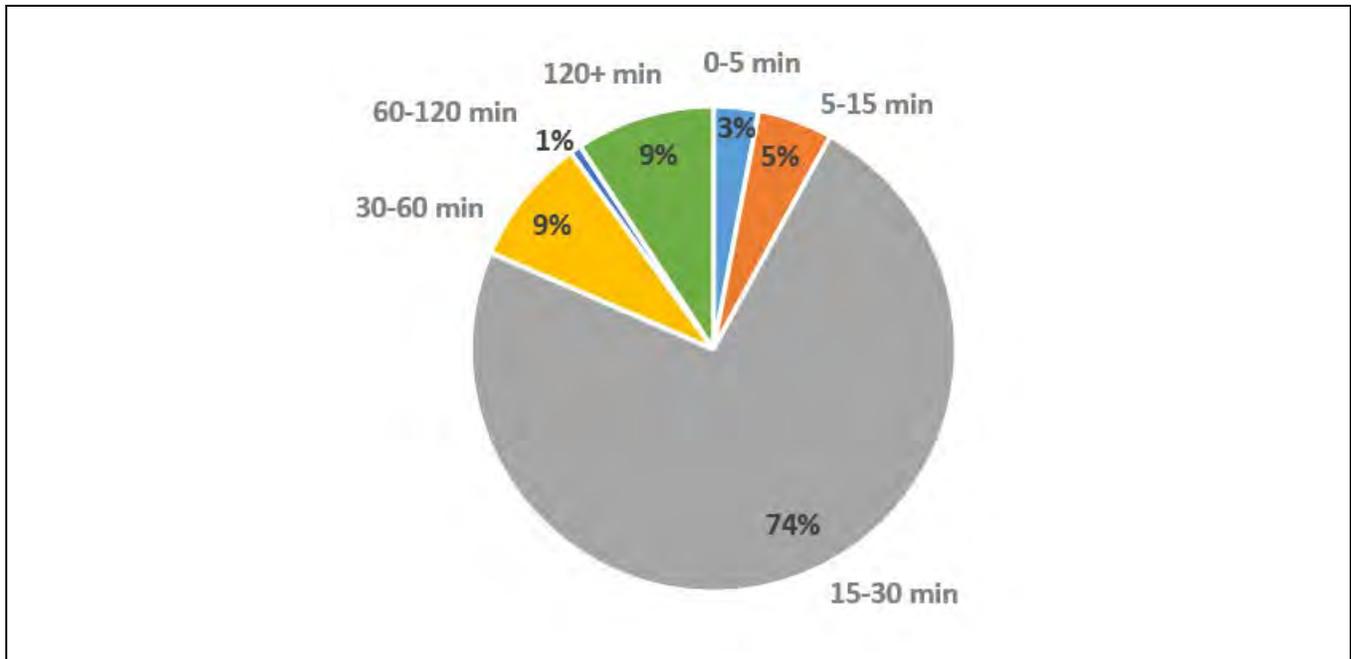
- **Bow Summit:** The survey data shows that most buses (74%) parked for 15-30 minutes. Some buses were observed to park for less than 5 minutes (3%) suggesting that they were unable to park due to vehicles being illegally parked or the bus parking spaces were occupied by other buses or illegally parked vehicles.

Chart 8: Bow Summit Parking Duration (4-day Average)

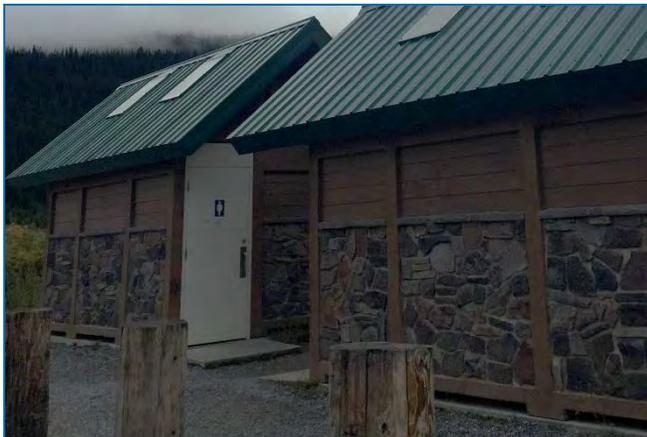
Photo 7: Bow Lake Day Use Area Washroom

- Bow Lake Day Use Area (Photo 7):** The Bow Lake Day Use Area is serviced by eight female stalls, four male stalls and one handicap stall. Given that the maximum observed queue was 3 min and on average, there is little to no wait, the existing washroom supply is therefore considered adequate. It was noted during the surveys that users were observed queueing outside the restrooms even when there were unoccupied stalls inside. This indicates that visitors are unaware that there are multiple stalls in each restroom.

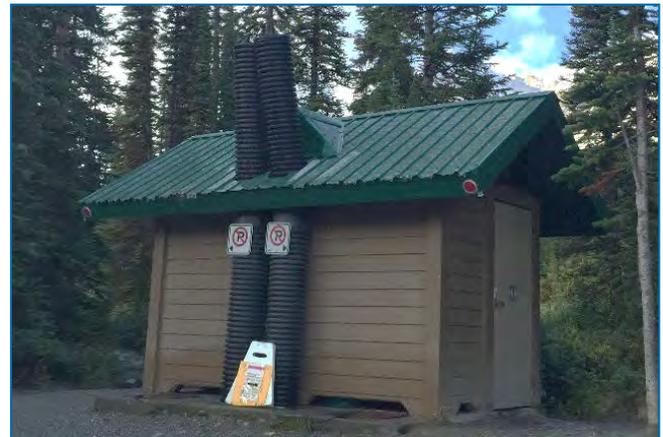
- Peyto Lake Day Use Area (Photo 8):** Two unisex stalls are provided at the Peyto Lake Day Use Area. During the peak time a maximum queue of seven persons and a wait time of 14 min was recorded; however, it was noted that one washroom was closed for cleaning. When both washroom were open a maximum queue of six persons with a wait of 11 min was observed. This suggests that additional washroom capacity may be required at peak times.

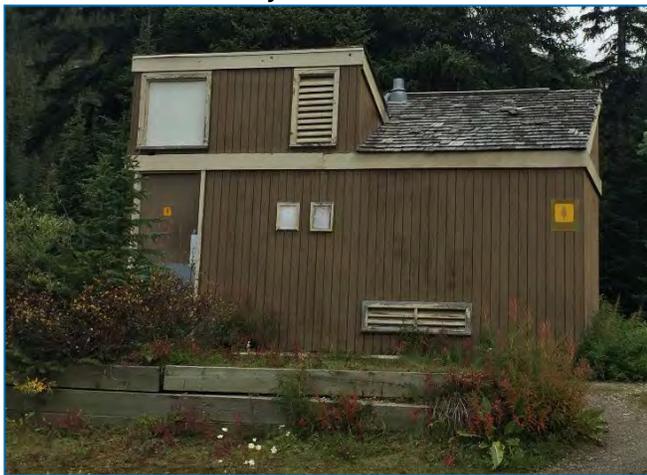
Photo 9: Bow Lake Picnic Area Washroom

- Bow Lake Picnic Area (Photo 9):** The picnic area provides two female stalls and two male stalls. As reflected in Table 4-4, all visitors were able to access the washrooms with no wait. Based this observations additional capacity are not needed.

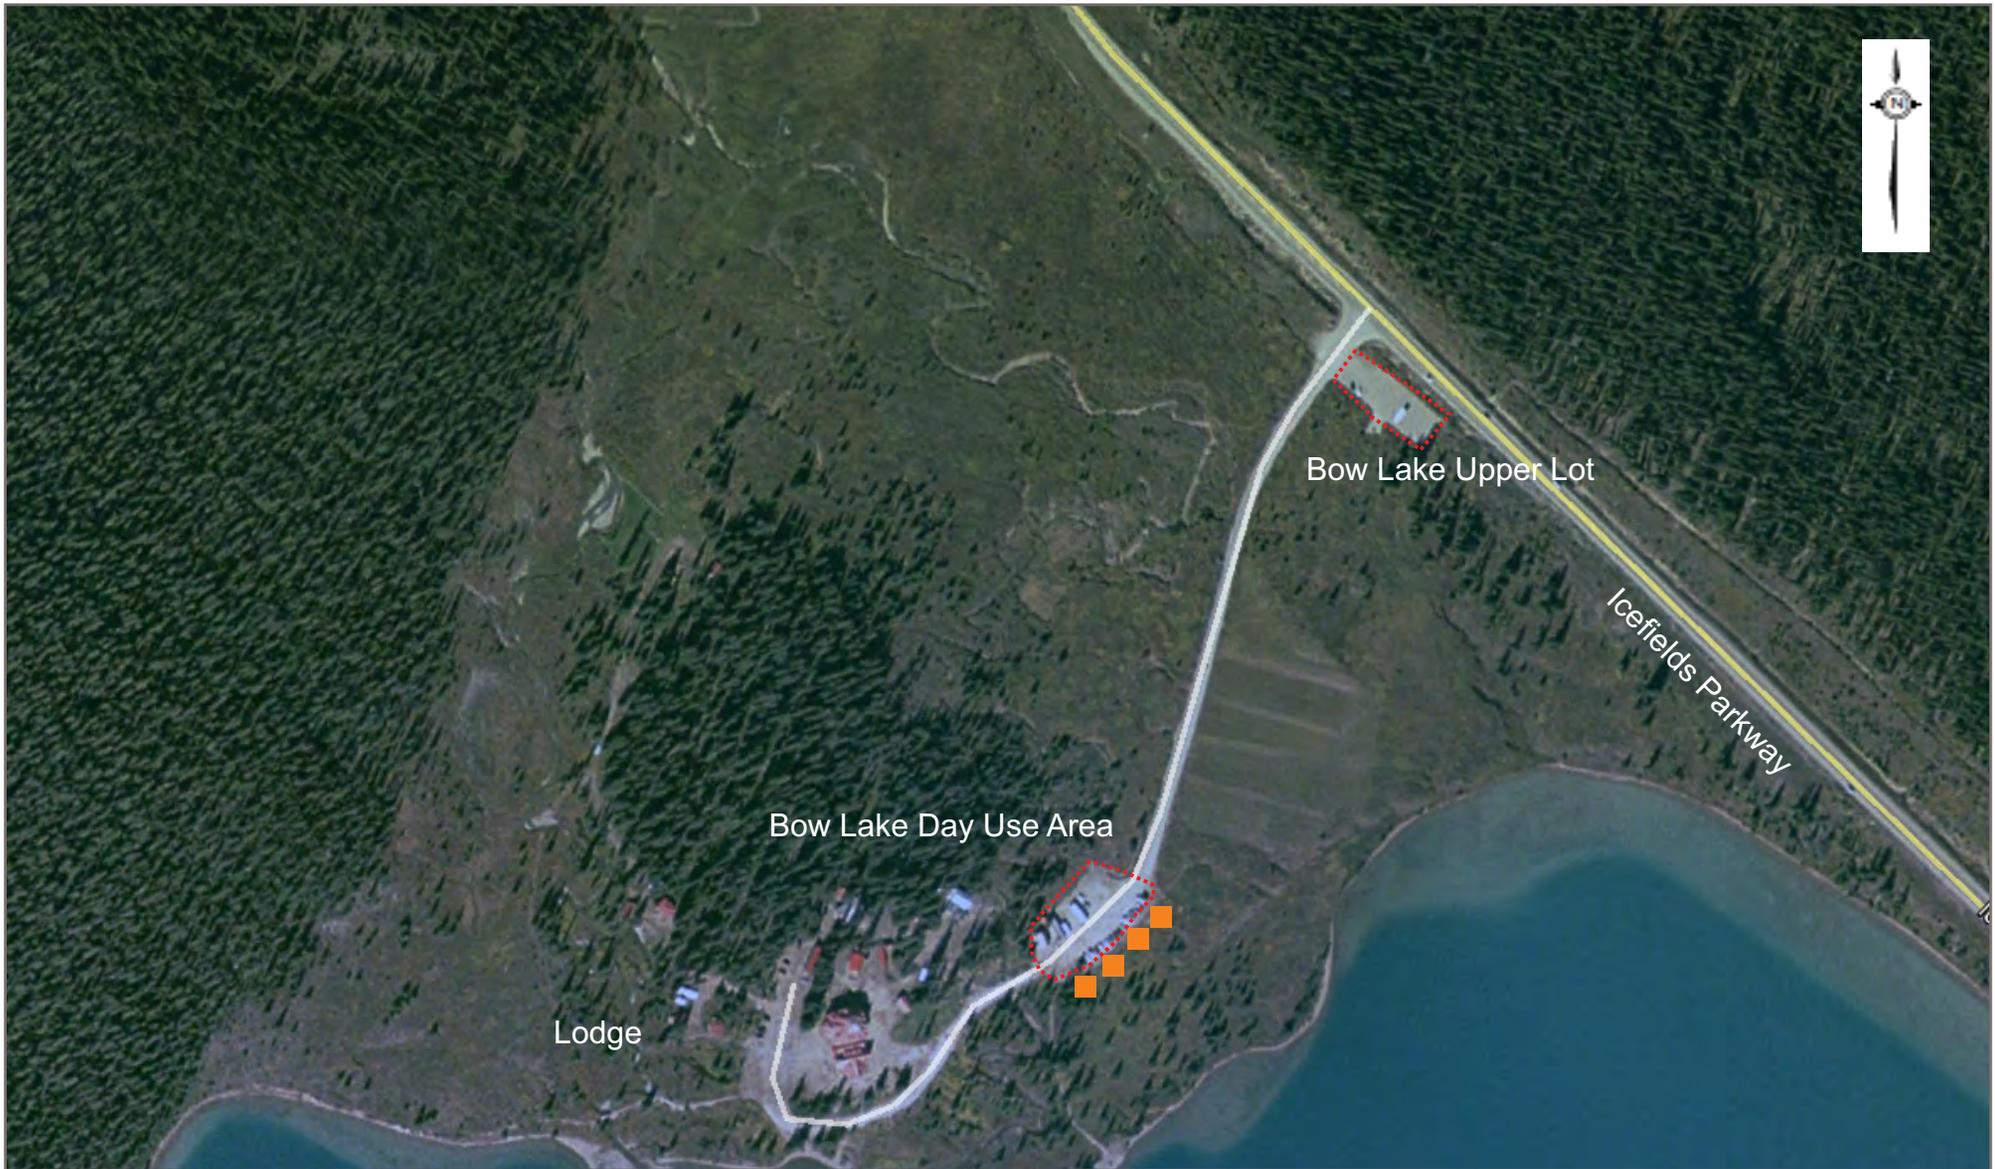
**Figure 1**

The surveys covered all parking areas and washrooms at Bow Lake and Peyto Lake in Banff National Park, Alberta. This included the viewpoint and picnic area located approximately 2 km southeast of the Bow Lake site access. Each of the surveyed locations is illustrated in Figure 1 with a description provided:

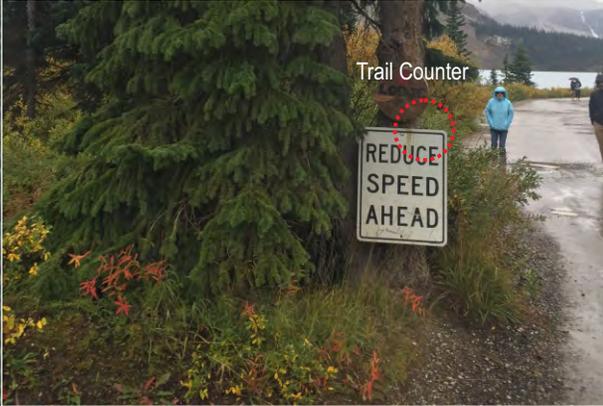
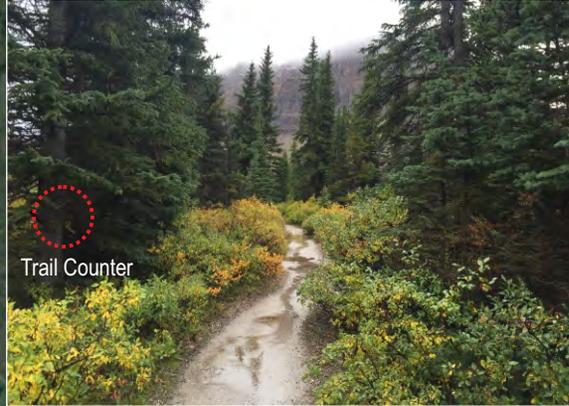
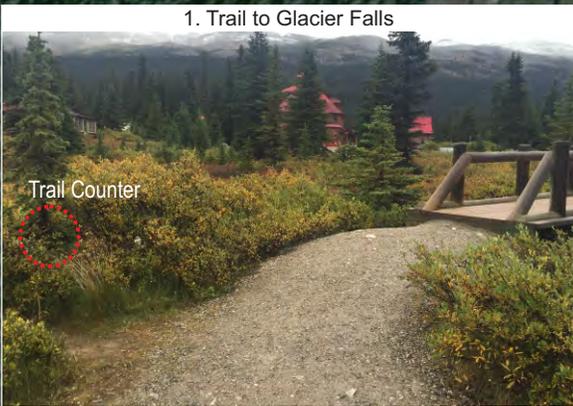
**Figure 4**

Trail counters were installed at major trail entrances and junctions to quantify the number of hikers. The locations of the trail counters are mapped in Figures 4 and 5.

2. Path to Num-Ti-Jah Lodge

3. Trail to Bow Lake

1. Trail to Glacier Falls

4. Lake Access Trail Counter
