Parks Canada Basic Impact Analysis

Amphitheatre Replacement, Fundy National Park.

The project site is located near the MacLaren Pond along the Point Wolfe Road in Fundy National Park, Alma, New Brunswick. The project site coordinates are 45.592732°N, 64.953158°W (see Figures 1 and 2 for the project location).

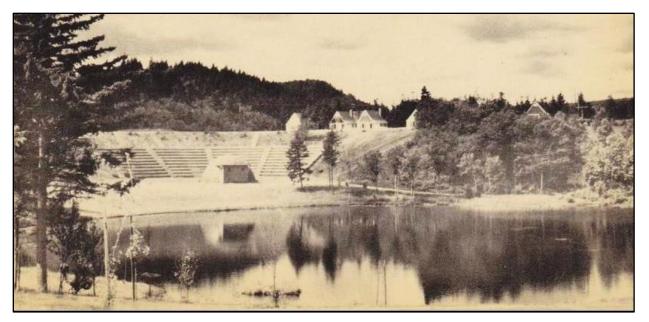
Figure 4. Amphitheatre with chalets in background (early 1950's)

Built in 1949 during the initial establishment of Fundy National Park, the amphitheatre is comprised of an open faced dome band shell with an attached back room (Figure 4). The structure is constructed of wood, and covered by a metal roof for the back room and a polyethylene fabric for the stage area (Figure 5-6). The amphitheater provides wooden seating for approximately 1000 people. This seating area was constructed on the natural slope facing the band shell just below the former Fundy Park Chalet facility (Figure 7), and is made entirely of pressure treated wood (Figure 8).

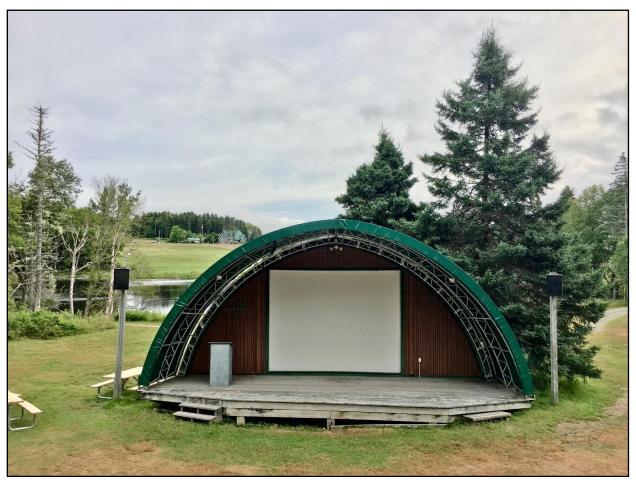
Figure 5. Amphitheatre covered stage

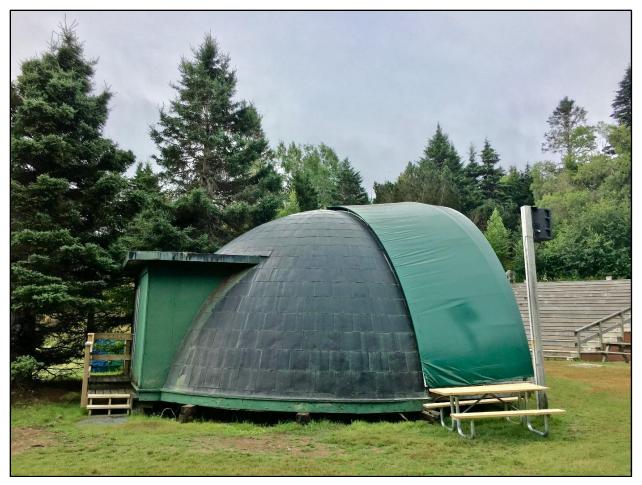
Figure 6. Side view of the amphitheatre covered stage

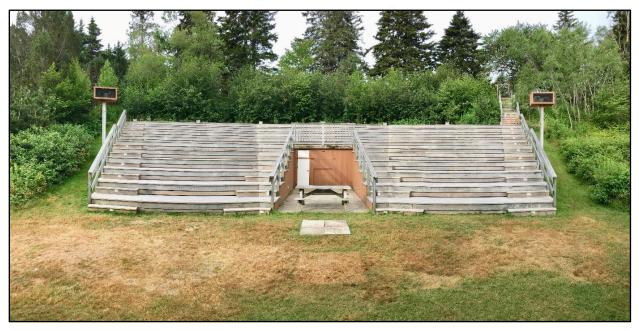
Figure 7. Panoramic view of the amphitheatre seating area

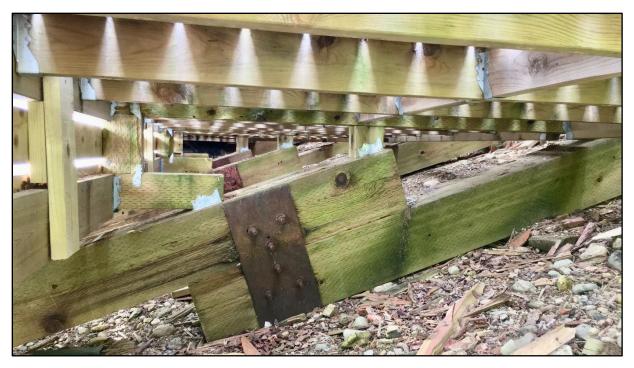
Figure 8. View of the amphitheatre seating area

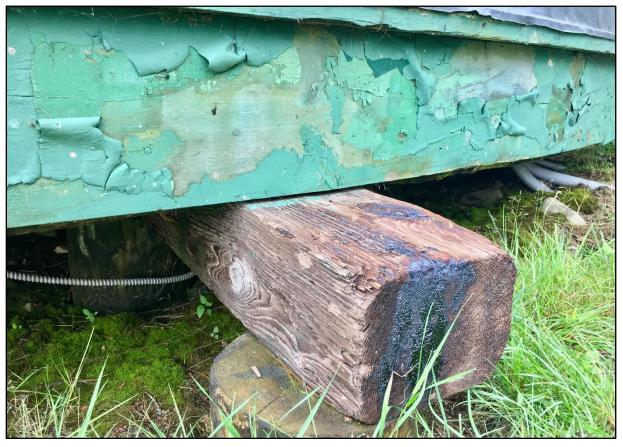
Figure 9. Amphitheatre floor exterior trim covered by lead paint (green) and creosote timber

During a site visit on July 27, 2017, it was noted that the amphitheatre floor was supported by creosoted timber beams and that the exterior siding of the floor was covered by multiple layers of a green lead paint which has started to peel onto the underneath ground (Figure 9). Analytical test results for three samples extracted from the exterior trims of the amphitheatre revealed that all samples were in compliance with provincial guidelines for disposal of lead paint and lead painted materials with leachable lead values well under the 5,000 μ g/L threshold (Table 1). The analytical results from the timber beams confirmed the presence of creosote (Table 2).

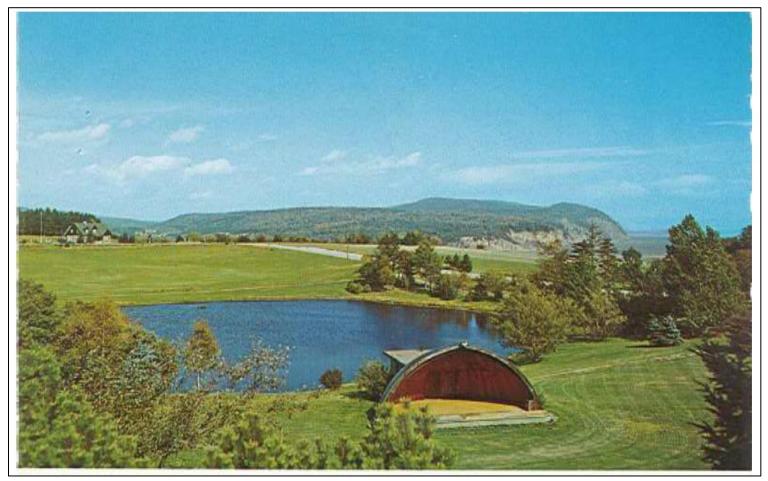
Figure 2. Fundy Amphitheatre in early 1950s. Note open band shell and enclosed porch-like structure at the back (which still exist today) (PCA Digital Files).

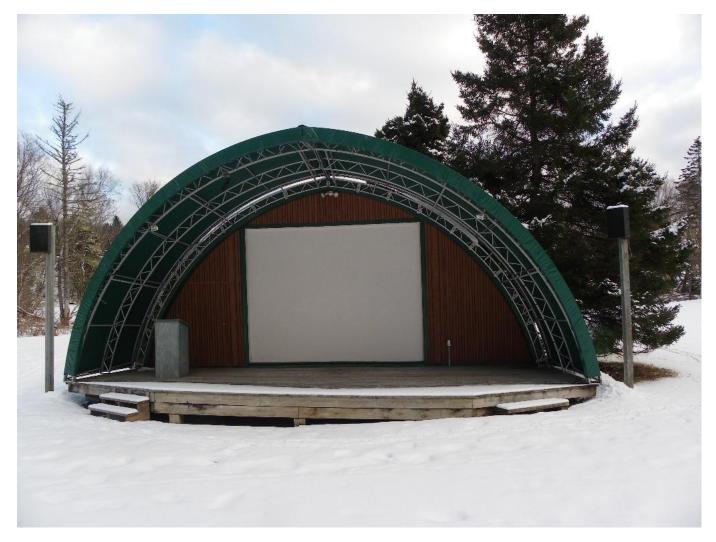
Figure 3. Current Amphitheatre to be demolished and replaced by a new one (PCA Digital Files).

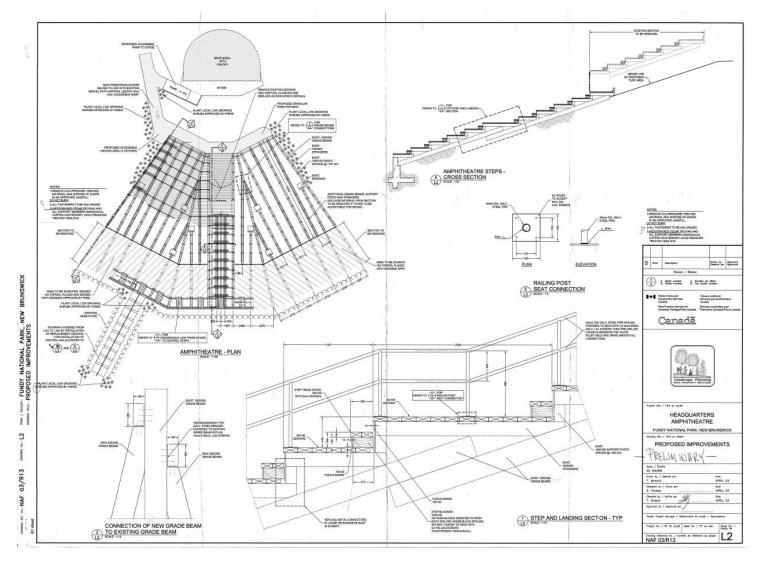
Figure 4. Preliminary proposed improvements to seating section (PWGSC 2003 - PCA Digital Files).

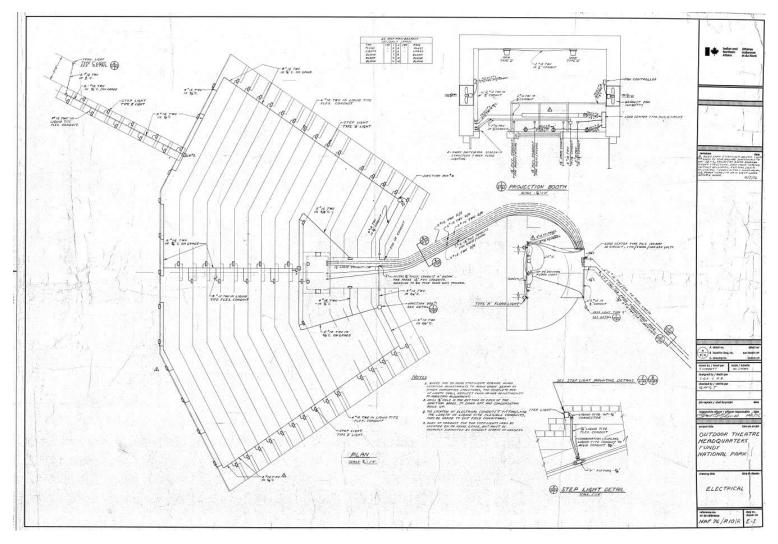
Figure 5. Preliminary proposed electrical improvements (PWGSC 2003 - PCA Digital Files).

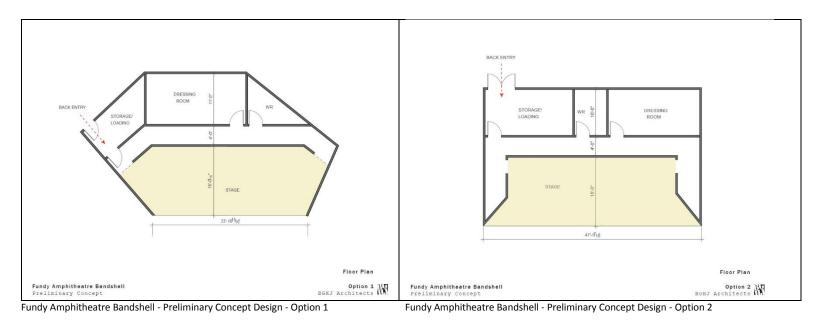
Figure 6. Preliminary Concept Design Options for the new Amphitheatre (BGHJ architects - PCA Digital Files).
