Title - Sujet New Maintenance Services Building	
Solicitation No. - N° de l'invitation EZ899-190130/A	Amendment No. - N° modif. 006
Client Reference No. - N° de référence du client	Date 2018-07-05
GETS Reference No. - N° de référence de SEAG PW-\$PWY-036-8370	
File No. - N° de dossier PWY-8-41021 (036)	CCC No./N° CCC - FMS No./N° VME
Solicitation Closes - L'invitation prend fin at - à 02:00 PM on - le 2018-07-13	Time Zone Fuseau horaire Pacific Daylight Saving Time PDT
F.O.B. - F.A.B. Plant-Usine: <input type="checkbox"/> Destination: <input checked="" type="checkbox"/> Other-Autre: <input type="checkbox"/>	
Address Enquiries to: - Adresser toutes questions à: Martin (PWY), Delia	Buyer Id - Id de l'acheteur pwy036
Telephone No. - N° de téléphone (778) 707-2139 ()	FAX No. - N° de FAX (604) 775-6633
Destination - of Goods, Services, and Construction: Destination - des biens, services et construction: CSC - William Head Institution - Metchosin, BC

This Amendment #006 is raised to Issue Addendum No. 2

RE: SUPPLEMENTAL PHASE II ENVIRONMENTAL SITE ASSESSMENT – 6000 WILLIAM HEAD ROAD, VICTORIA, BC (DRAFT)

Supplemental Phase II ESA
6000 William Head Road, Victoria, BC
SLR Project No.: 2

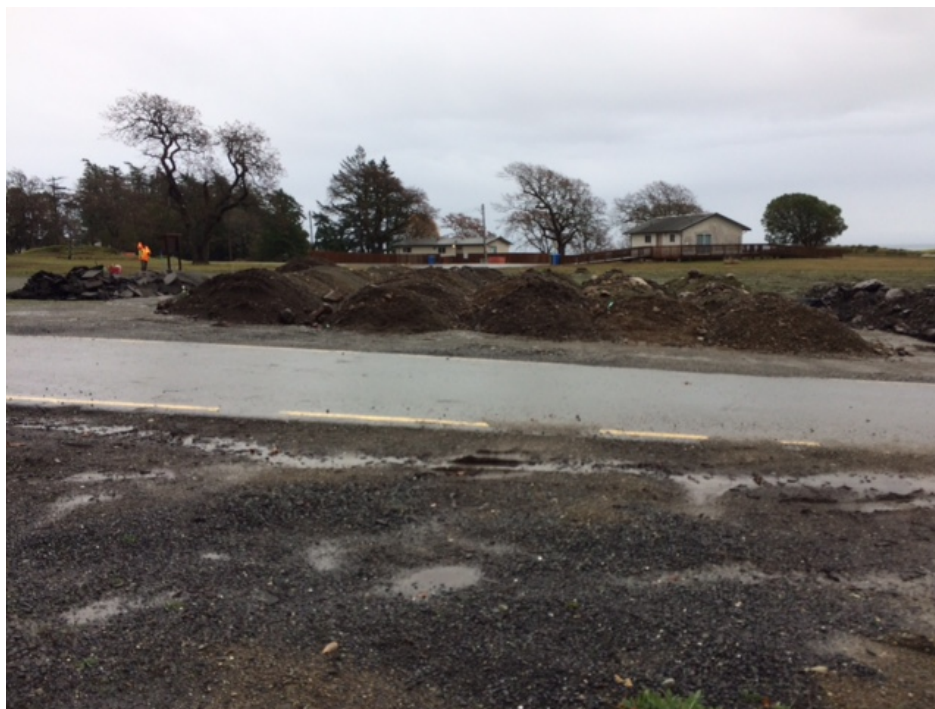
Photograph 1: View of the soil stockpiles temporarily being stored onsite. The main gate is to the left of this photo. View looking east.

On November 23, 2017, SLR observed approximately six windrows of stockpiled soil occupying the main portion of the subject site. Each stockpile contained an estimated 40 cubic metres (m³) of soil and there was no protective covering (e.g. a geo-textile or poly tarp) on top of the soil or between the stockpiled soil and the unpaved ground. Ms. Kelly Bales of CSC informed SLR that this soil was from other projects around the William Head Institution and that they required a flat, open area to temporarily stockpile the soil. Ms. Bales further informed SLR that she did not expect this material to be used at the subject site, but could not confirm its final destination. SLR informed PSPC of the soil stockpiles, who requested that this material be tested in the event that the soil is used onsite.

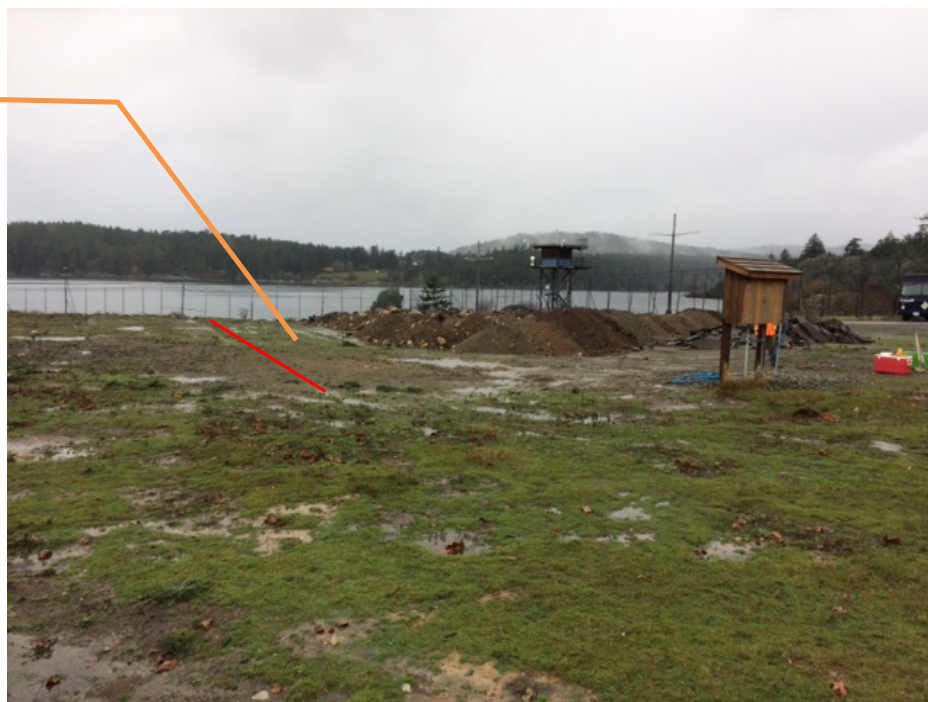
Photograph 2: View of the site looking southwest. Note that the stockpiles occupy most of the site with only a small portion of the site being accessible (the red line is the approximate eastern boundary of the site). Pedder Bay is in the background.

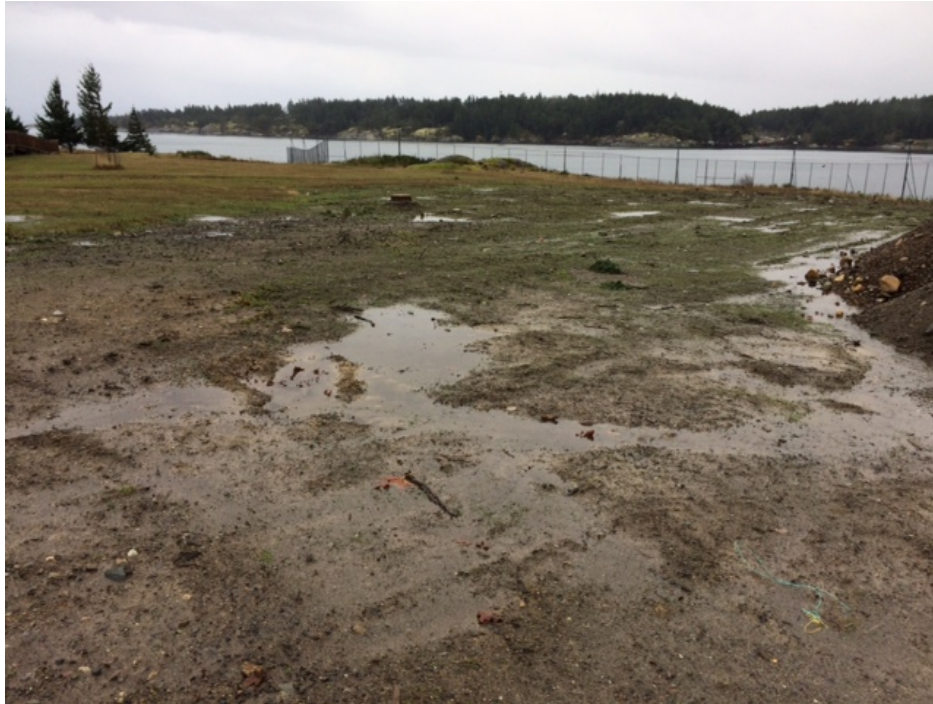
Photograph 3: View of eastern portion of the site looking south. Pedder Bay is in the background.

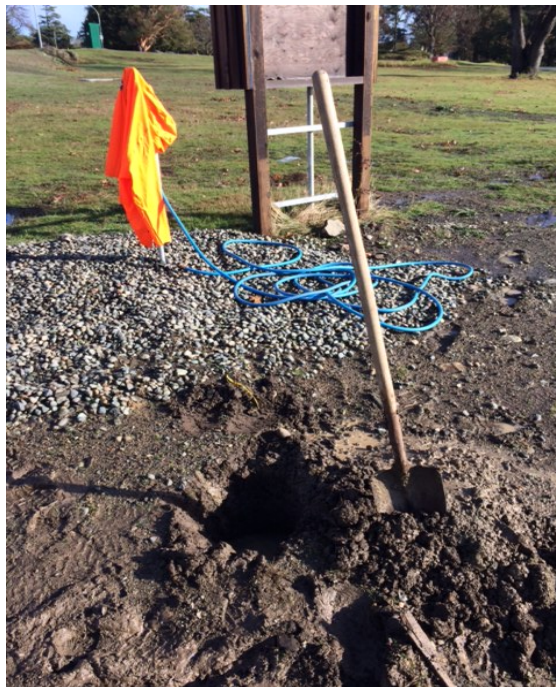
Photograph 4: View of test pit TP17-06 located near the former fuel storage shed. View looking northeast.

Visual or olfactory evidence of contamination was not encountered in the test pits or in the stockpiled soil. Water seepage due to recent rain events was noted at each of the test pits except at test pit TP17-03. No groundwater was encountered.

Generally, a 0.05 m topsoil layer was observed followed by a coarse sand and angular gravel layer to approximate 0.4 mbgs. Below that, a layer of sandy silt / silty sand with trace clay was observed. No bedrock was encountered.
