Basic Impact Analysis

**Poonamalie Dam - Phase II - Access Road
Rideau Canal Waterway
Salter Lane, Smith Falls, Ontario**

September 2018

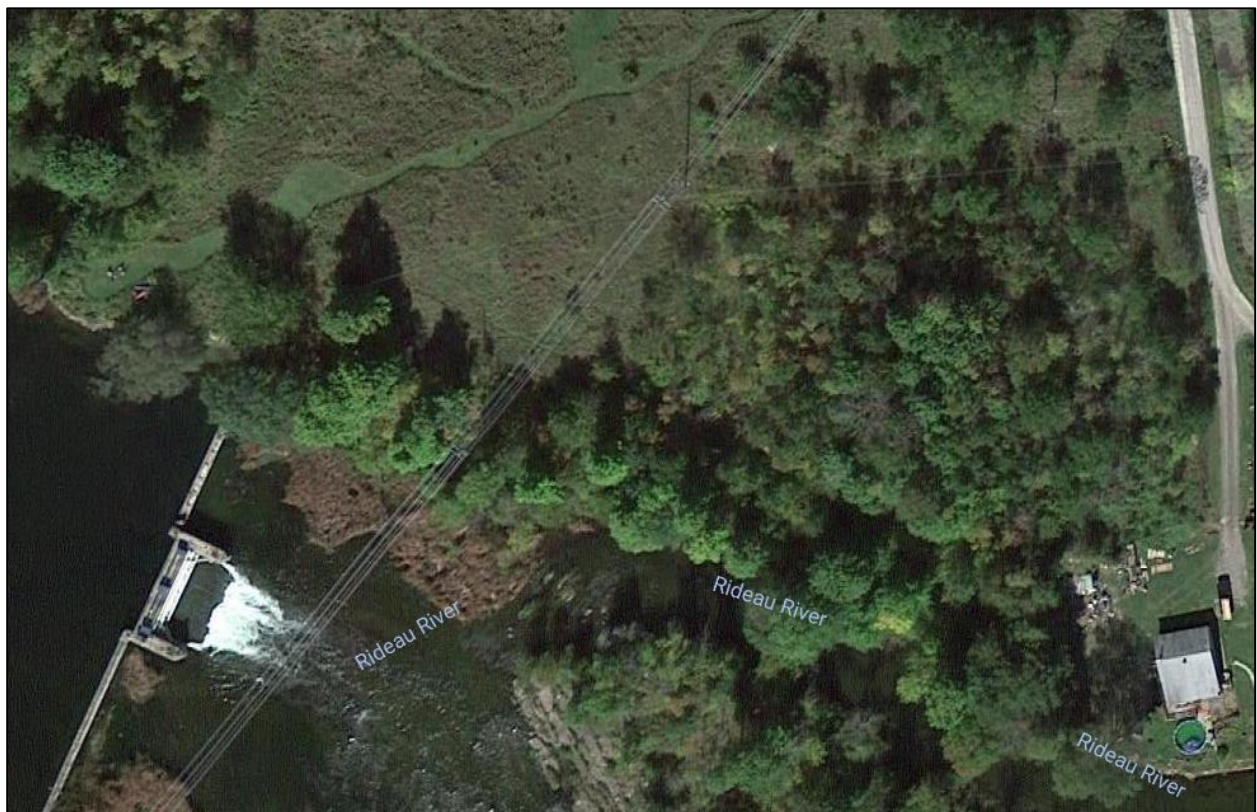
Figure 1: Google Earth aerial image of the proposed project area.

This project takes place within close proximity to residential properties and lands maintained and utilized for the RC system. The locks, dam and associated park areas are heavily influenced by past and present human development and activities. See **Figures 1, 2 and 4** above for satellite imagery of the general project site areas and their surrounding environmental conditions.

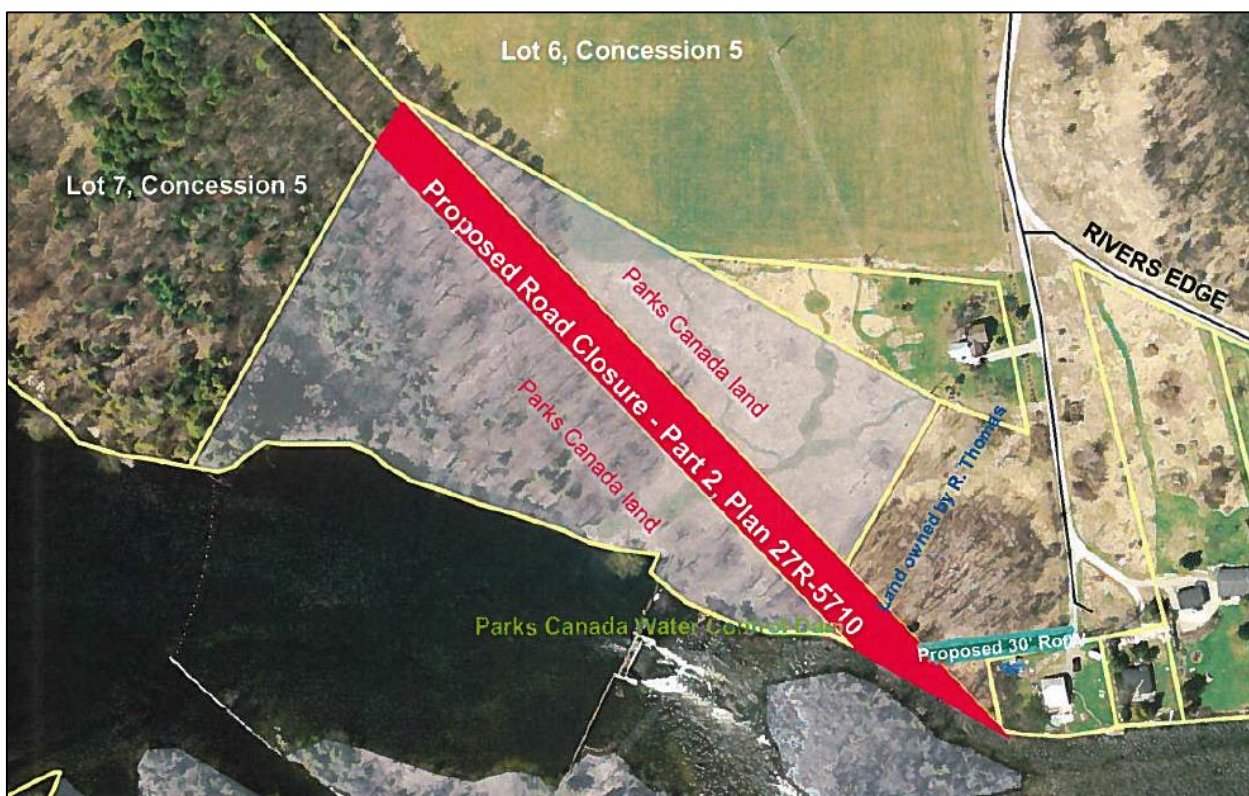
Figure 2: Map of the property ownership of PCA lands and the surrounding area. Areas with covered in a pink opaque hue and the strip highlighted in red are PCA property. The green strip with white lettering was purchased from the private landowner and is now PCA owned. All other property is privately owned.

All work will be undertaken on Federal Lands under the jurisdiction of Parks Canada Agency (PCA) – RC. The area featured in **Figure 2** as a green strip with white lettering was purchased from the private landowner and is now PCA owned.

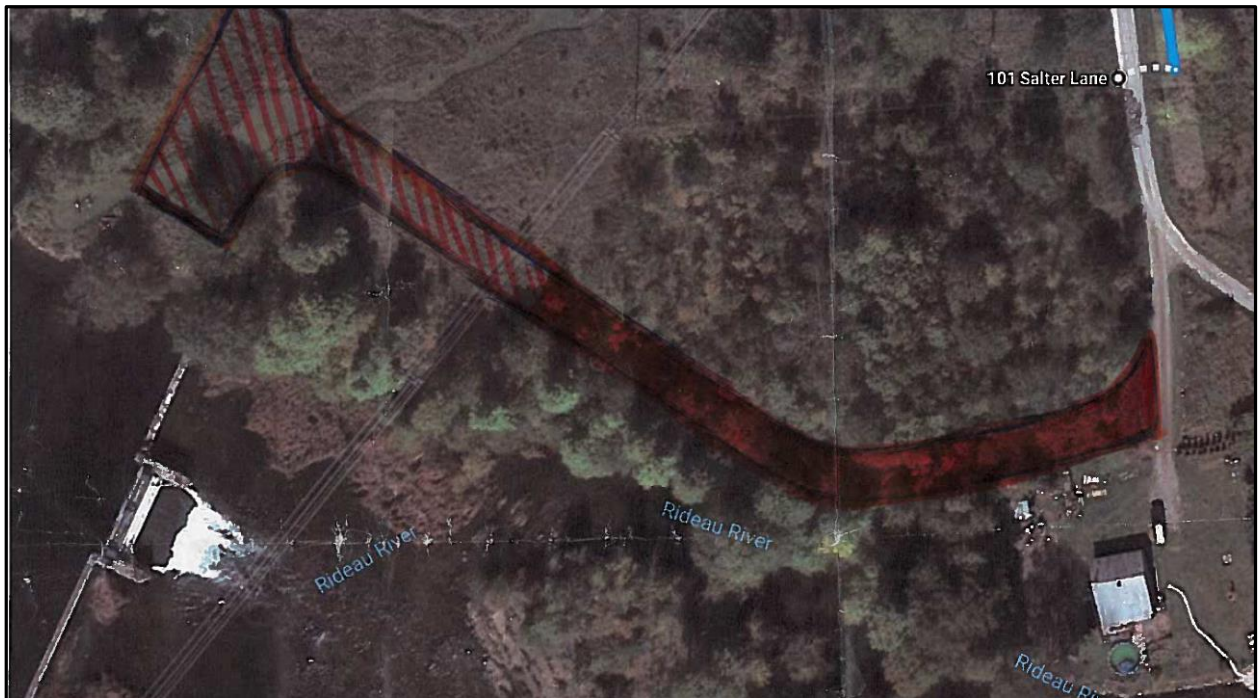
Figure 4: Estimated footprint of new access road and parking area, as well as anticipated footprint for permanent vegetation removal outlined in Red (approximately 1350 m²). Solid red shading represents forested area to be impacted (approximately 688.5 m²), and red-hatched area represents the open field and mowed area to be impacted (approximately 661.5 m²).

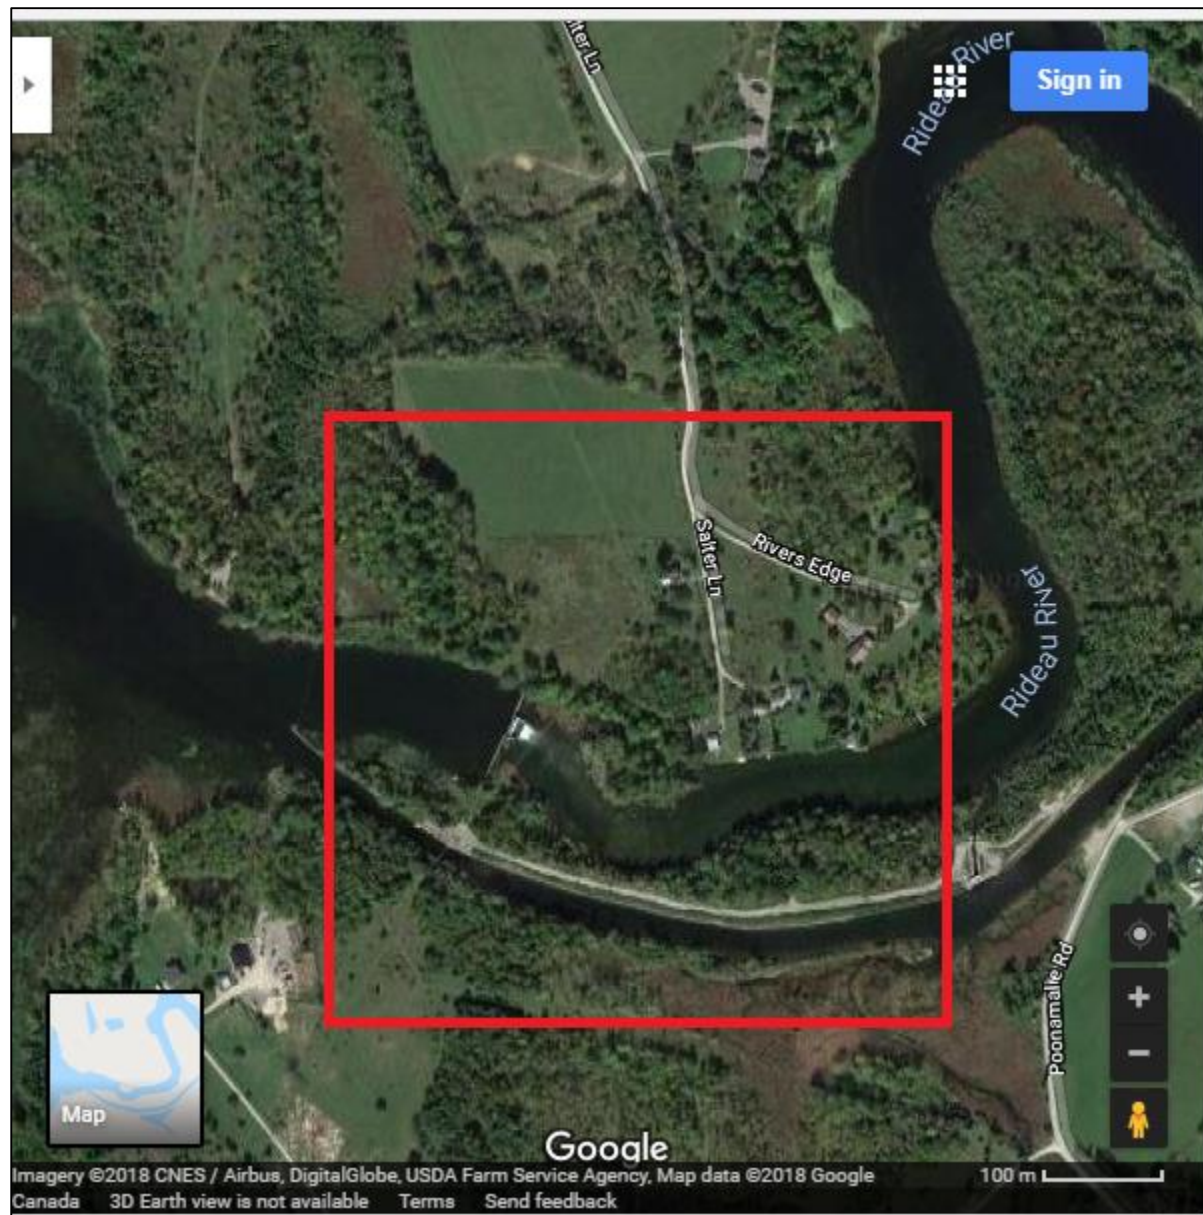
Figure 5: Red square outlines a 5 km x 5 km grid around the project site. Forested area within grid is estimated at 35 %.

As illustrated in **Figure 5** below, forested cover within a 5 km x 5 km grid around the project side is approximately 35%. With this, the biophysical attribute requirements for foraging and nesting habitat are not met for Golden-winged Warbler, and the areas designated for permanent vegetation removal is not considered loss of Critical Habitat. The presence and utilization of habitat by this species within the project area, or areas immediately adjacent to it, are highly unlikely. Furthermore, the likeliness of any adverse impacts to the survivability and success of Golden-winged Warbler or its respective Critical Habitat resultant of this project, is negligible.

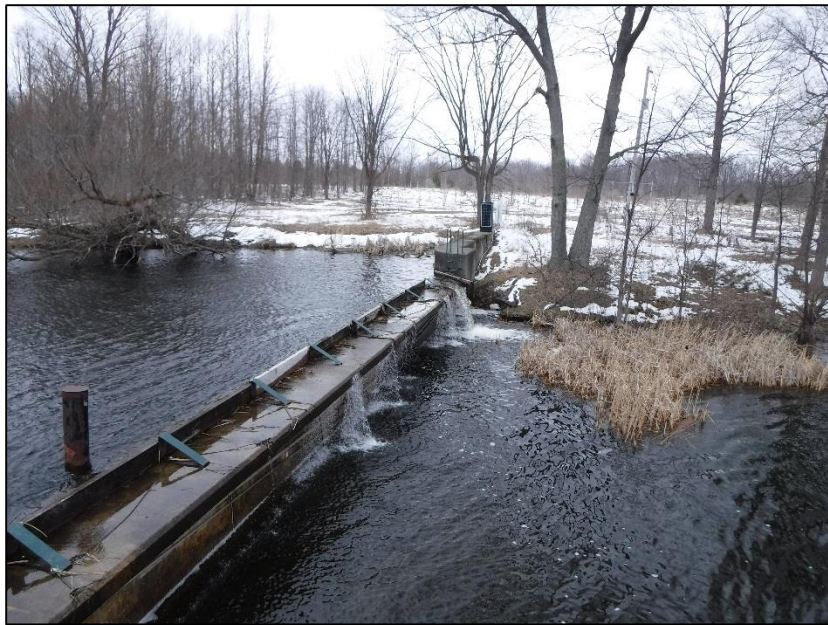
Photo 1: Poonamalie Weir, facing shoreline and to-be parking area (facing north). Photo taken March 19th, 2018.

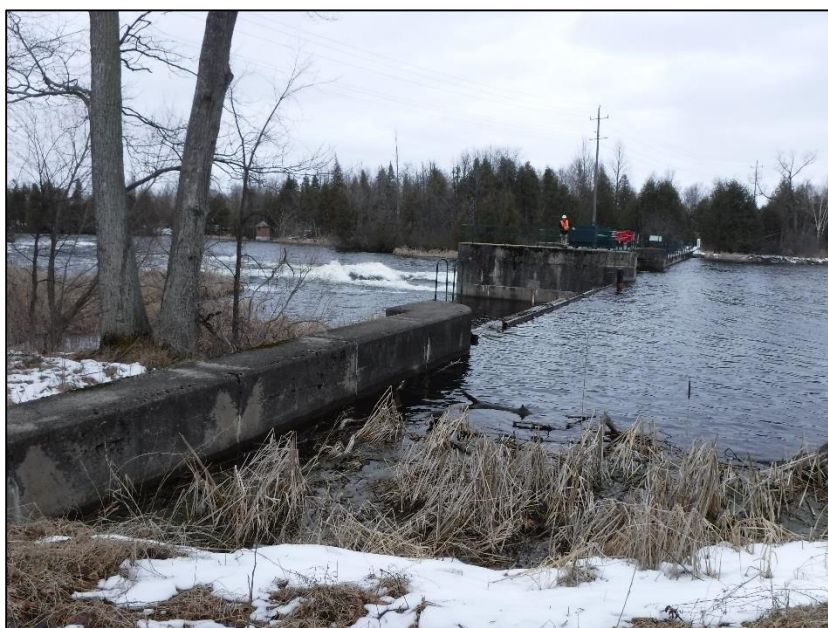
Photo 2: Poonamalie Dam and Weir, facing shoreline (facing south). Photo taken March 19th, 2018.

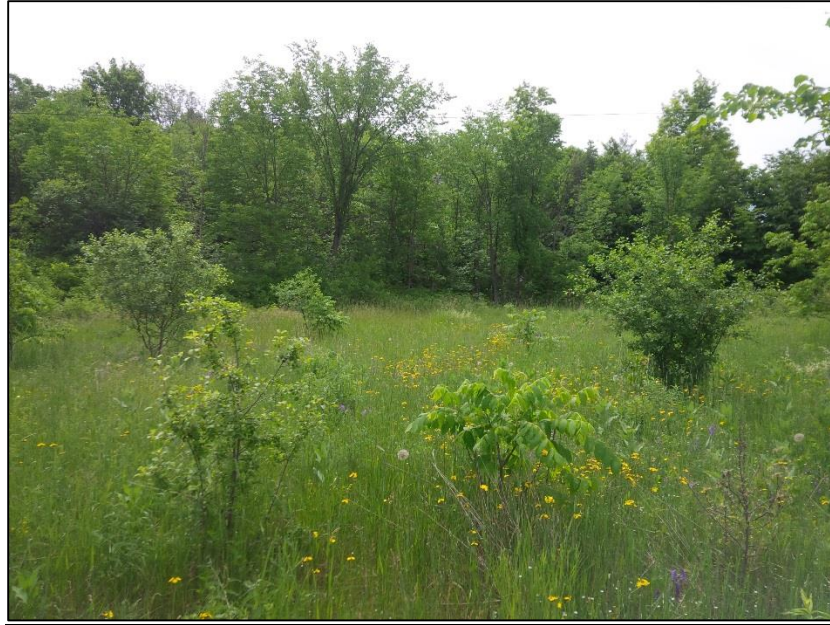
Photo 3: Open field facing to-be access road (facing east). Milkweed visible (*Asclepias* L.). Photo taken by Environmental Officer, Sarah Bunting June 20th, 2018.

The former access road area is largely clear, save for some young trees such as White Oak (*Quercus alba*) and Elm (*Ulmus sp.*), low-lying undergrowth such as Poison Ivy (*Toxicodendron radicans*) and Virginia Creeper (*Parthenocissus quinquefolia*), and some smaller scrubby-plants and brush such as Red Wild Raspberry (*Rubus idaeus*) (see **Appendix A – Photos 3 to 6** and **Appendix C** for a species list of vegetation in the project area).

Milkweed has been observed to be present within the 'wild' vegetative areas of the project site, particularly in the long-grassed areas and on the western side of the site (See **Photos 3 and 6 of Appendix A**).

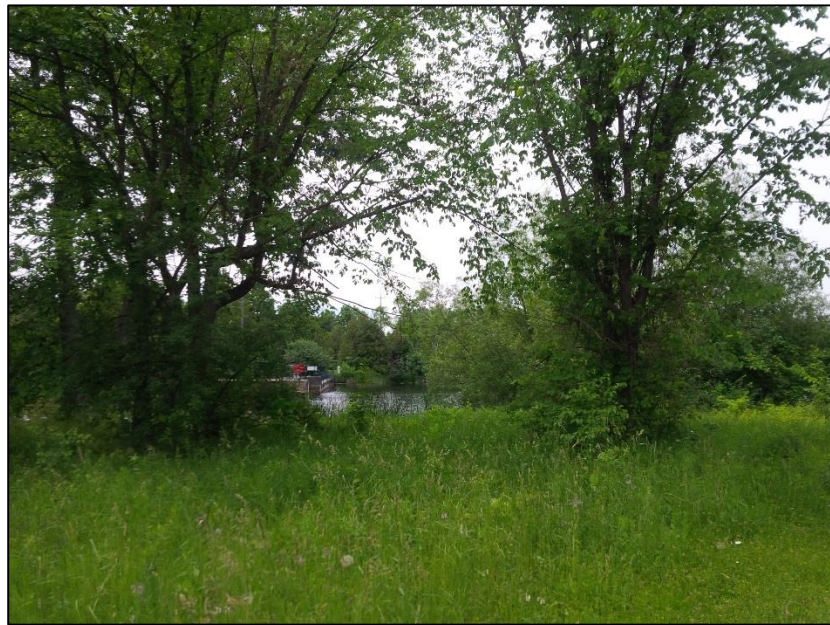
Photo 4: Two trees large to be removed. Facing to-be parking area (facing south). Photo taken by Environmental Officer, Sarah Bunting June 20th, 2018.

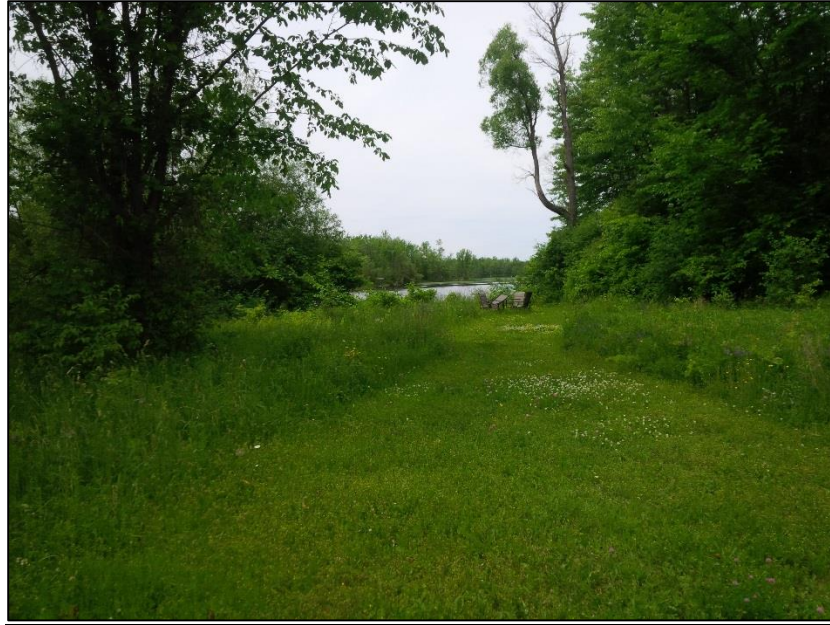
Photo 5: Facing to-be parking area (facing south). Photo taken by Environmental Officer, Sarah Bunting June 20th, 2018.

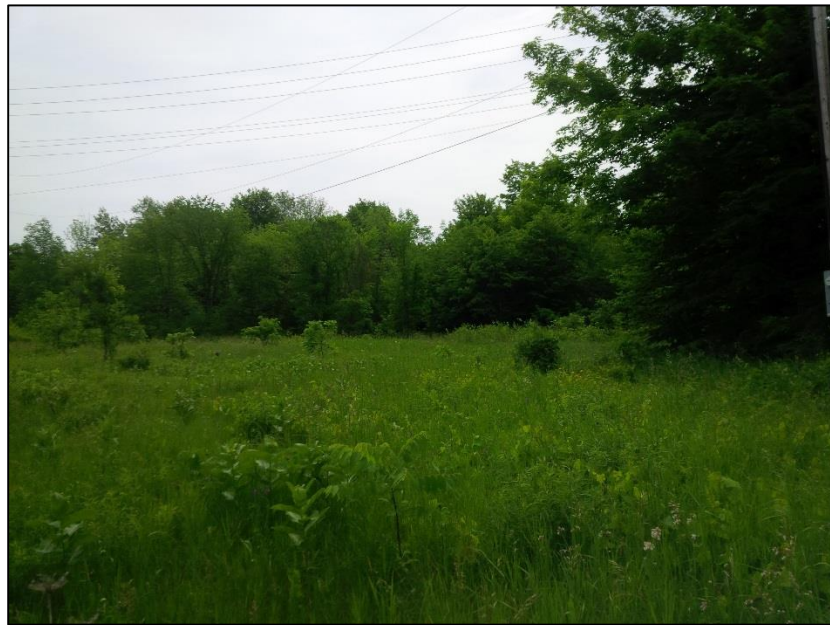
Photo 6: Open field facing to-be access road (facing east) Milkweed visible. Photo taken by Environmental Officer, Sarah Bunting June 20th, 2018.

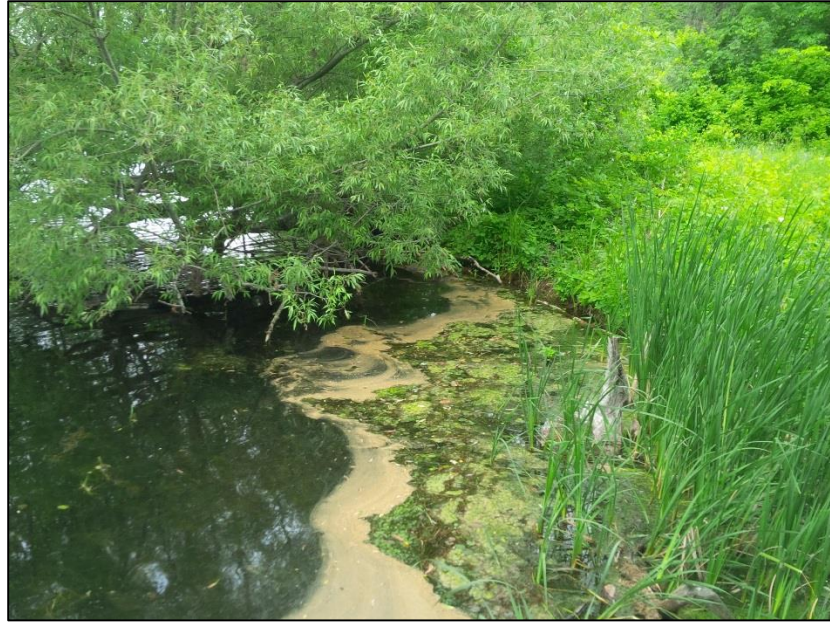
Photo 7: Facing shoreline where rip-rap to be placed (facing west). Photo taken by Environmental Officer, Sarah Bunting June 20th, 2018.

Overall, fish habitat which may potentially be impacted by the planned works is restricted to the shoreline area of the southern end of the western parking area where riprap is to be placed along the shoreline. The footprint for rip-rap placement is estimated to be 48 m² (3 m x 16 m). The area between the edge of the rip-rap and shoreline is to remain in its natural vegetated state. In-water works is not anticipated, however depending on water levels and site conditions at the time of construction, there is potential for this area to be flooded and low-scale in-water works may be required.

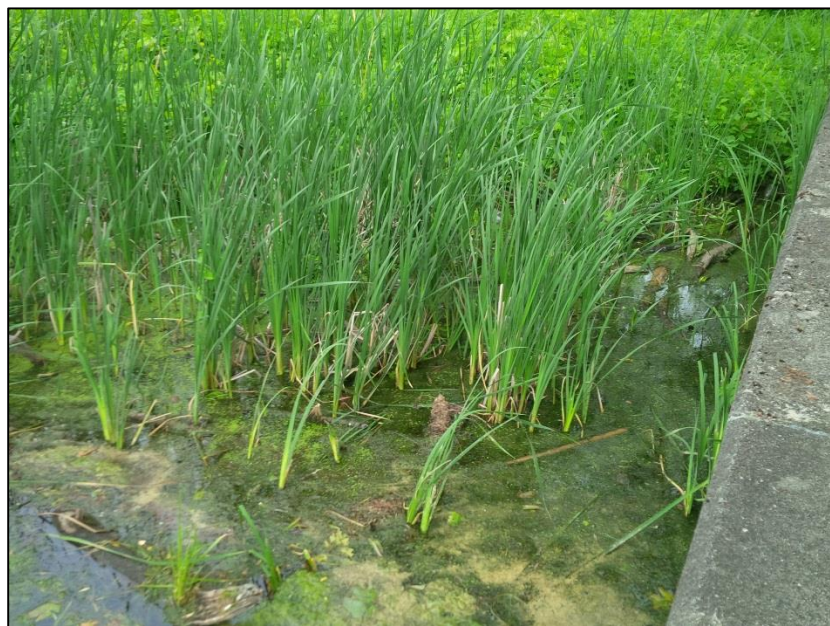
Photo 8: Facing shoreline where rip-rap to be placed (facing north). Photo taken by Environmental Officer, Sarah Bunting June 20th, 2018.

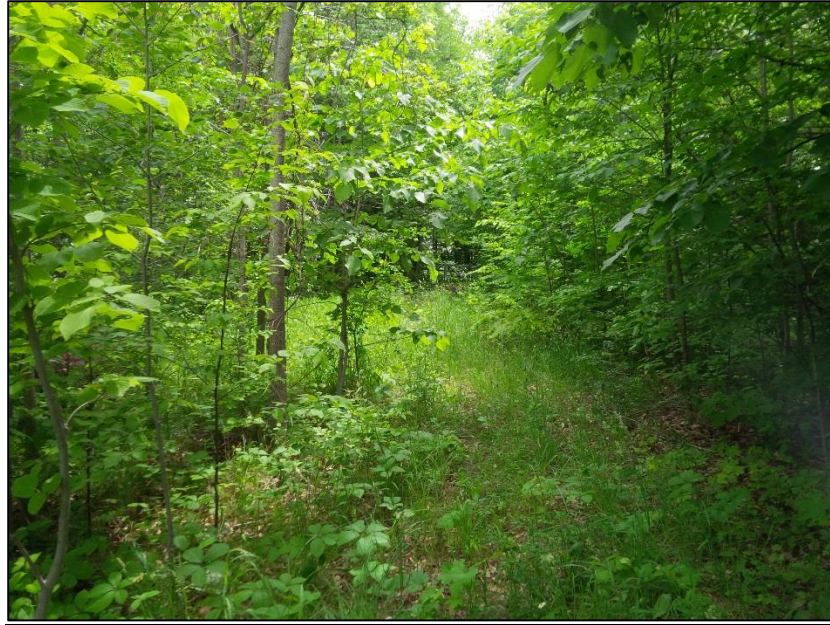
Photo 9: Facing remnants of former access road through forested area, where new access road shall be placed (facing east). Photo taken by Environmental Officer, Sarah Bunting June 20th, 2018.

Trees within the footprint of the access road through the forested area were observed to be quite young and lean. Hollows within trees within this footprint were not noted during any site visits. Furthermore given their age, it is unlikely that trees within this area would possess hollows, if any. Larger trees in the more mature successional sections of the forested area adjacent to the former/to-be-constructed access road, may possess tree hollows and bark-peels.

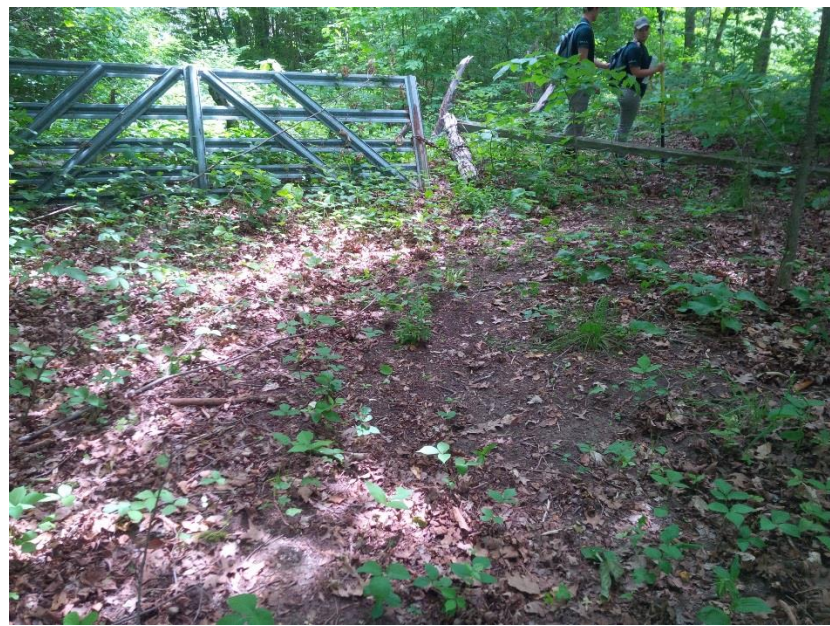
Photo 10: Facing remnants of former access road through forested area and old access gate, where new access road shall be placed (facing east). Poison Ivy (*Toxicodendron radicans*) visible. Photo taken by Environmental Officer, Sarah Bunting June 20th, 2018.

It should also be noted that Poison Ivy was recorded to be predominant around the site area, particularly along remnants of the former access road and around the old access gate.

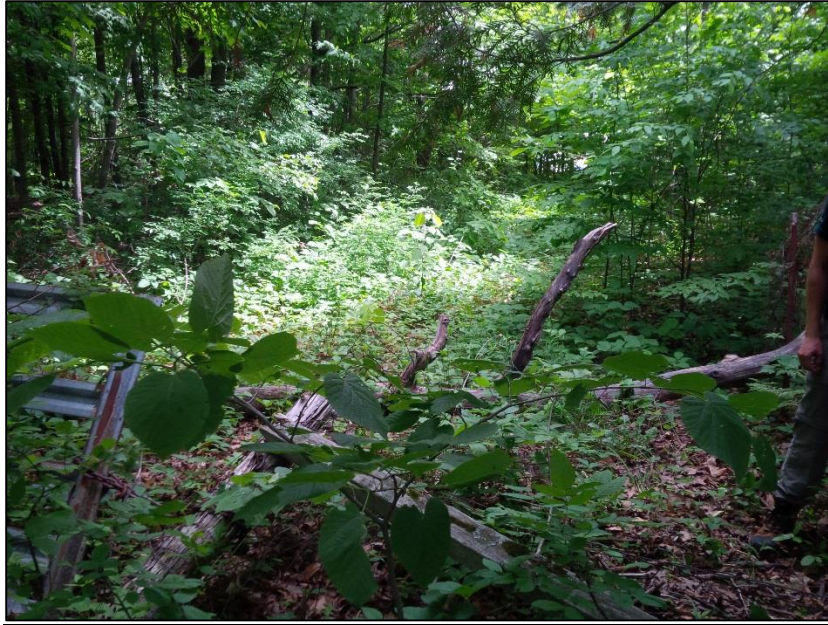
Photo 11: Facing remnants of former access road through forested area and old access gate, where new access road shall be placed (facing east). Poison Ivy visible. Photo taken by Environmental Officer, Sarah Bunting June 20th, 2018.

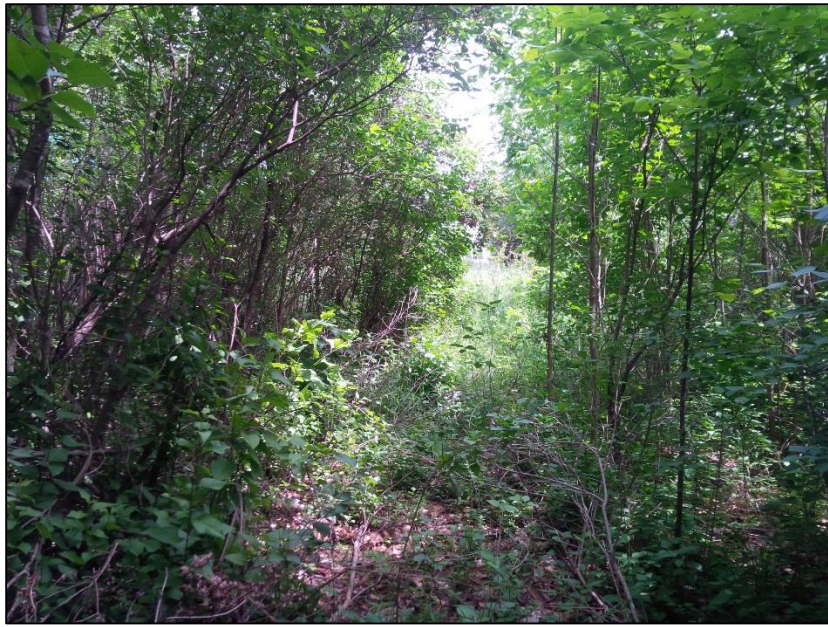
Photo 12: Facing remnants of former access road through forested area, where new access road shall be placed (facing east). Poison Ivy visible. Photo taken by Environmental Officer, Sarah Bunting June 20th, 2018.

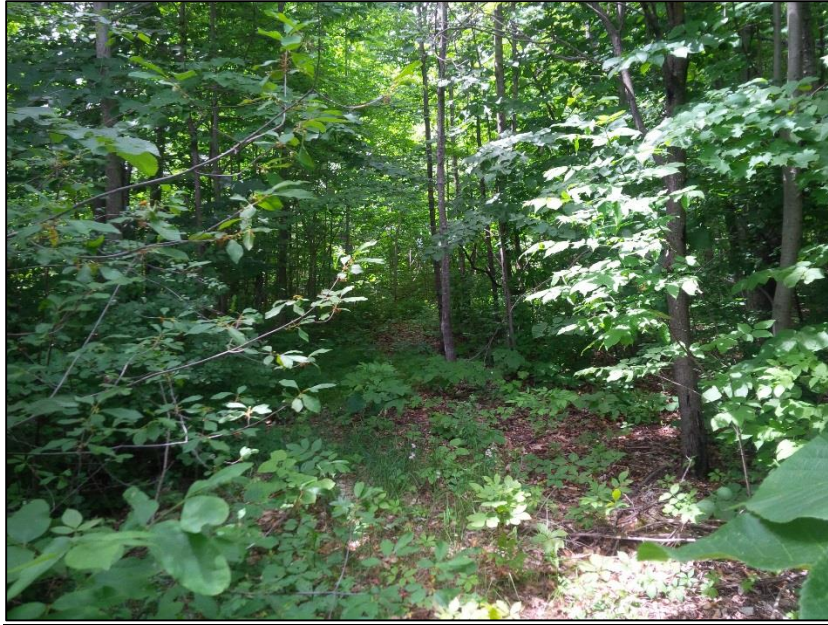
Photo 13: Facing remnants of former access road through forested area, where new access road shall be placed (facing west). Poison Ivy visible. Photo taken by Environmental Officer, Sarah Bunting June 20th, 2018.

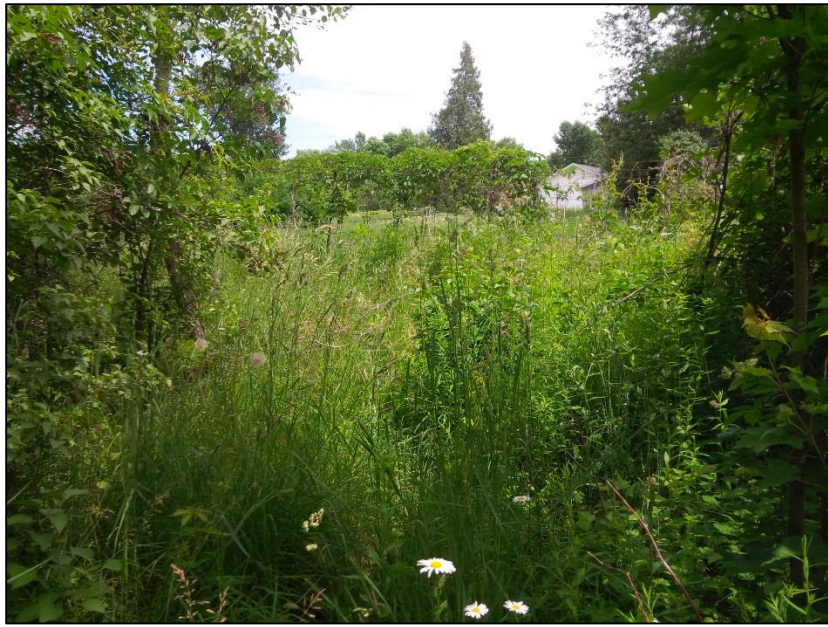
Photo 14: Facing remnants of former access road through forested area, where new access road shall be placed (facing east). Photo taken by Environmental Officer, Sarah Bunting June 20th, 2018.

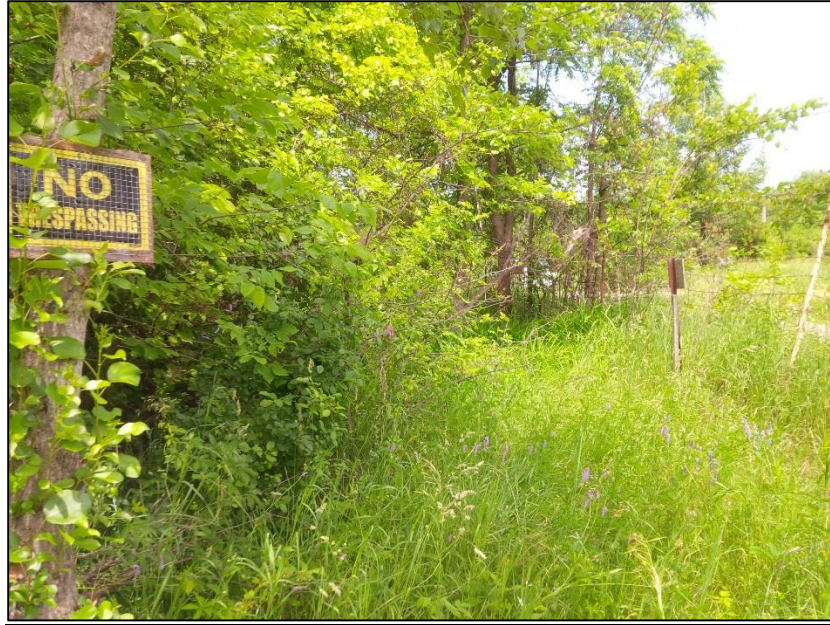
Photo 15: Facing remnants of former access road through forested area, where new access road shall be placed (facing north). Photo taken by Environmental Officer, Sarah Bunting June 20th, 2018.
