**Sir John A. Macdonald Parkway Bridge O/P Lebreton  
(SN016470)**

MH NO. 2140670  
Contract No. ISD14-7114

**STRUCTURE EVALUATION REPORT**

January 2015

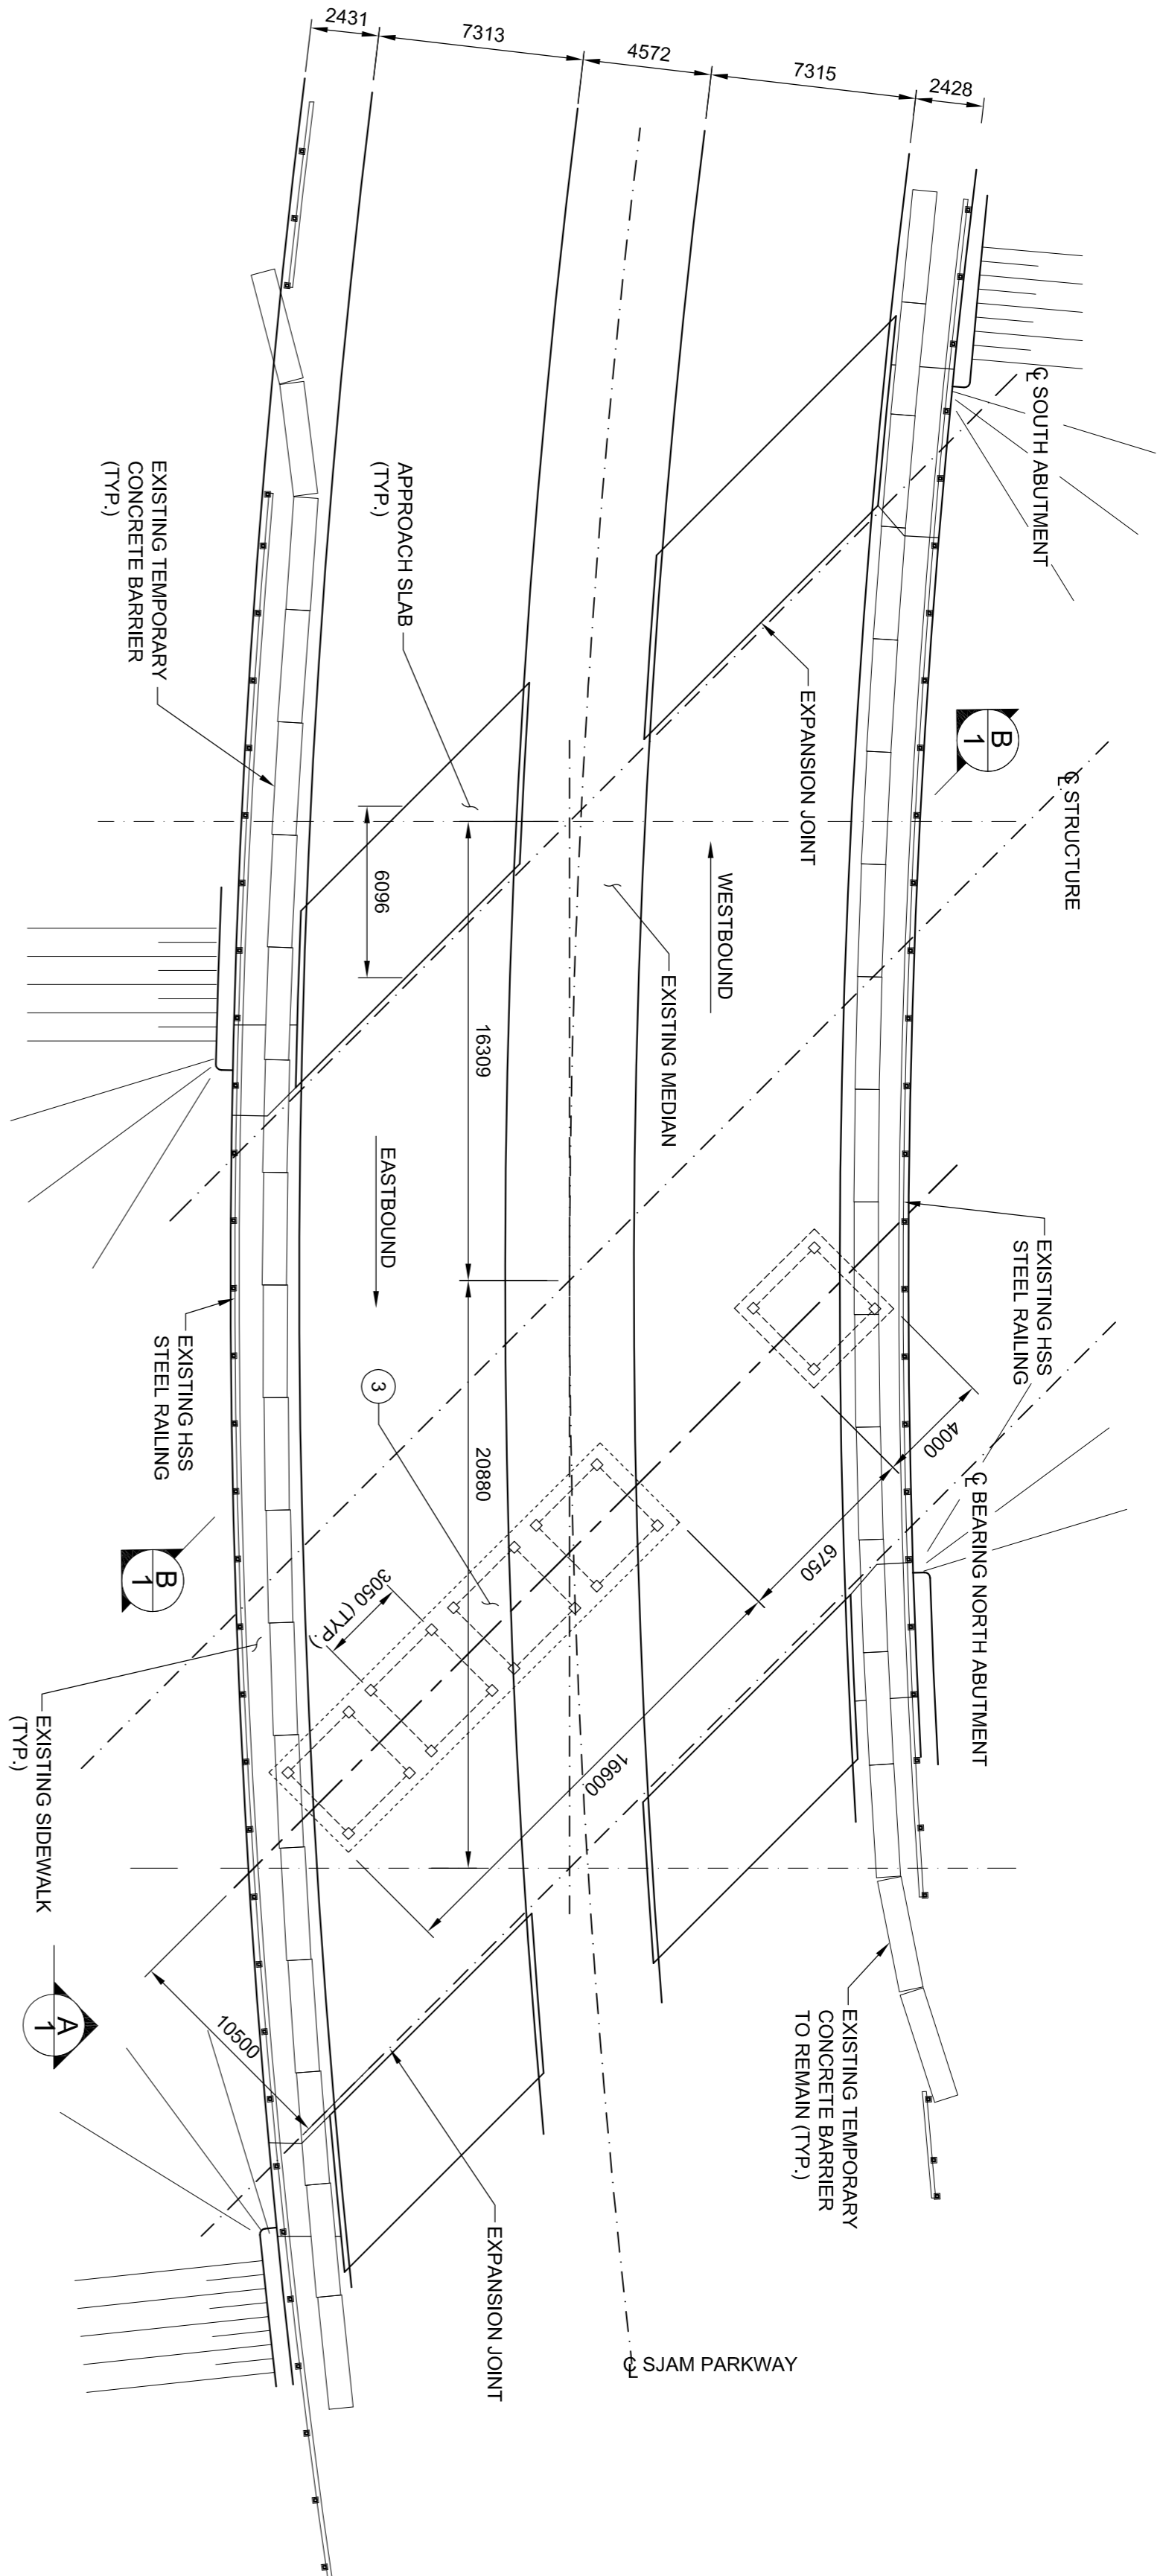
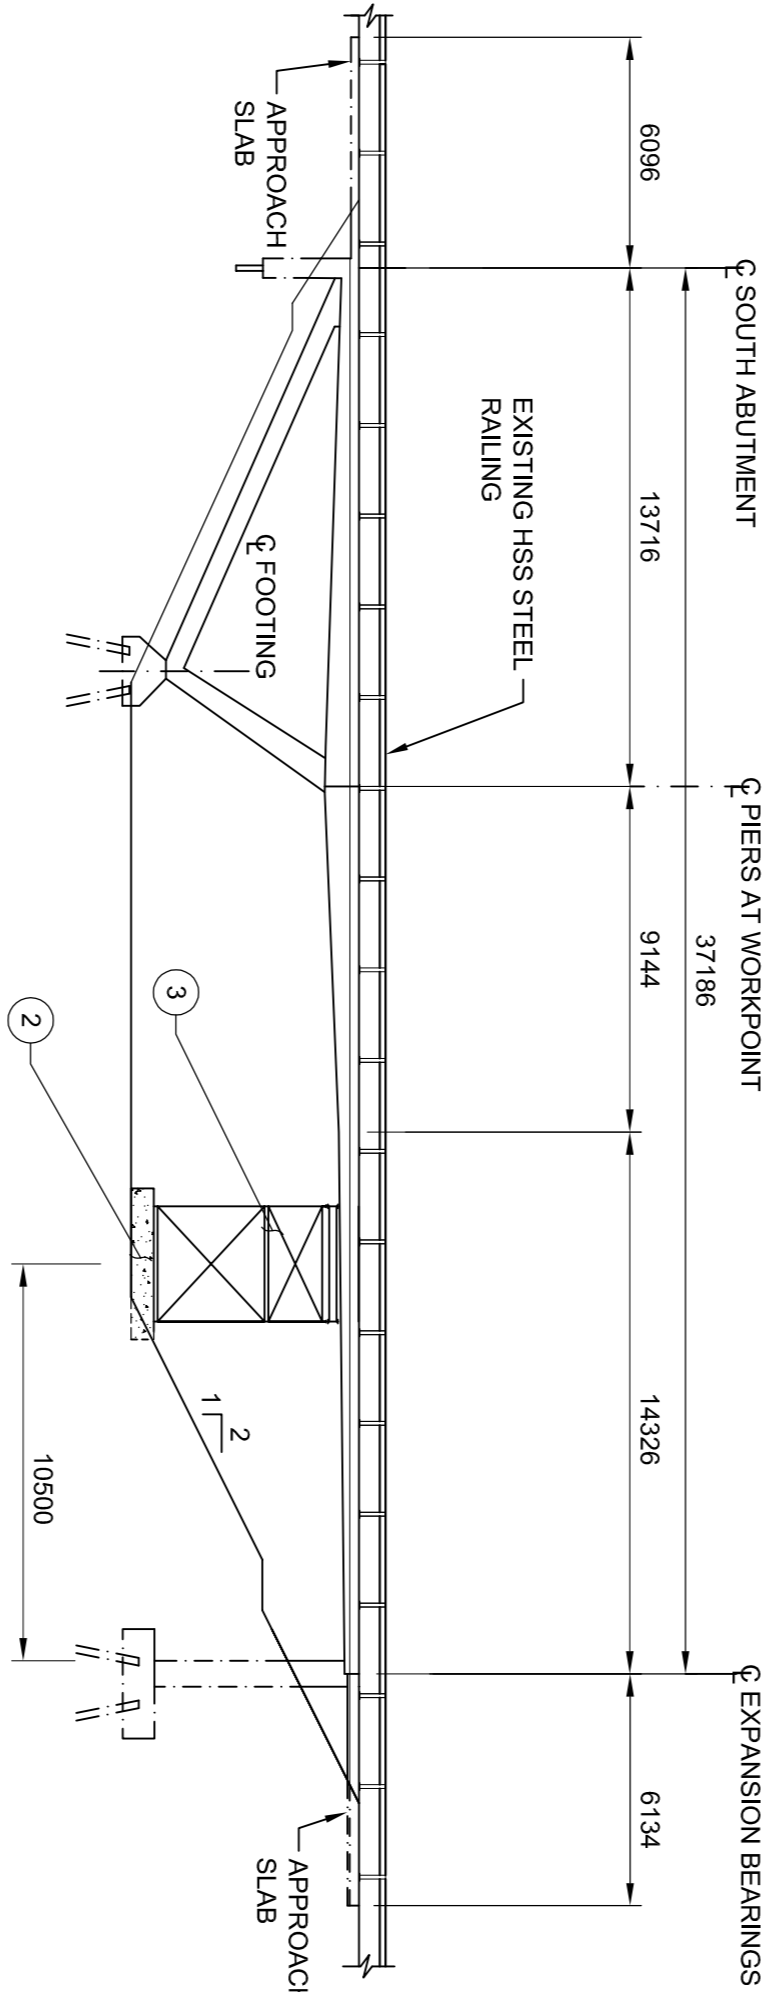
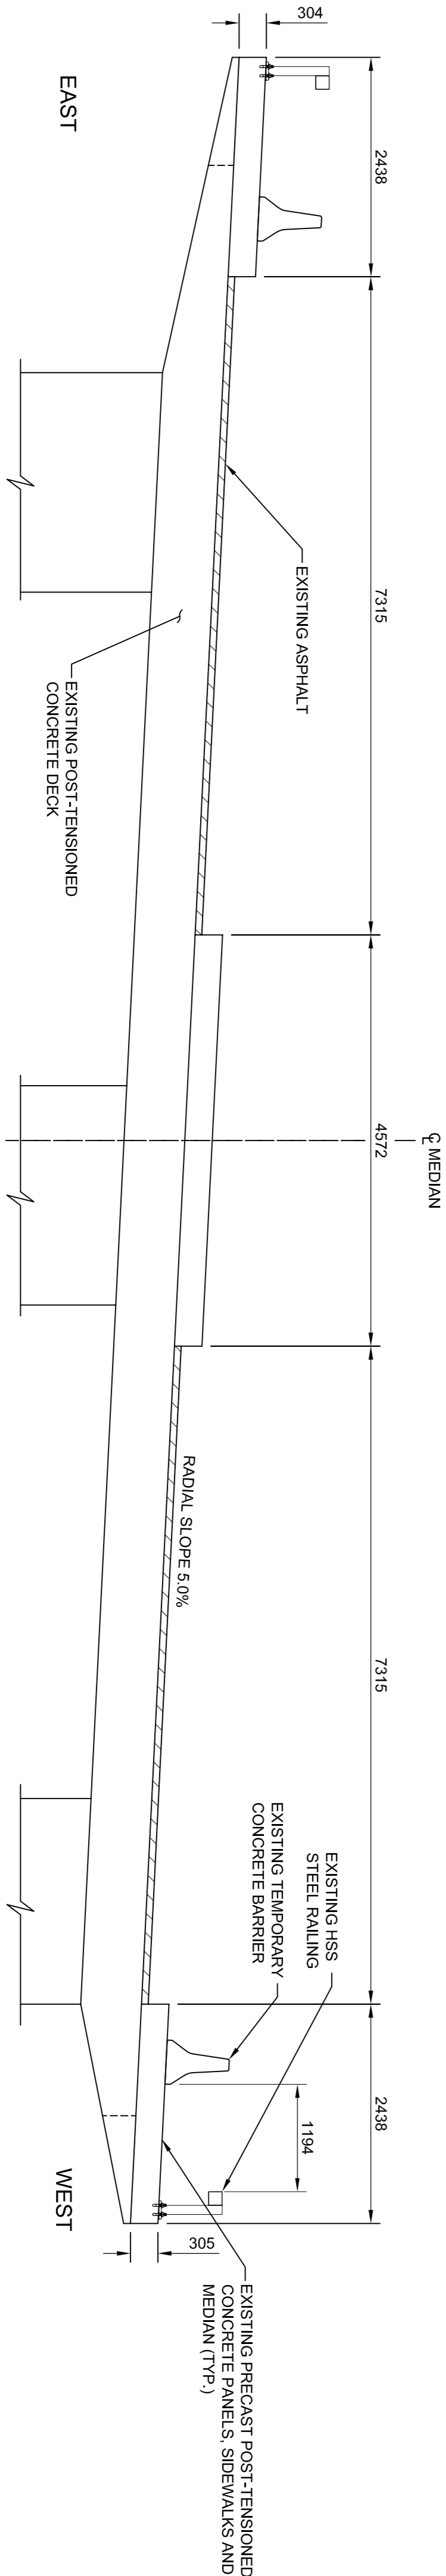
PLAN  
1:200

1. TRAFFIC CONTROL
2. CONSTRUCT FOUNDATION PADS FOR SHORING TOWERS
3. SUPPLY AND ERECT HIGH-LOAD SHORING TOWERS
4. REMOVE SHORING TOWERS AND CONCRETE FOUNDATION PADS AFTER COMPLETION OF ADJACENT CONTRACT. RESTORE SITE TO ORIGINAL OR BETTER CONDITION

Shoring is recommended to prop the north span of the bridge. Temporary shoring could be implemented without major disruption and without permanently altering the bridge. Upon completion of the adjacent LRT construction, the installation would be removed. The shoring system has a commercial salvage that could be recovered. The proposed shoring layout is shown on the drawing General Arrangement in Appendix A.

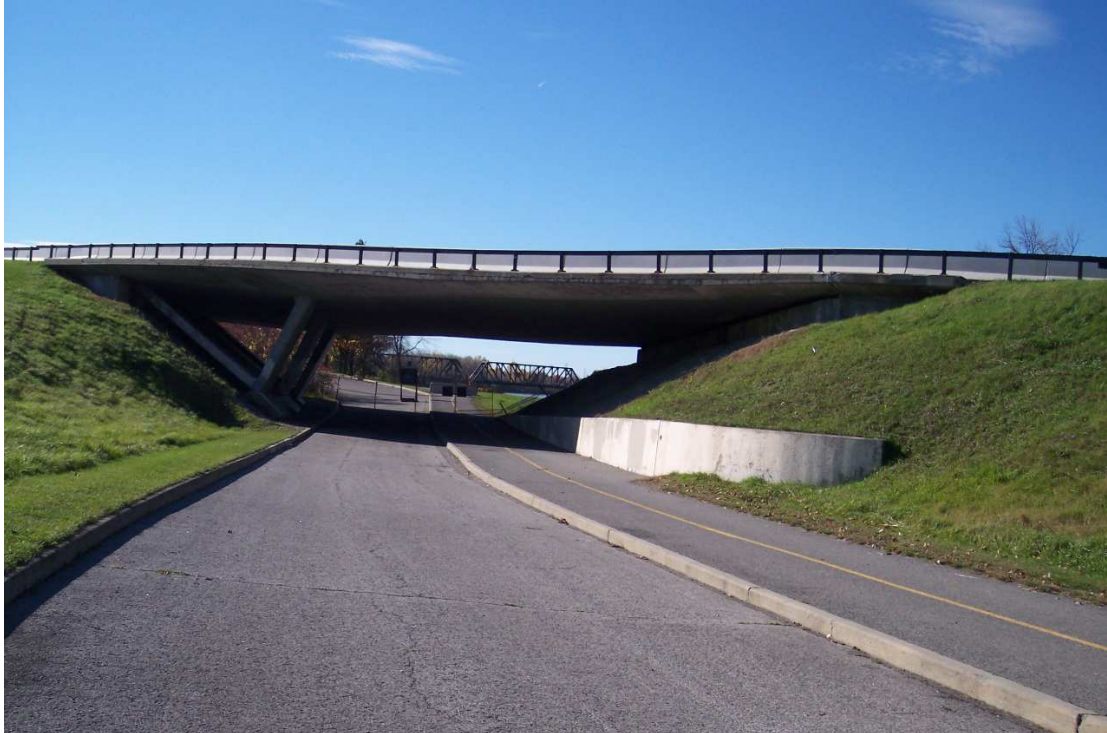
Photo 1: East elevation of the bridge

The sag deformation in the north span is greatest on the east side of the bridge (photo 1). The visible components generally follow the sag; however the extent of any padding or overlay is not documented.

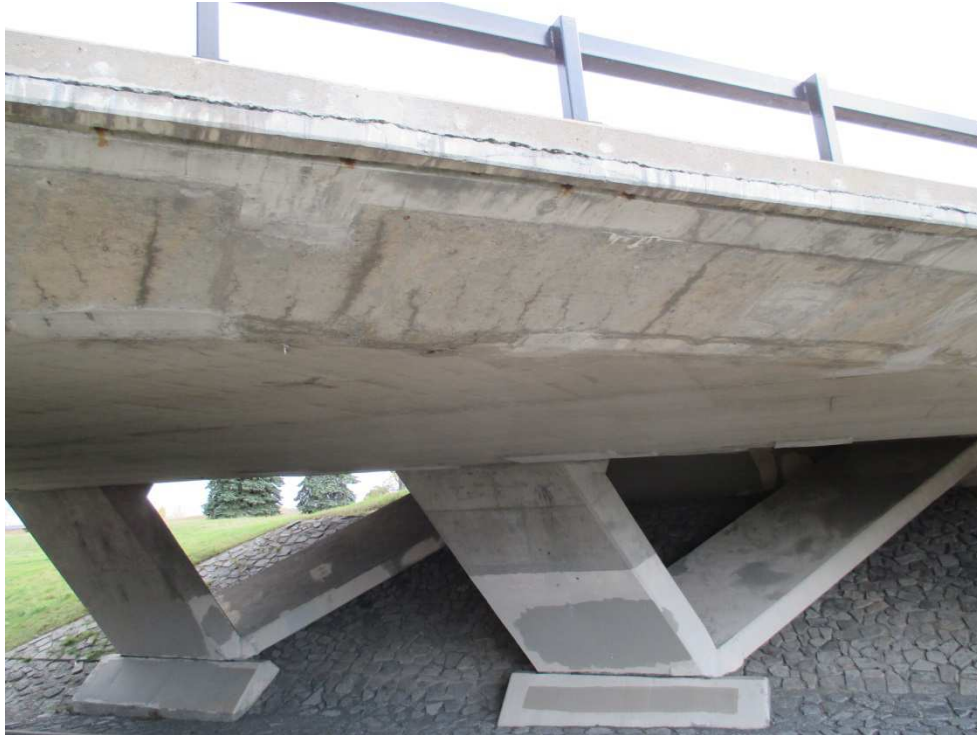
Photo 3: Bridge deck soffit and fascia

The bridge deck is generally in good condition, but the cantilevers exhibit previous patch repairs and deterioration (cracks, minor spalls) indicative of corrosion of embedded reinforcing steel as a result of splash and spray from the roadway (Photos 3,4,5,15).

The two reinforced concrete legs of the pier are in good condition. The exposed concrete surfaces appear to have been coated with concrete sealer (Photo 3). No significant deficiencies were noted.

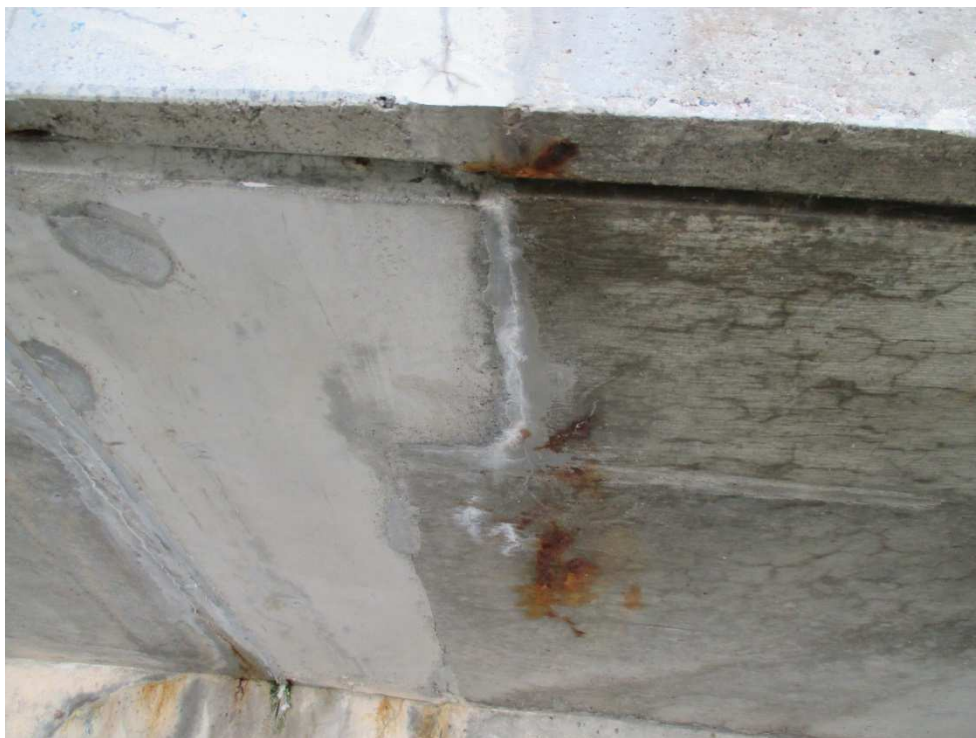
Photo 5: Corrosion of reinforcement in cantilever

1. Remove existing TCBs, railing system, sidewalks and bridge deck cantilevers. Reconstruct concrete sidewalk and bridge cantilever to accommodate new PL2 steel railing.
2. Replace elastomeric bearings and steel plates.
3. Localized concrete patch repair.
4. Replace expansion joint assemblies with strip seal type assemblies. Although eliminating the expansion joints by means of semi-integral abutment conversion may be feasible, it is not recommended due to performance complications associated with the high skew angle.

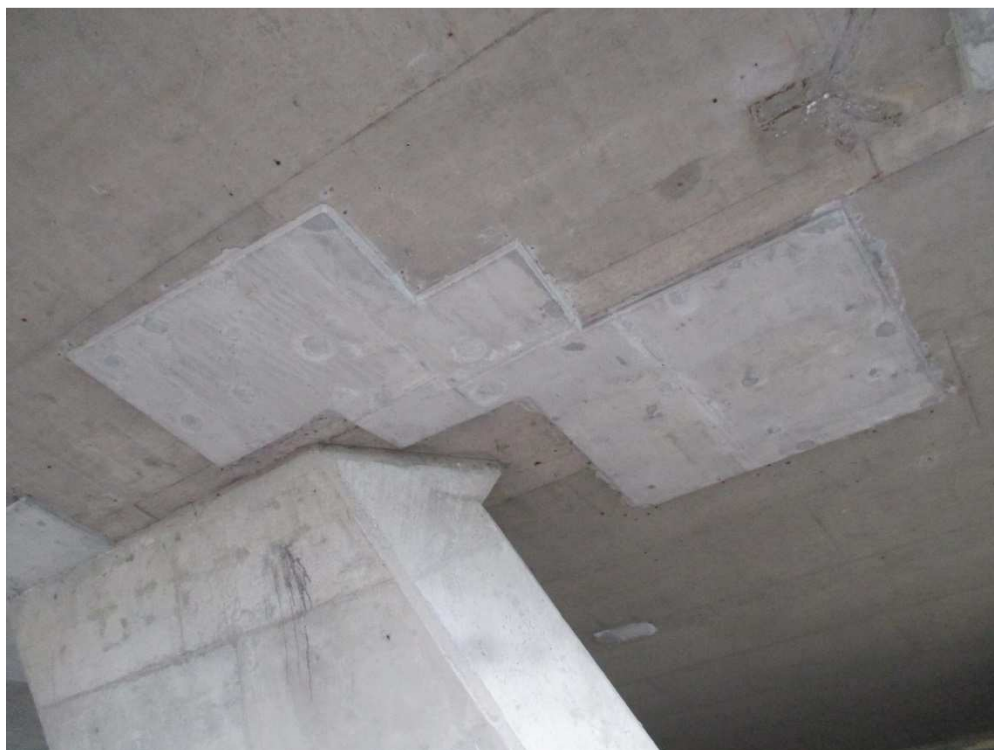
Photo 6: Overbuilt patches in the bridge deck

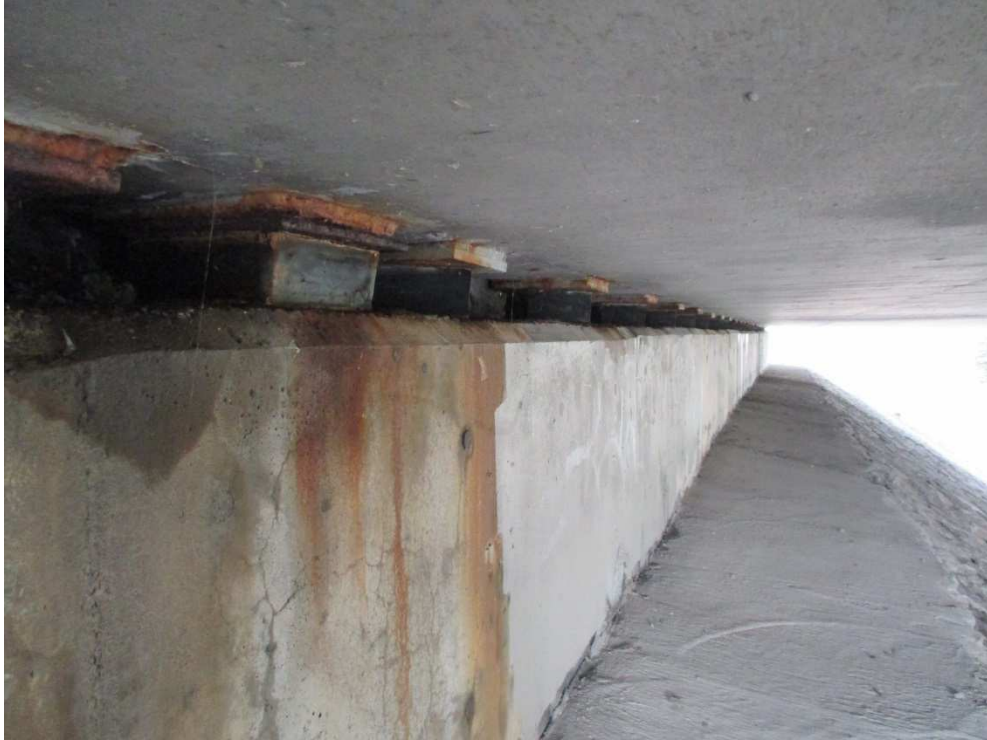
Both abutments are generally in good condition. Minor spalling at the southeast corner of the bridge was noted. Evidence of water leakage through the expansion joints includes staining and rusted shoe plates (Photo 7).

The elastomeric bearings and steel plates are generally in fair to poor condition. Horizontal cracks (Photo 7, 8) were noted on several elastomeric bearings and the steel bearing shoe plates are severely corroded. Significant differential deformations between the bearings were noted.

Photo 7: leaking water and rusted steel plates

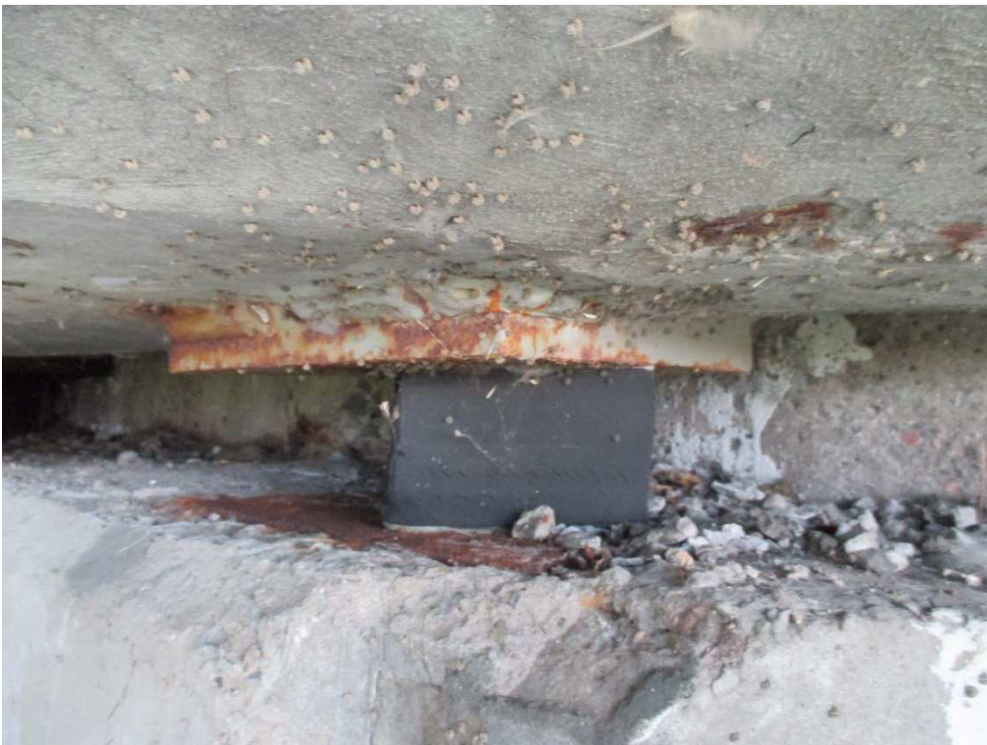
Photo 8: Horizontal cracks in elastomeric in bearing

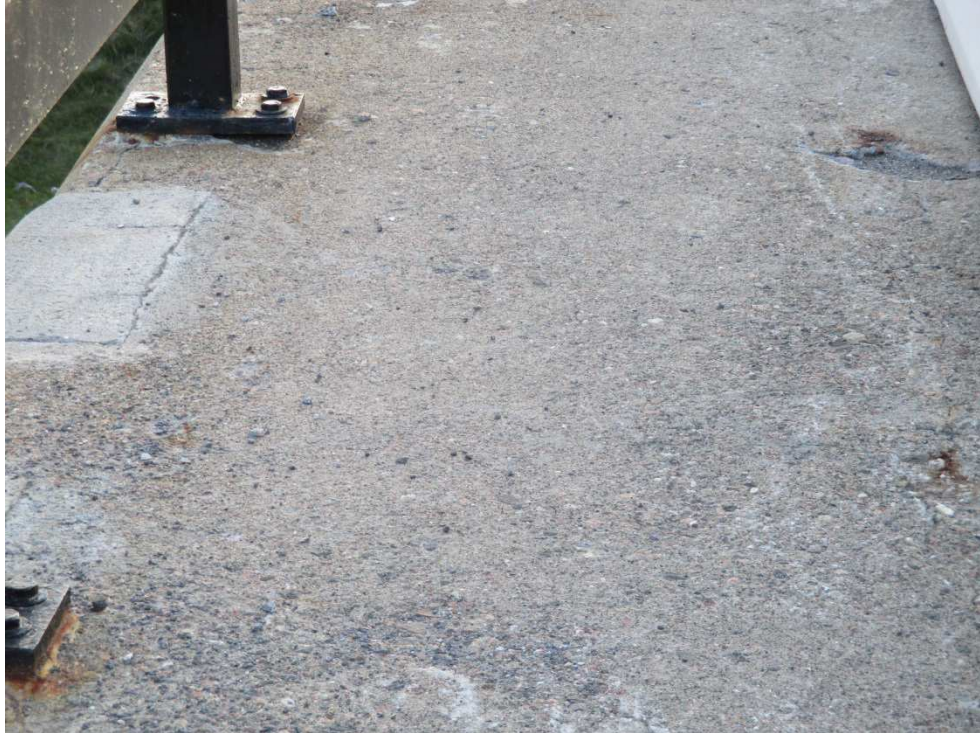
Photo 9: Sidewalks

The post-tensioned precast concrete sidewalks and median are in fair condition. Light scaling and narrow to wide cracks were noted on the surface of sidewalks and median, light spalling was also noted at several locations on the sidewalk (Photo 9, 13). Grout in the installation holes was broken off at some locations.

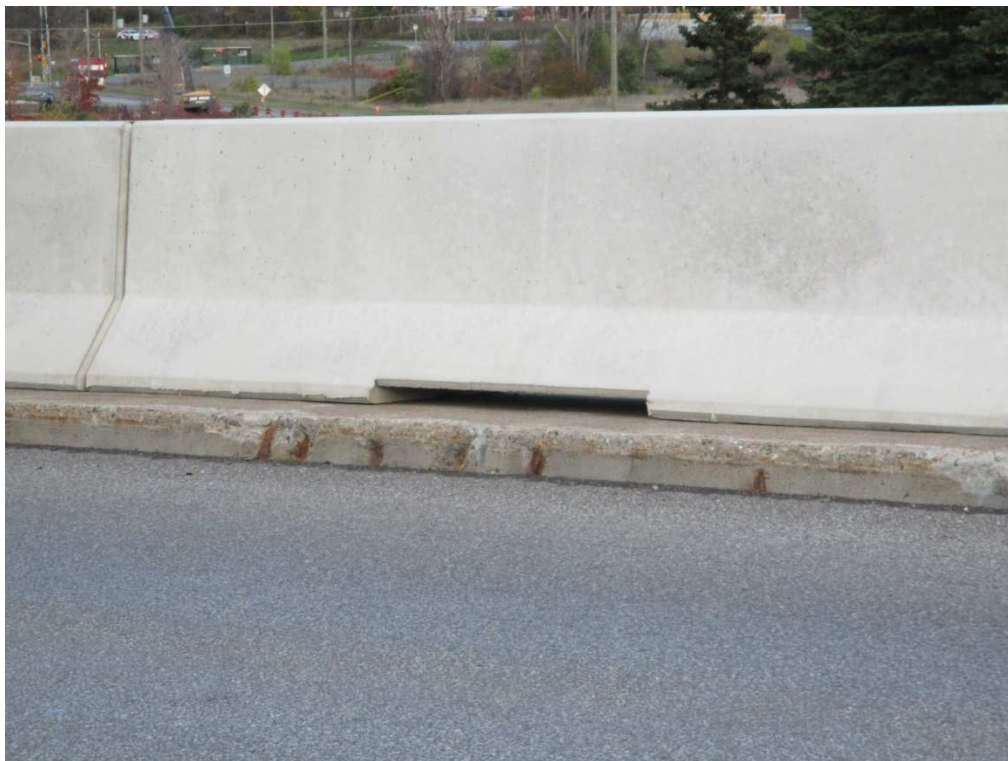
The sidewalks and median curbs are generally in fair to poor condition. Localized abrasion, spalling, cracks and corroded reinforcement were noted (Photo 10) .

Photo 10: Spalling in curb

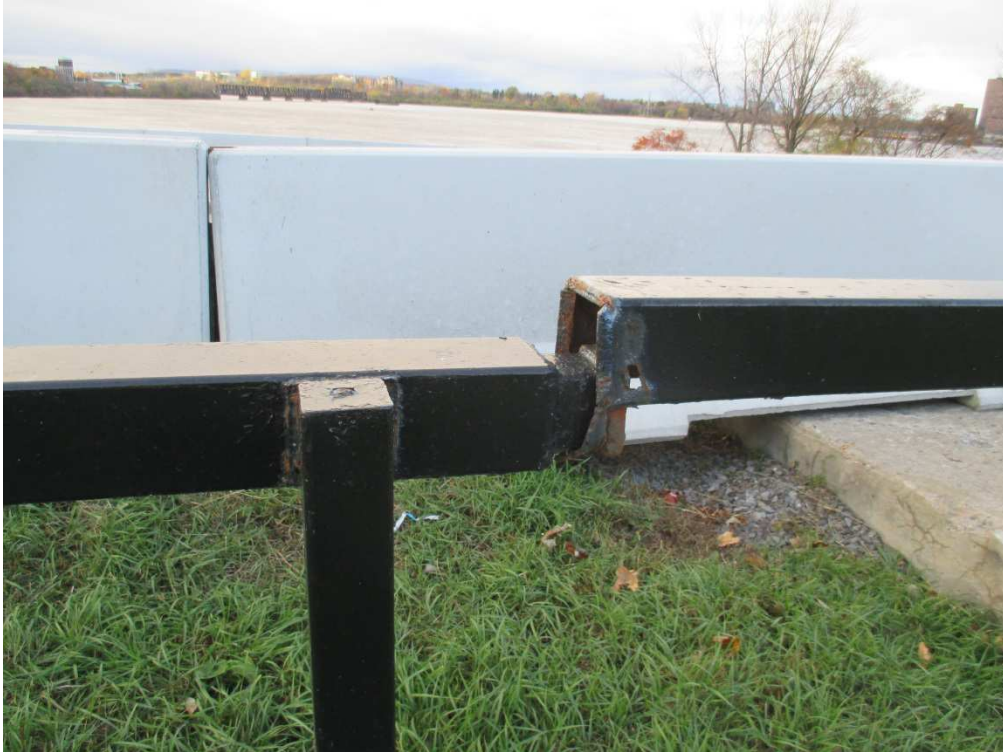
The steel HSS section railing and post traffic barrier system on the bridge are generally in fair condition. Severe corrosion was noted at the ends of railings (Photo 11); the portions over the bridge deck were well maintained. Missing anchor bolts were noted at two posts. The existing railing system does not meet current CHBDC requirements.

Photo 11: Corrosion and missing connection in railing

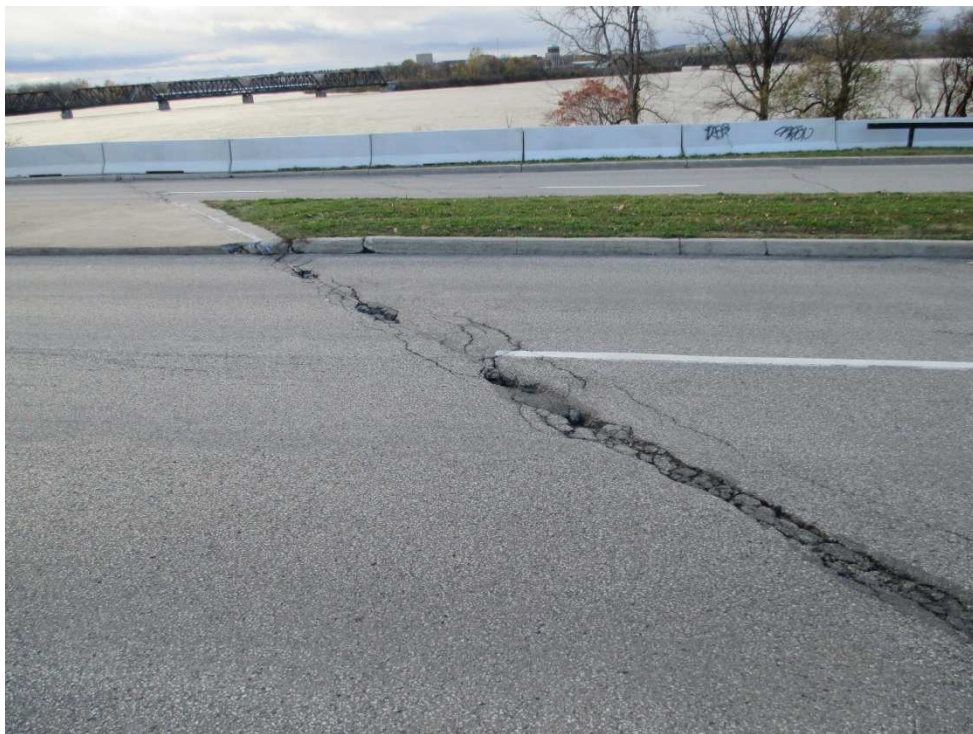
The asphalt wearing surfaces in the west bound lane and east bound lane are in fair to poor condition. Large cracks and asphalt raveling coincide with the expansion joints at either end of the bridge deck. Severe longitudinal cracks and light to medium transverse cracks were noted near the approach slabs.

The paved over expansion joints at both abutments are continuous across the bridge. The expansion joint assemblies are not visible. There are no concrete end dams. The asphalt pavement is distressed at the joints (parallel cracking, ravelings) and there is evidence of water leakage through the joints.

Photo 12: Severe cracks in asphalt at expansion joint

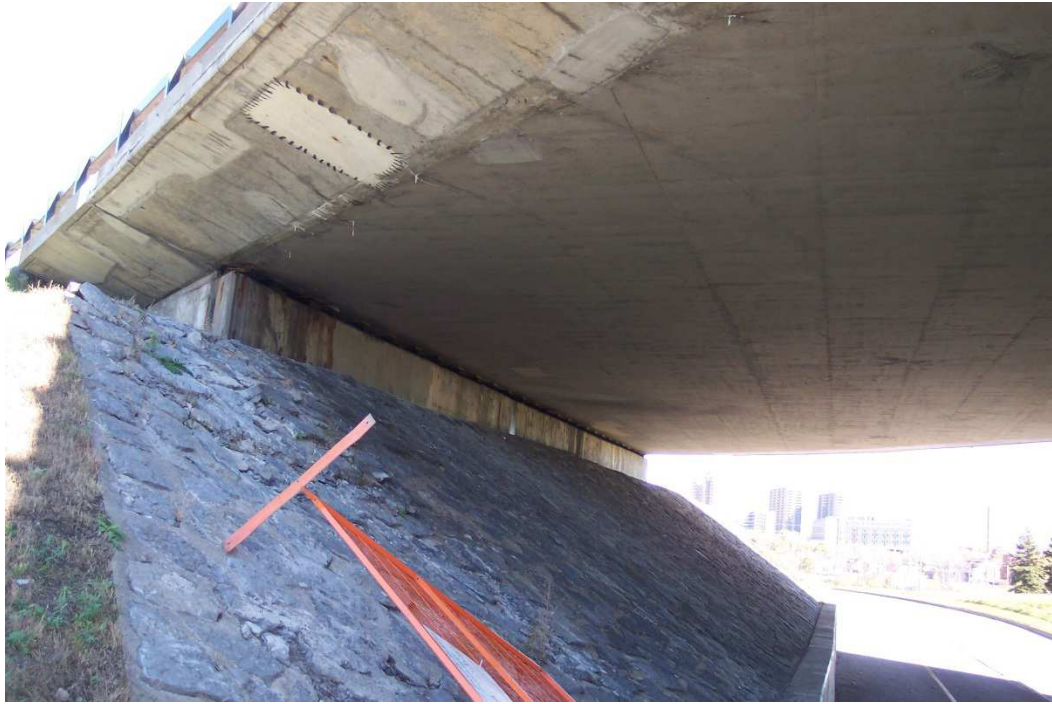
Both the north and south embankments are in good condition, the embankments have been well protected with grouted laid stone. Some loose stones (about 2.5 m<sup>2</sup> area) were observed at the northwest corner of the embankment.

Photo 15: Loose stones in embankment

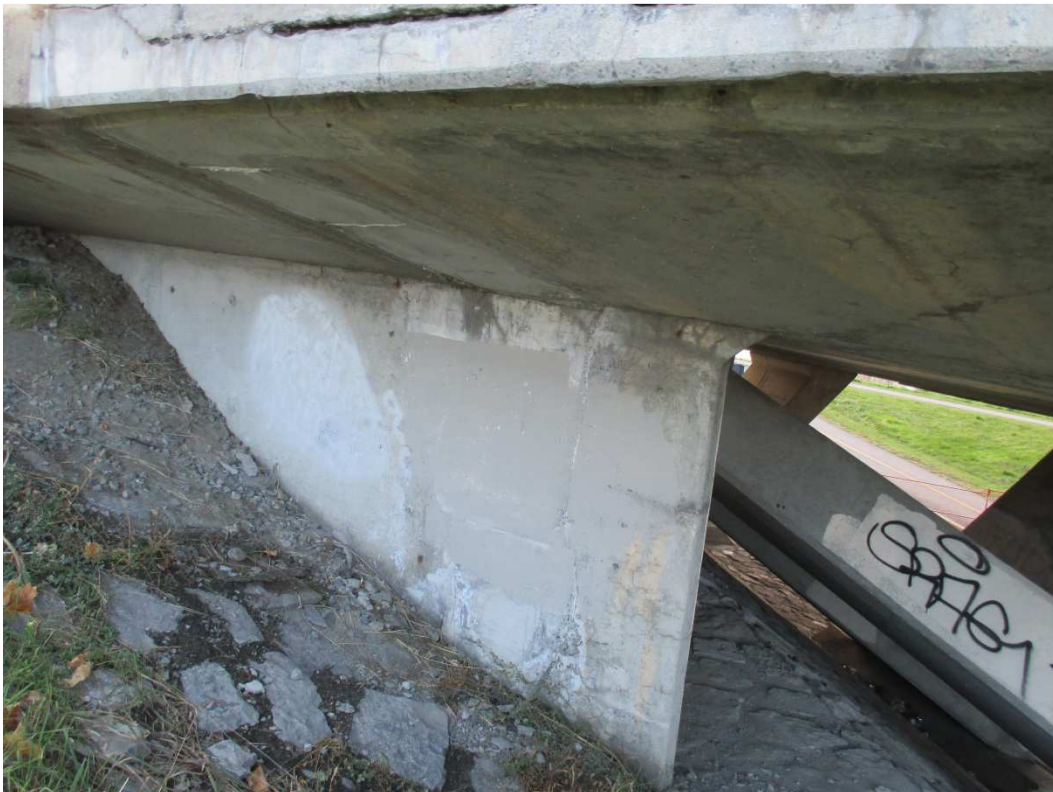
Photo 16: West wingwall

The exposed parts of wingwalls are in good condition.

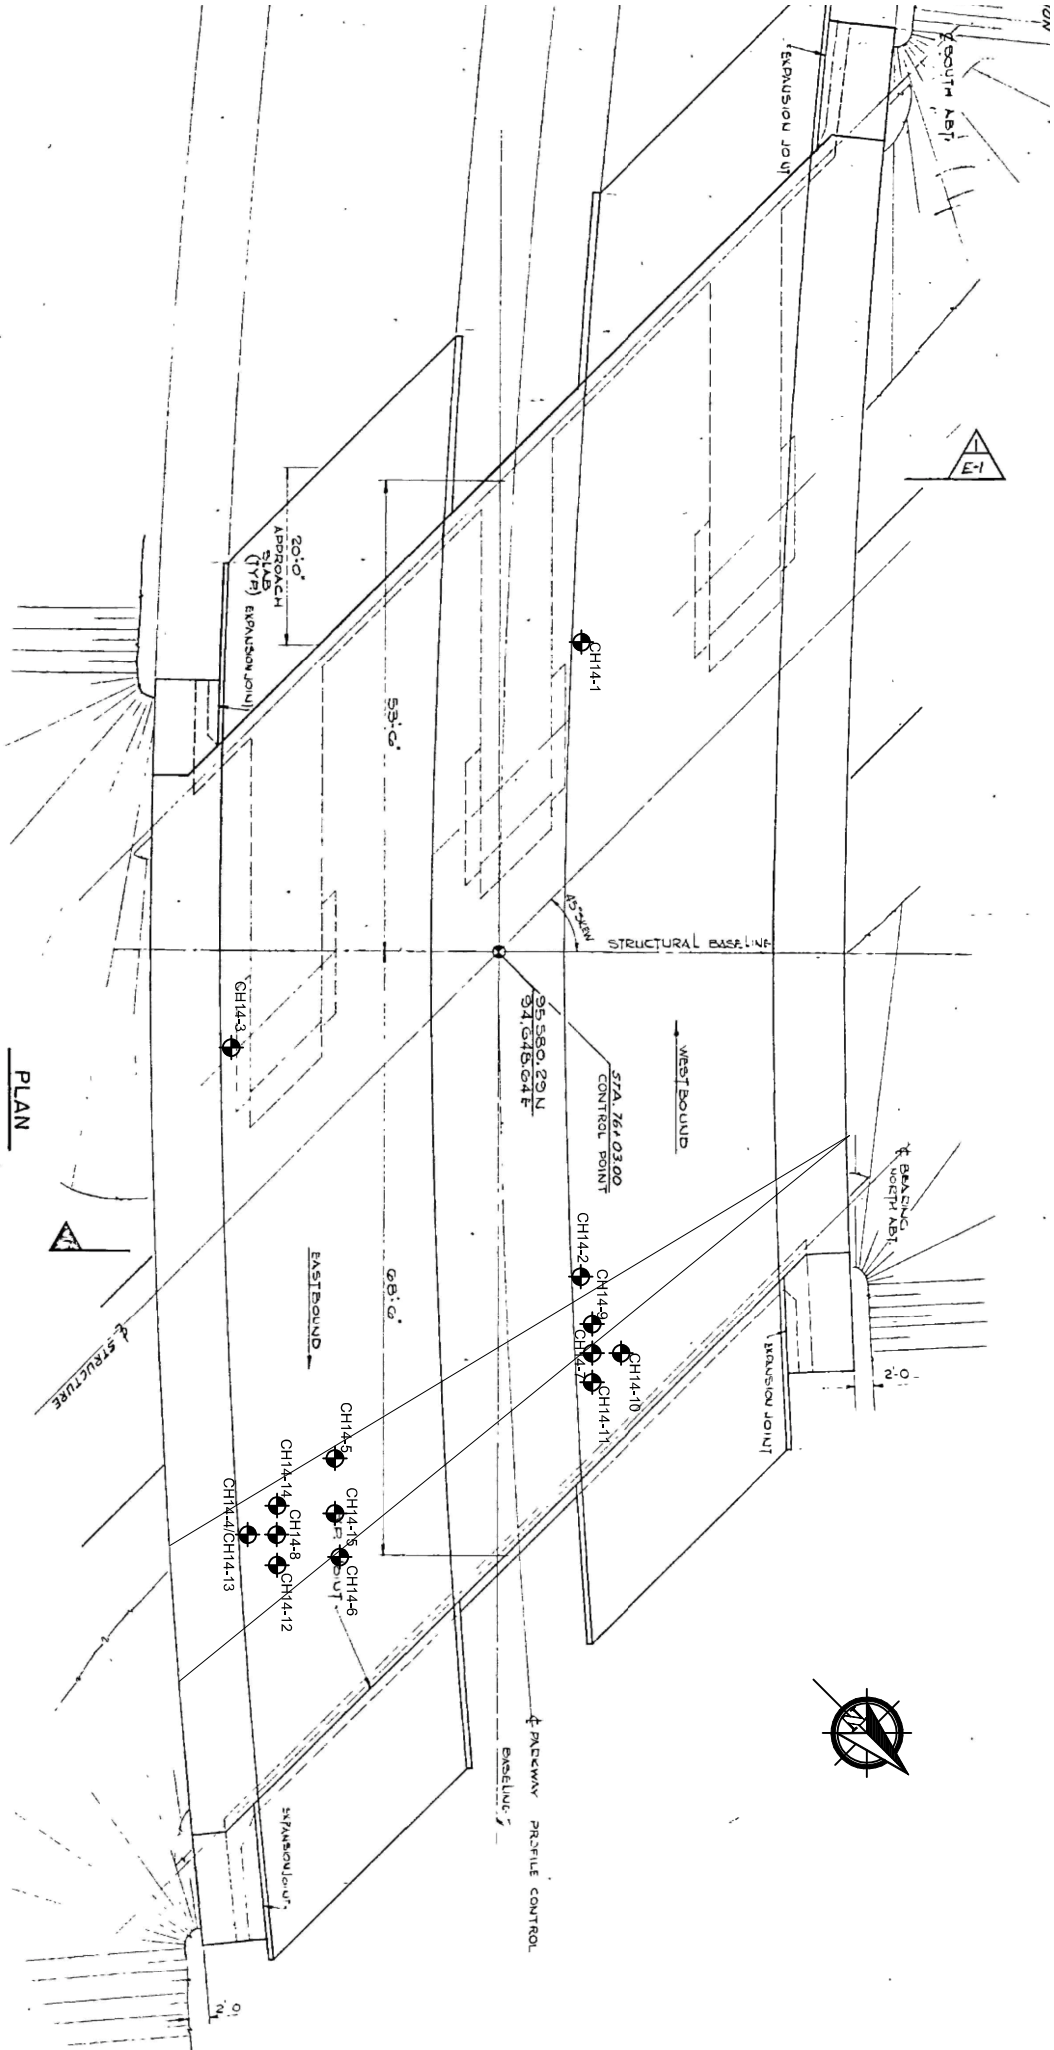
Two cores (CH14-8 and CH14-7, located on the eastbound and westbound side of the bridge, respectively) were advanced through the full depth of the bridge. At CH14-7 on the north side of the median, the concrete deck was found to be 410 mm thick (not including the asphalt above). At CH14-8 on the south side of the bridge, the concrete deck was found to be 510 mm thick.

Eastbound Lane				
CORE #	DISTANCE FROM EASTERN EXP. JOINT	DISTANCE FROM MEDIAN (EDGE/CURB)	ASPHALT	CONCRETE
4	9.3 m (W)	7.0 m (S)	118 mm	--
5	9.1 m (W)	3.8 m (S)	145 mm	--
6	5.5 m (W)	3.7 m (S)	165 mm	--
8	8.5 m (W)	5.9 m (S)	0 - 165 mm	165 mm - 675 mm
12	7.4 m (W)	5.9 m (S)	170 mm	--
13	9.4 m (W)	7.0 m (S)	170 mm	--
14	9.5 m (W)	6.0 m (S)	155 mm	--
15	7.2 m (W)	3.8 m (S)	160 mm	--

Asphalt cores at 13 locations in the sag region revealed asphalt thickness varying from 92 mm to 140 mm in the westbound lanes and 118 mm to 170 mm (2 lifts asphalt paving plus waterproofing system) in the eastbound lanes. The asphalt thickness in the south span (without sag) is around 90 mm (the original design thickness was 76 mm).

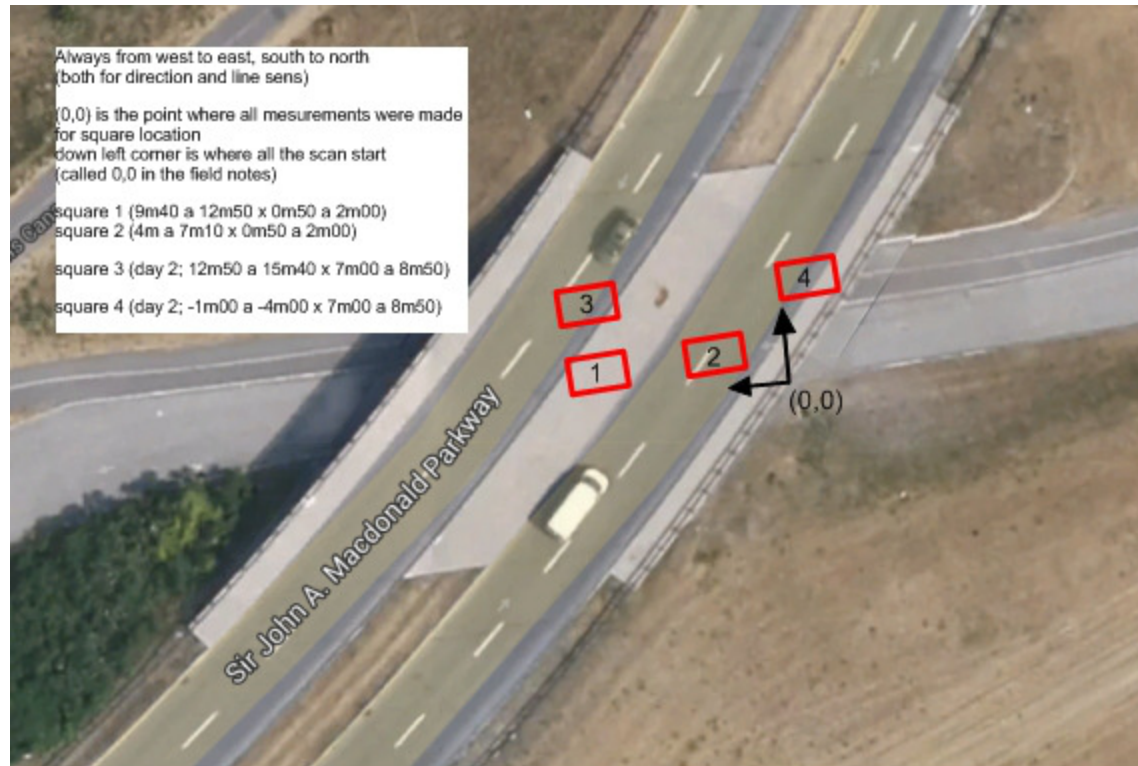
Figure 2: Scan Areas under the bridge

Data was also collected at four locations using a cherry-picker lift on the underside of the bridge (Figure 2). Two of those locations were in the middle of the long span directly under the bike path. There was a scan under the westbound lanes and another under the eastbound lanes that produced identical results as shown in Figure 6. Figure 7 shows the regions where data was collected overlaying an image provided by the National Capital Commission. There is reinforcing steel that is only 2 or 3 cm deep and the Type A cables that are precisely 9cm deep or 3.5 inches.

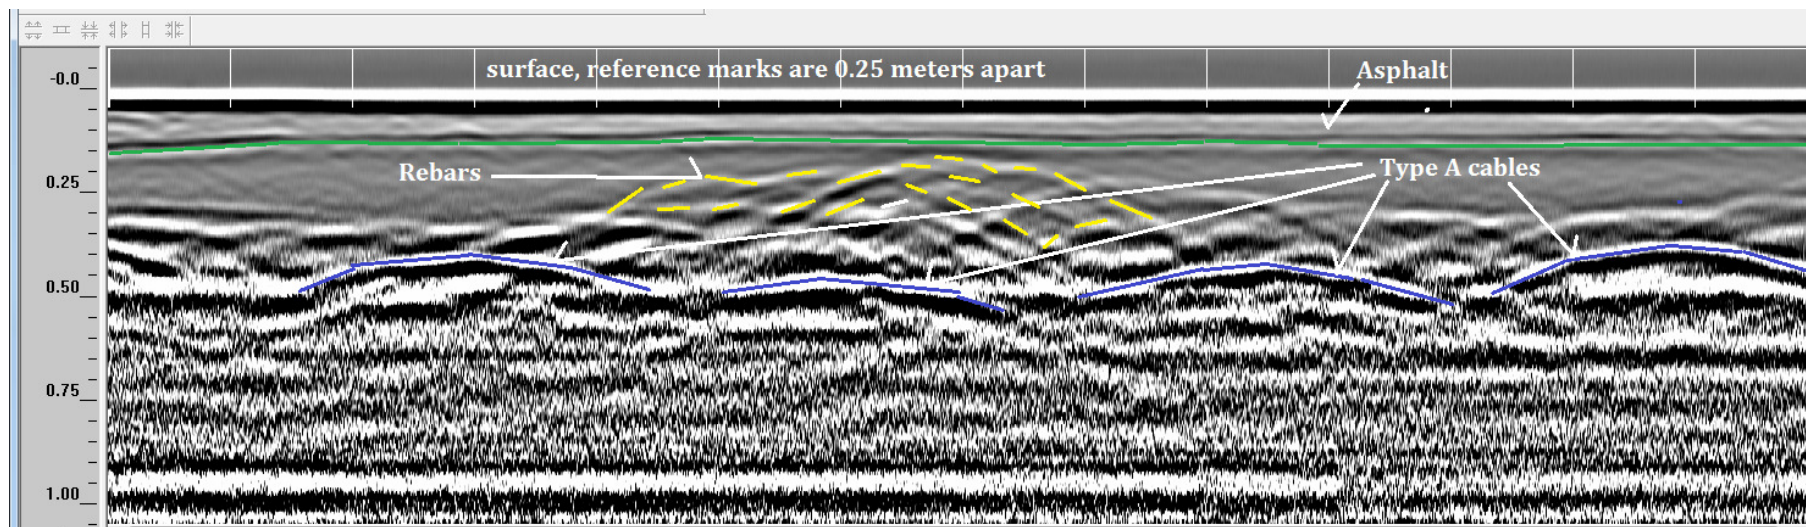
Figure 3: Example Radar image on the surface of the Sir John A. MacDonald Pkwy Bridge.

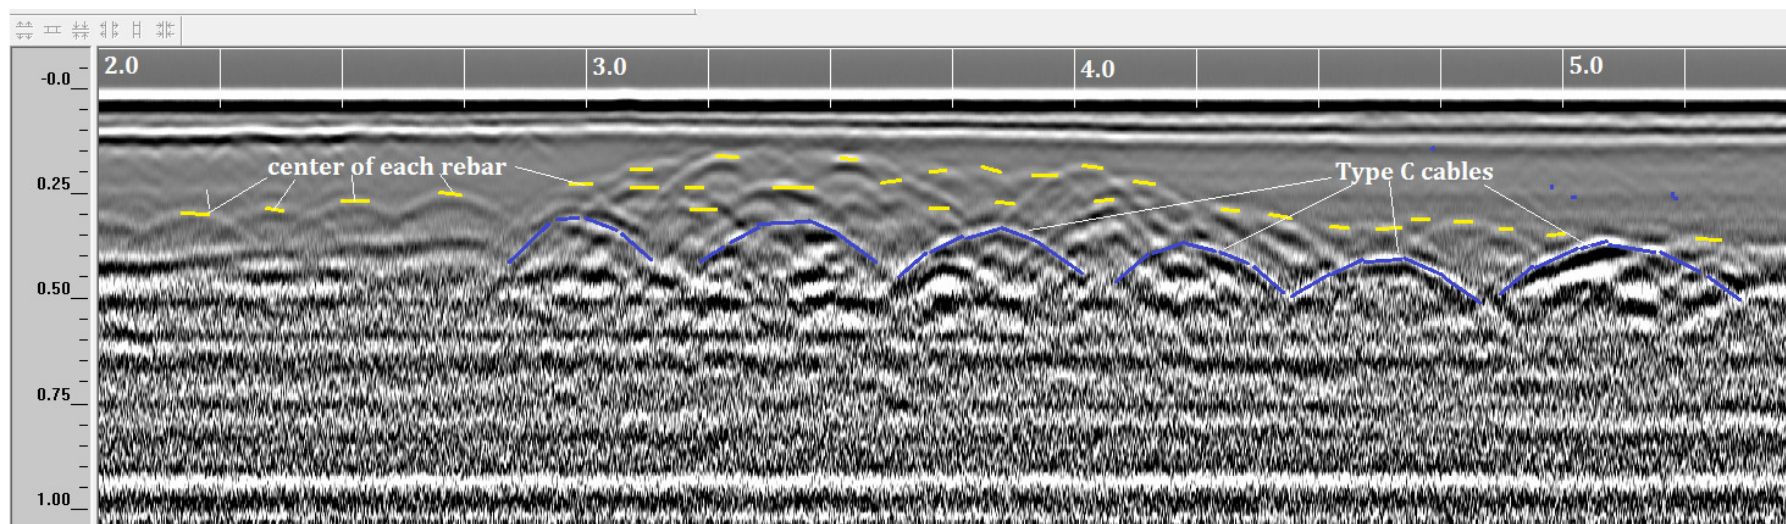
Figure 4: Example Image collected on one portion of Lane 2, highlighting Type C cables.

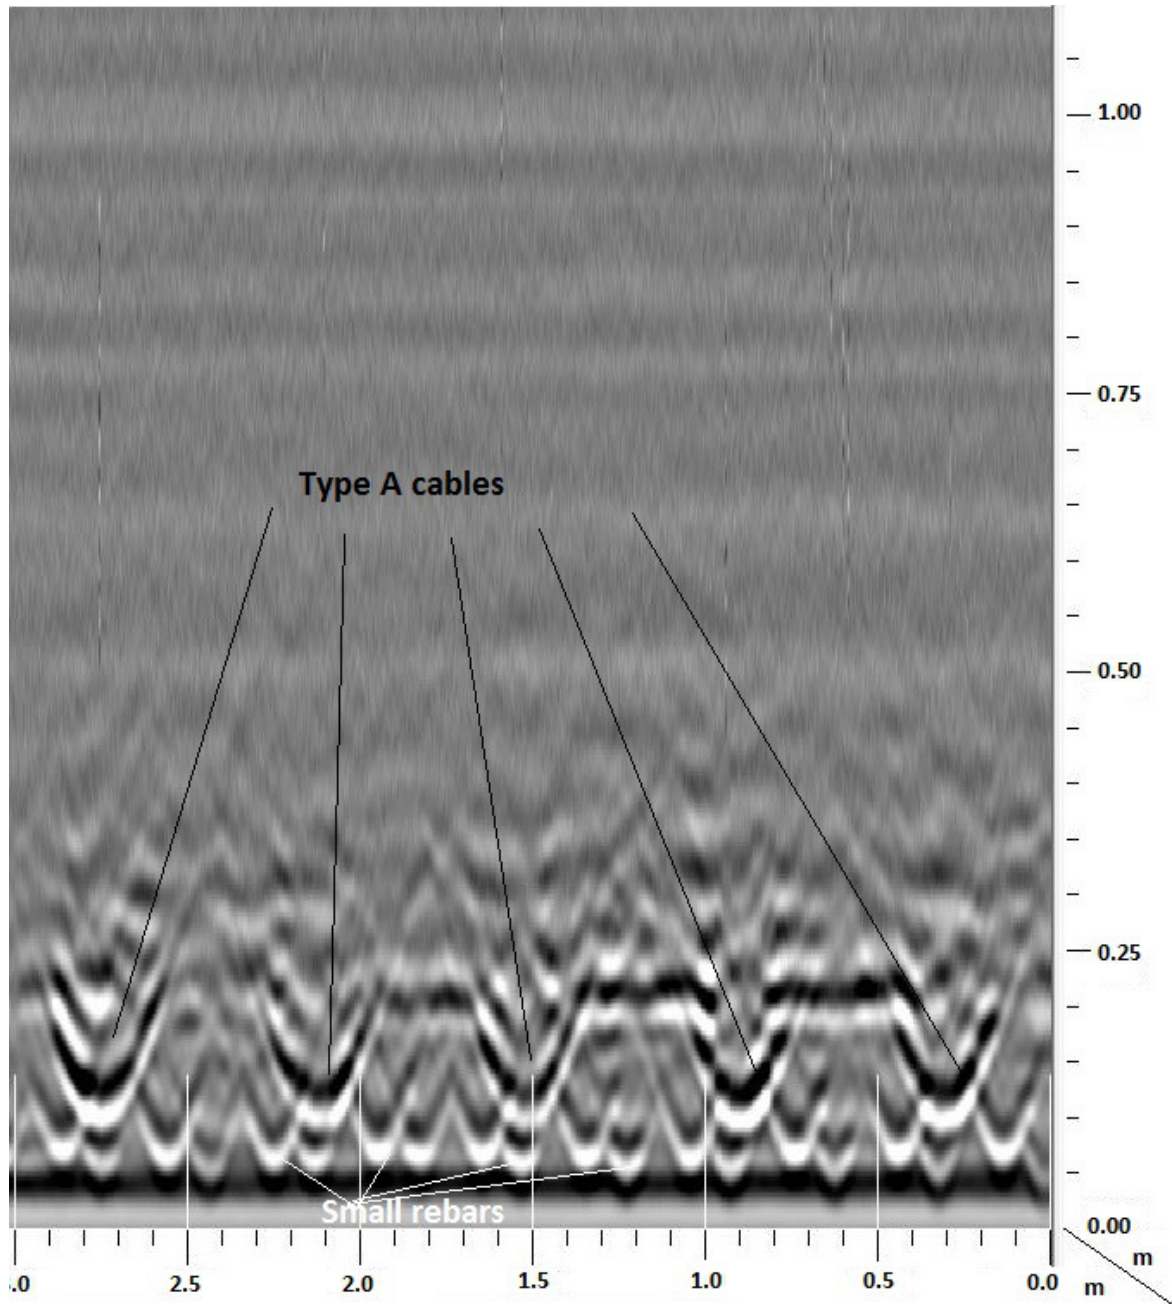
Ground Penetrating Radar scans in the sag region of the bridge identified post-tensioning ducts at 90 mm from the soffit of the bridge deck at approximately 600 mm spacing. These findings are consistent with the dimensions shown on the design drawings, providing confirmation that the relative position of the post tensioning tendons was not compromised. Details of the investigation are provided in Appendix F.

Figure 6: Example section collected under the westbound lanes. The Type A cables are precisely 9cm deep (3.5 inches) and 2 feet apart.
