# PRELIMINARY ASBESTOS BUILDING MATERIALS MANAGEMENT SURVEY

CENTRE FOR AQUATIC AND ENVIRONMENTAL RESEARCH,  
4160 MARINE DRIVE, WEST VANCOUVER, BC

REAL PROPERTY, SAFETY & SECURITY, FISHERIES AND OCEANS CANADA  
PROJECT NUMBER 171-11570-00  
SEPTEMBER 2017

**Project: Preliminary Asbestos Building Materials Management Survey**

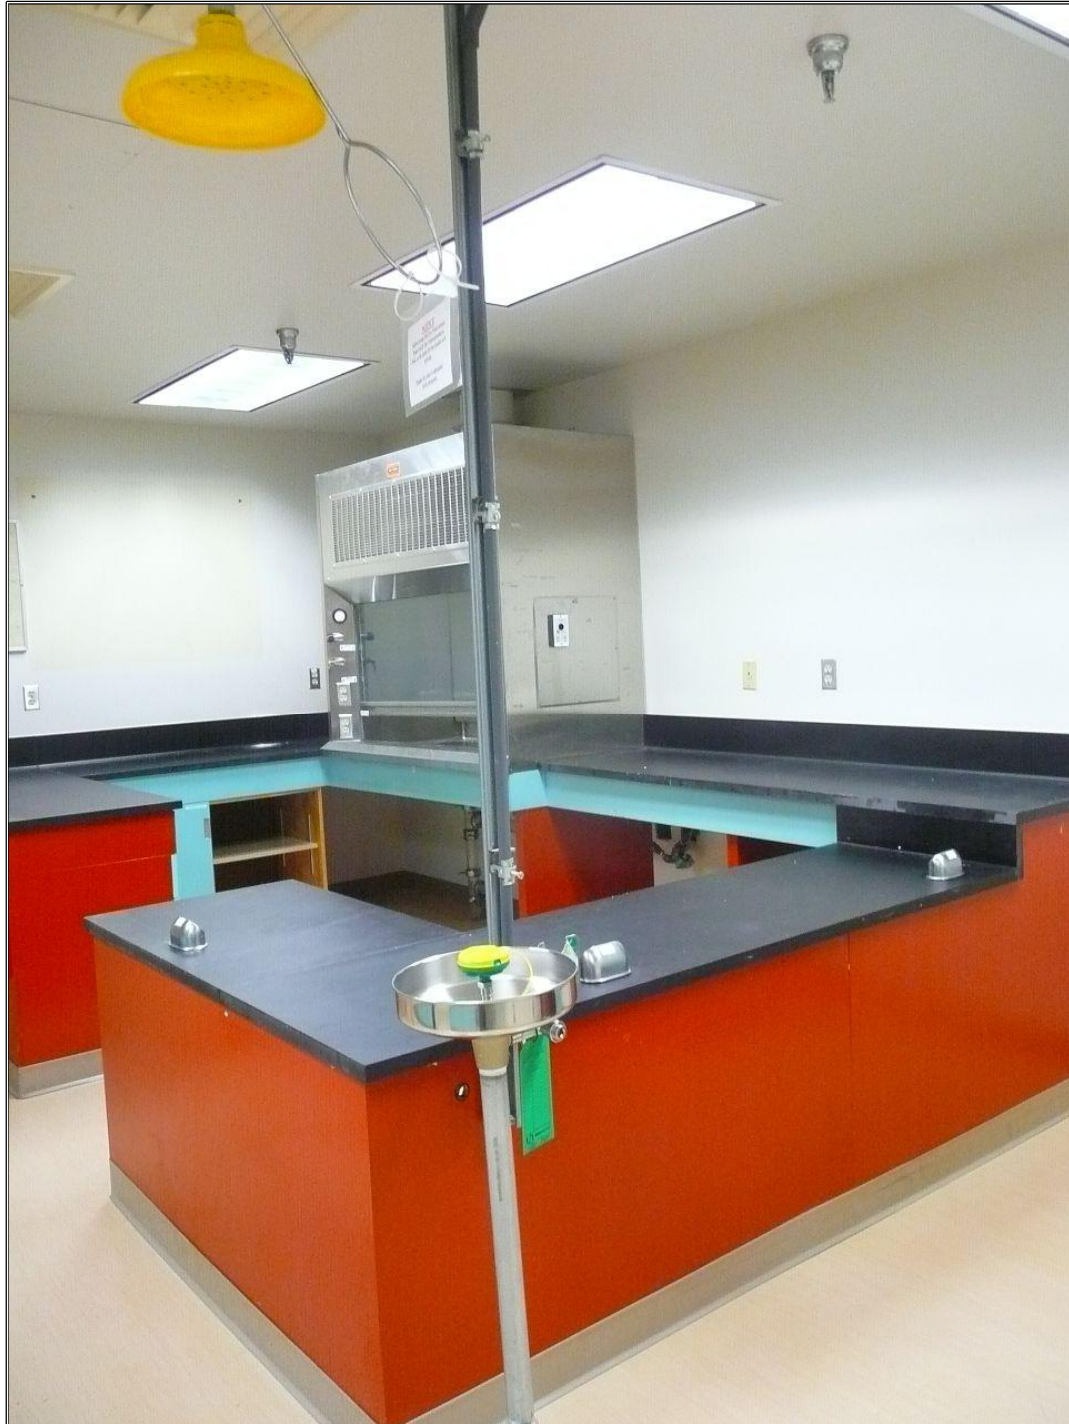
Typical Laboratory - Room 110  
Vinyl Sheet Flooring, Laboratory Counter Top,  
Painted Drywall Walls and Drop Ceiling with Drywall Joint Compound, and Vent Hood.

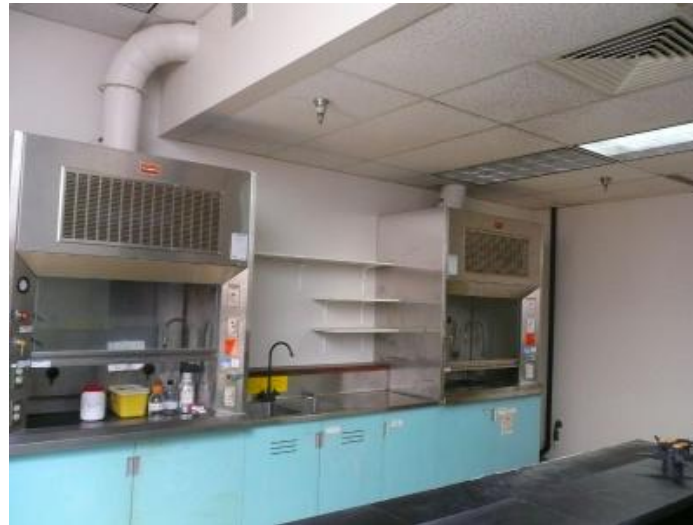
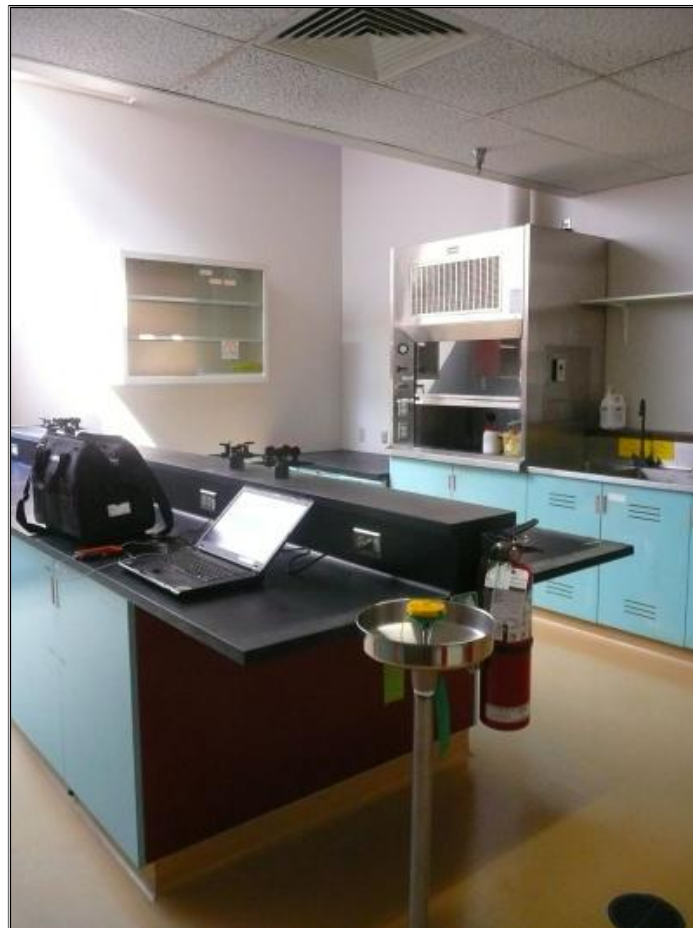
Typical Laboratory - Room 104

Vinyl sheet flooring, Pliable Baseboard Moulding, Laboratory Counter Top,  
Painted Drywall Walls with Drywall Joint Compound,  
Drop Suspended Ceiling Tiles, and Vent Hoods.

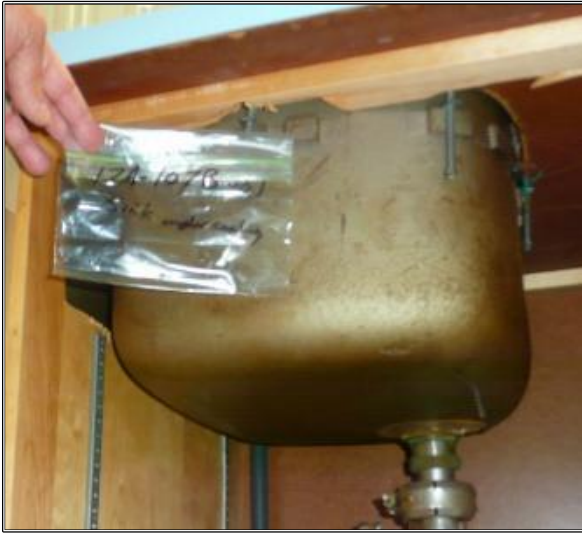
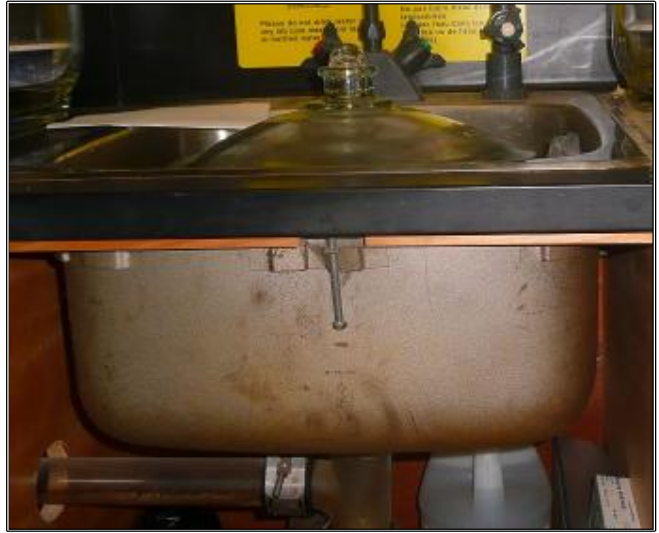
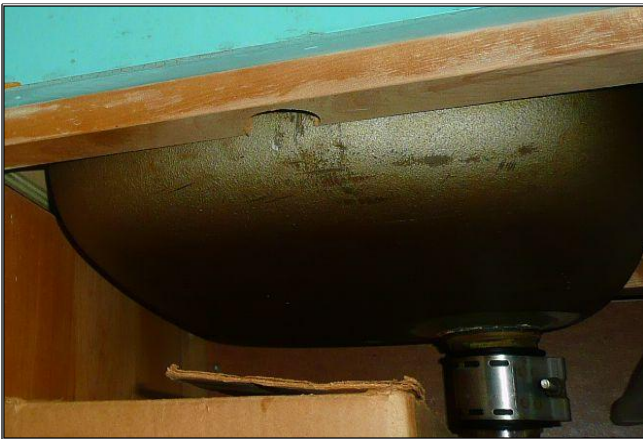
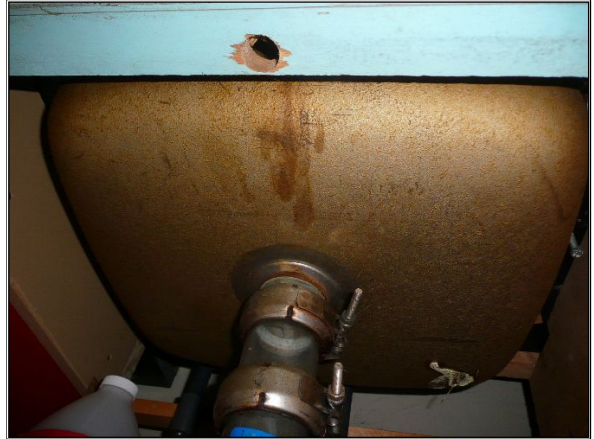
- Laboratory stainless steel sinks, both single and double basins, all with applied mastic like undercoatings → two primary colour variants observed 1.) white, and 2.) bronzy - greenish/silver. **The Sink Undercoating, Bronzy Silver and/or Greenish Silver as sampled in Rooms 107b and 110 and similarly as observed to be present in Rooms 107a, 110b, 125, 127a, 127b, 127c, was determined to be Asbestos-Containing (refer to Section 7.1 below).**

- **The Sink Undercoating, Bronzy Silver and/or Greenish Silver as sampled in Rooms 107b and 110 and similarly as observed to be present in Rooms 107a, 110b, 125, 127a, 127b, 127c, and 128 are herein extrapolated to be Asbestos-Containing (PC 1.1 – 10% Chrysotile).**

Sinks with Bronzy Silver and/or Greenish Silver Undercoating as sampled in Rooms 107b and 110 and similarly as observed to be present in Rooms 107a, 110b, 125, 127a, 127b, 127c, were determined to be Asbestos-Containing.

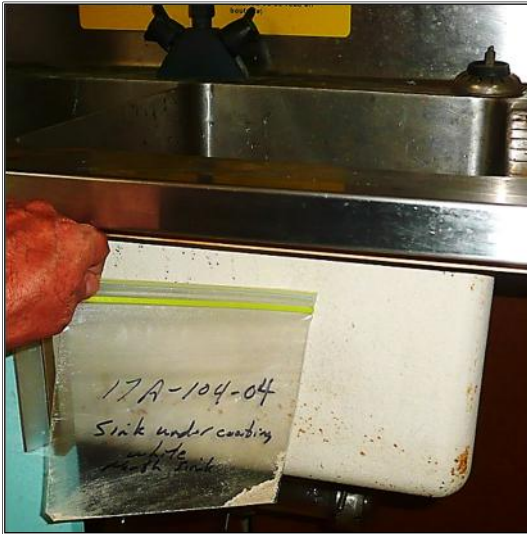
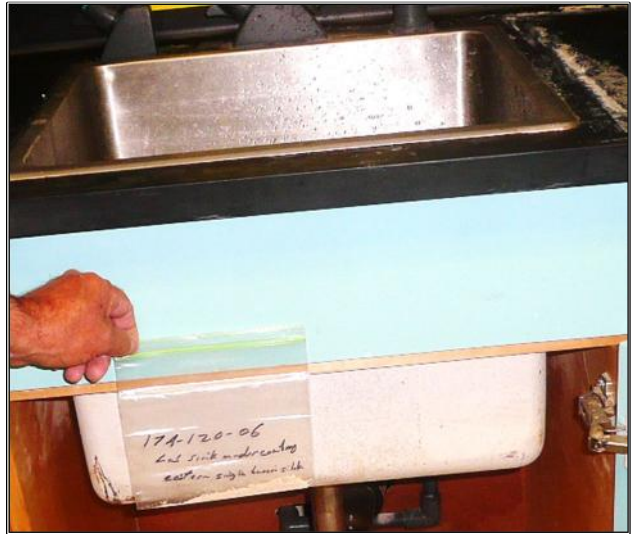
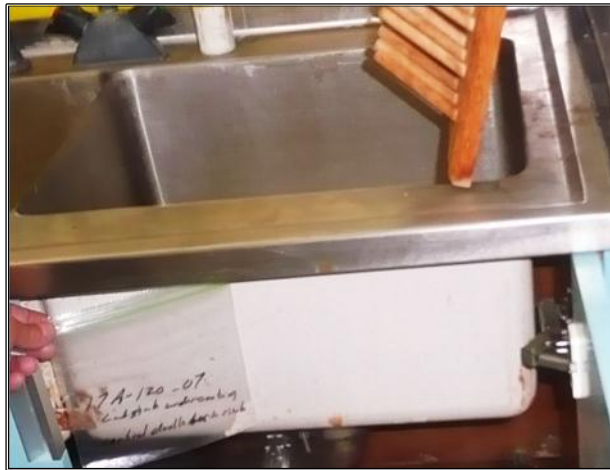
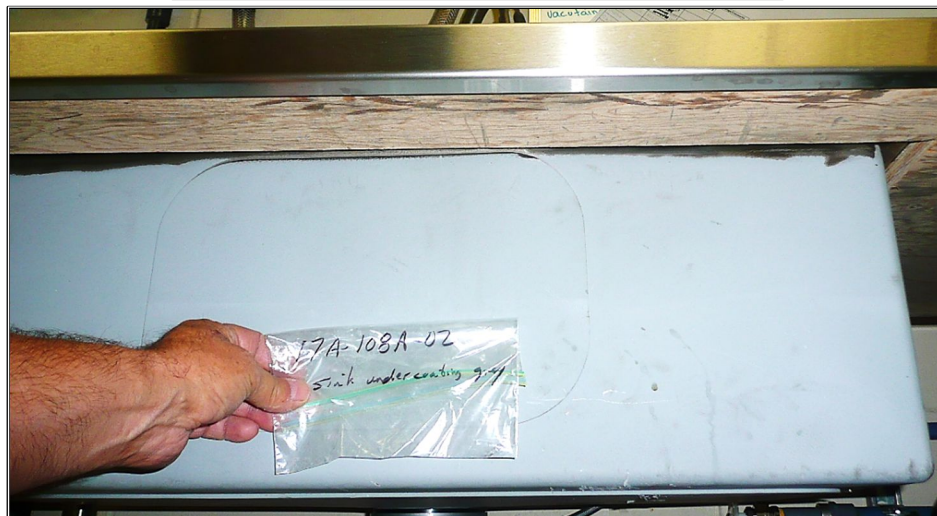
Sinks with White, Off-White and Light Grey Undercoating as sampled were found to be None Detect for asbestos.

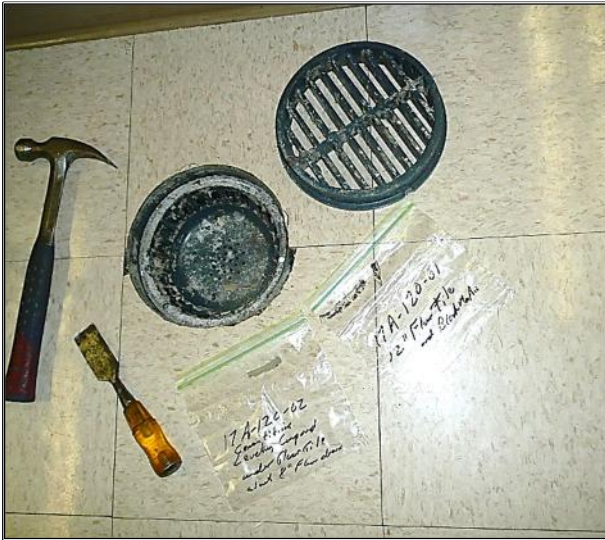
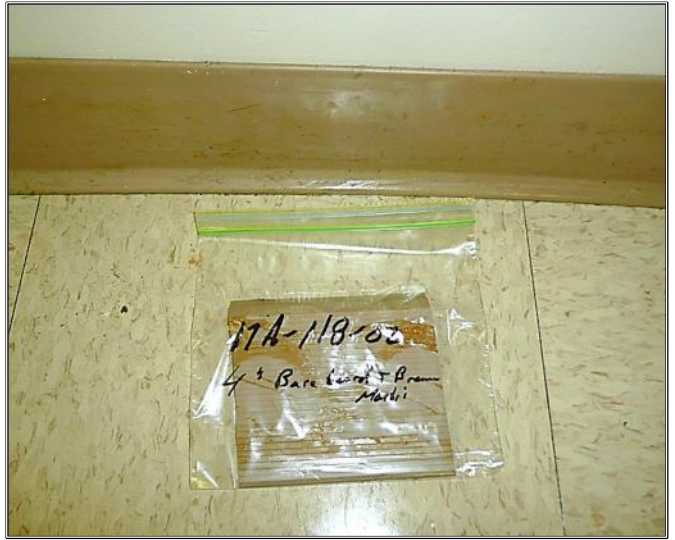
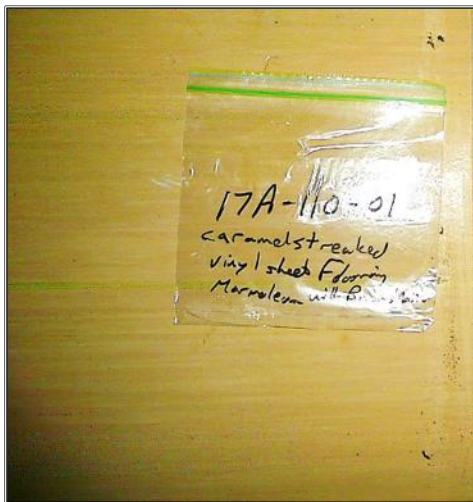
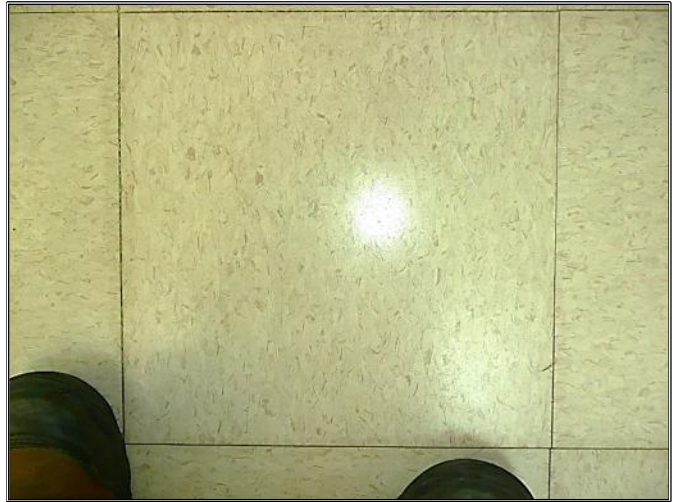
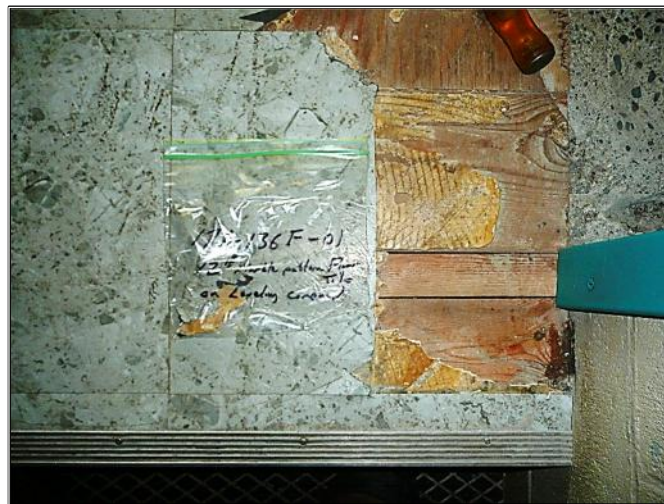
Floor Tile and Vinyl Sheet Flooring  
as sampled were found to be None Detect for asbestos.

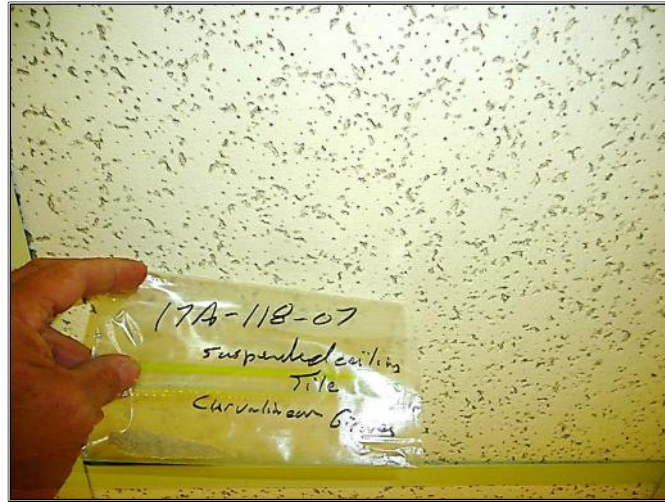
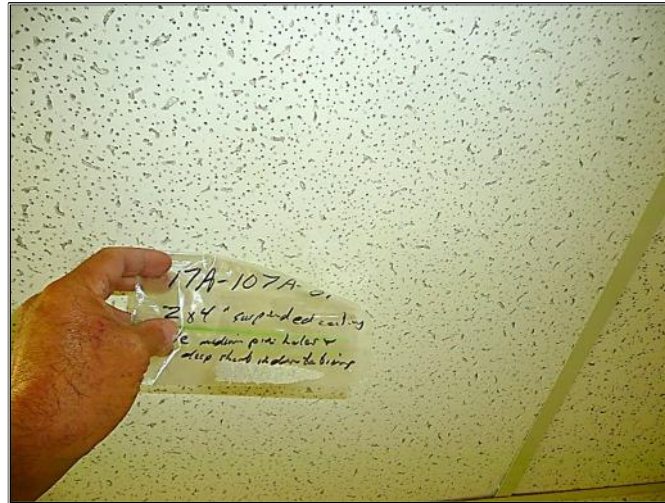
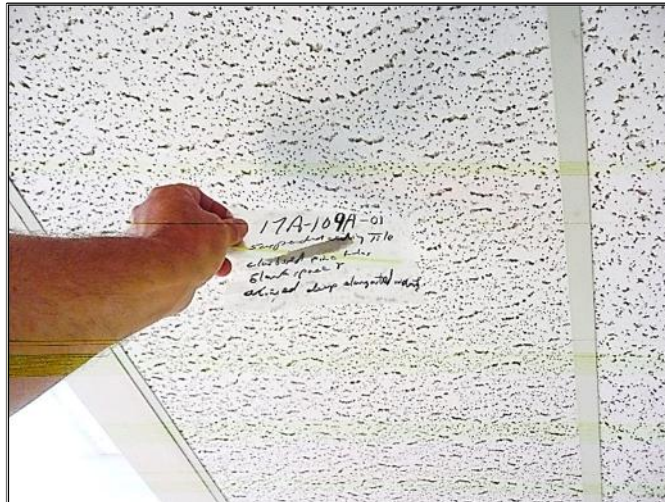
Suspended Ceiling Tiles  
as sampled were found to be None Detect for asbestos.

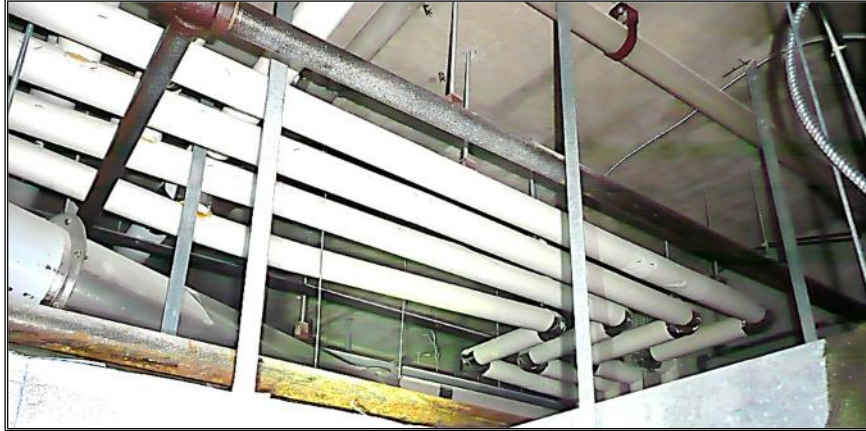
Thermal Pipe Insulation as observed was Modern and Non-Suspect for Asbestos.

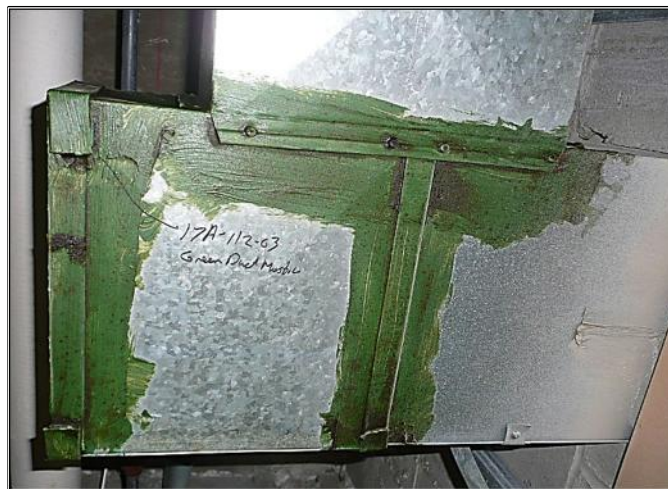
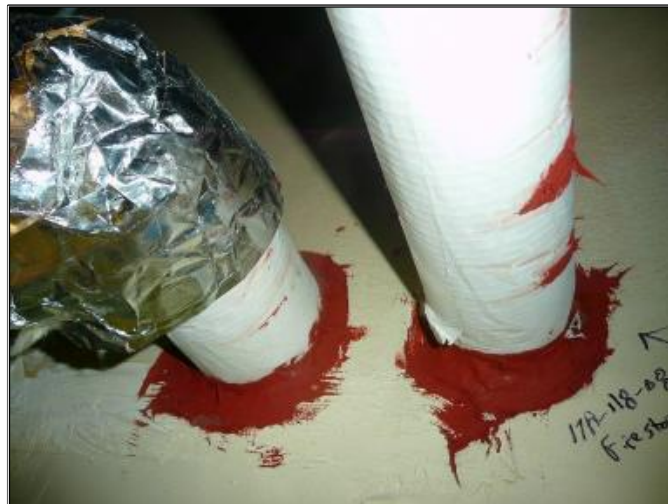
Green Duct Mastic and Red Fire Stop as sampled were found to be None Detect for asbestos.

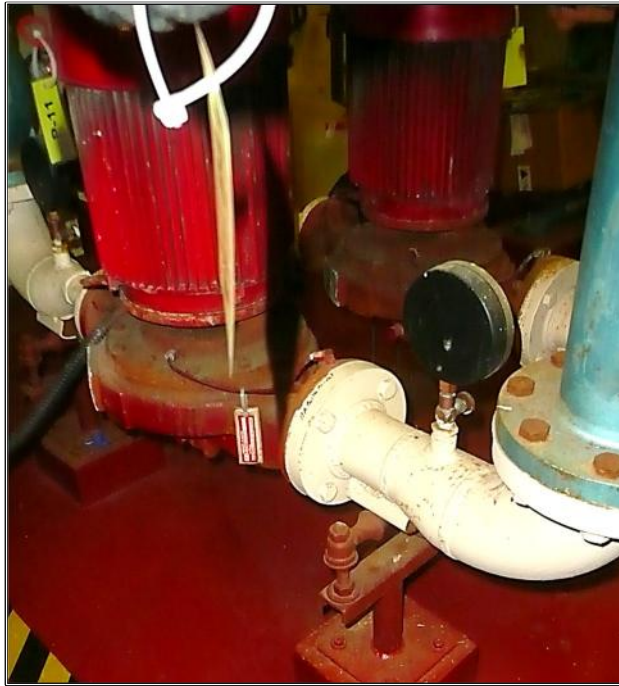
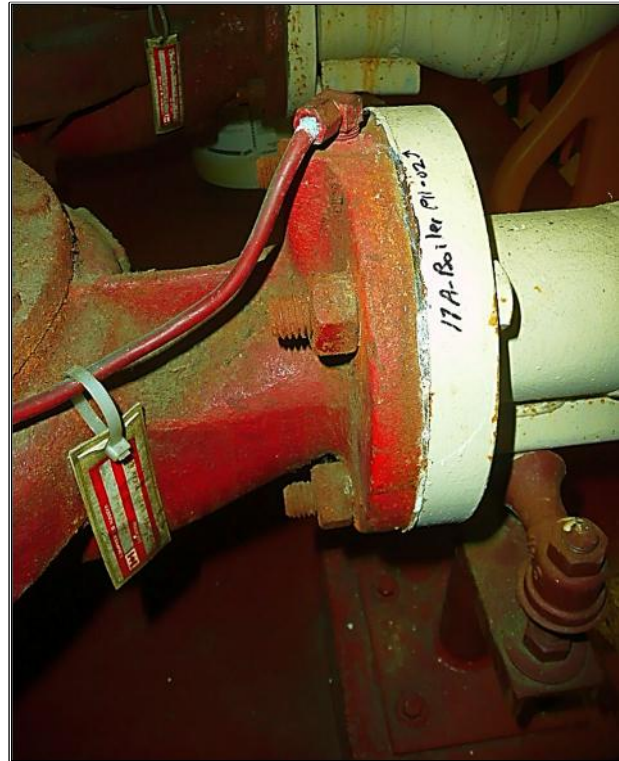
- **The gaskets associated with heat pump connection pipe fittings as observed on the south side of heat Pump P11 in Room 144 Mechanical is herein extrapolated to be Asbestos-Containing (30% Chrysotile).. Associated gaskets and potential internal componentry or packing may also be asbestos containing.**

The gasket associated with heat pump connection pipe fittings as observed and sampled on the south side of heat Pump P11 in Room 144 Mechanical was found to be Asbestos-Containing (30% Chrysotile). Associated gaskets and potential internal componentry or packing may also be asbestos containing.

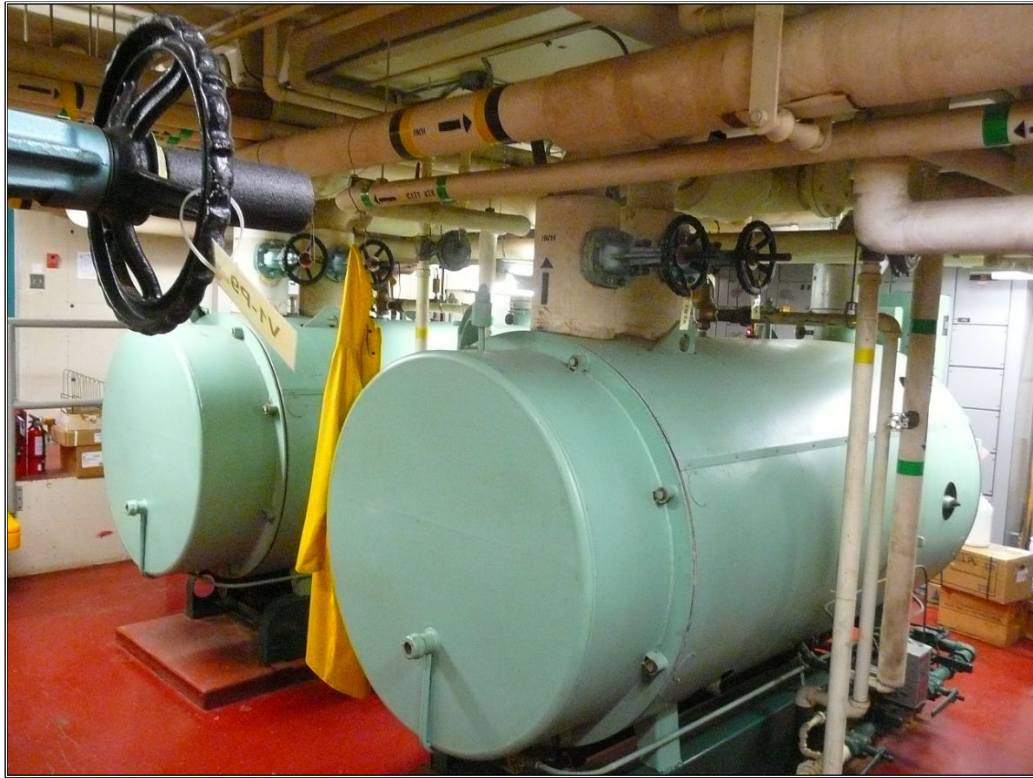
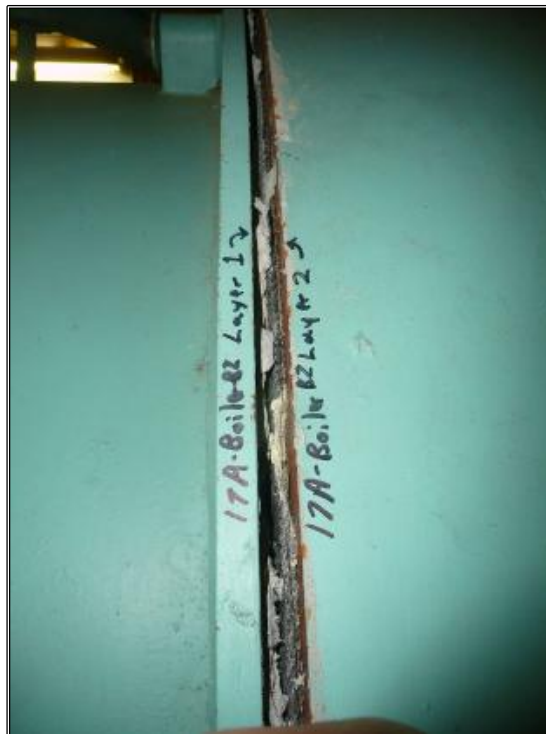
The North End Layered Packing and Gasket associated as observed and sampled on the north end of Boiler B2 in Room 144 Mechanical was found to be None Detected for asbestos.

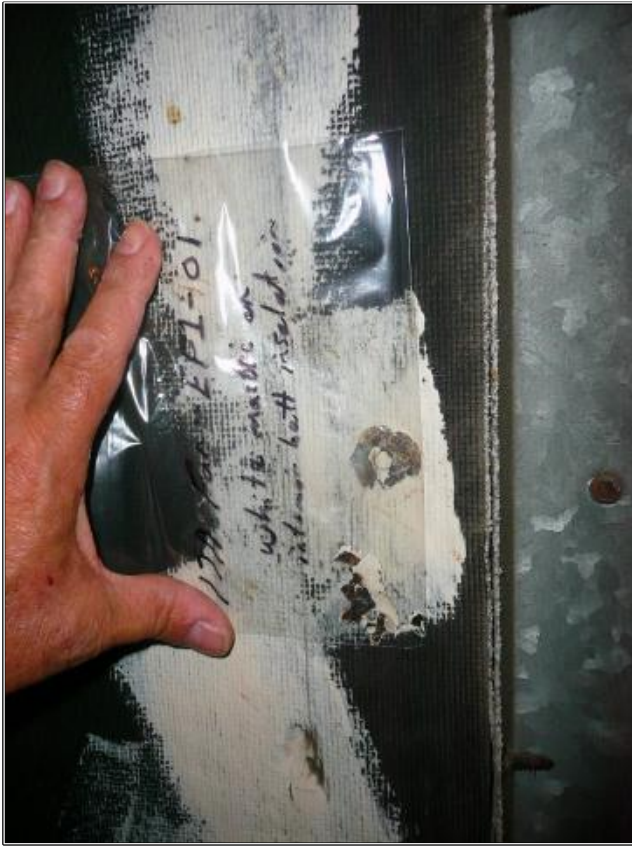
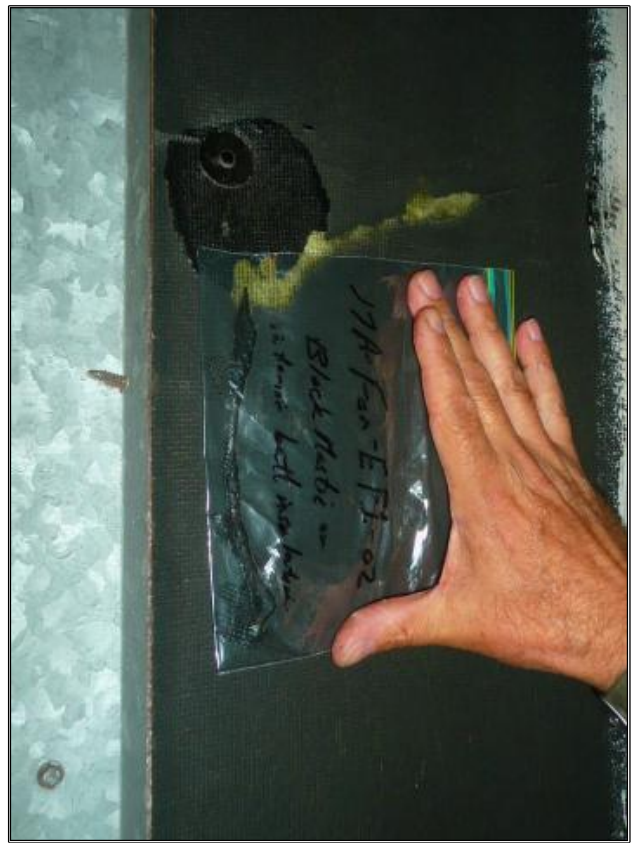
The White and Black Mastics on Interior Batt Insulation as observed and sampled within the Exhaust Fan EFl in the Main Fan Room was found to be None Detected for asbestos.

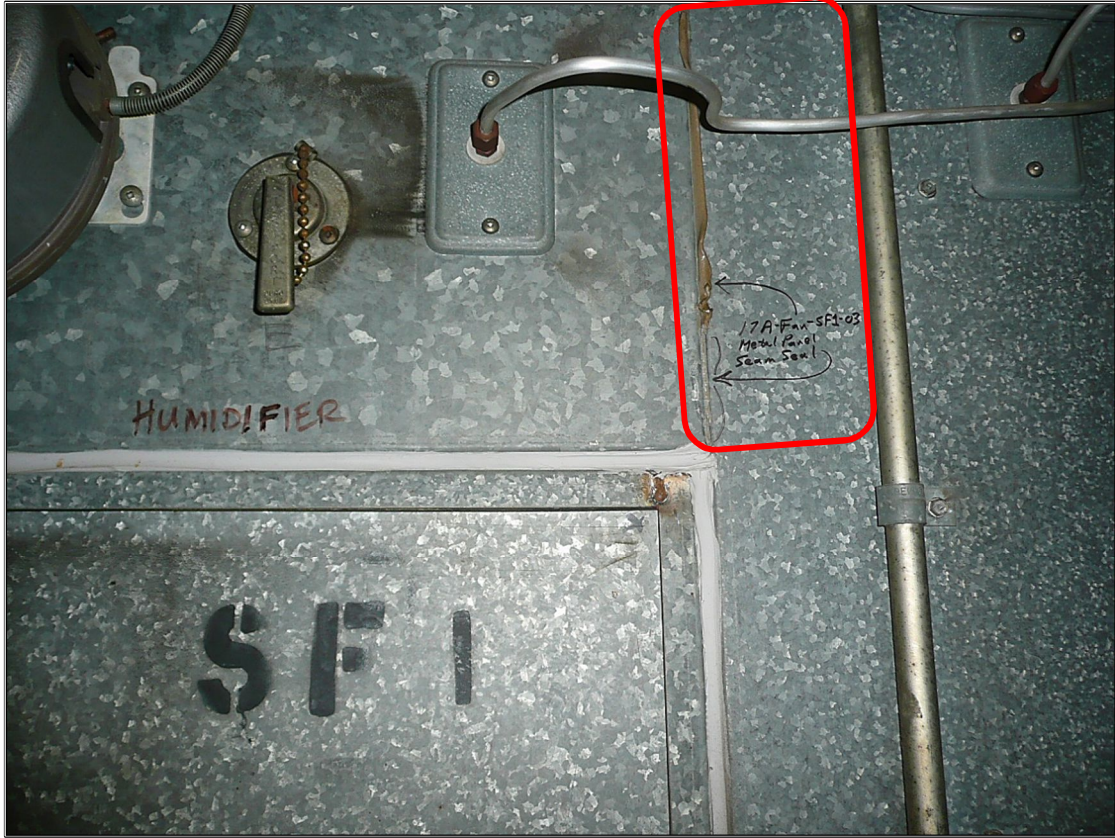
- **The Grey Seam Sealant used between metal panels as sampled and observed on the Exterior Supply Fan SFI above the right corner of the 4th door to the south in the main Fan Room on the second level is herein extrapolated to be Asbestos-Containing (PC 1.8% Chrysotile).**

The Grey Seam Sealant used between metal panels as sampled and observed on the Exterior Supply Fan SFI above the right corner of the 4th door to the south in the main Fan Room on the second level is herein extrapolated to be Asbestos-Containing (PC 1.8% Chrysotile).

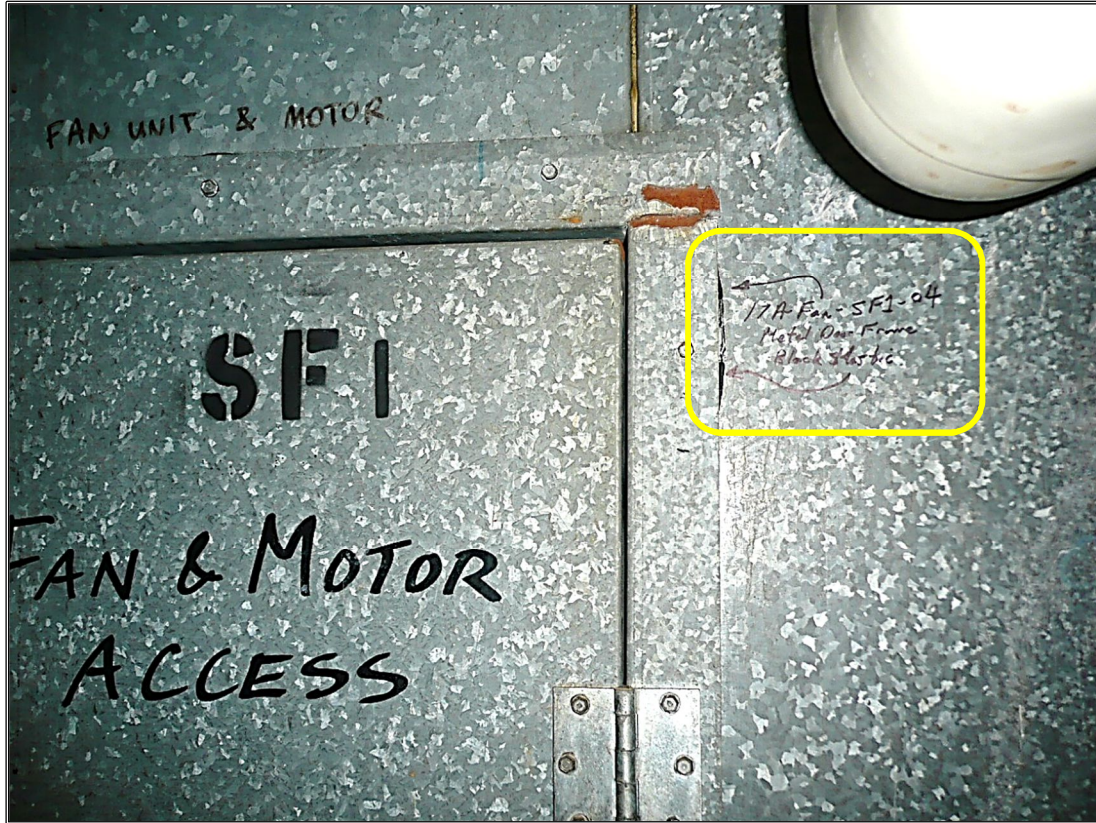
The Black Mastic from under the door edge as sampled and observed on the Exterior Supply Fan SFI Upper Right Door Frame 5th Door to the South was found to be None Detected for asbestos.

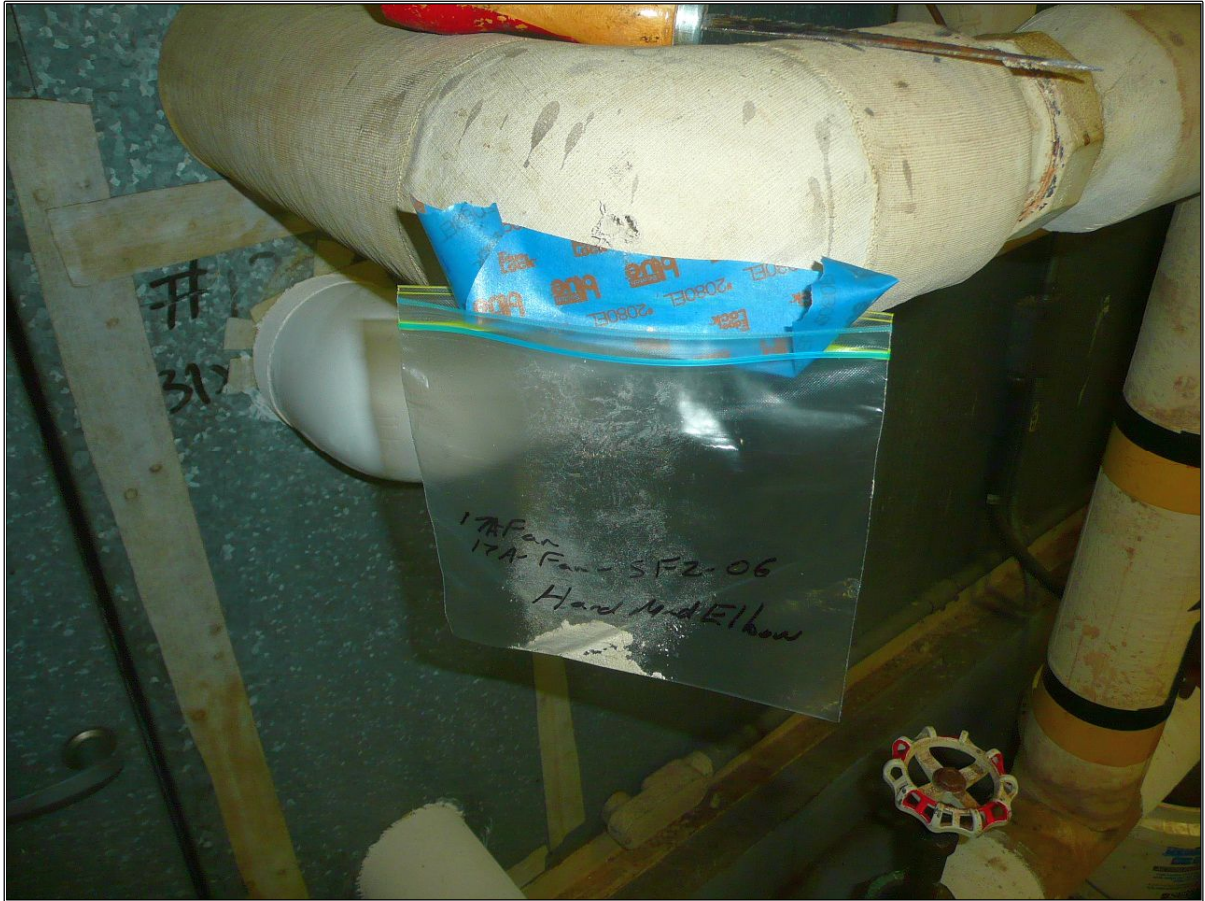
The Thermal Pipe Insulation Hard Mud Elbow as sampled and observed on the North Supply Fan SF2, near 2nd Door to the West was found to be None Detected for asbestos.
