Appendix "B"

Seal Cove Timber, Sediment Samples & Probes

Report Writer: Brandon Sparkes

Date: September 24th 2018

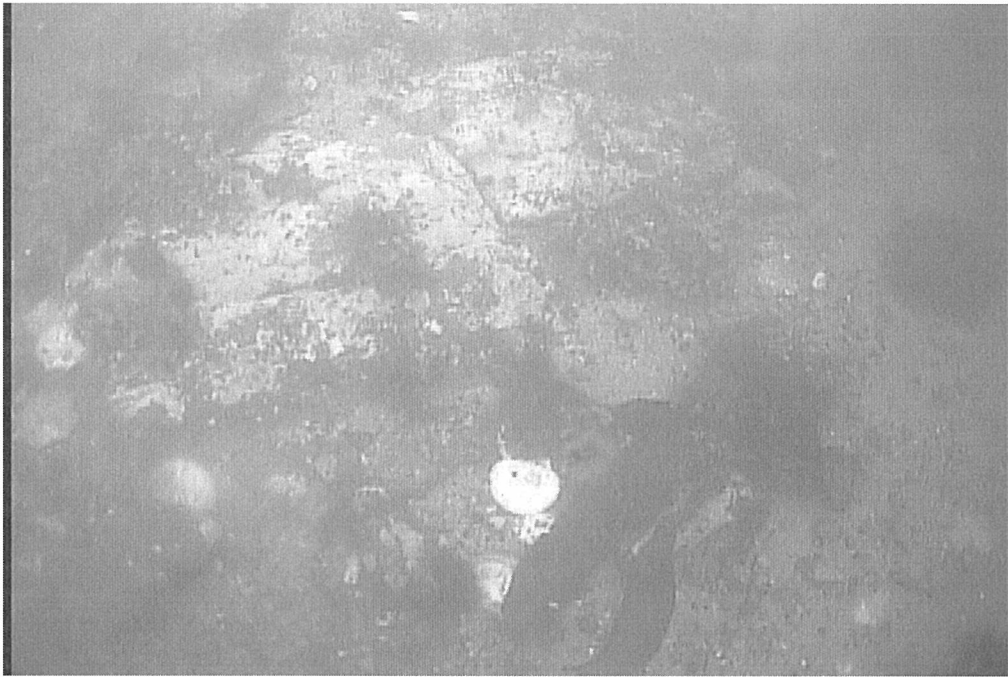
A outcrop of bedrock that was seen near the seaward end of the wharf on the north side.

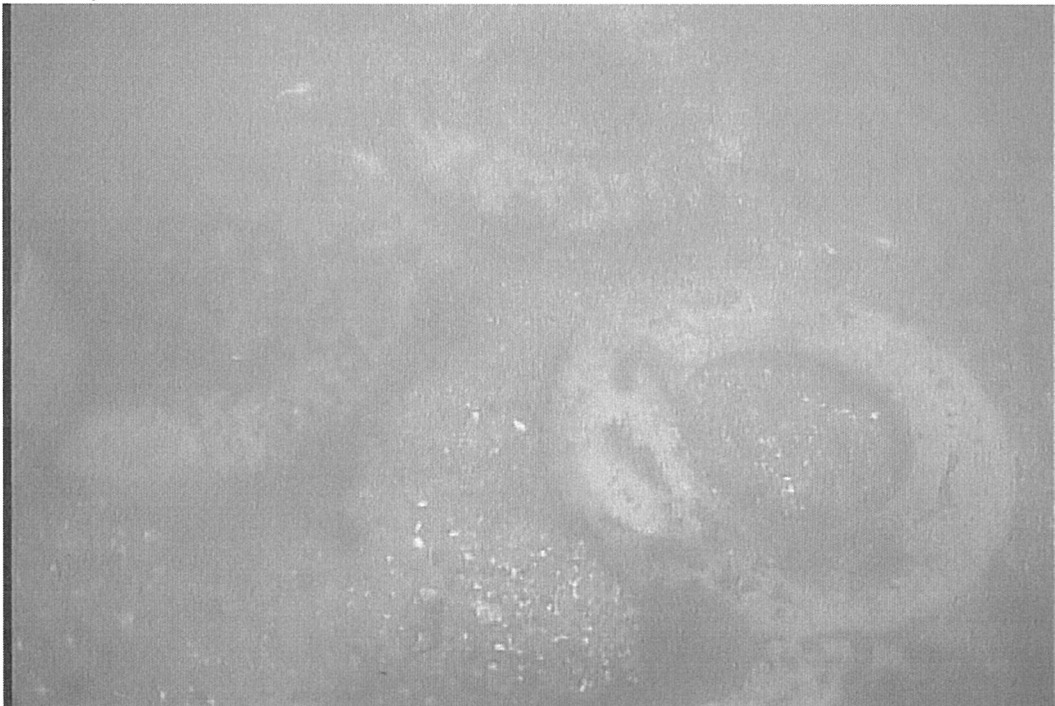
A large amount of tires were seen during the probes, mainly on the south side. There was 20+ large tires on the seabed on the south side.

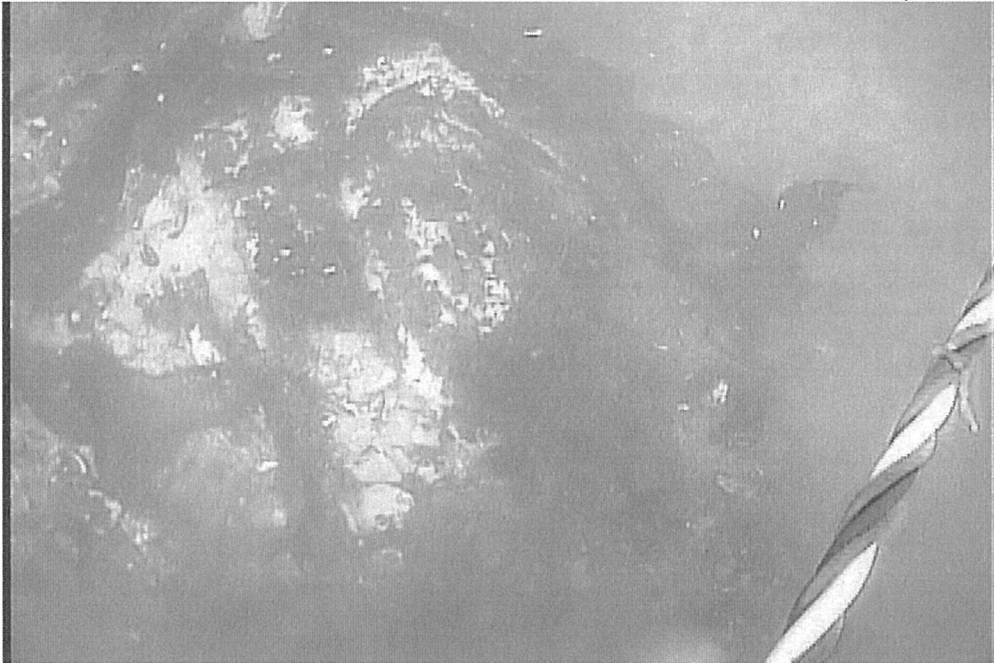
Another outcropping of bedrock on the north side near the seaward end of the wharf.
