**Factual Geotechnical Report
Proposed Rehabilitation
Structures 401 & 402**

Lameque Wharf, New Brunswick

February 27, 2018
Project: 10456.73

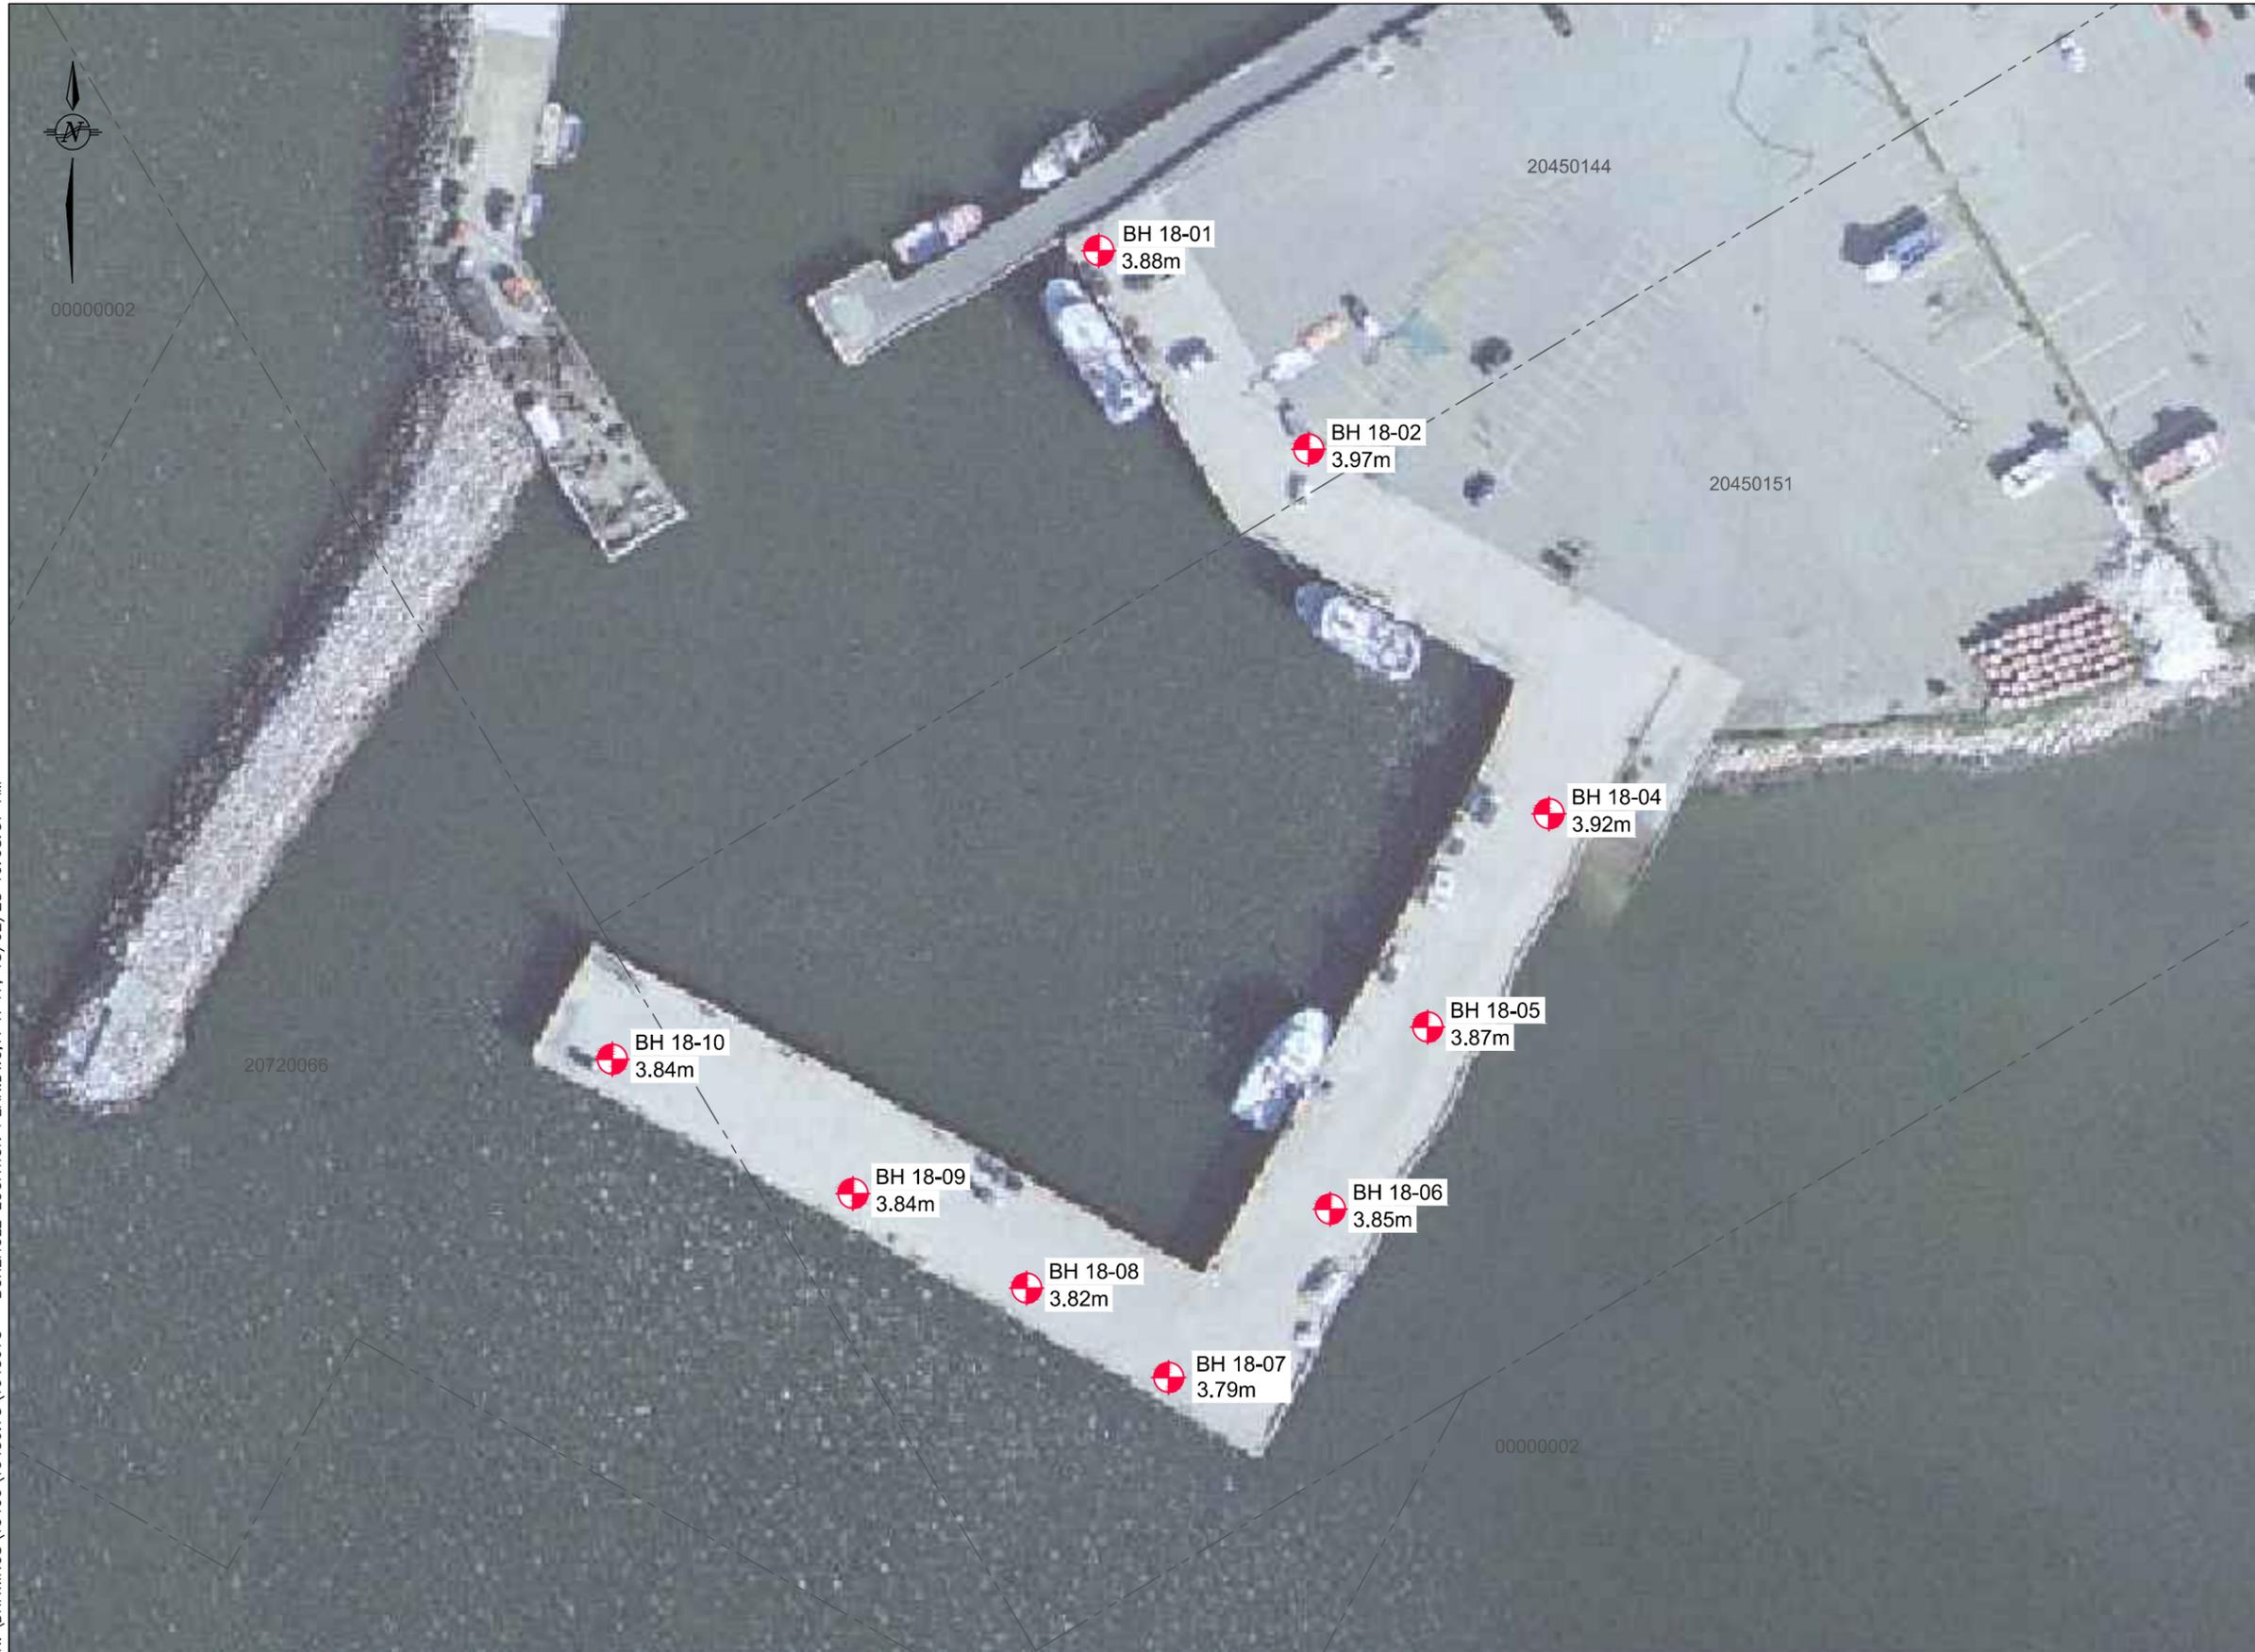
BOREHOLE LOCATION PLAN

A borehole location plan showing site features is included in Appendix A.

Nine boreholes (BH18-01 to BH18-10, excluding BH18-03) were advanced at the site between February 5 and 13, 2018 in the presence of GEMTEC geotechnical personnel. Due to ice cover at the time of investigation and the deteriorating condition of the wharf, boreholes could not be advanced from a barge nor advanced over the edge of the structure into the harbour. Therefore, boreholes were advanced through the existing concrete deck at structures 401 and 402. Borehole locations were selected by GEMTEC based on access and site features.

A site and borehole location plan is presented in Appendix A. Descriptive terms and detailed borehole logs are appended (Appendix B). Laboratory testing results are included in Appendix C and select site photos are presented in Appendix D.

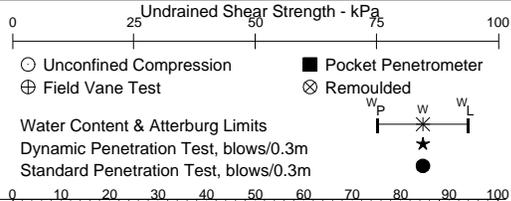
Client	Public Works & Government Services Canada	Proj No.	10456.73	BOREHOLE BH18-01 Page 1 of 1
Project	Geotechnical Investigation	Date Drilled	13.Feb.2018	
Location	Lameque Wharf, Lameque NB

DEPTH m	SAMPLE				LOG	DESCRIPTION	
	No	TYPE	N (RQD)	REC (mm)			
0						0.10 ASHPHALTIC CONCRETE 3.78	
						p.30 FILL 3.58	
						Red to brown sand and gravel Sandstone fill, weak	
1							
2							
3							
4							
5	1	S	9	175			
6							
6	2	S	7	250			
7							
7	3	S	8	400		6.85 -2.97	
						7.01 SAND and SILT -3.13	
						Grey to black sand and silt, some shells	
						GLACIAL TILL	
						Red to brown silty sand and gravel, trace	
						7.87 clay -3.99	
8	5	HQ	30	1473		SANDSTONE BEDROCK	
						Grey fine-grained sandstone bedrock	
9						8.71 -4.83	
						MUDSTONE BEDROCK	
						Red to brown mudstone bedrock	
10	6	HQ	58	1520			
11							
11	7	HQ	50	1520			
12							
						12.34 -8.46	
						End of borehole at 12.3 metre below existing top of deck

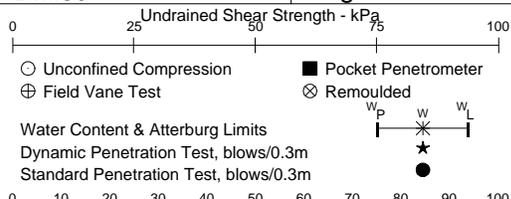
Client	Public Works & Government Services Canada	Proj No.	10456.73	BOREHOLE BH18-02 Page 1 of 1
Project	Geotechnical Investigation	Date Drilled	13.Feb.2018	
Location	Lameque Wharf, Lameque NB

DEPTH m	SAMPLE				LOG	DESCRIPTION
	No	TYPE	N (RQD)	REC (mm)		
0					0.10	ASPHALTIC CONCRETE 3.87
					p.30	FILL 3.67
						Red to brown sand and gravel Sandstone fill, weak
1						
2	1	S	19	200		
	2	S	15	150		
3						
	3	S	3	150		
4	4	S	5	100		
5	5	S	6	200		
	6	S	6	300		
6						
	7	S	8	150		
7	8	S	6	450		
					7.31	-3.34
	9	HQ	0	200	7.57	-3.60
	10	HQ	83	1520		
						SAND and SILT Grey to black sand and silt, some shells
						MUDSTONE BEDROCK Red to brown mudstone bedrock
9						
	11	HQ	73	1520		
10						
	12	HQ	57	1194		
11						
12					12.19	-8.22
						End of borehole at 12.2 metres below existing top of deck

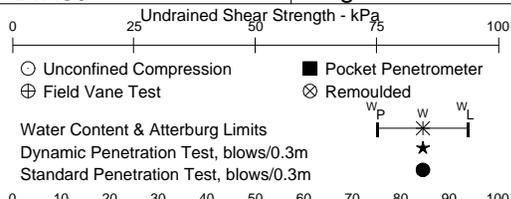
Client	Public Works & Government Services Canada	Proj No.	10456.73	BOREHOLE BH18-04 Page 1 of 1
Project	Geotechnical Investigation	Date Drilled	05.Feb.2018	
Location	Lameque Wharf, Lameque NB

DEPTH m	SAMPLE				LOG	DESCRIPTION	SPT
	No	TYPE	N (RQD)	REC (mm)			
0					0.22 CONCRETE SLAB	3.70	
					0.32 FILL	3.60	
1	1	S	101	100	Red to brown sand and gravel Sandstone fill, weak		
2	2	S	31	400			
3	3	S	16	300			
4	4	S	10	350			
5	5	S	15	375			
6	6	S	6	375			
7	7	S	8	225			
8	8	S	6	400			
6					5.84 SAND and SILT	-1.93	
					6.40 Grey to black sand and silt, some shells	-2.49	
9	9	S	12	200	MUDSTONE BEDROCK		
					Red to brown mudstone bedrock		
10	10	S	87	300			
11	11	HQ	100	305			
12	12	HQ	53	1520			
13	13	HQ	97	1473			
10.84					End of borehole at 10.8 metres below existing top of deck	-6.93

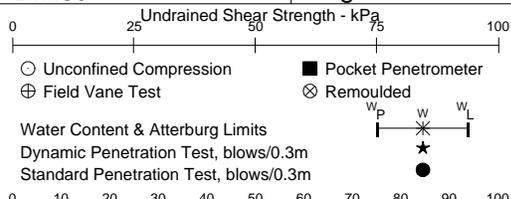
Client	Public Works & Government Services Canada	Proj No.	10456.73	BOREHOLE BH18-05 Page 1 of 1
Project	Geotechnical Investigation	Date Drilled	06.Feb.2018	
Location	Lameque Wharf, Lameque NB

DEPTH m	SAMPLE				LOG	DESCRIPTION	Undrained Shear Strength - kPa
	No	TYPE	N (RQD)	REC (mm)			
0					0.22 CONCRETE SLAB	3.65	
					0.32 FILL	3.55	
1	1	S	101	75	Red to brown sand and gravel Sandstone fill, weak		
2	2	S	29	350			
3	3	S	10	300			
4	4	S	10	300			
5							
6	5	S	10	200			
7	6	S	6	325			
					7.01 SAND and SILT	-3.14	
					7.16 Grey to black sand and silt, some shells	-3.29	
					MUDSTONE BEDROCK		
8	8	HQ	63	1499	Red to brown mudstone bedrock		
9							
10	9	HQ	68	1520			
					10.90	-7.03	
					End of borehole at 10.9 metres below existing top of deck

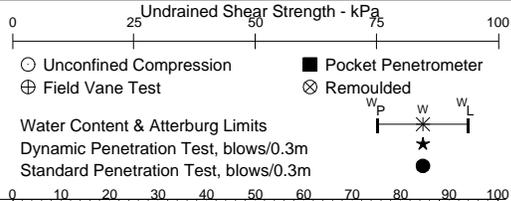
Client	Public Works & Government Services Canada	Proj No.	10456.73	BOREHOLE BH18-06 Page 1 of 1
Project	Geotechnical Investigation	Date Drilled	06.Feb.2018	
Location	Lameque Wharf, Lameque NB

DEPTH m	SAMPLE				LOG	DESCRIPTION	Undrained Shear Strength - kPa
	No	TYPE	N (RQD)	REC (mm)			
0						0.22 CONCRETE SLAB 3.63	
						0.32 FILL 3.53	
						Red to brown sand and gravel Sandstone fill, weak	
1	1	S	83	575	[Cross-hatched pattern]		
	2	S	27	350			
2	3	S	13	350			
	4	S	15	425			
3							
	5	S	6	350			
4							
	6	S	10	250			
5							
	7	S	3	350			
6							
	8	S	33	0		7.19 SILT -3.34 Grey to brown clayey silt	
7							
	9	HQ	55	1346		8.08 MUDSTONE BEDROCK -4.23 Red to brown mudstone bedrock	
8							
	10	HQ	48	1473			
9							
	11	HQ	90	1520			
10							
	12					12.37 -8.52 End of borehole at 12.4 metres below existing top of deck

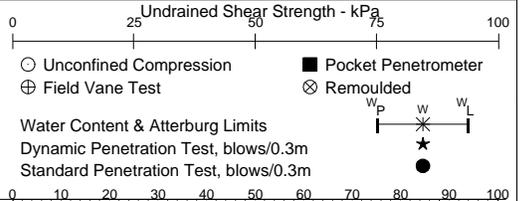
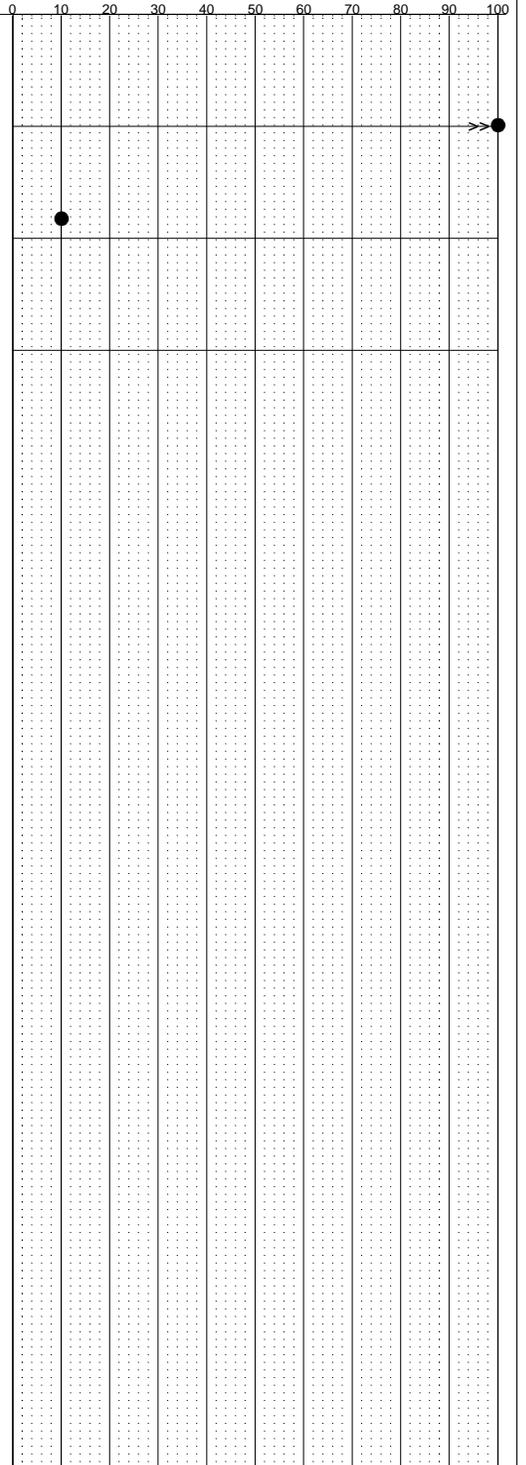
BH18-07
Page 1 of 1

DEPTH m	SAMPLE				LOG	DESCRIPTION
	No	TYPE	N (RQD)	REC (mm)		
0					0.22	CONCRETE SLAB 3.59
					0.32	FILL 3.49
						Red to brown sand and gravel Sandstone fill, weak
1	1	S	101	120		
	2	S	10	300		
2						
3					3.05	0.76

End of borehole at 3.1 metres below existing top of deck
Borehole was terminated due to encountering an unknown object

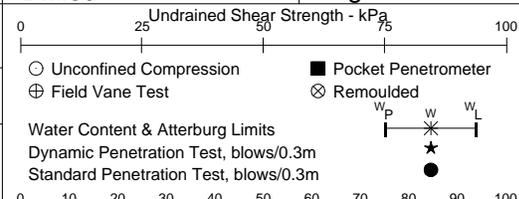
Client	Public Works & Government Services Canada	Proj No.	10456.73	BOREHOLE BH18-08 Page 1 of 2
Project	Geotechnical Investigation	Date Drilled	07.Feb.2018	
Location	Lameque Wharf, Lameque NB

DEPTH m	SAMPLE				LOG	DESCRIPTION	SPT
	No	TYPE	N (RQD)	REC (mm)			
0					0.22	CONCRETE SLAB	3.60
					0.32	FILL	3.50
						Red to brown sand and gravel Sandstone fill, weak	
1	1	S	101	200			
	2	S	9	400			
2							
	3	S	22	300			
3							
	4	S	7	225			
4							
	5	S	6	250			
5							
	6	S	8	200			
6							
	7	S	11	200			
7							
	8	S	33	300	7.92	GLACIAL TILL	-4.10
8					8.53	Red to brown silty sand and gravel, trace clay	-4.71
						MUDSTONE BEDROCK	
						Red to brown mudstone bedrock	
9							
	9	S	15	400			
10							
	10	HQ	10	151			
11							
	11	HQ	20	965			
12							
	12	HQ	0	200			
13

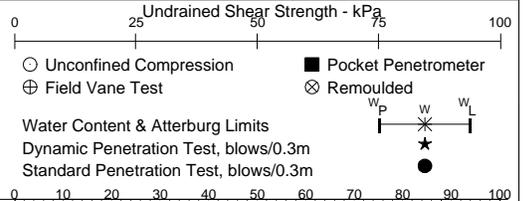
BH18-09
Page 1 of 2

DEPTH m	SAMPLE				LOG	DESCRIPTION	SPT	
	No	TYPE	N (RQD)	REC (mm)				
0					0.22 CONCRETE SLAB	3.62		
					0.32 FILL	3.52		
					Red to brown sand and gravel Sandstone fill, weak			
1	1	S	101	100				
	2	S	7	250				
2								
3	3	S	19	350				
						Lab Testing: Gravelly sand, some silt (AASHTO A-1-b)		
4								
5	4	S	6	250				
6								
7								
8	5	S	7	150				
9	6	S	3	200				
10								
11	7	S	14	175		7.92 SILTY SAND	-4.09	
					8.38 Grey to black silty sand	-4.55		
12	8	S	20	550	GLACIAL TILL			
					Red to brown sandy silt, some gravel, trace clay			
13	9	S	32	400				
					Lab Testing: Sandy silt, trace gravel (AASHTO A-4 to A-7)			
14	10	S	36	400				
15	11	S	26	0				
16	12	S	48	0				
17					11.88 MUDSTONE BEDROCK	-8.05		
18	13	HQ	0	787	Red to brown mudstone bedrock

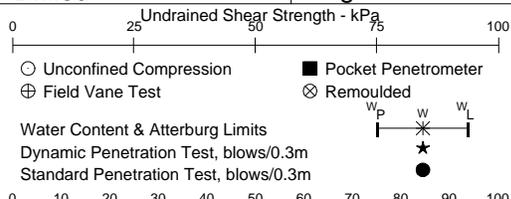
Client	Public Works & Government Services Canada	Proj No.	10456.73	BOREHOLE BH18-10 Page 1 of 2
Project	Geotechnical Investigation	Date Drilled	08.Feb.2018	
Location	Lameque Wharf, Lameque NB

DEPTH m	SAMPLE				LOG	DESCRIPTION	SPT
	No	TYPE	N (RQD)	REC (mm)			
0					0.22 CONCRETE SLAB	3.62	
					0.32 FILL	3.52	
					Red to brown sand and gravel Sandstone fill, weak		
1							
2	1	S	9	250			
3							
4	2	S	4	100			
5							
6	3	S	8	300			
7							
8	4	S	9	225			
9	5	S	5	200			
10	6	S	5	200			
11	7	S	5	300			
12	8	S	2	250	9.14	-5.31	
13	9	S	10	500			
14	10	S	16	300			
15	11	S	20	400	11.43	-7.60	
16					GLACIAL TILL		
17	12	S	18	0	Red to brown silty sand and gravel, trace clay		
18	13	S	19	350

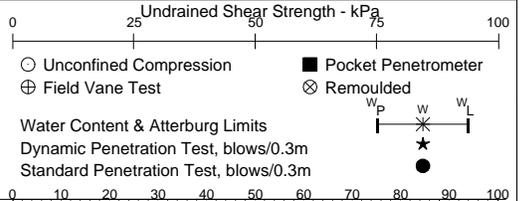
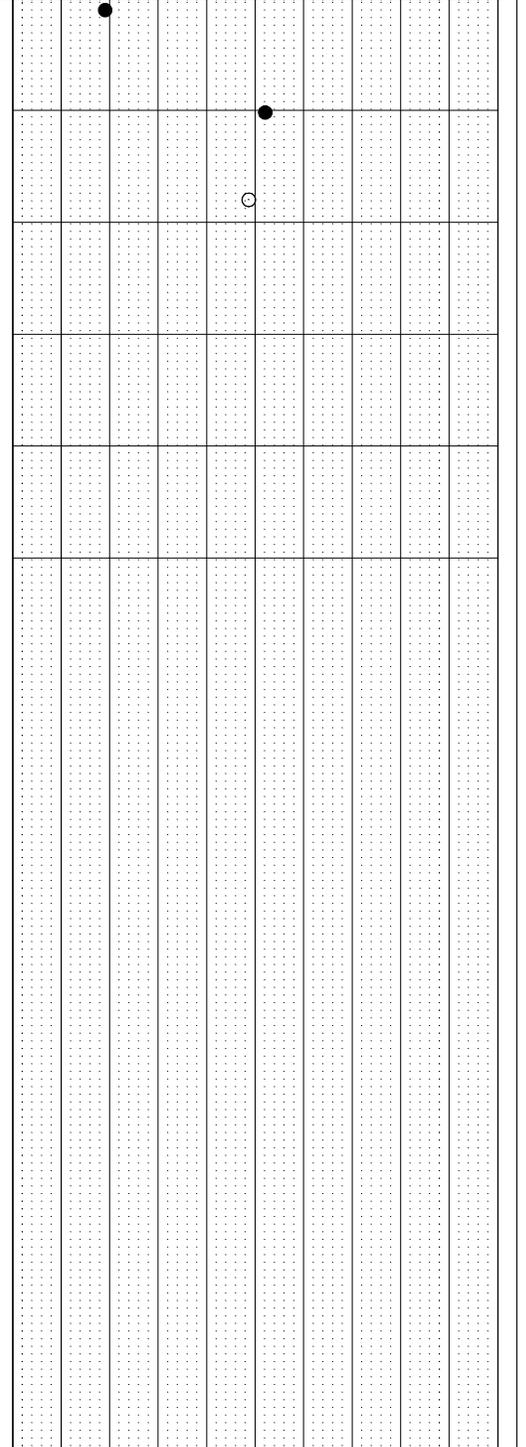
BH18-10
Page 2 of 2

DEPTH m	SAMPLE				LOG	DESCRIPTION
	No	TYPE	N (RQD)	REC (mm)		
13						
14	14	S	52	150		13.97 -10.14 MUDSTONE BEDROCK Red to brown mudstone bedrock
15	15	HQ	42	1346		
16	16	HQ	82	1520		
17	17	HQ	35	1473		16.69 -12.86 SANDSTONE BEDROCK Grey fine-grained sandstone bedrock
18						18.39 -14.56 End of borehole at 18.4 metres below existing top of deck

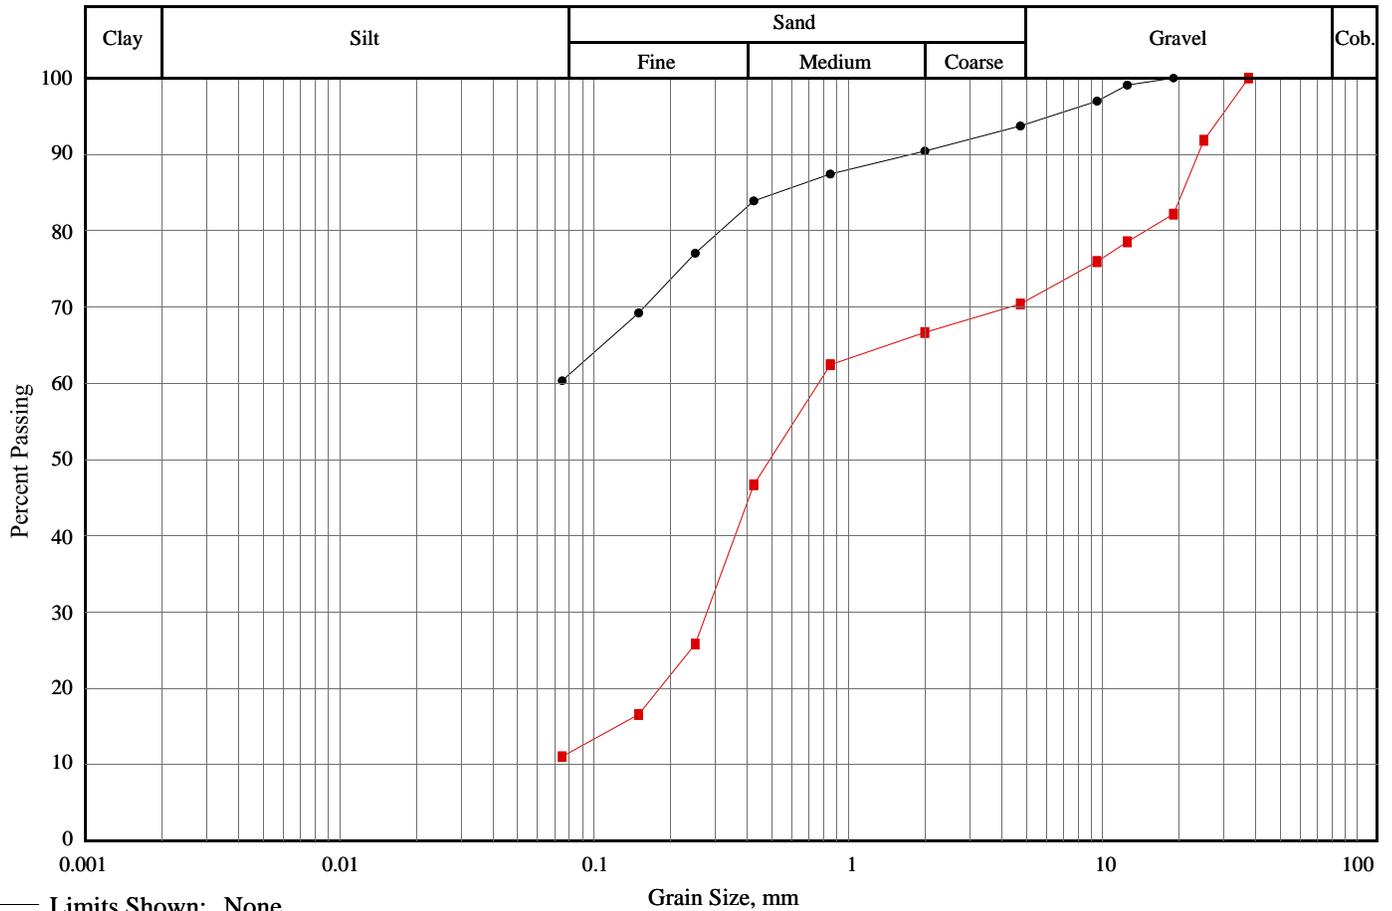
Soils Grading Chart

Line Symbol	Description	Borehole/ Test Pit	Sample Number	Depth	% Cob.+ Gravel	% Sand	% Silt	% Clay	Date Sampled
—●—	GLACIAL TILL	BH18-09	S10	10.0-10.6m	6.3	33.4	60.3		18/02/15
—■—	SANDSTONE FILL	BH18-09	S3	3.0-3.6m	29.6	59.4	11.0		18/02/15

Line Symbol	Sample Description	AASHTO	D ₁₀	D ₁₅	D ₅₀	D ₈₅	% 5-75µm
—●—	Sandy silt , trace gravel	A-4 to A-7	---	---	---	0.53	---
—■—	Gravelly sand , some silt	A-1-b	---	0.12	0.49	20.59	---

Laboratory index testing undertaken on two representative samples of the glacial till shows that the material comprises 6 to 30% gravel, 33 to 59% sand, and 11 to 60% silt and clay sized particles. The moisture contents of the glacial till ranges from approximately 13 to 17%.

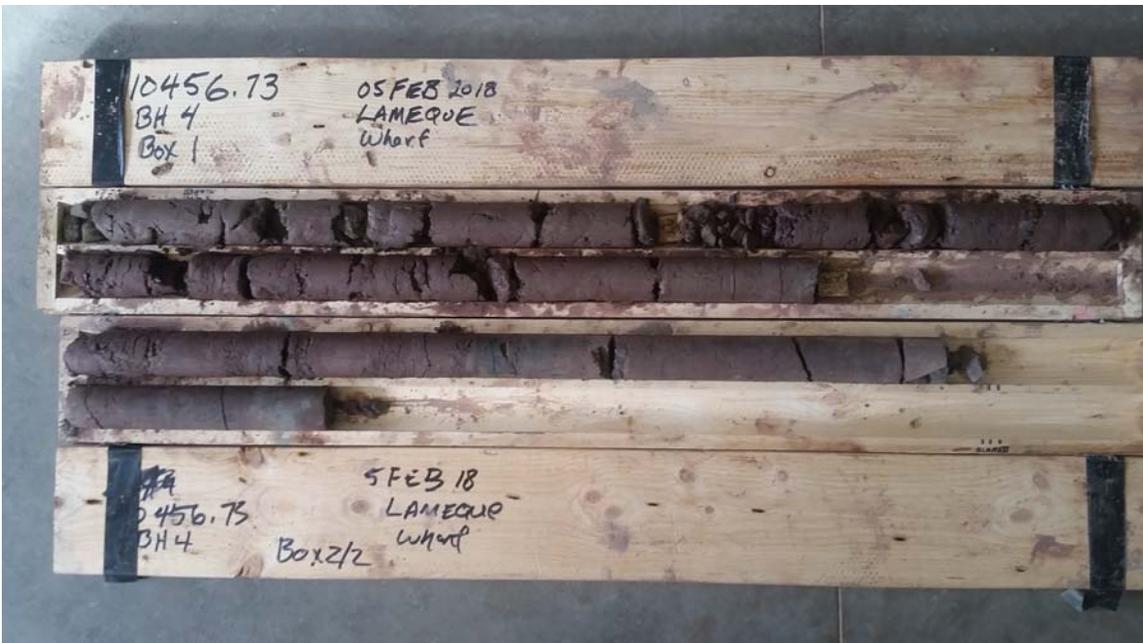
Mudstone bedrock extracted from BH18-04. 6.4 to 10.4 metres below existing top of deck.

Red to brown mudstone bedrock was encountered in all boreholes, except BH18-07 which was terminated prior to reaching bedrock elevations. Based on RQD values averaging 52%, the overall quality of the mudstone bedrock can be described as poor and severely fractured with close fracture spacing (60 to 200 millimetres).

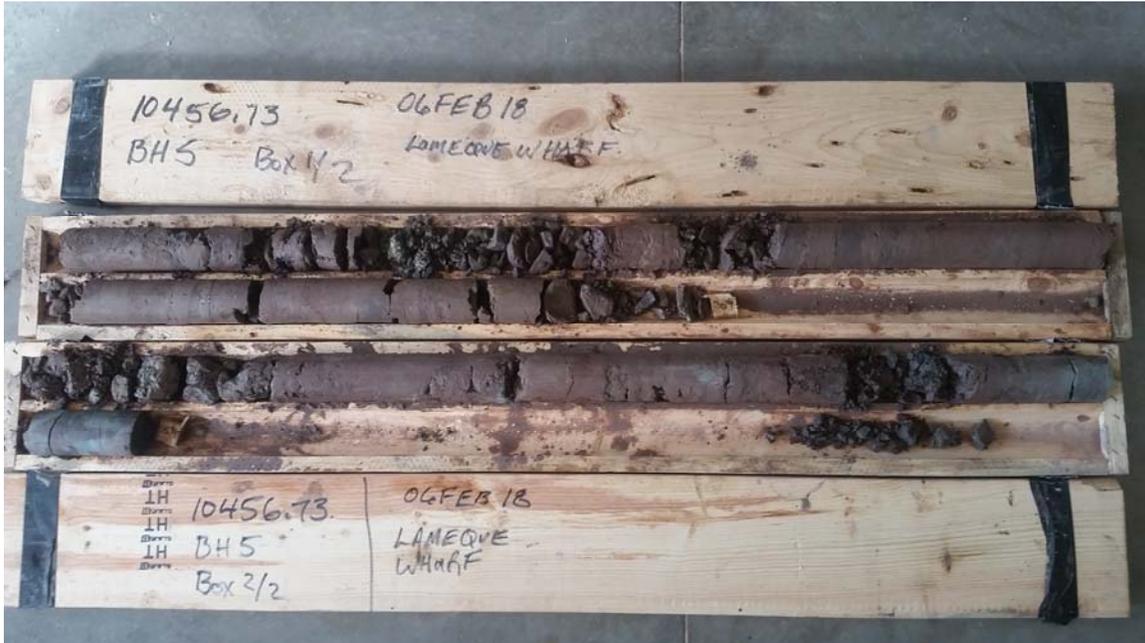
Mudstone bedrock extracted from BH18-05. 7.2 to 10.9 metres below existing top of deck.

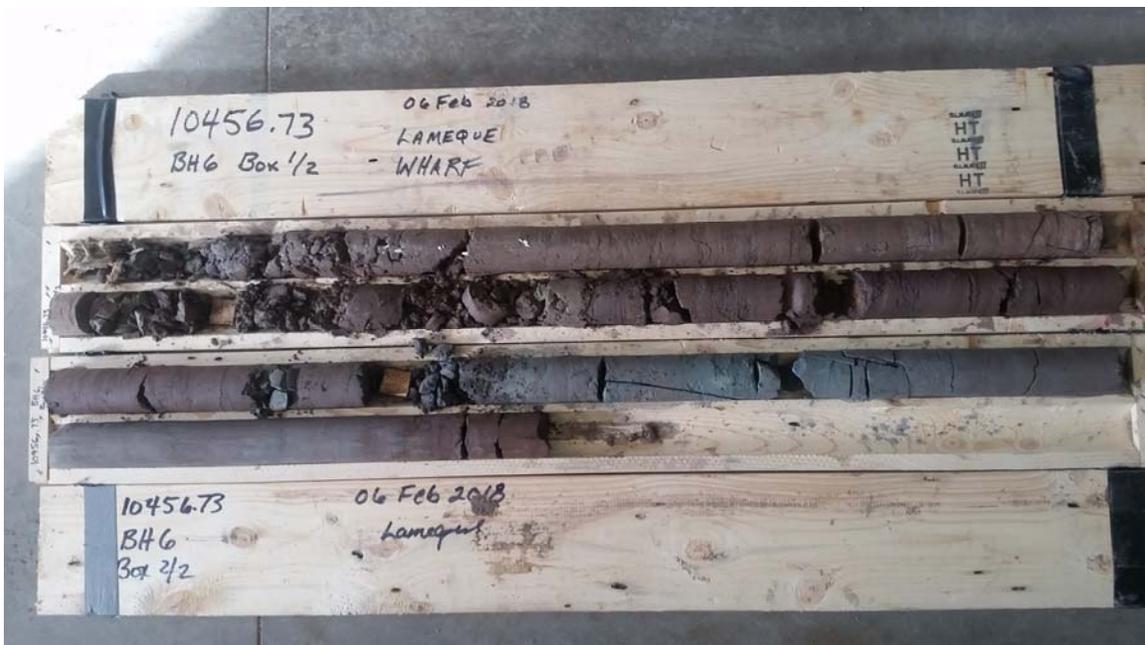
Mudstone bedrock extracted from BH18-06. 8.1 to 12.4 metres below existing top of deck.

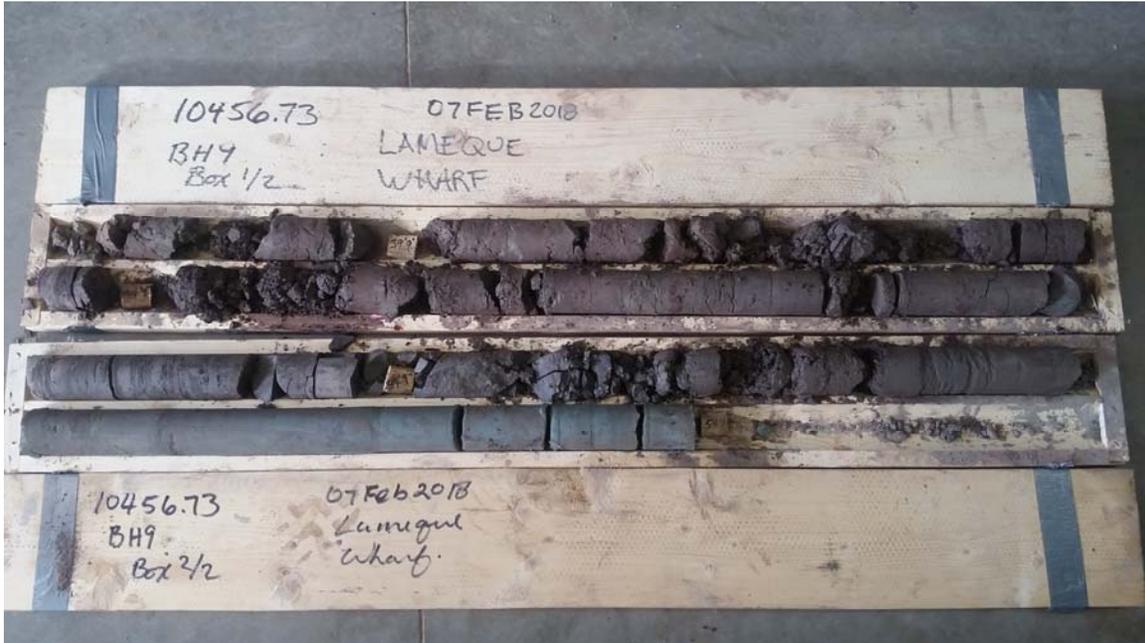
Mudstone bedrock extracted from BH18-09. 11.9 to 16.7 metres below existing top of deck.

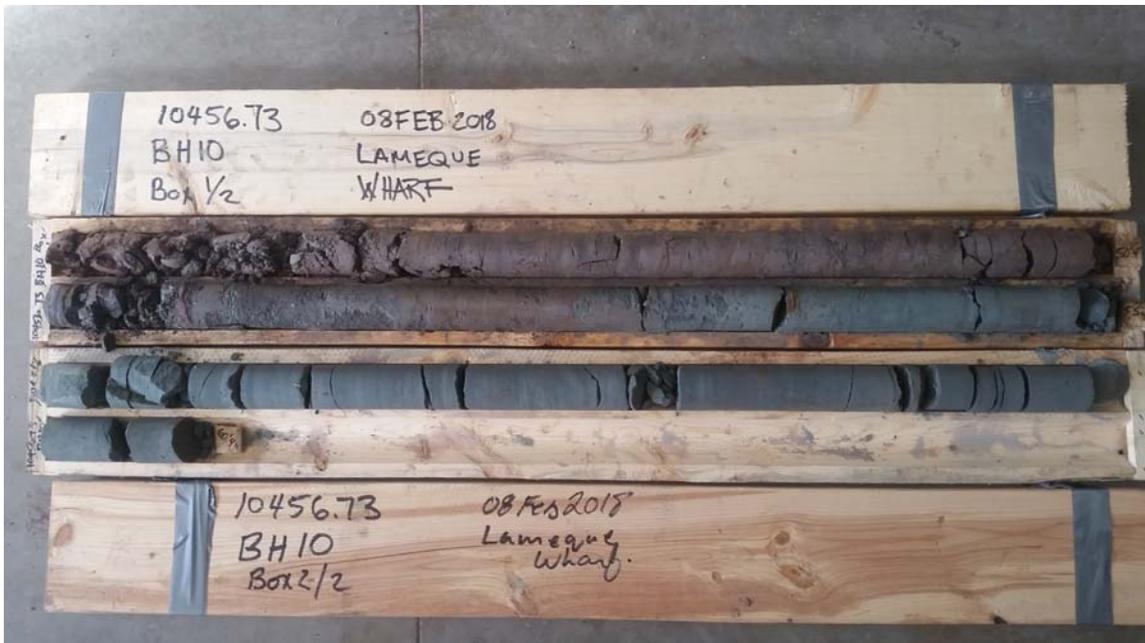
Bedrock extracted from BH18-10. Mudstone: 14.0 to 16.7 metres below existing top of deck. Sandstone: 16.7 to 18.4 metres below existing top of deck.

Grey fine-grained sandstone bedrock was encountered overlying the mudstone bedrock of BH18-01 and underlying the mudstone bedrock of BH18-10. RQD values of 30 and 35%, respectively, indicate that the overall quality of the encountered sandstone bedrock is poor and severely fractured with close fracture spacing (60 to 200 millimetres).
