12 March 2014
Levelton File # R714-0308-00

**RE: GEOTECHNICAL ASSESSMENT
HIGHWAY NO. 4 – PACIFIC RIM NATIONAL PARK**

As requested, Levelton Consultants Ltd. (Levelton) has carried out a geotechnical assessment relating to two specific sections of Highway 4 within the Pacific Rim National Park that have been performing poorly. The sections included approximately 300 m of southbound lane near Station 16+000 (as measured from the southern limit of the park) and approximately 50 m of southbound lane near Station 13+000.

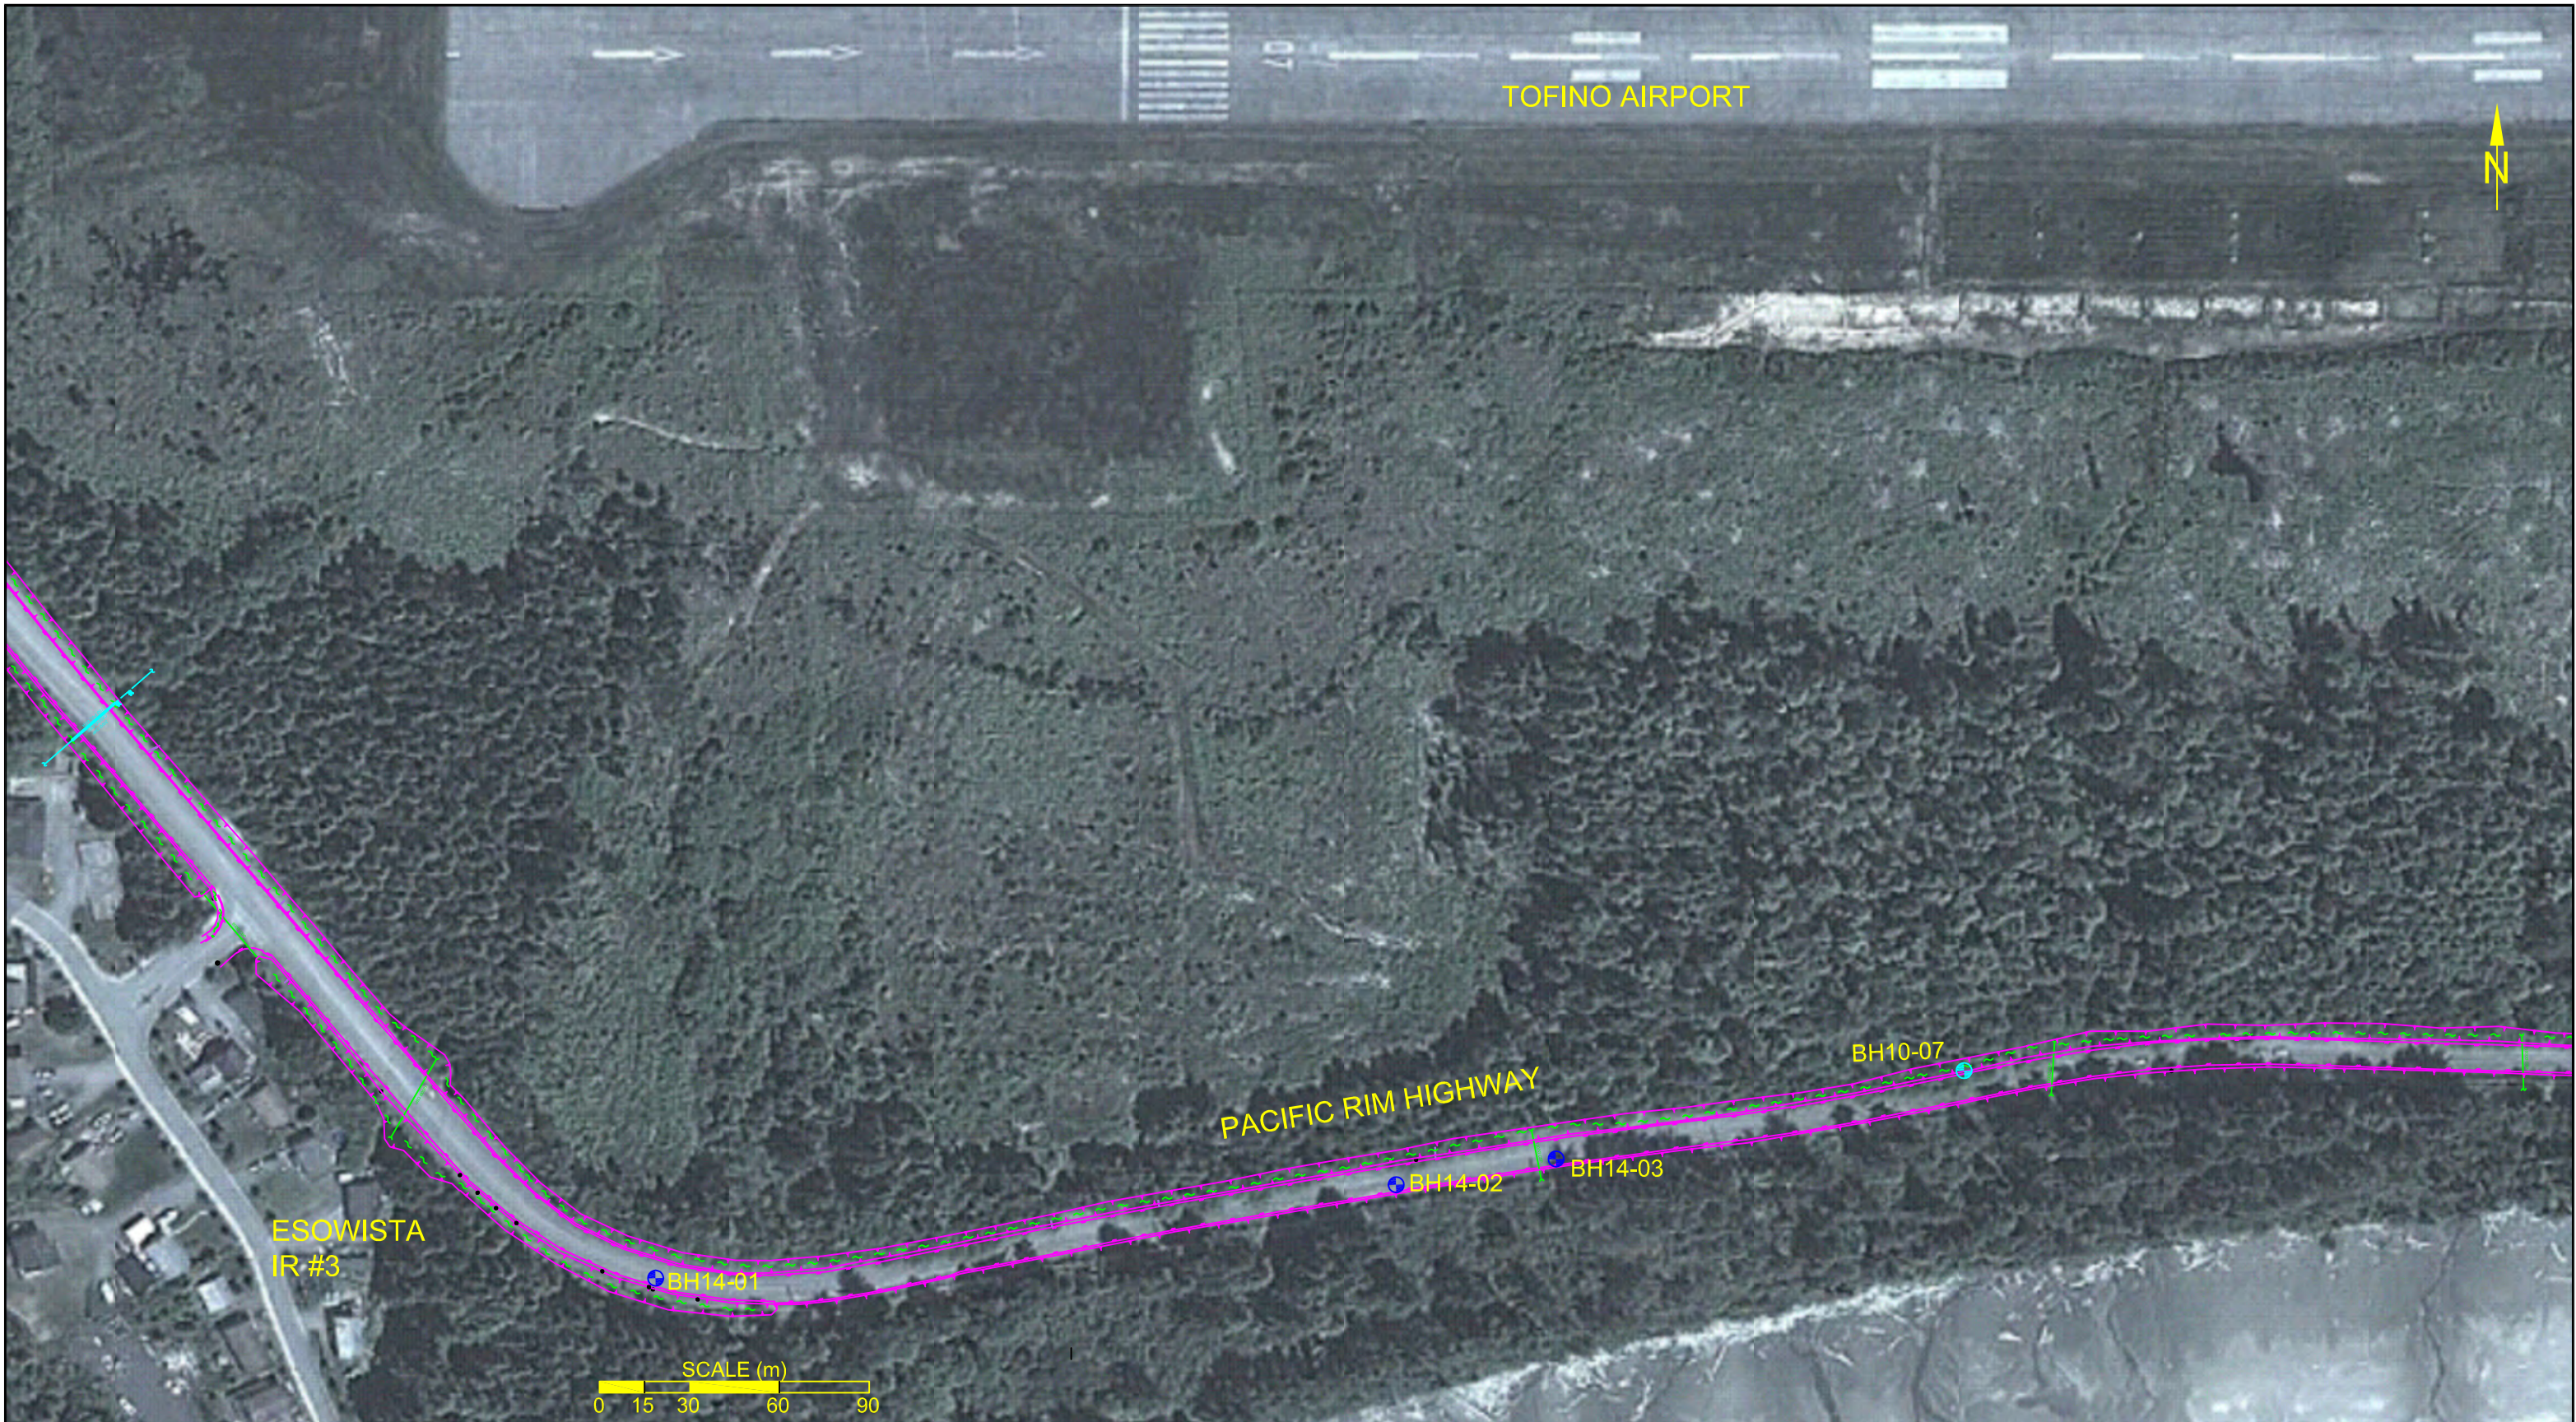
FIGURE NO.:
2

Four boreholes (BH14-01 through BH14-04) were advanced as part of the current assessment at the approximate locations shown on Figures 2 and 3. The boreholes were located in areas where there was visible distress (i.e., cracks) in the east bound lane of the road.

PROJECT:	GEOTECHNICAL ASSESSMENT HIGHWAY NO. 4 - PACIFIC RIM NATIONAL PARK, TOFINO, BC
CLIENT:	WSP CANADA INC.
TITLE:	BOREHOLE LOCATION PLAN - FOR BH14-01, 02, AND 03
THIS DRAWING IS THE SOLE PROPERTY OF LEVELTON CONSULTANTS LTD. AND CANNOT BE USED OR DUPLICATED IN ANY WAY WITHOUT THE EXPRESSED WRITTEN CONSENT OF LEVELTON. THE GENERAL CONTRACTOR SHALL VERIFY ALL DIMENSIONS AND REPORT ANY DISCREPANCIES OR OMISSIONS TO LEVELTON.

In 2010, Levelton carried out a subsurface assessment near the eastern part of this section as part of a sewer project. As part of that project, a borehole (BH10-07) was drilled and logged by Levelton about 140 m east of the area on the north side of the road. At that time, the conditions in the borehole consisted of 180 mm of layered asphalt, overlying 580 mm of sand and gravel fill, overlying organic silt. A significant amount of wood debris was encountered at the surface of the organic silt. The approximate location of BH10-07 is shown on Figure 2 and the summary borehole log is attached for reference.

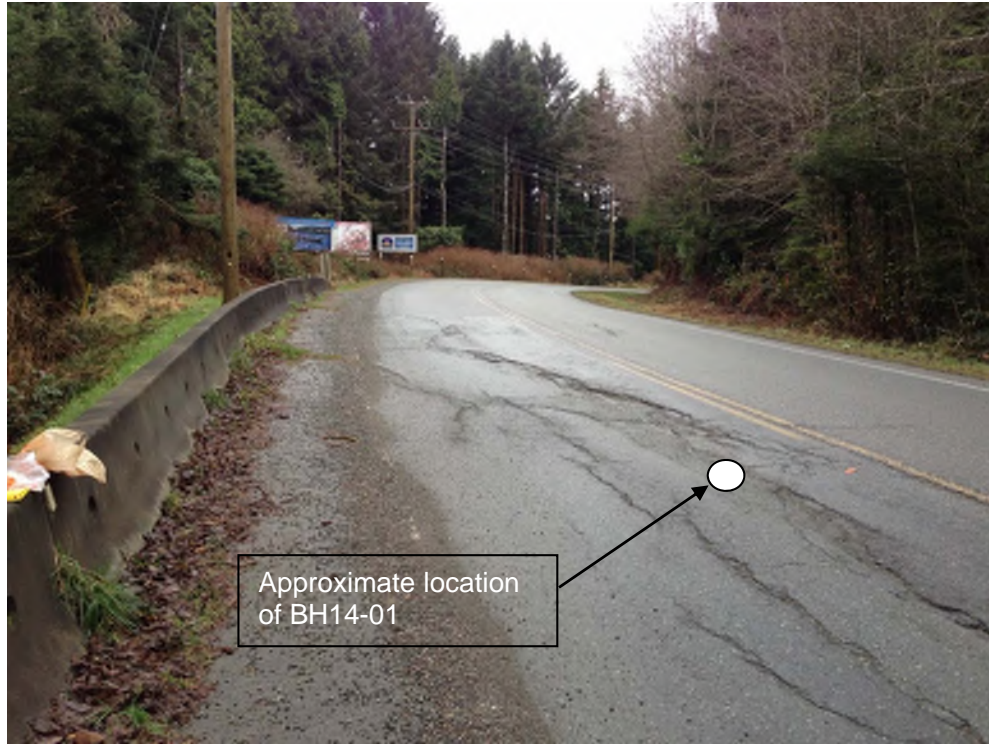
This section of highway was about 300 m in length and had various sections of the east bound lane that appeared to be performing poorly. The worst area appeared at the westernmost part of this section near the Esowista Reserve. This area was a curved and sloped section of road where the terrain sloped down from north to south and from west to east. Concrete barriers (“no-posts”) lined the south shoulder of the road and the terrain dropped down steeply to the south to about 6 m in elevation below of the concrete barriers.

Photo 1: Condition of road on eastbound lane near Esowista IR #3 (11 February 2014)

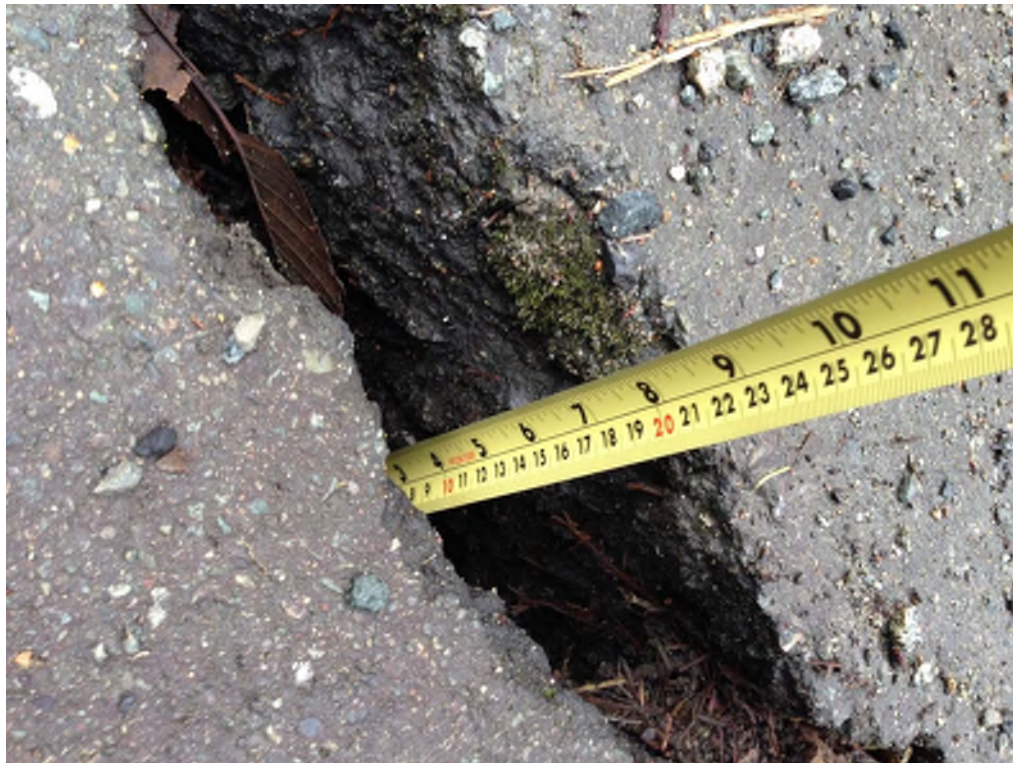
Several large longitudinal cracks were observed in this area. The cracks were open at the surface, with the most obvious near the south shoulder where the crack had opened about 60 mm. A tape measurer could reach to a depth of 200 mm before encountering resistance.

Photo 2: Open crack in south shoulder of road near BH14-01 (11 February 2014)

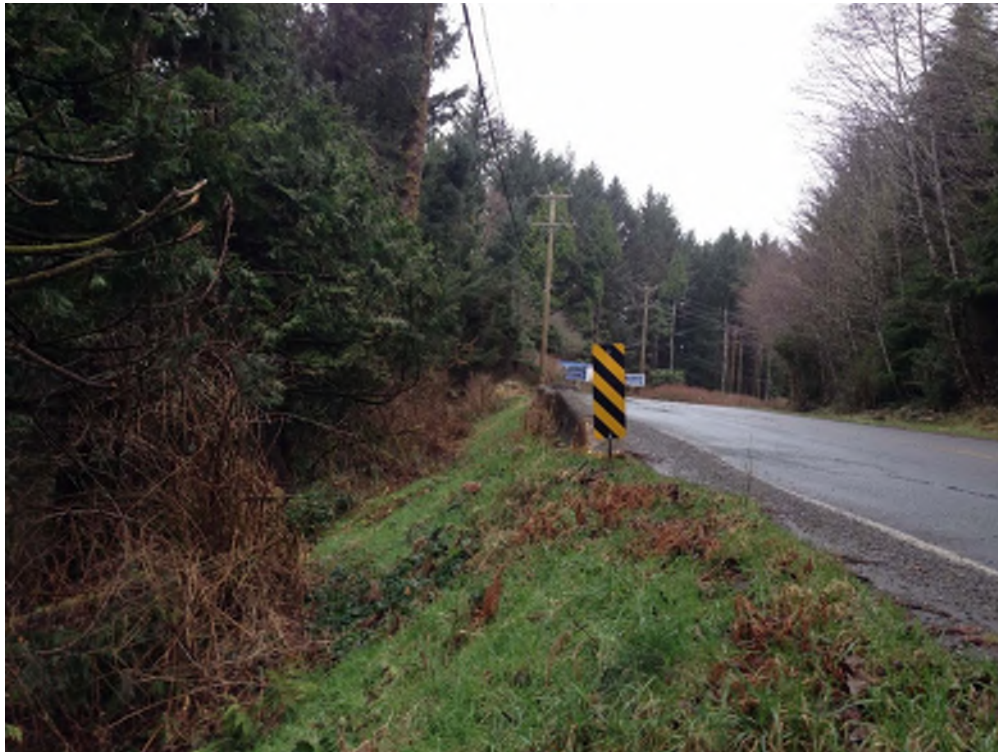
Photo 3: Road embankment slope south of BH14-01 (11 February 2014)

If the road cannot be reconstructed at this time, some localized improvements could be carried out. These would include repair of existing culverts along with localized unloading which would involve removing layers of existing asphalt and replacing localized poor soils with lightweight backfill. If this is the only option that is considered at this time, light weight pumice fill soils should be incorporated into a geosynthetically confined soil (GCS) system. GCS is a layered network of closely spaced soil (200 mm thick) confined between layers of geotextile. The GCS would provide increased shear strength to support areas that are locally steep and would buffer settlements across the road. This would be best suited for the high embankment and locally steep embankment areas that were encountered at BH14-01 and BH14-04.

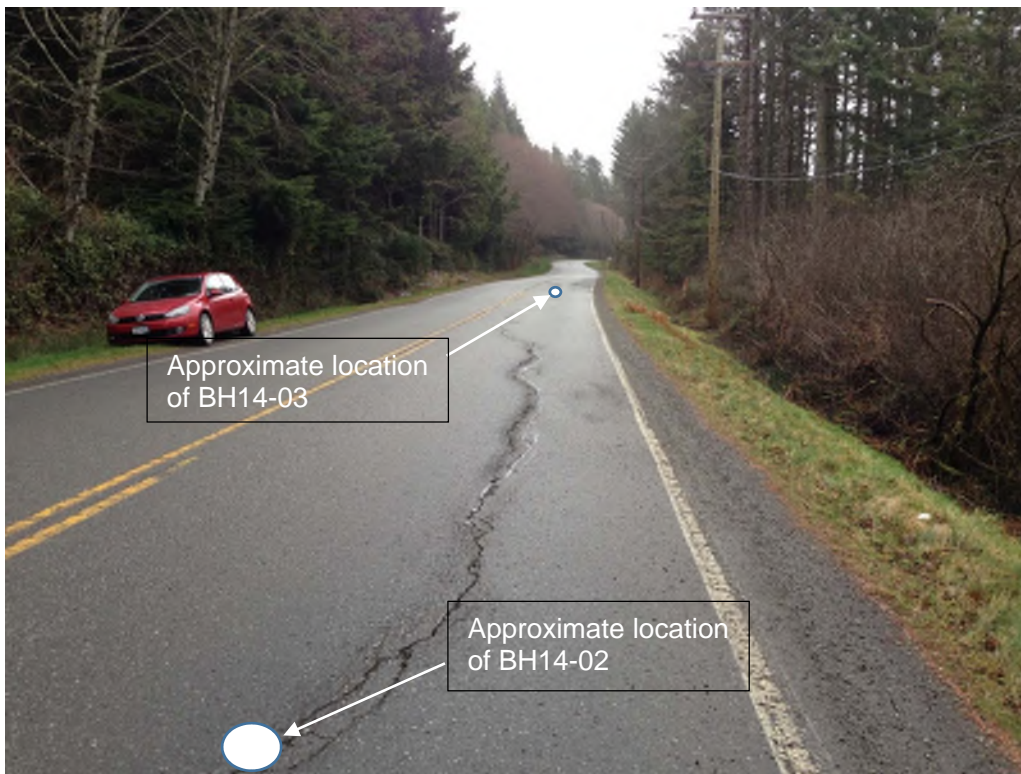
As described above, the 1.2 m diameter culvert that was located near BH14-02 and BH14-03 has flows entering the inlet but not exiting the pipe. As such, it is likely corroded and is allowing water to enter into the road fill prism and subgrade. This condition could lead to future stability issues if the water scours and removes fill and subgrade material during high flows and washes out parts of the road.

Photo 4: View looking east of open crack in road near BH14-02 and BH14-03 (11 February 2014)

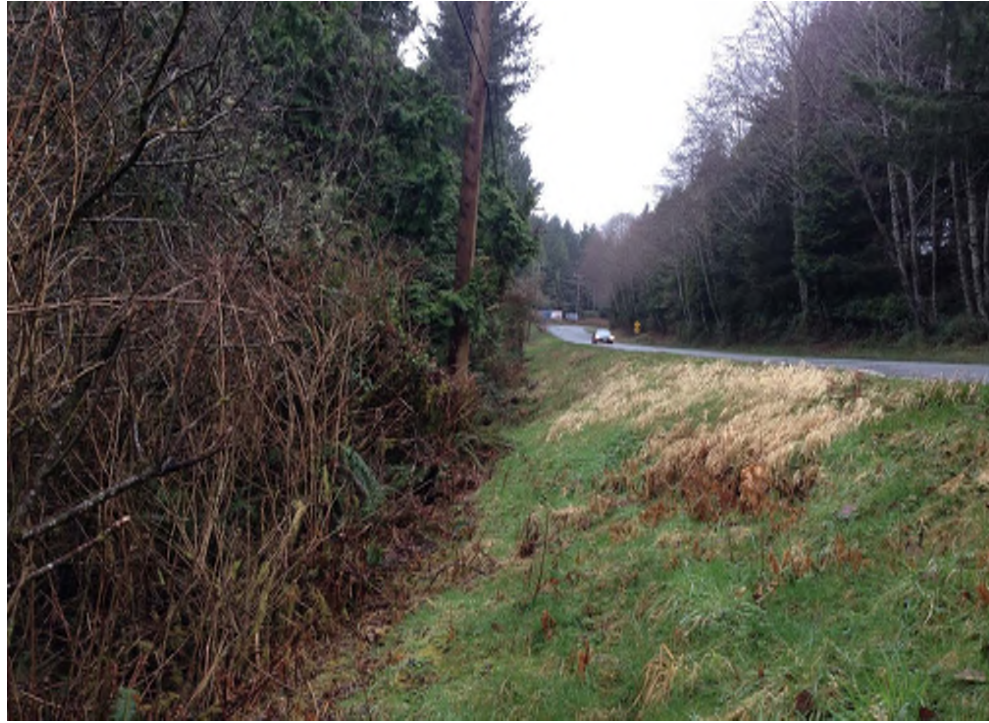
Photo 5: Road embankment slope south of BH14-01 (11 February 2014)

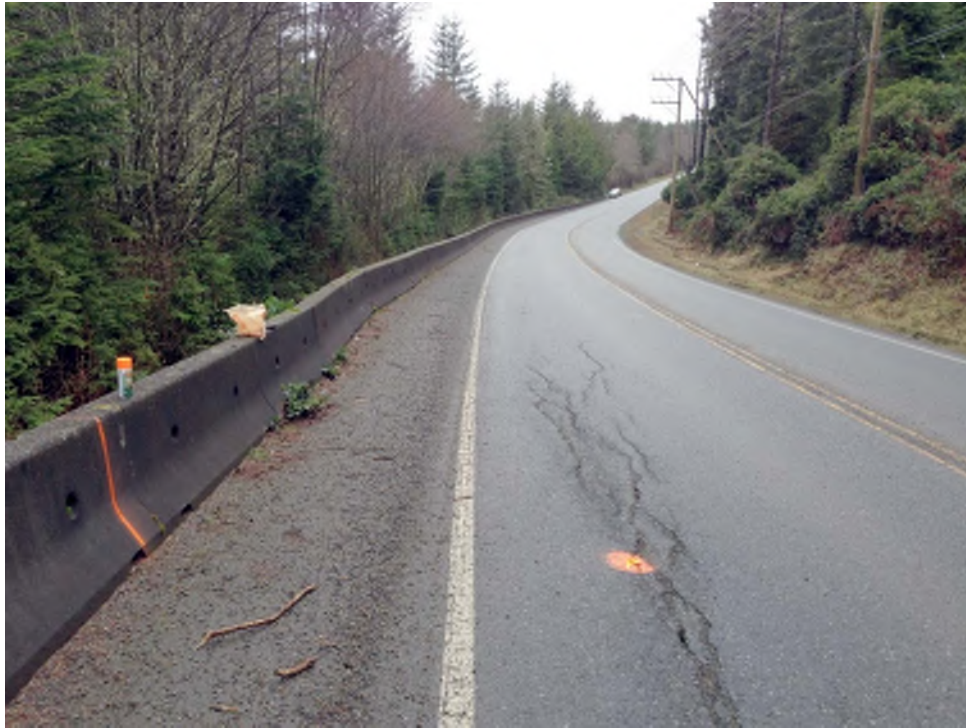
The section of highway at Station 13+000 was sloped and curved. The terrain sloped down from the north to south and from the east to west. No-post concrete barriers lined the south side of the road. There was a linear crescent-shaped crack, about 30 to 50 m in length, along the south side of the road. The crack was open at the surface about 12 mm in some areas. Adjacent to the crack, the shoulder of the road was relatively narrow and the terrain dropped down steeply about 10 m in elevation to the south from within about 300 mm from the outside edge of the no-post barriers.

Photo 7: View looking west at road condition near BH14-04 (11 February 2014)

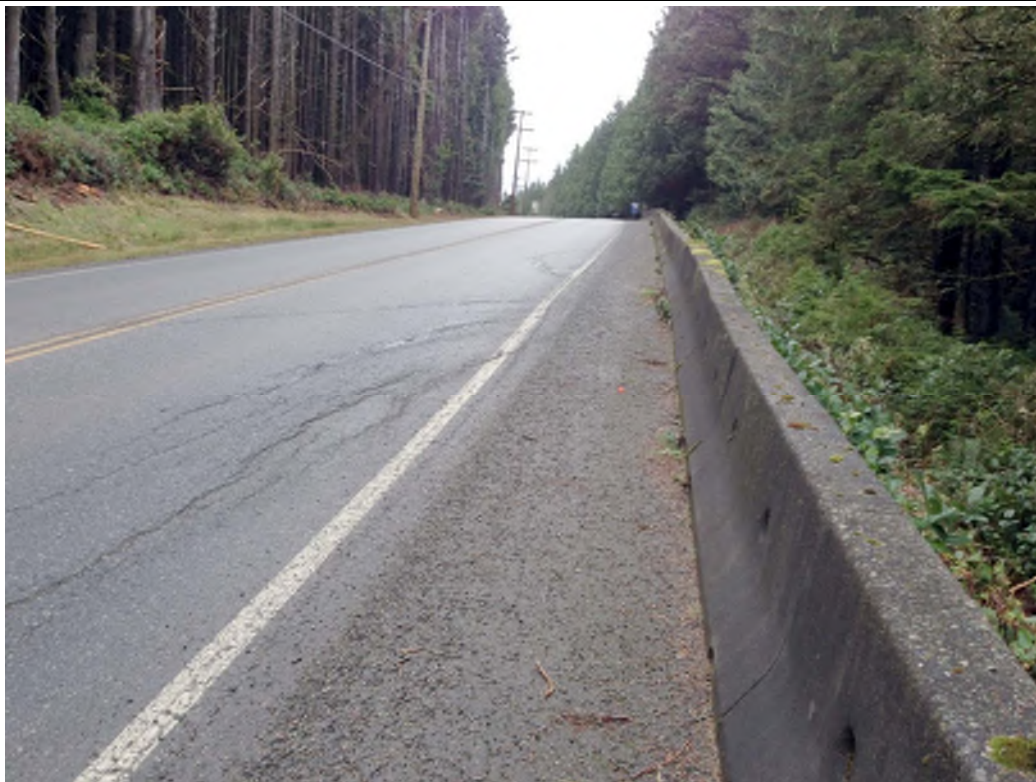
Photo 8: View looking east at road condition near BH14-04 (11 February 2014)

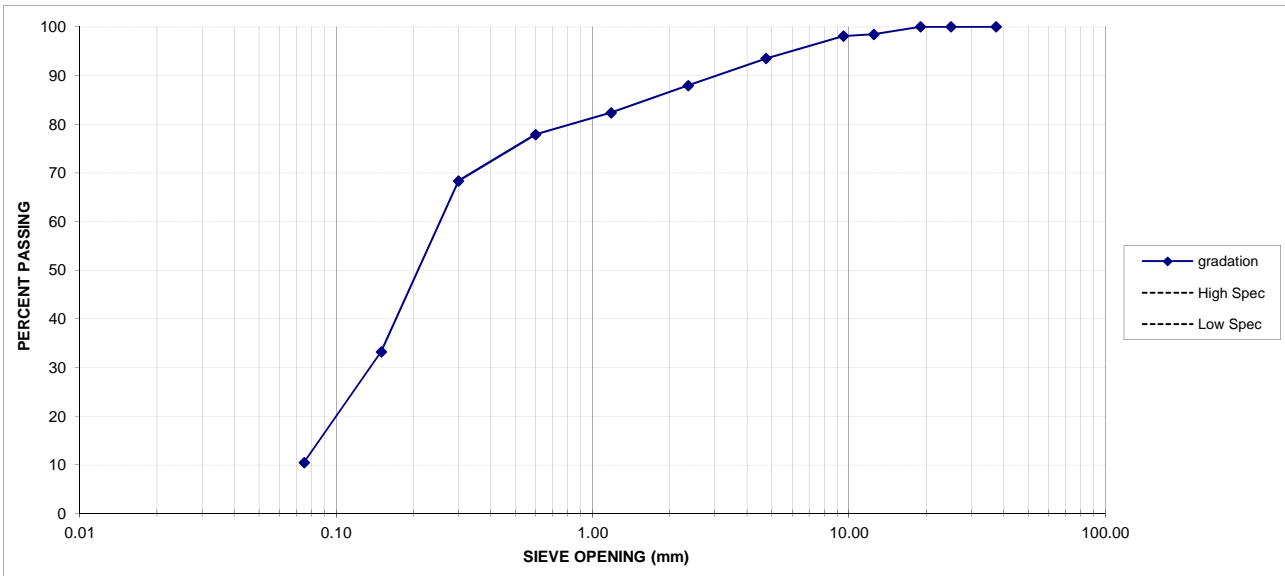
AGGREGATE GRADATION:

The above noted grain size analysis is based upon a percentage by mass. Within the 'sand' component, there was a significant amount of wood debris, estimated to be about 50% by volume.

Sieve	% Passing
37.5	100.0
25	100.0
19	100.0
12.5	98.5
9.50	98.1
4.75	93.5
2.36	87.9
1.18	82.4
0.600	77.9
0.300	68.4
0.150	33.3
0.075	10.5

REMARKS: Tested in accordance with ASTM C- 136 and C-117
Wood Debris observed to be approximately 50%
by volume retained on the 2.36mm sieve.
