# Remedial Action Plan Lead Paint and Lead Impacted Soil Abatement

*Camp Robin Hood in Rouge National Urban Park*

**Golder Associates Ltd.**

August 2018

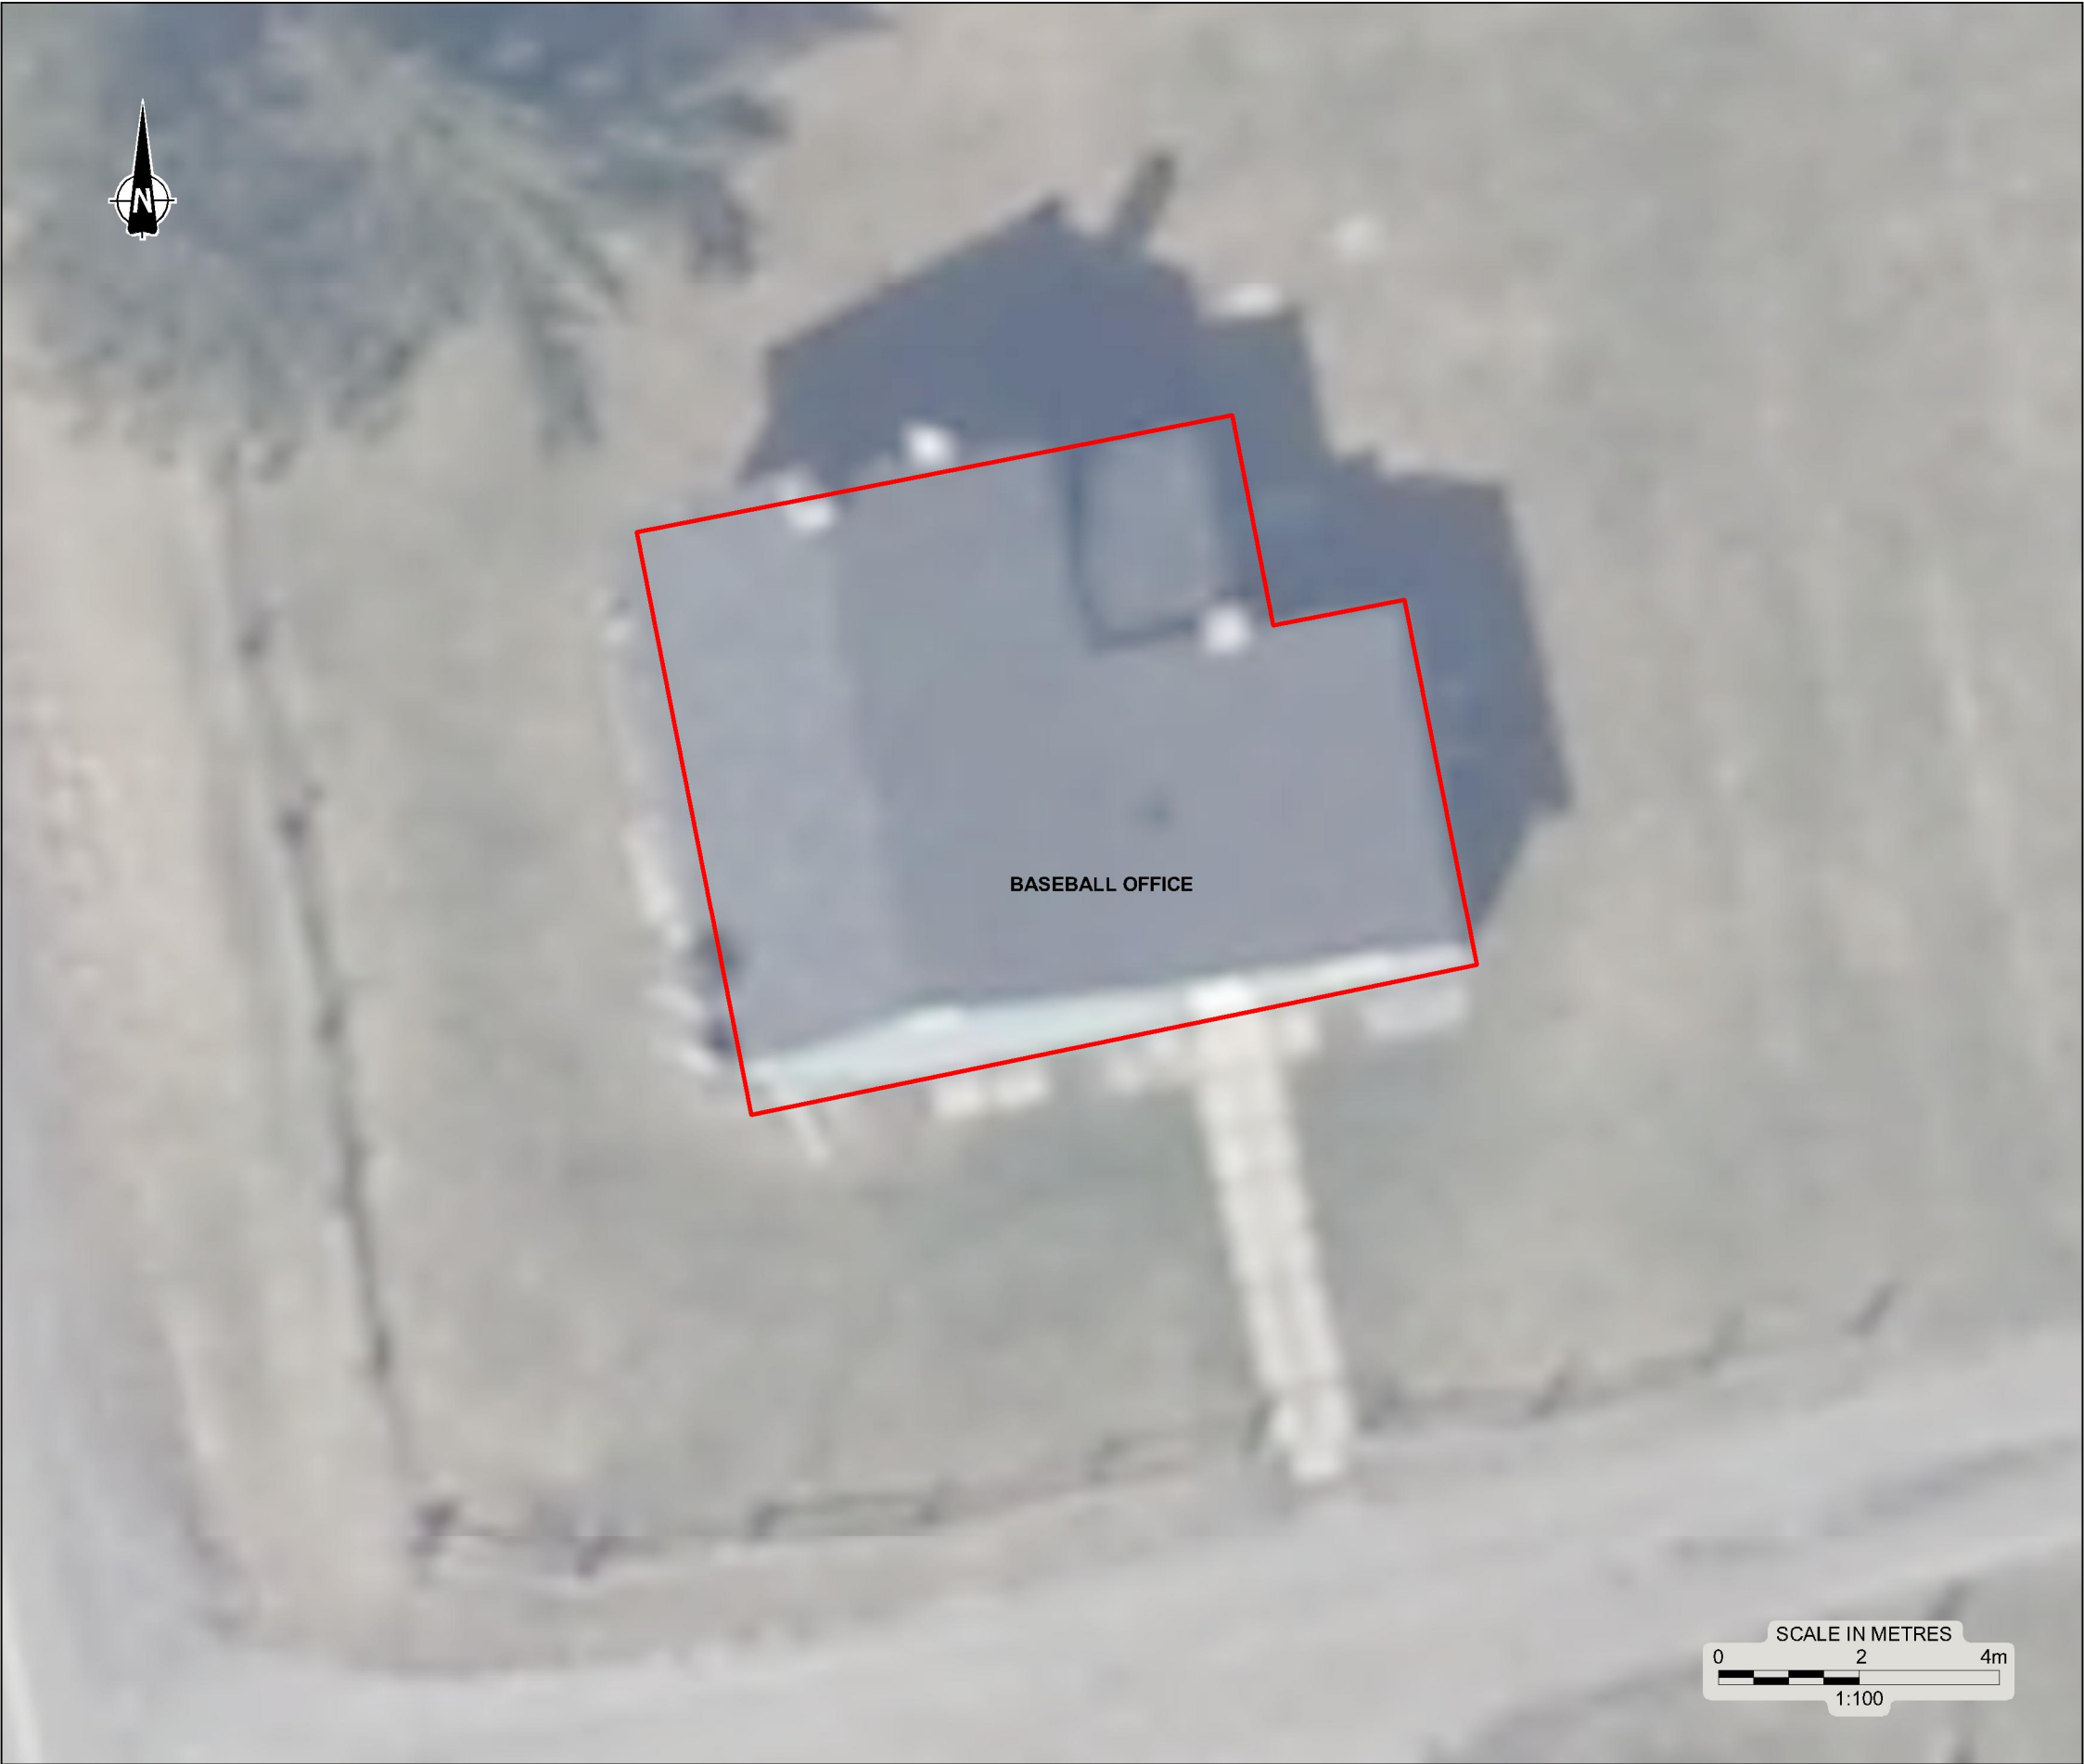
- LEAD BASED PAINT SURFACE AREA REQUIRING ABATMENT USING PEEL AWAY LEAD PAINT REMOVAL SYSTEM

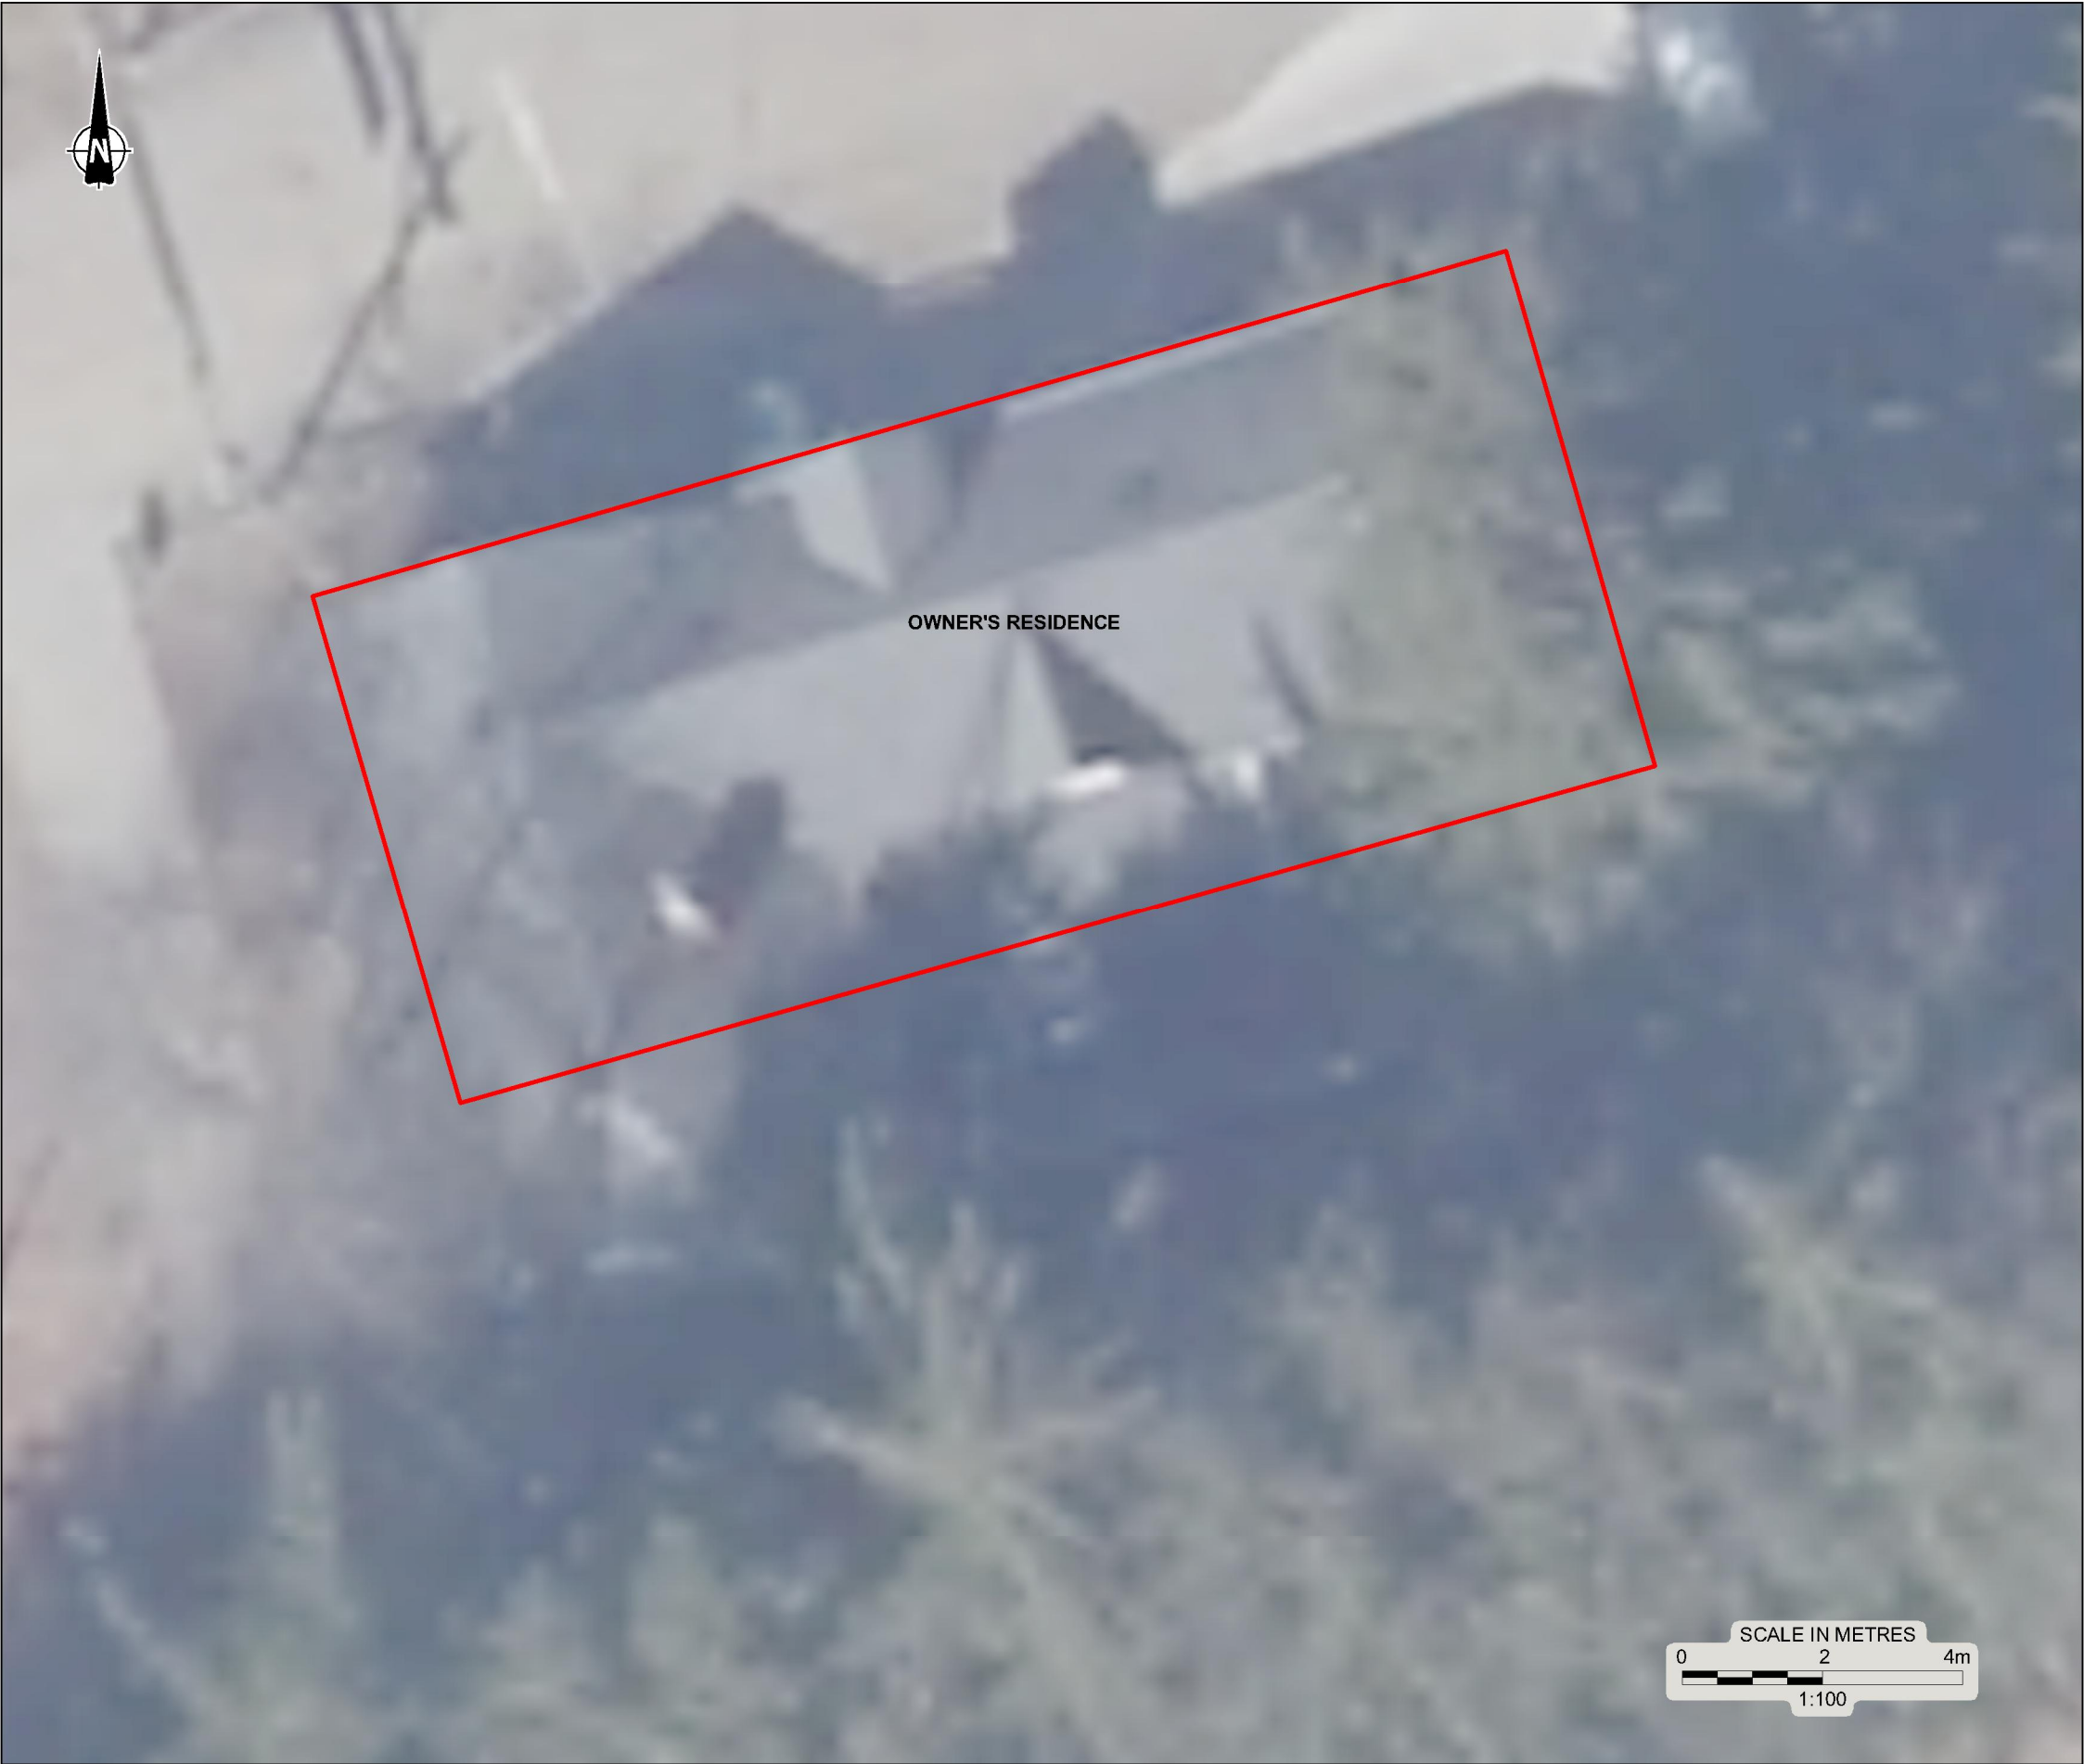
- [Red Polygon] LEAD BASED PAINT SURFACE AREA REQUIRING ABABTEMENT USING PEEL AWAY LEAD PAINT REMOVAL SYSTEM

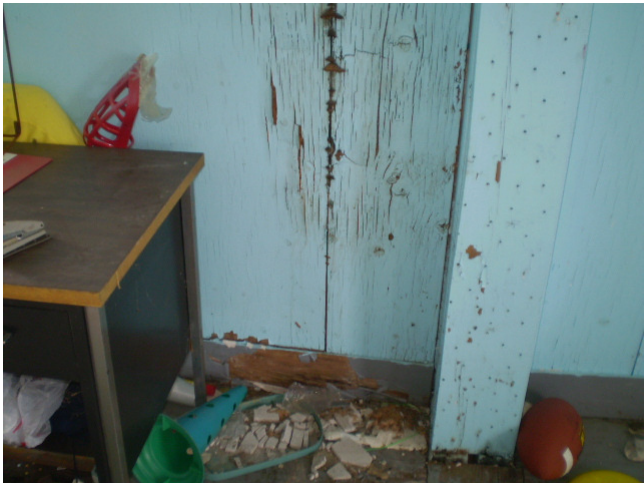
**Photograph 17:** Damaged wall surface on the interior of the sports building.

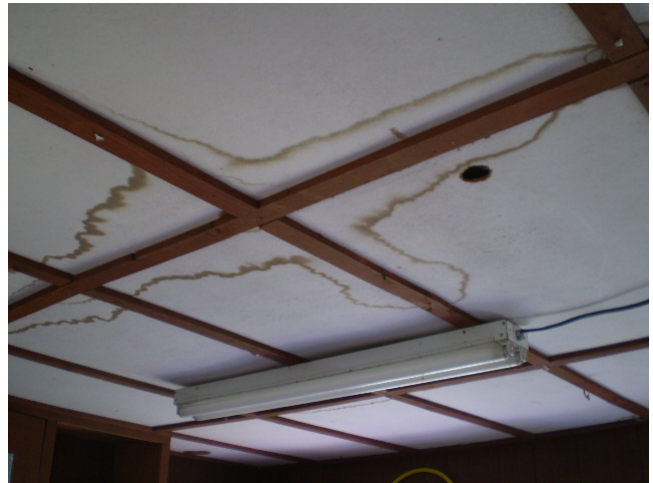
**Photograph 18:** Water staining observed in the camp craft building.

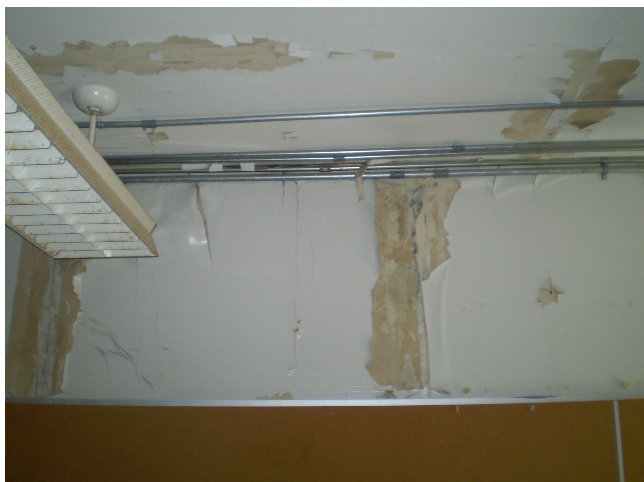
**Photograph 19:** Cracked and peeling paint in the southern portion of the cooper dome.

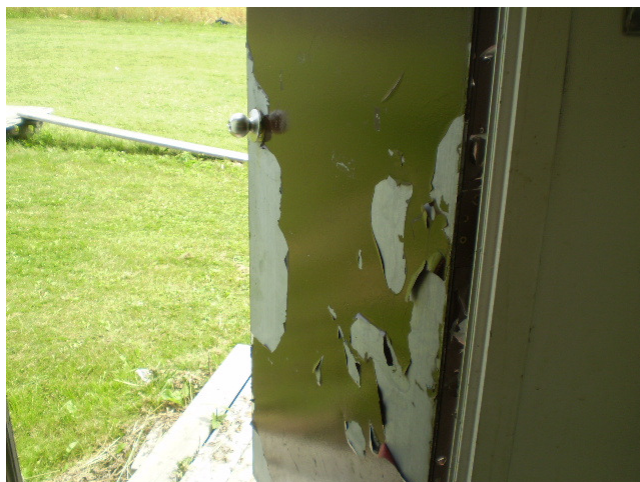
**Photograph 20:** Cracked and peeling door paint of the sports building.

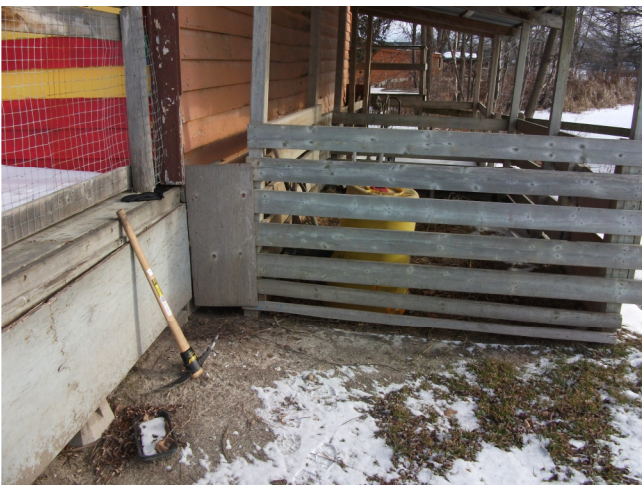
**Photograph 29:** A view of the soil sample obtained from the southwest corner of the Program building where cracked and peeling lead-based paint was identified (SS-110-5).

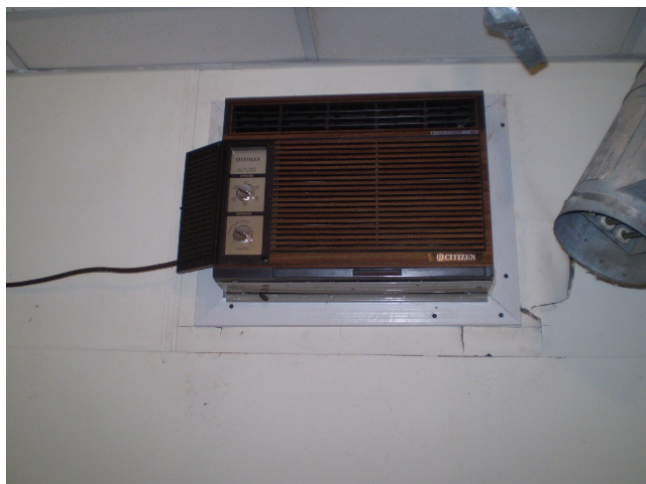
**Photograph 45:** Potential ODS containing air conditioning unit located in the portable located to the east of the Friar Tuck building.

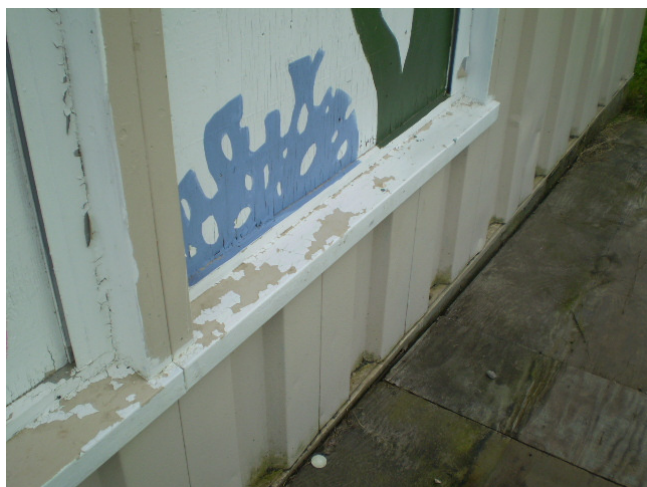
**Photograph 46:** Cracking and peeling paint located on the window sill of the portable to the east of the Friar Tuck building.
