Parks Canada Basic Impact Analysis

Maintenance Garage, Fundy National Park.

The project site is located inside Fundy National Park Compound Maintenance, Trades and Storage Facility, accessible from NB Highway 114 in Fundy National Park, Alma, New Brunswick. The project site coordinates are 45.597°N, 64.9541°W (see Figures 1 and 2 for the project location).

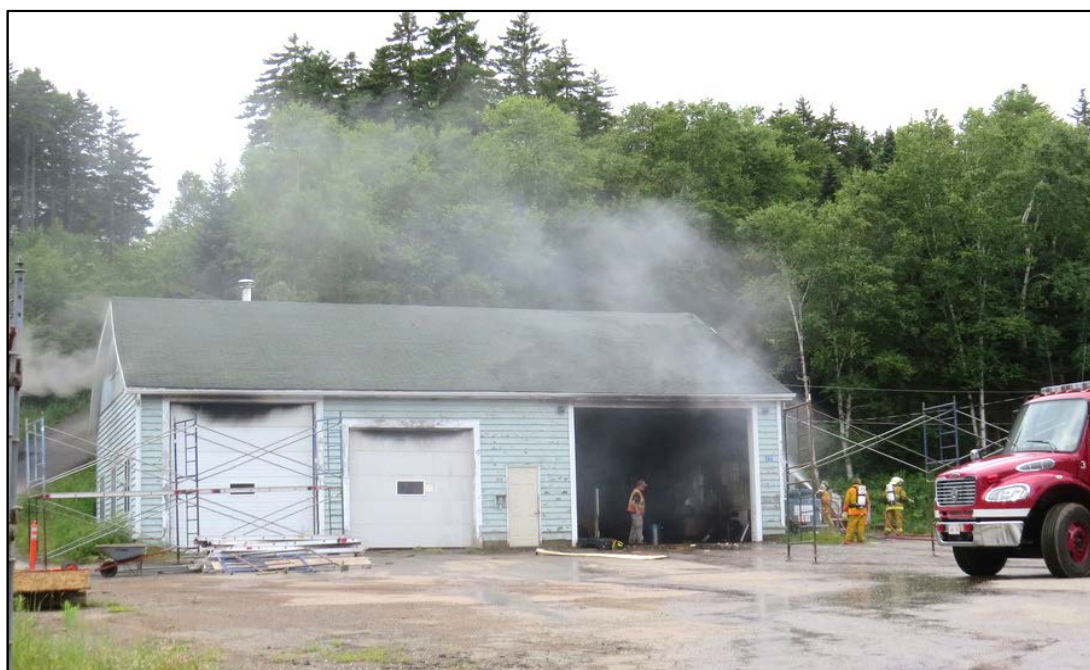
Figure 3: View of the maintenance garage while on fire on July 28, 2014

On July 28, 2014, firefighters from Alma, Riverside-Albert and Hillsborough responded to a small fire in the maintenance garage at Fundy National Park (Figure 3). The fire started near an electrical panel, but there was only heavy smoke and no visible flames. One wall and a window were damaged, along with the electrical panel and a welder.

Following a structural assessment of the building, it was determined that it should be decommissioned. A building demolition and petroleum hydrocarbon remediation report was produced by Stantec (2016) after the complete demolition of the building. The report reveals that all contamination has been remediated, which include the removal of exterior lead paint prior to the demolition, the removal of a concrete underground tank identified east of the former garage and the assessment of its footprint for petroleum hydrocarbon impacts; and the remediation of any identified or potential petroleum hydrocarbon impacts following building demolition including any stains, in order to improve site conditions in accordance with federal standards. Stantec personnel did not observe any unacceptable impacts to the surrounding ground surface as a result of the exterior lead paint removal and subsequent general clean-up activities. The results of confirmatory soil sampling from the remedial excavation areas completed by Stantec indicate that unacceptable risks to human and ecological receptors are not expected. Petroleum hydrocarbon impacts above provincial or federal guidelines were not identified in groundwater samples. As a result, the report concluded that no further assessment or remediation at the maintenance garage area is required. However, if future construction projects require soil to be removed from the site, it should be tested to determine appropriate disposal options. Base on a review of previous work conducted by Conestega-Rover and Associates for the general area at the Fundy maintenance compound, outstanding environmental concerns may still be present at the Fundy maintenance compound. A review of these outstanding concerns should be completed to assess any additional environmental assessment or remediation requirements for the compound, including the decommissioning of previously installed monitoring wells.

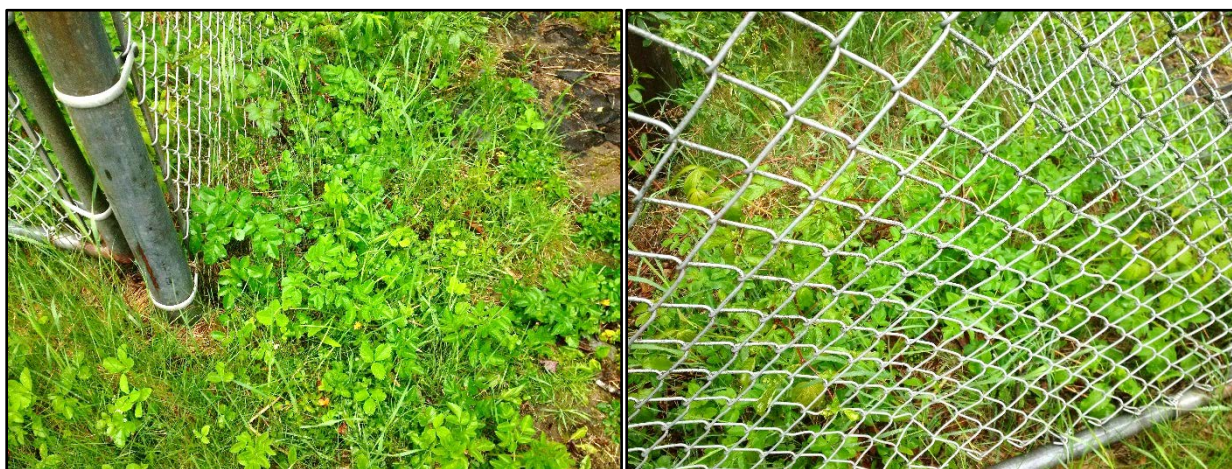
Figures 11-12: Location of woodland angelica around the electrical substation

The proximity of the project with specimens of woodland angelica, a tall (1-3 m) and robust perennial plant, might be problematic as its sap is rich of an organic chemical compounds, furanocoumarins, that can cause skin rashes and blisters when exposed to ultraviolet light, including sunlight. Native to most of Europe and Western Asia, this tall, purple-stemmed herbaceous plant was intentionally introduced as a garden herb in the 18th century. In North America, the species is only known from New Brunswick, Nova Scotia, Quebec and Ontario. Woodland angelica reproduces by seed and also spread by rhizomes (Appendix IV). During a site visit, this species was located near the chain-link fence surrounding the electrical substation (Figures 11-12). The successful Contractor will be responsible to eradicate populations of invasive plant species that fall within the project limits prior to the start of construction. Eradication efforts must follow the guidelines provided in the Fundy National Park Invasive Plant Action Plan.
